AA2346.00
Greenridges, 99 Ballam Road, Lytham

Historic Building Recording: July 2018

Sanderson Borland Architects

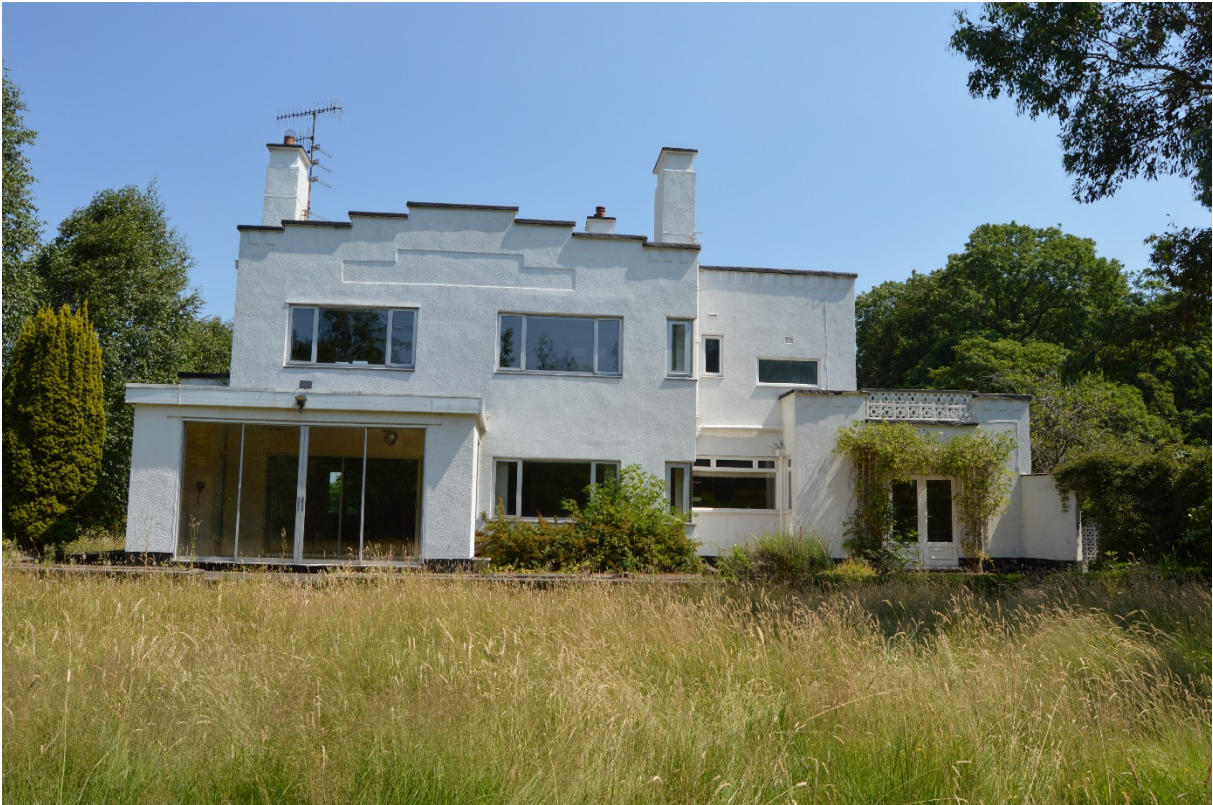
Plate 5 West elevation of Greenridges (photo 021)

The layout of bays for the west elevation unsurprisingly mirrors that of the principal east elevation, with four ground floor bays and three first floor bays, adhering as before to reduced massing (*plate 5*). Ground floor bays from north to south comprise the conservatory (obscuring the lounge save for a single wrap-around light at the north edge of the elevation), lights to the dining room, a light on the north side of the kitchen/diner and an entrance on the south side of the kitchen/diner. This division within the kitchen/diner reflects an original sub-division in this area of the house between a northerly service area and more southerly storage compartments (discussed in *c. interior*, below). At first floor level, on the same vector, bays are apparent for the master bedroom, bedroom 1 and the bathroom and shower room combined. The roof terrace extends across to the west elevation to allow views of the rear garden.

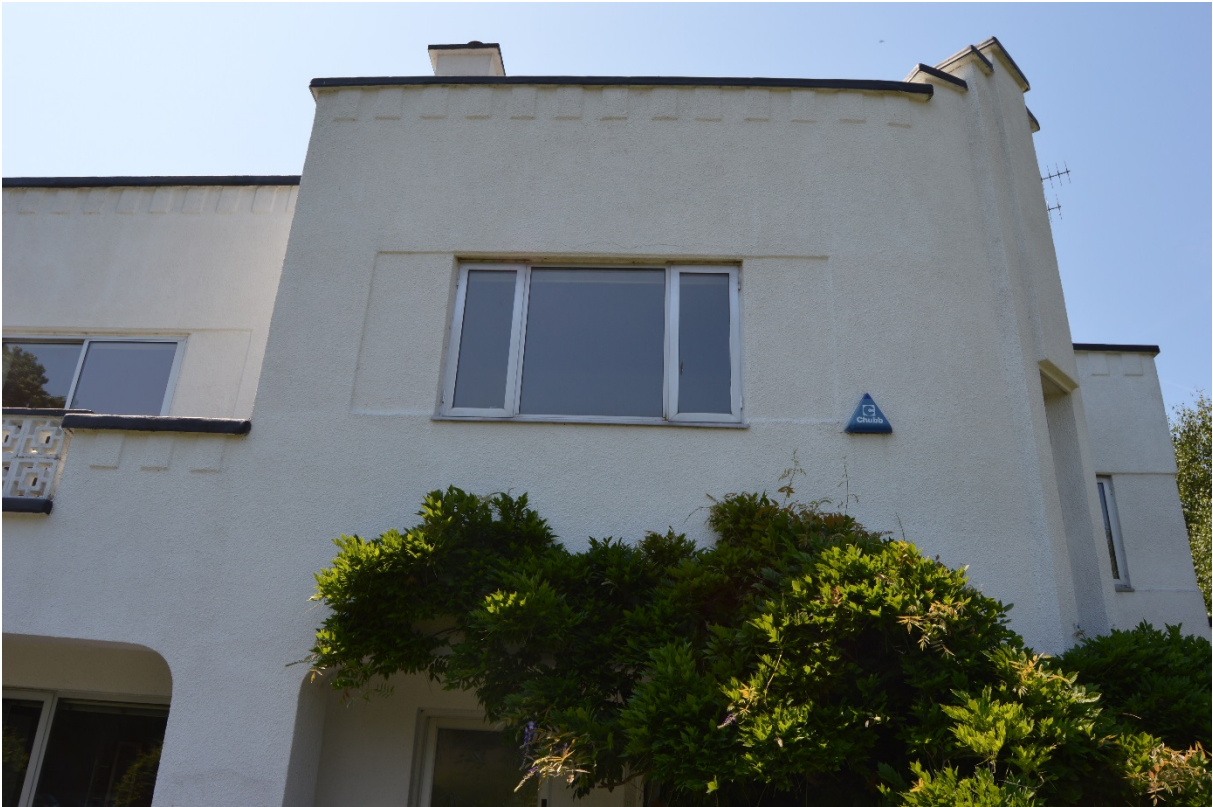
Plate 7 Casement window, principal elevation (photo 068)

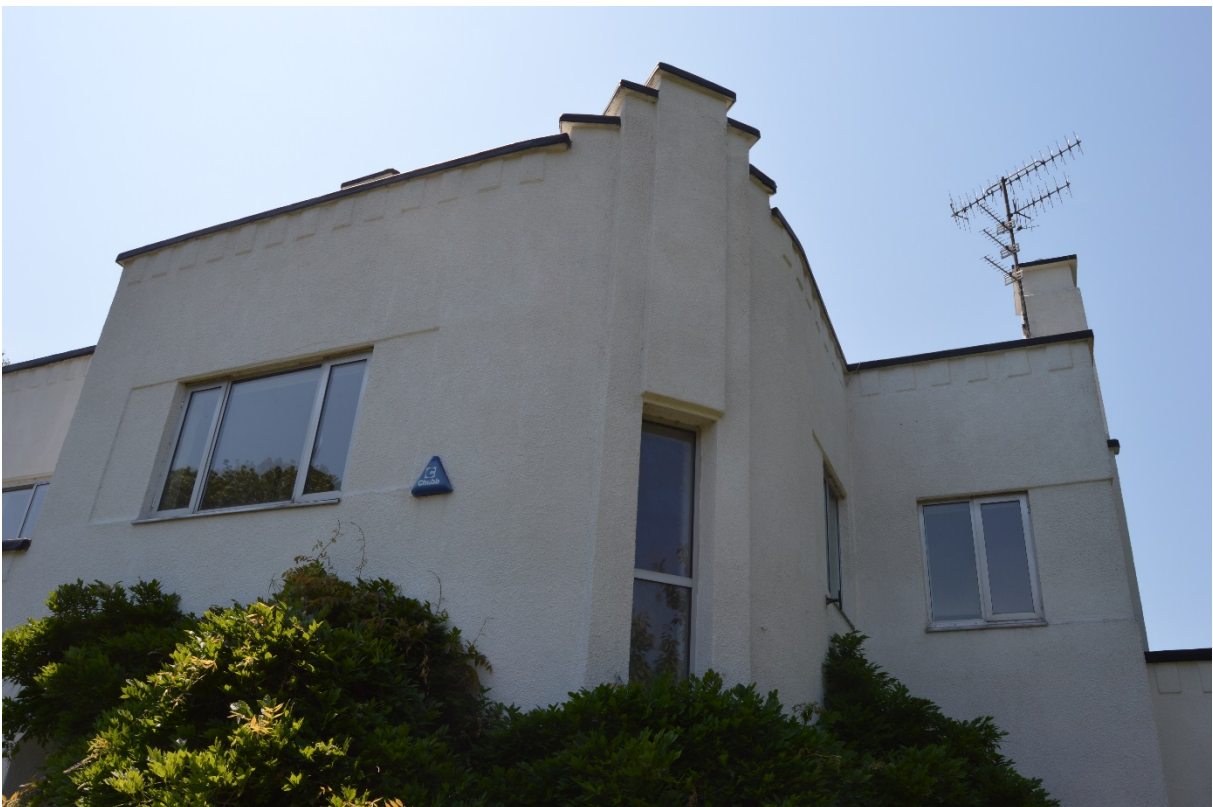
Plate 8 Casement window, north-east corner (photo 067)

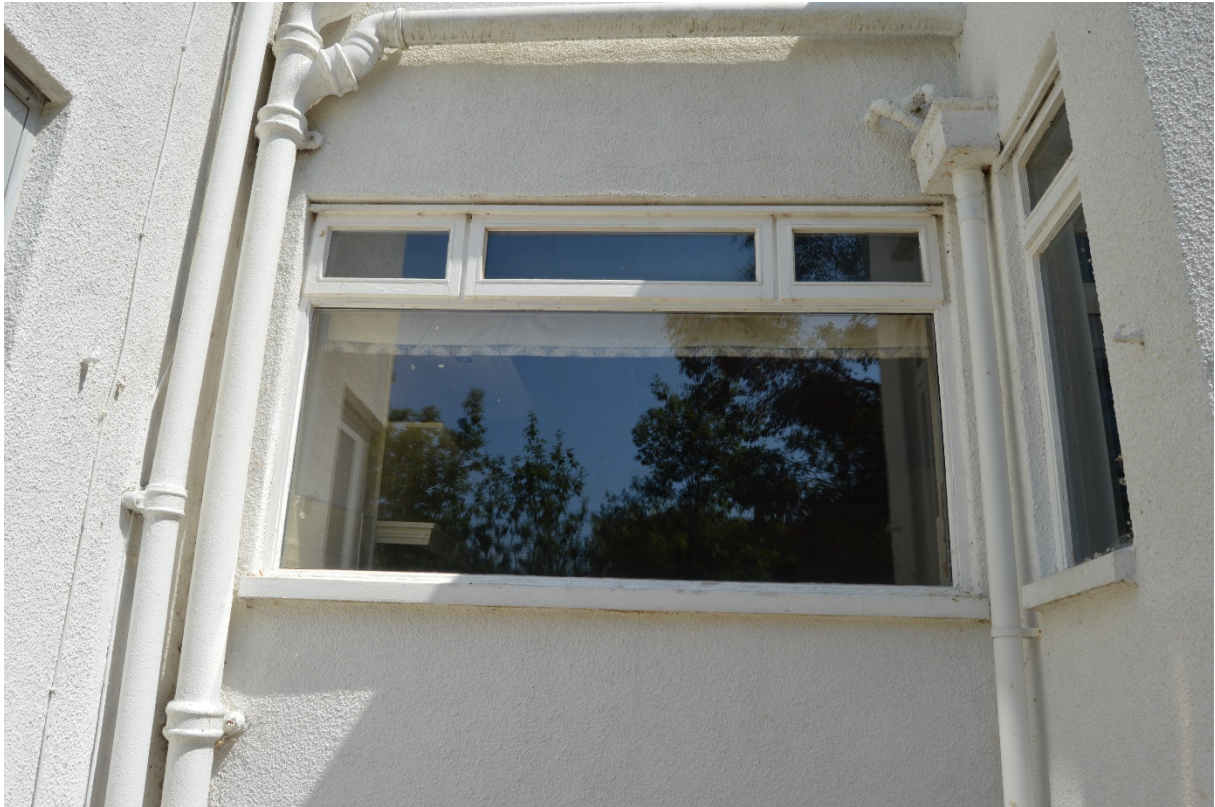
the building are modern metal, double-glazed replacements (noting several uPVC examples on the principal elevation), with the exception of two windows opening into the kitchen/diner and pantry respectively, where plain wooden casements survive (*plate 9*). These are likely original to the 1935 build. Several of the window lights on the east and north elevations are accompanied by blind openings, suggestive of infilled lights, in some cases suggestive of wrap-around lights. However, these recessed panels are clearly depicted in the 1936 Henley Cables advert in the Architects Journal, determining that they are either decorative or else abortive design elements in the course of the original build. External drainage for the building comprises pipework and hoppers, decorated with the Tudor Rose motif (*plate 10*). These are modern fittings coated in a cream pebbledash render in order to blend in with the finish of the wider building.

Plate 9 Original casement window, west elevation (photo 054)

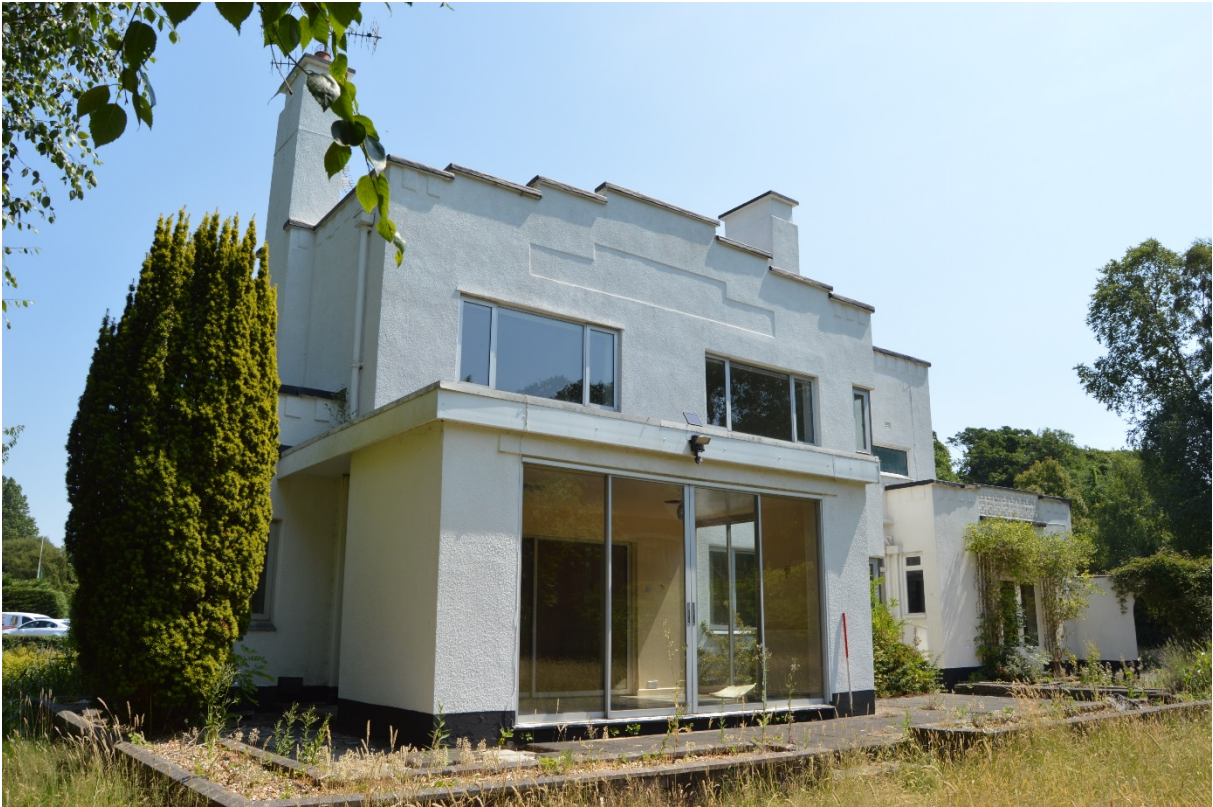
Plate 11 Inset panel, first floor west elevation (photo 024)

Several other features are distinct to particular elevations. The most prominent of these is a long, thin stepped panel positioned above the first floor windows on the west elevation (*plate 11*). As with the north-east corner of the building, the otherwise flat parapet steps up in line with the panel. On this same elevation, moulded lintels can be identified above the master bedroom window and the conservatory entrance, directly below. These mouldings are clearly a pair. They are either associated with the later addition of the conservatory, or else the conservatory moulding apes an earlier design once associated with the lintel of the lounge window/entrance. Given the absence of this decoration from the flat window to bedroom 1, and therefore an absence of symmetry, it is tentatively proposed that these mouldings form later additions dating to the addition of the conservatory. A porch with dentil decoration overhangs the south entrance to the building on the south elevation (*plate 12*). A hexagonal porchlight is positioned central to the underside of this porch and may represent one of the few surviving original fittings. Finally, the chimney stacks each have a broad inset course positioned along their length just prior to flat and squared flaunching, from which the pots rise.

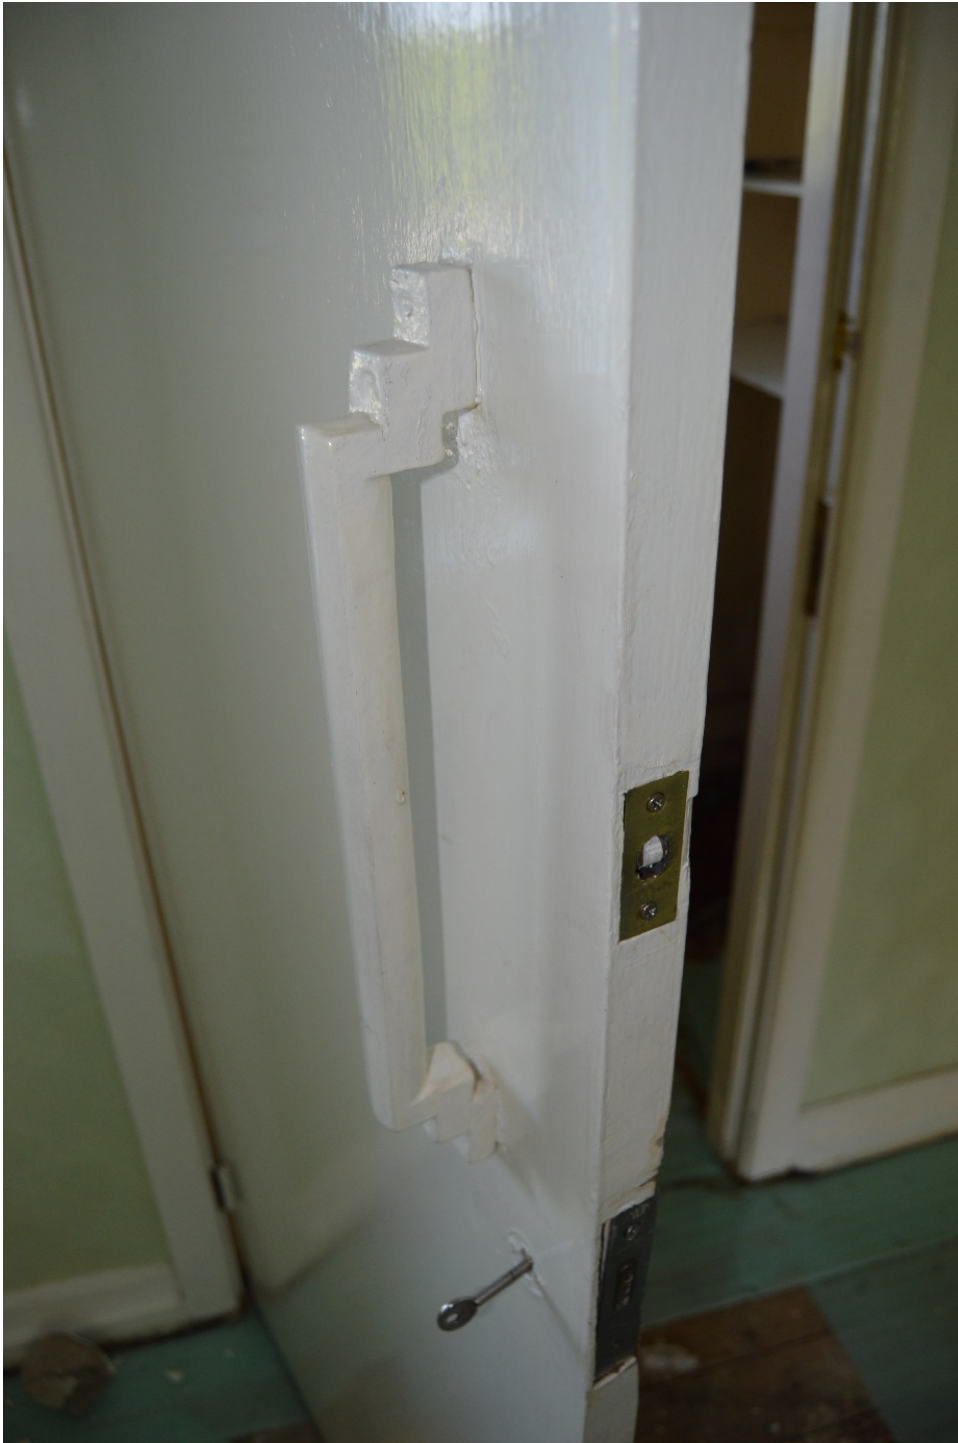
Plate 16 Example of door handle (photo 186)

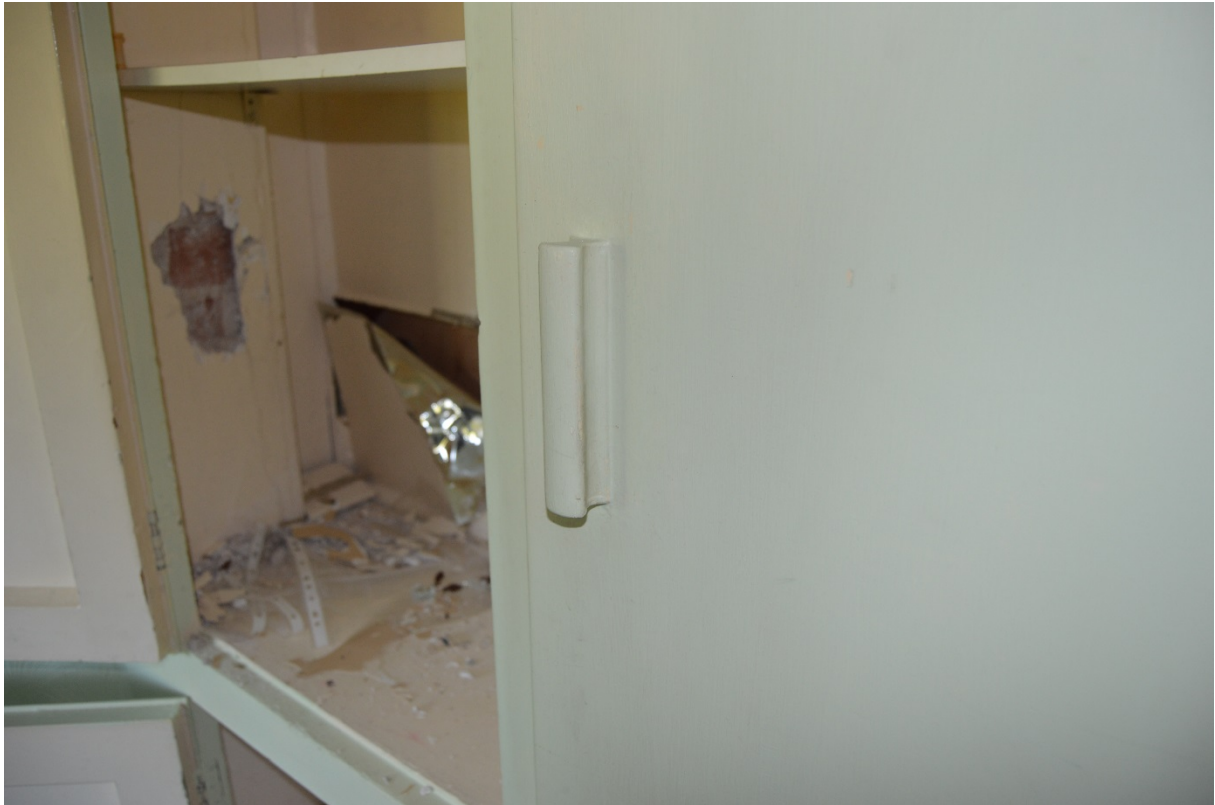
Plate 17 Example of cupboard handle (photo 258)

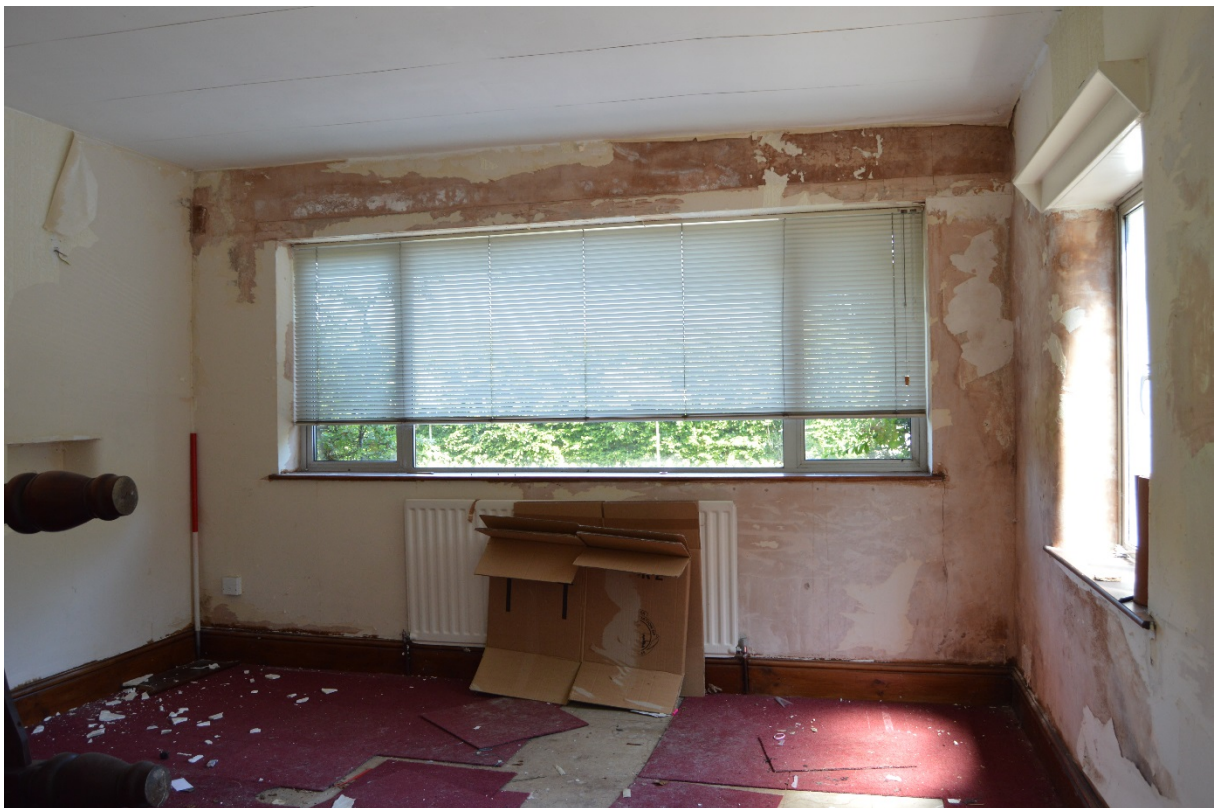
Plate 18 Games room, former integrated garage (photo 141)

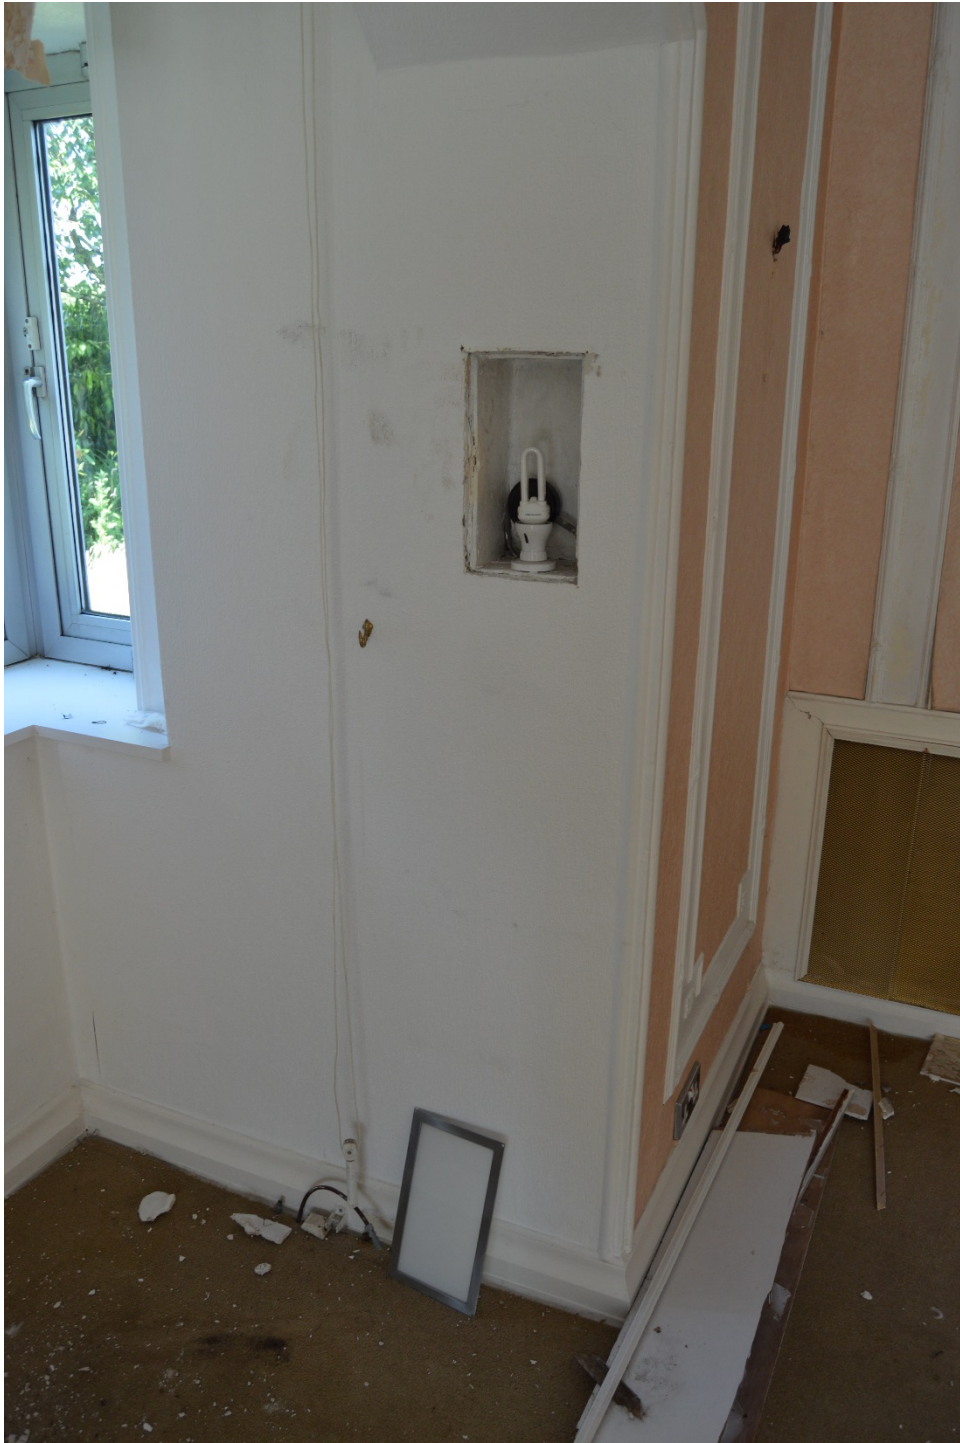
Plate 22 Inset lighting, lounge (photo 237)

The fireplaces on the ground floor are all modern replacements with the exception of the Art Deco tiled fireplace on the south wall of the dining room (*plate 21*). Original inset lighting is located on either side of the recess for the fireplace in the lounge (*plate 22*). The stepped motif found on the exterior (and on the door handles) is repeated once more on the banister rail of the staircase itself (*plate 23*). The other side of the rail is matched by a chrome rail, though it is unclear whether this actually represents a surviving original fitting.

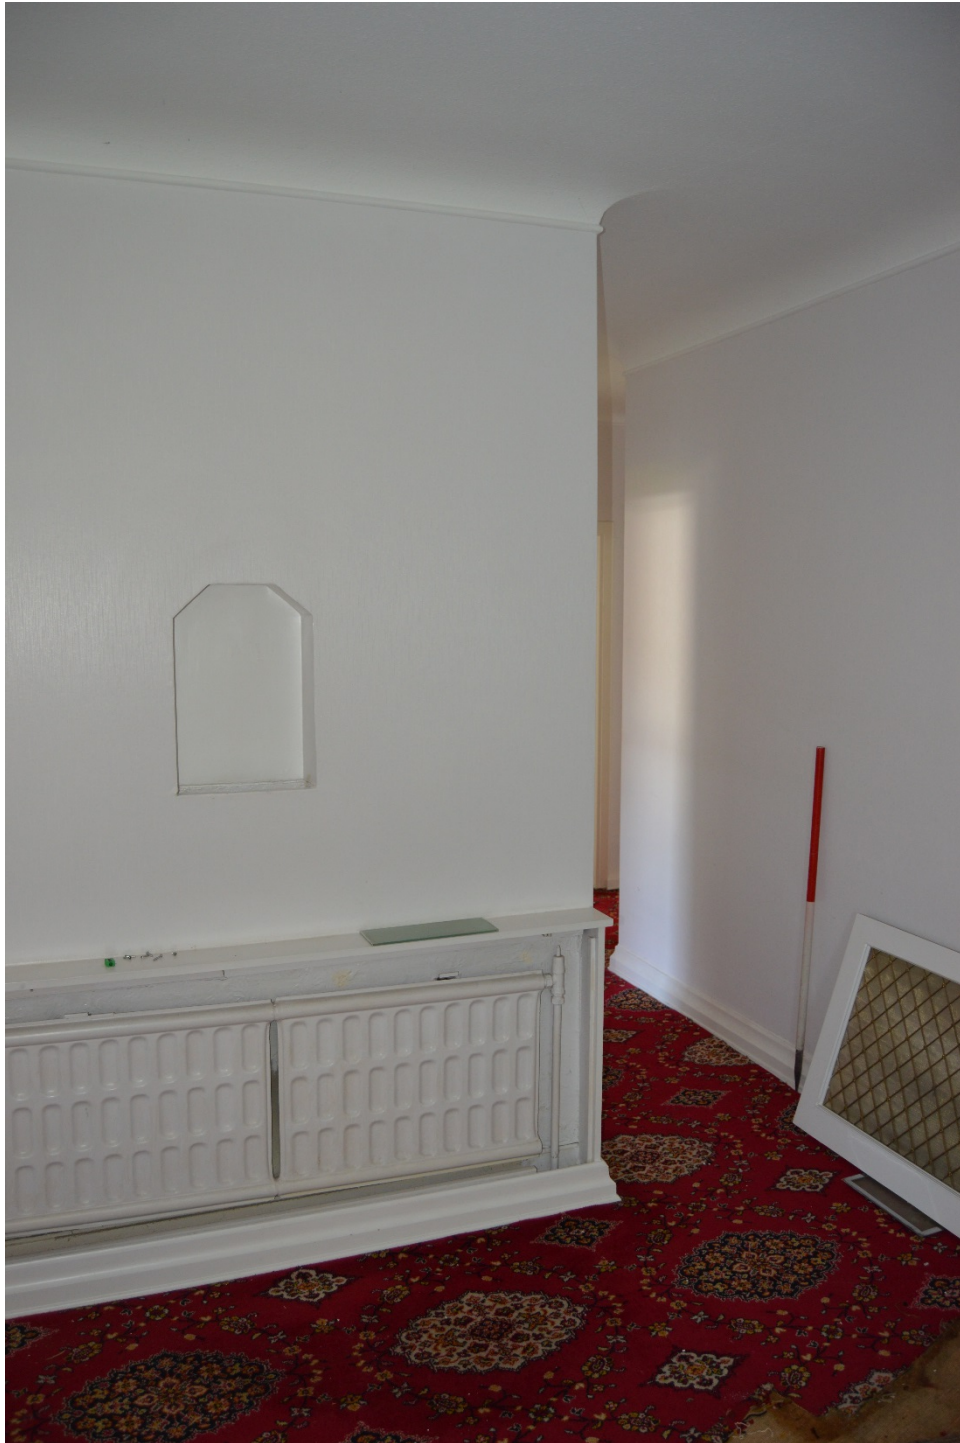
Circulation in the first floor of the building is more straightforward, with all spaces connecting to the central hall (1F; *plate 24*), with the exception of the roof terrace accessed through bedroom 2. There has been significantly less development on this floor, as evidenced by the survival of original electrical fittings on the sideboards. The earlier coving is also apparent, except in the master bedroom (*plate 25*). Inset lighting, as identified in the ground floor lounge and the stepped banister rail of the stairs, is present in the central hall (1F) and as a wrap-around corner feature in the southerly corridor extension of the hall (1F).

Plate 24 First floor hall (photo 308)

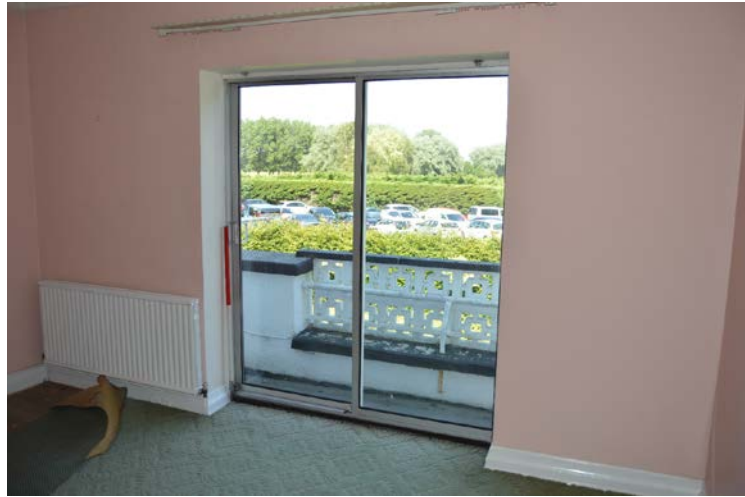
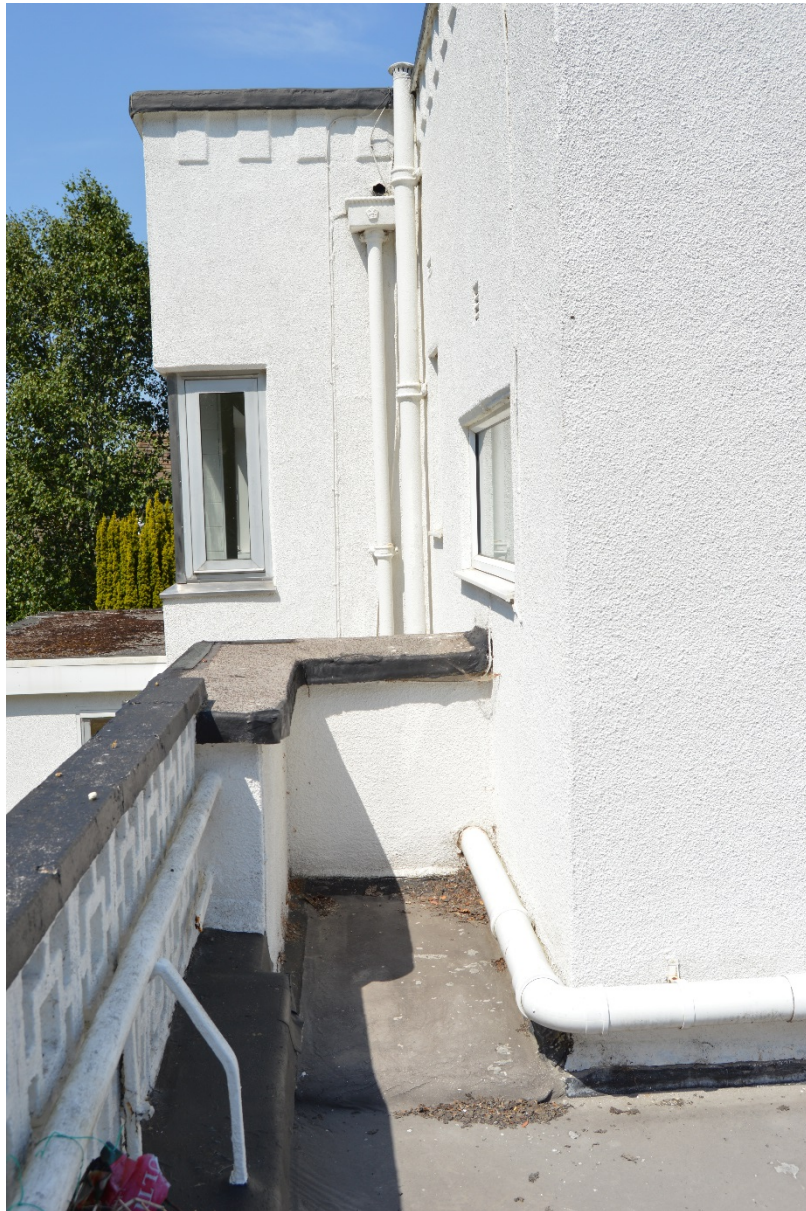
The cupboards in bedrooms 2 and 3 each represent later additions, although the cupboard in the bathroom may be an original feature. Three fireplaces were once present in the first floor, in bedroom 1, bedroom 2 and the master bedroom. All of these have since been infilled by breeze-blocks. The bathroom and shower room on the south side of the first floor represent a modern refit, although the sunken bath itself may itself be a refit of an original sunken design, given the brick fabric (as exposed in the preceding asbestos survey; *plate 26*). Mention must finally be made of a discrepancy between the early sketch of the first floor plan and the building as depicted in the Architects' Journal advertisement. Whereas the advert depicts a single light with an accompanying infilled panel (as observed during the present survey), the sketch instead depicts two discrete lights. Crucially, these lights would have frustrated access to the roof terrace. The present French door leading from bedroom 2 to the Roof Terrace is a modern addition, though the documentation suggests a design change during the construction of Greenridges, enabling access to the terrace (*plates 27 and 28*).

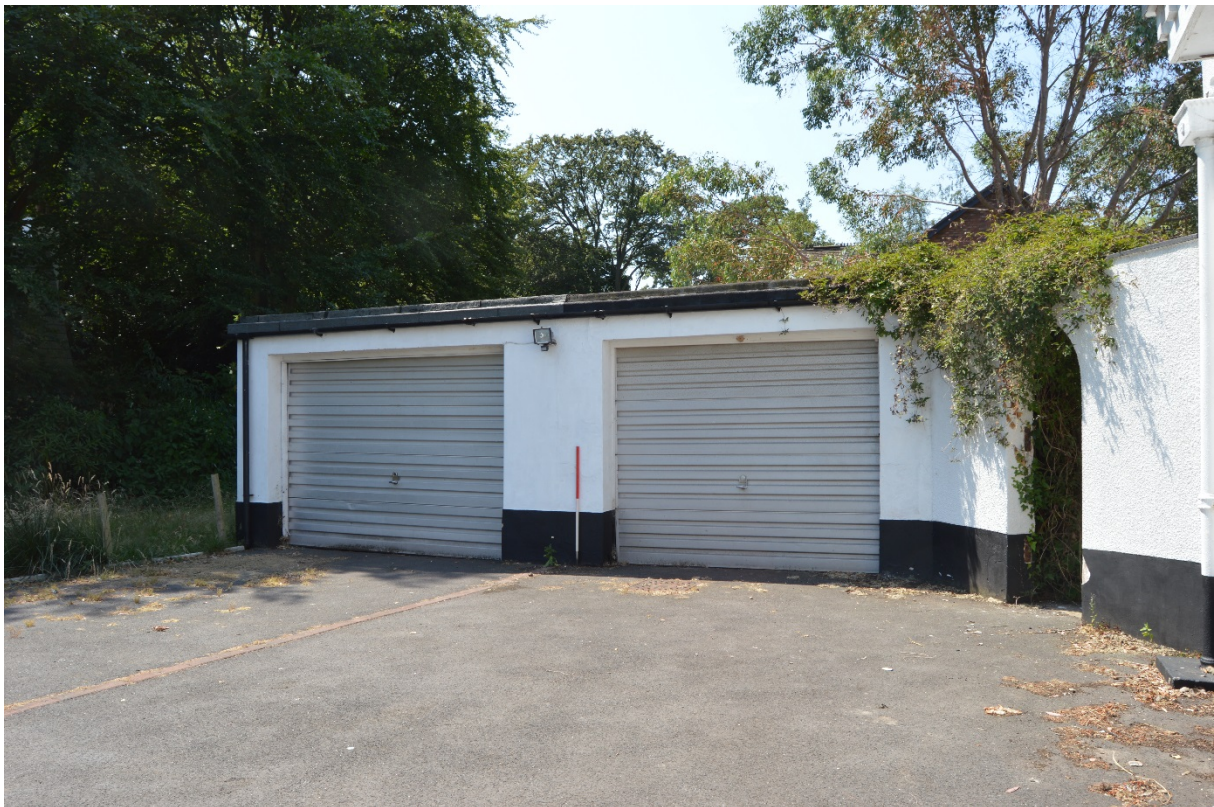
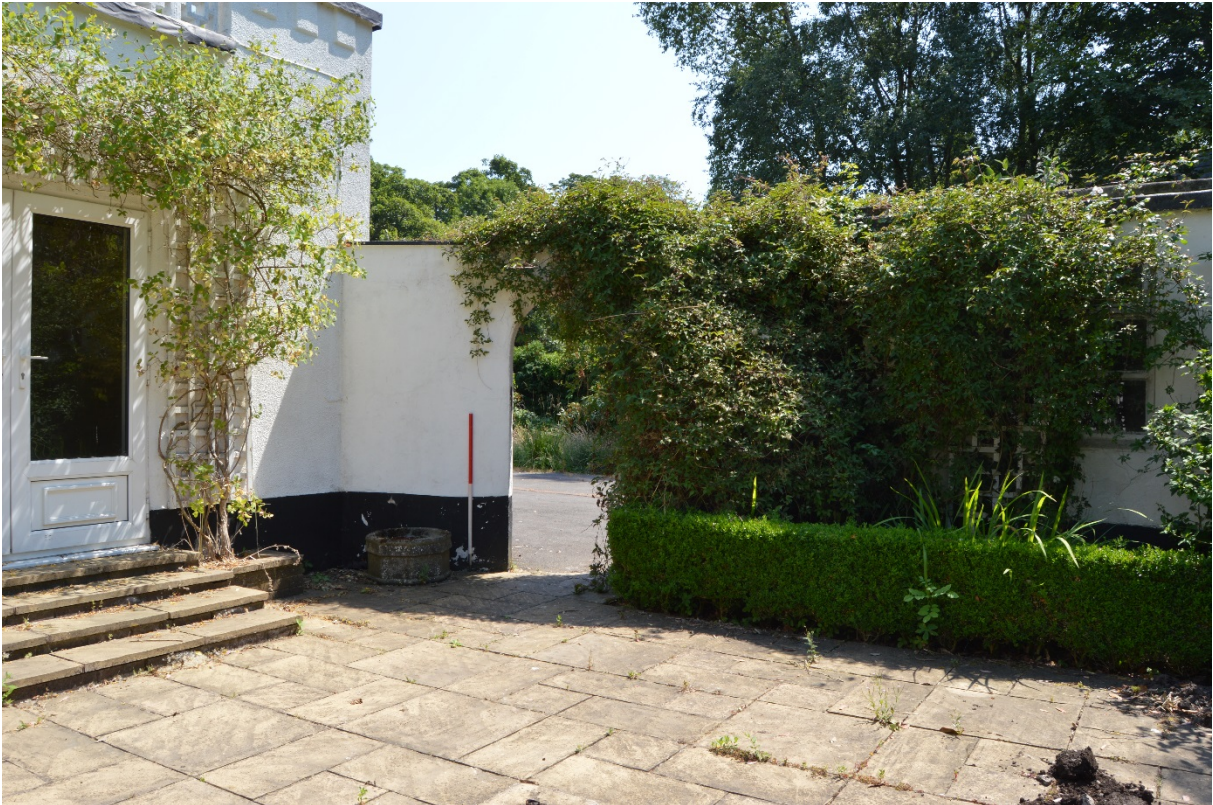
Three substantial ancillary structures are present within the property boundary of Greenridges. A pair of garages is located immediately south-west of the residence linked to the main house by a panel wall, with a greenhouse abutting the west wall of each (*plates 29 and 30*). Ordnance Survey mapping, as noted above, confirms the presence of both garages by 1966. Sketch plans of the property assume that the outbuildings referred to in the 1950 sale of the property in the *Yorkshire Post* and *Leeds Intelligencer* include both garages. The lack of mention of an integrated garage in the sale makes it reasonable to assume that parking facilities had been moved outside of the house itself by this time, but it is also clear that the garages were not constructed as a pair. Garage 2 is the earlier of the two, constructed of red brick, a flat asphalt roof and with two windows looking into the garden. The panel wall is contemporary with this garage. Garage 1 meanwhile is of breezeblock construction, with a single light in the south wall and an entrance with flanking lights in the west wall, connecting to the abutting green house. Given the presence of windows and an entrance in the west wall, the greenhouse is almost certainly of the same date as the later garage. Further evidence for the later addition of garage 1 comes from the asphalt surface of the courtyard, which preserves the former southern boundary, aligned with the southern edge of garage 2. The eastern wall of the courtyard, constructed of decorative blocks in the same style as the Roof Terrace, also shows evidence that it has been extended to encompass an expanded courtyard (*plate 31*).
