Barnbogle Castle

South Queensferry, City of Edinburgh

Historic Building Recording and Archaeological Monitoring: July 2017 – July 2018

August 2018

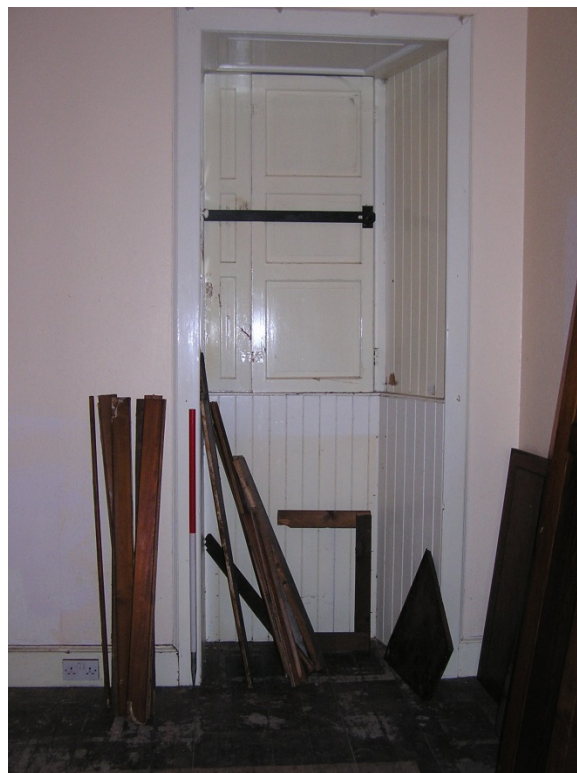
Plate 8 Window on west wall of archive room

To the west of the kitchen is the archive room. This contained windows on the south and east walls and a modern blocked fireplace on the east wall (*Plate 7*). The window recess was lined with white painted wooden panelling with wooden shutters (*Plate 8*). The room was filled with removed wooden panels and is currently used for storage.

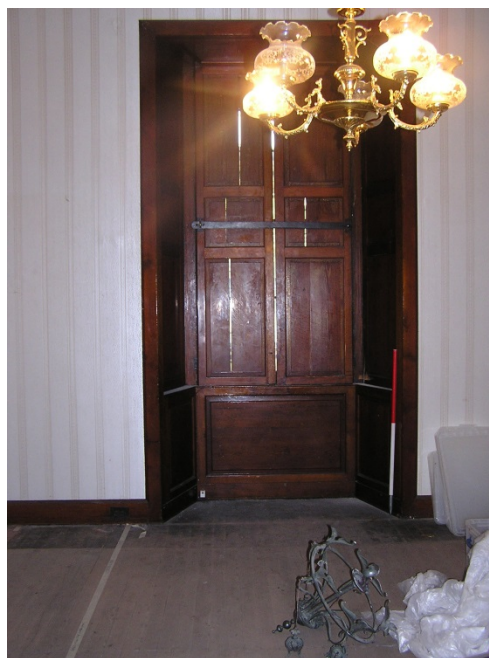
Plate 10 Window on west wall of bedroom

The bedroom was wallpapered and lit by a chandelier. There was a fireplace in the north-east corner of the room (*Plate 9*); this was relatively late, constructed of yellow firebricks with a wooden surround. The windows were recessed and had wooden panelling beneath, with wooden shutters (*Plate 10*). Monitoring in May 2018 revealed the ceiling joists and floorboards above, following opening up of part of the ceiling.

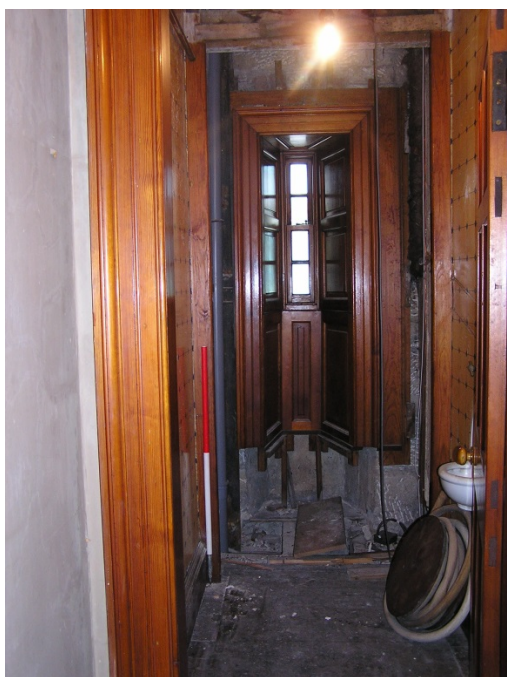
Plate 11 Window on south wall of urinal room

The urinal room comprised two small compartments separated by a timber door. The inner room was wallpapered with a yellow and blue tile pattern and had a recessed wooden panelled window at the south wall, identical to the WC on the Ground floor (*Plate 11*). The ceramic urinal was on the west wall, with traces of the plumbing visible in the tiles. There was a lever comprising a metal bar held by a hand directly above the urinal affixed by screws; the lever was marked with 'SHUT' and 'OPEN' (*Plate 12*).

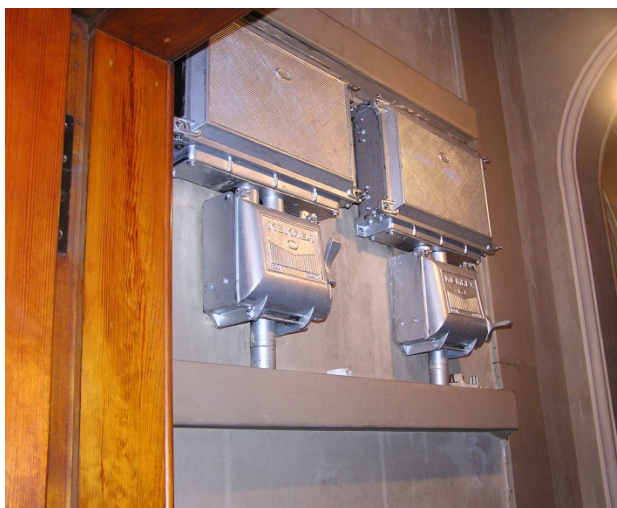
Plate 13 Electrical cabinets

The outer compartment had been partly stripped, with the flooring removed; there were electrical cabinets installed on the west wall (*Plate 13*). The urinals were stripped out as part of the renovations and the ceilings partly opened up during this process. The ceilings were of lath and plaster and exposed the wooden ceiling joists above.

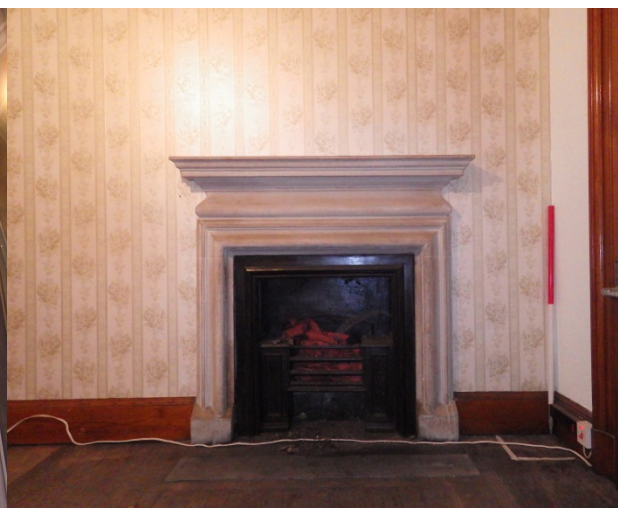
Plate 14 Fireplace on east wall of housekeeping room

The housekeeping room was to the east. It was wallpapered, with a fireplace on the east wall and a window on the south. The fireplace was open and contained a marble fire surround with a cast iron grate (*Plate 14*). The window recess on the south wall had wooden panelling with a boxed in sink and a set of brass taps on the adjacent wall (*Plate 15*), presumably fed by the plumbing to the urinal next door. There was a single bell on the west wall (*Plate 16*).

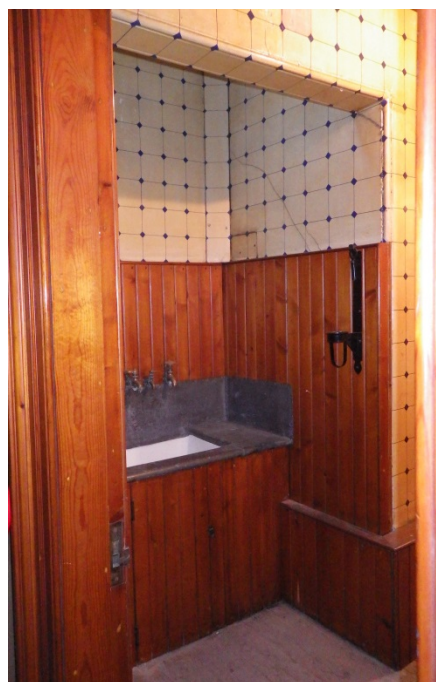
Plate 18 Recessed sink in second floor WC

Both compartments were papered with wallpaper patterned with yellow and blue tiles as in the urinal room on the first floor, with an identical ceramic urinal on the west wall. There was a recess in the north-east corner of the room, which was panelled below and tiled above, with a fitted sink within (*Plate 18*). There was a slate surround to the ceramic sink, which was fitted with a plug and fed by three taps above. A cupboard was below the sink. Above the sink was a 'laylight', as marked on the drawings.

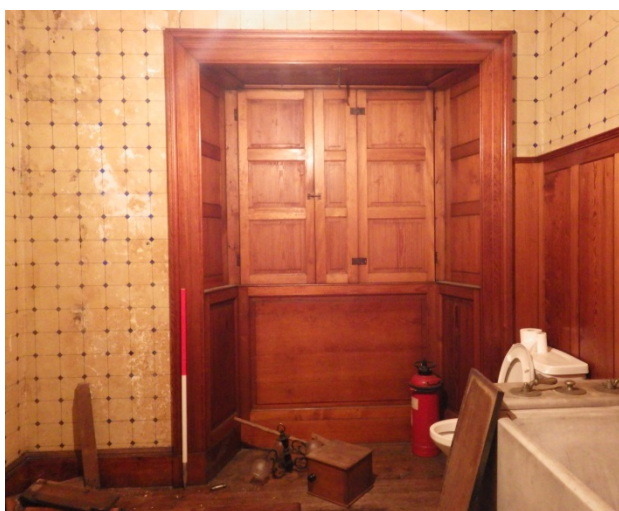
Plate 19 Window in south wall of bathroom second floor

To the east of the WC was a bathroom, this had a window on the south wall and a raised wooden plinth on the west side with fitted marble bath and a modern toilet adjacent. The window was recessed and wooden panelled to the floor with wooden shutters (*Plate 19*). The whole room was wallpapered in the same yellow and blue tiled pattern, with wooden skirting; the floor coverings had been removed and exposed wooden floorboards.

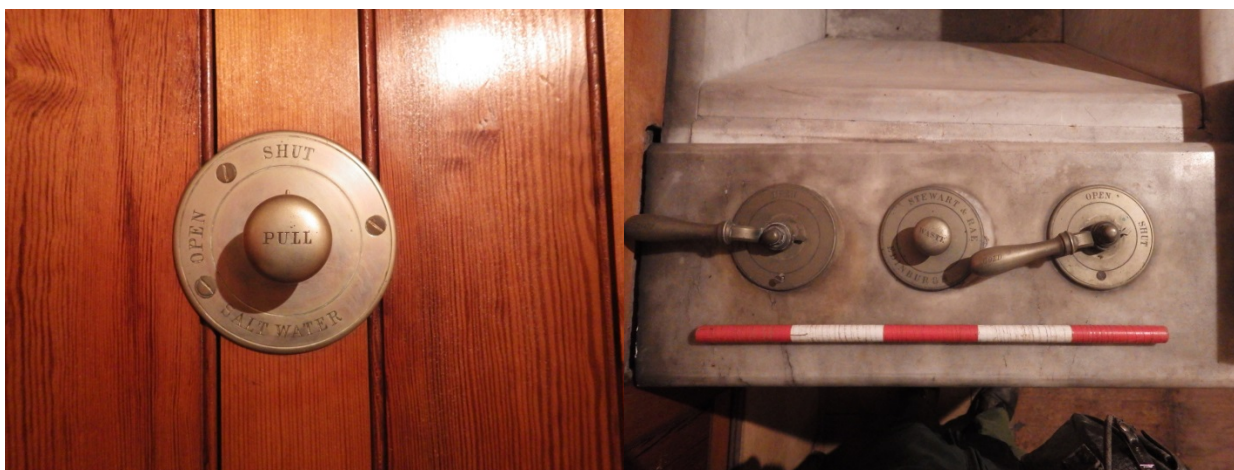
The bath was c2m long and c0.6m deep and was sloped at the south (tap) end (*Plate 20*). There was a handle on the wall marked 'PULL' within a circular metal plate marked with 'OPEN', 'SHUT' AND 'SALT WATER' (*Plate 21*); the owner confirmed that the bath was fed by water from the sea. There were three handles at the end of the bath, made by 'STEWART & RAE, EDINBURGH'. From left to right the handles are marked 'HOT'; 'WASTE' and 'COLD' (*Plate 22*). The hot and cold taps are within a circular metal plate marked with 'OPEN' and 'SHUT'; the waste plug is a handle that is pulled upwards to let the water drain.

Plate 21 Handle to let in salt water

Plate 22 Handles on bath: hot, waste and cold

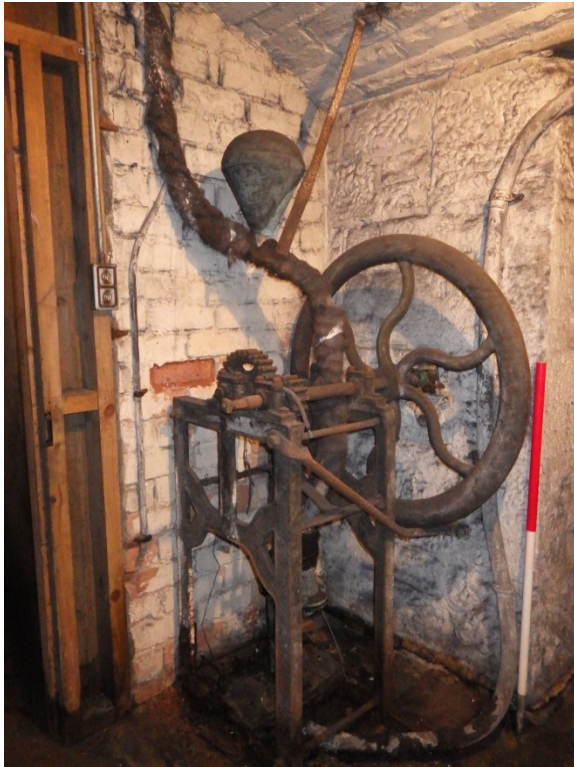
Plate 23 Seawater pump in cellar

The proposals for the cellar are for the installation of a tank within the furnace room. All accessible areas of the cellar were recorded through the photographic survey. Access to the cellar is via a series of stairs, at the base of which the seawater pump is located (*Plate 23*). To the west is a passage leading to the coal cellar and a larder (*Plate 24*); opposite is a door leading through a short passage to the furnace room. The cellar is stone built with a brick barrel-vaulted roof.

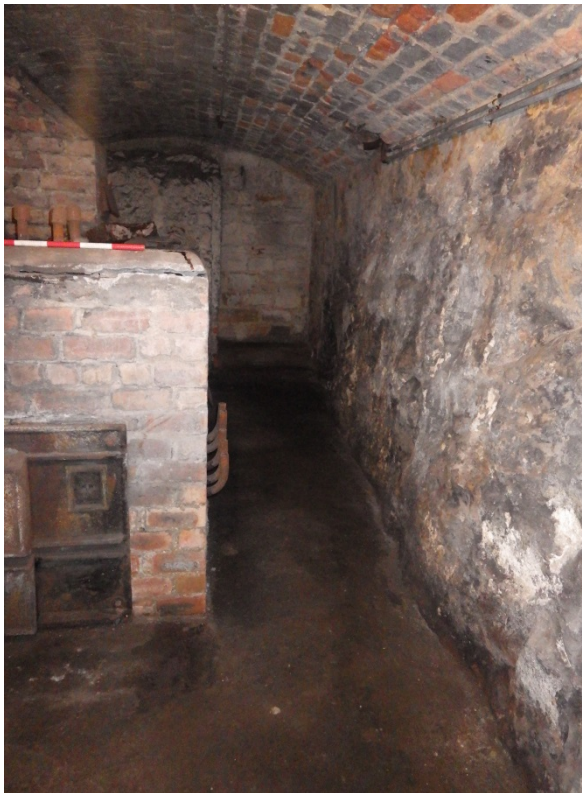
Plate 25 View along north wall of furnace room, with blocking at west end and furnace in foreground

The earliest (accessible) cellar appears to be what is now the furnace room. The north wall of this room has been formed out of cut bedrock, with later (19th century) brick barrel-vaulting built on top (*Plate 25*). There is a brick furnace against the south wall of the room.

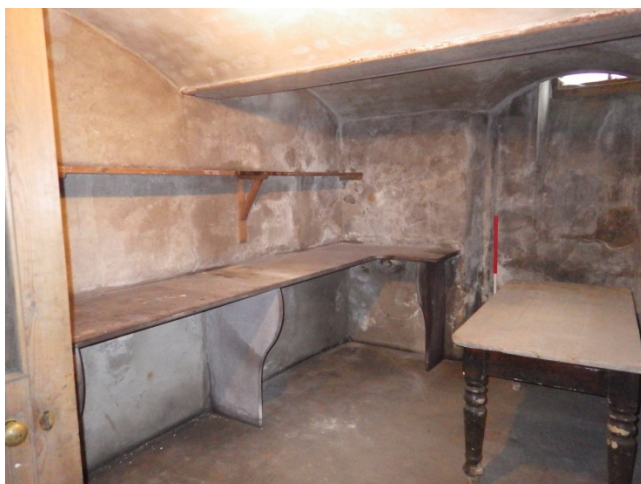
Plate 29 Larder from doorway

The larder is whitewashed and contains a stone bench around the east wall, with a wooden shelf above and a freestanding table (Plate 29). On the outside wall, there is evidence that this room was originally open and the doorway is a later insertion. There is brickwork either side of the doorway; this has been whitewashed along with the rest of the room and the corridor (Plate 30).

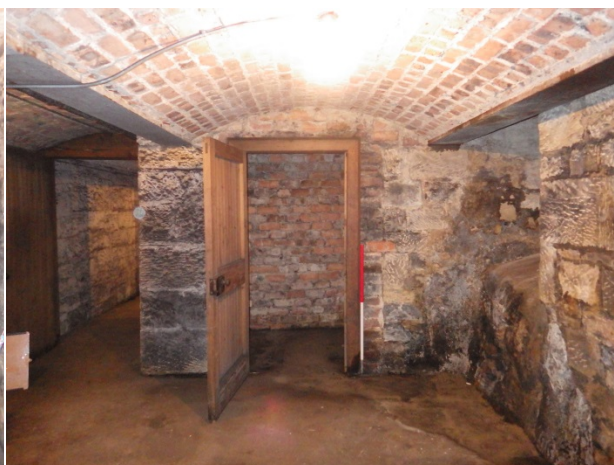
Plate 32 Store on east wall of coal cellar

The coal cellar is at the west end of the accessible internal cellars. There is a cast iron pillar in the centre of the room and two coal chutes on the south side (Plate 31). A store is off the east wall; this shows some modification as the opening to the larder appears to have been bricked up and the doorway has been reduced (Plate 32). The north wall of the coal cellar leads to the N room (see above). There is a blocked entrance in the east wall which formerly led into the furnace room (Plate 33). The original wall is cut into bedrock and the opening blocked with masonry.

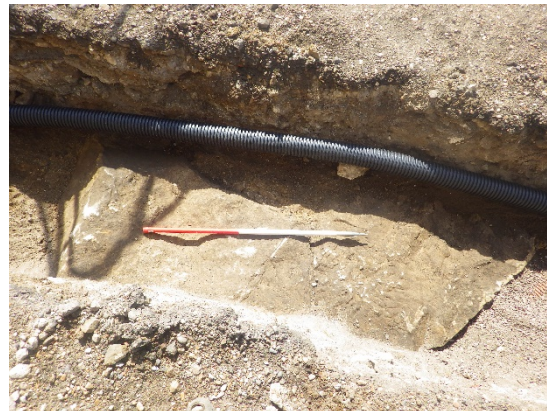
Plate 45 Bedrock [025]

The central section of the Trench 2, running across the Castle terrace, revealed the cut into the bedrock that was made to level the terrace for the construction of the building [025]. It is unclear when the bedrock was terraced and only the west end of the bedrock had been treated that way. A recently installed service trench cut the bedrock on the west side (see *Plate 44 and Plate 45*).

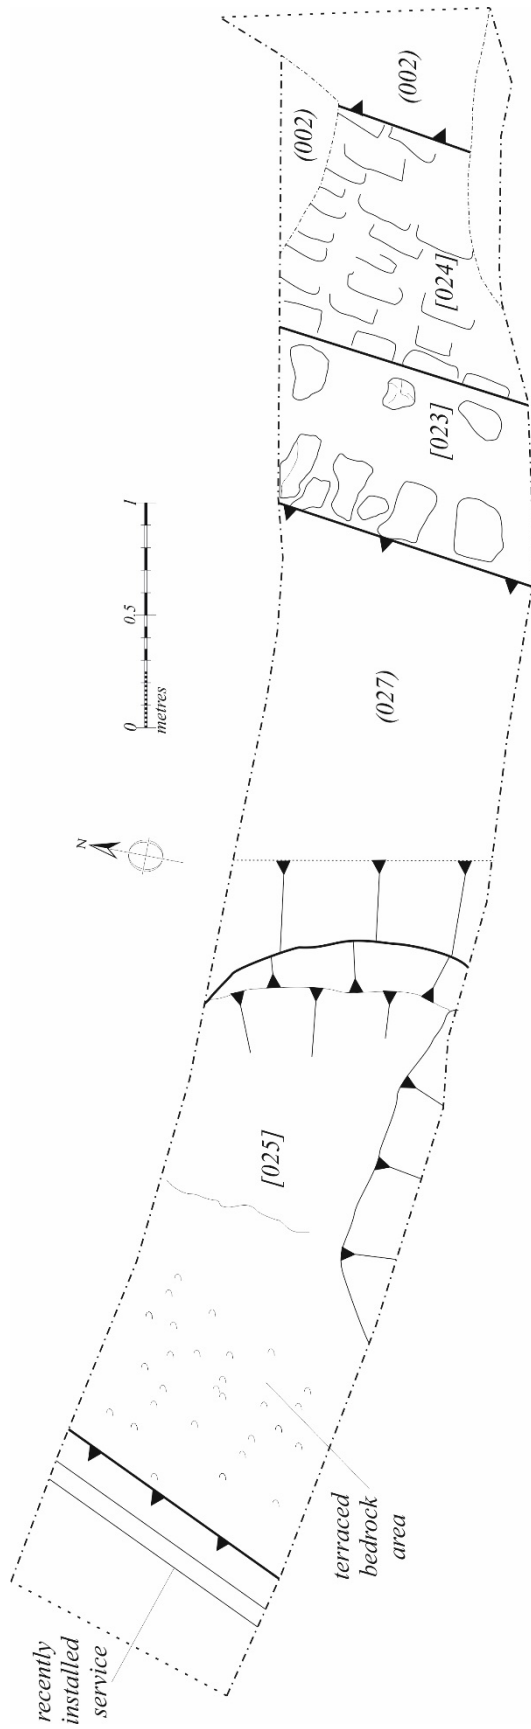
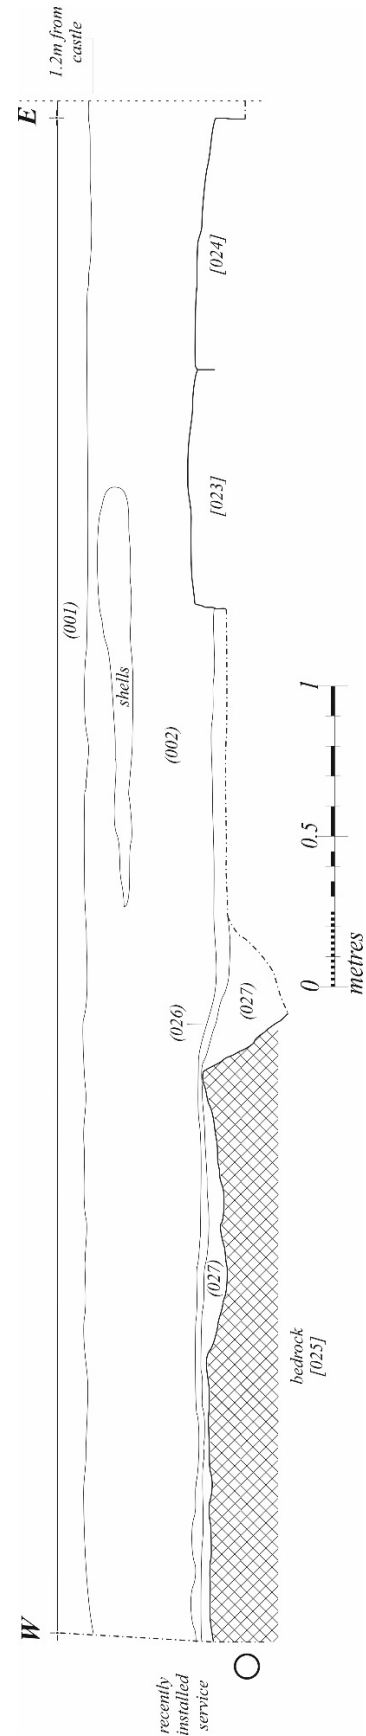
Two built structures were also recorded, side by side, within the trench. One made of squared sandstone and bonded by grey lime mortar [023], the other of brick and grey lime mortar [024] (see *Figure 10 and Figure 11*). Their function and date is unclear, it seems likely, however, that they are wall foundations related to the 17th century rebuild (see *Plate 46 and Plate 47*).

Figure 10 Plan of Features [023] and [024] and Bedrock [025]

Figure 11 South facing Section of Features [023] and [024] and Bedrock [025]
