Black Bull Close

Dunbar, East Lothian

Phase 1: Historic Building Recording, monitoring and evaluation: May – October 2018

October 2018

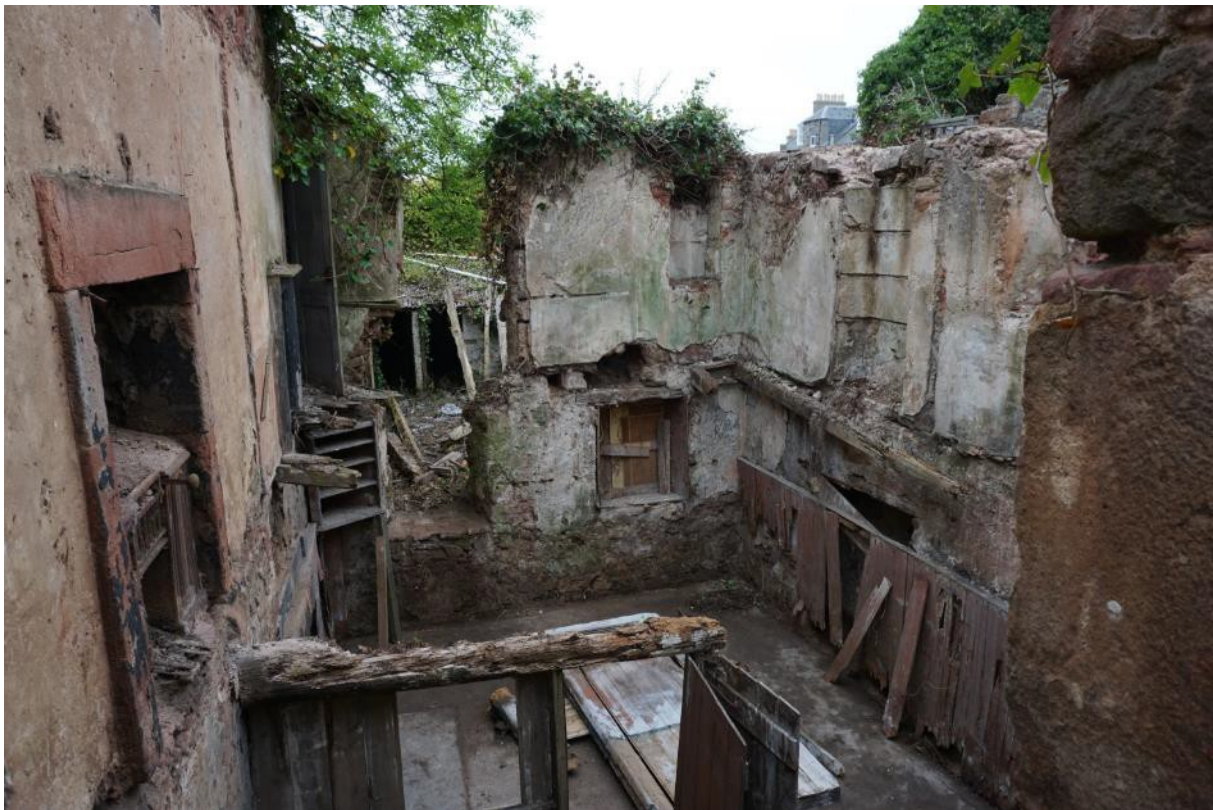
Building 4, looking west

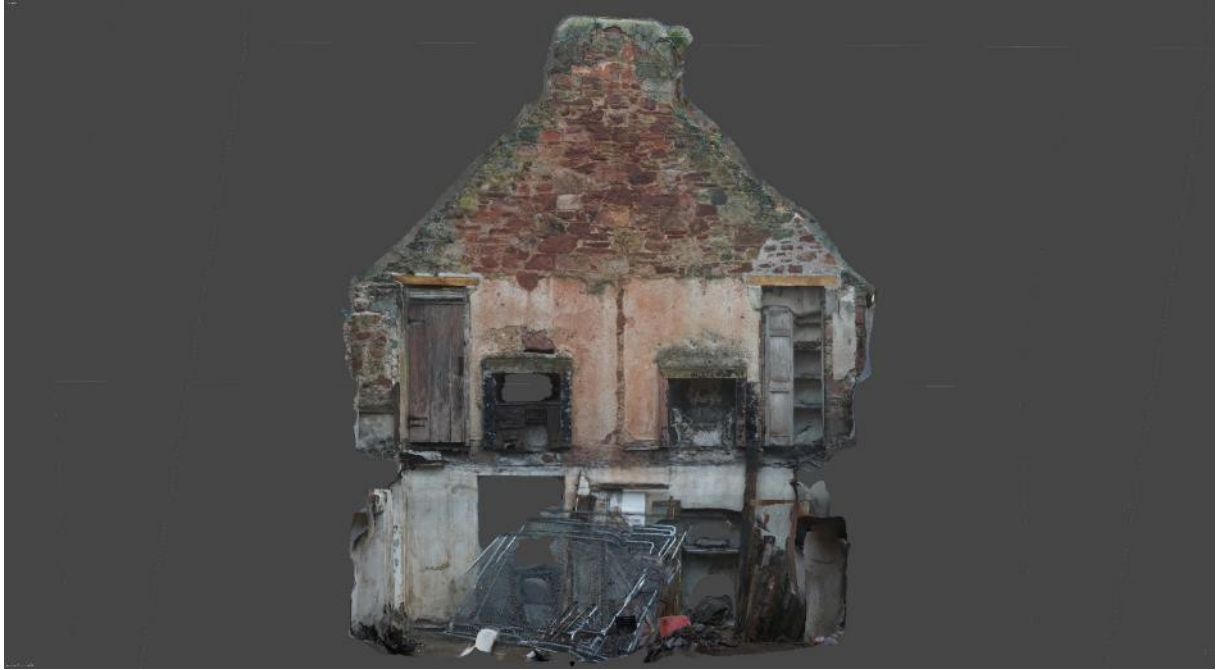
Figure 6 East interior elevation of Building 1

In order to make the building safe to allow public access it was necessary to renew the timber lintels over the door at the east end. The timbers that were removed were found to have evidence of previous use: an initial inspection has indicated they are oak timbers, most likely from a ship. The timbers are currently undergoing assessment by specialists to determine their suitability for dendrochronological dating and further analysis.

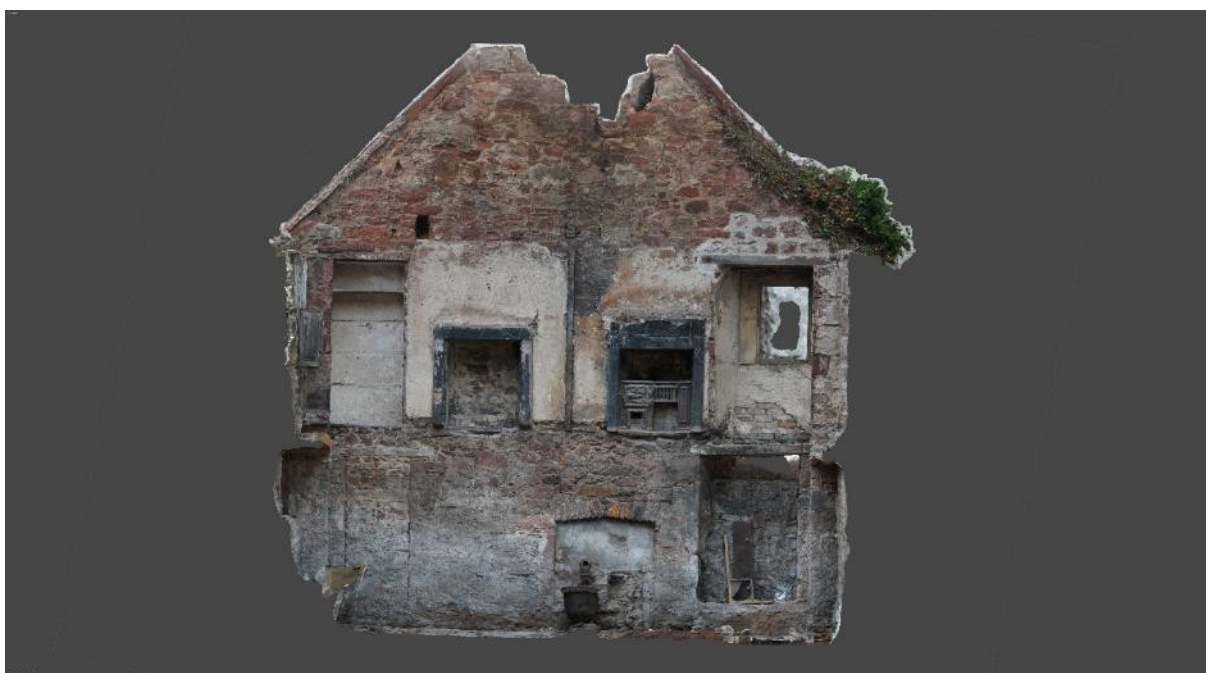
Figure 9 West interior elevation of Building 1

The west end still retained some of the earlier flagstones (*Plate 1*). There were also a number of fittings thought to relate to its use as a butchers shop. A large ceramic sink sits beneath the window onto the close, and a large cast iron boiler was built into a blocked former range/fireplace within the west wall. This room has a window at the north end of the west gable opening out on to Building 2; it appears that this window was formerly a door (*Plate 2*).
