# Kellie Castle

*Library Ceiling: investigation of floor structure holding up early 17<sup>th</sup> century plaster ceiling*

The National Trust for Scotland

*February 2019*

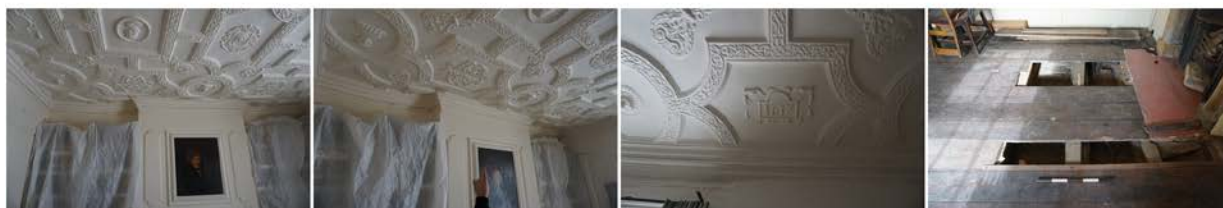
1547-(01).JPG

The decorative plaster ceiling of the library (*room 25*) is dated 1617 and is of historical importance; part of this ceiling directly above the fireplace had locally dropped considerably, but historically. It was suggested that cracking associated with the distorted ceiling had recently extended and there was concern that the ceiling and structure above was failing (*plate 1*).

*Plate 1 early 17th C plaster ceiling of library slumping above fireplace (photo 01)*

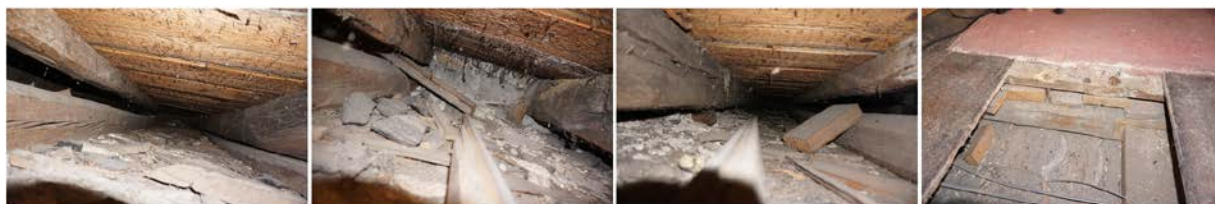
1547-(48).JPG

A 0.10 x 0.10m squared beam with waney edges and some light shakes, this beam appears to be located along the line of the main drop in the ceiling below. The plaster ceiling below appears to be attached to the underside of this beam. A number of threaded bolts run through the beam also appear to support the ceiling below (*plate 3*). Most of these visible only run through this beam and not into the overlying *Joist 2* with the noted exception of one in front of the fire hearth (*photo 48*).
