Gateshead College, Durham Road, Gateshead

Desk Based Assessment and Photographic Survey: May 2008

Desk Based Assessment and Photographic Survey (May 2008)
(project AA. 1672)

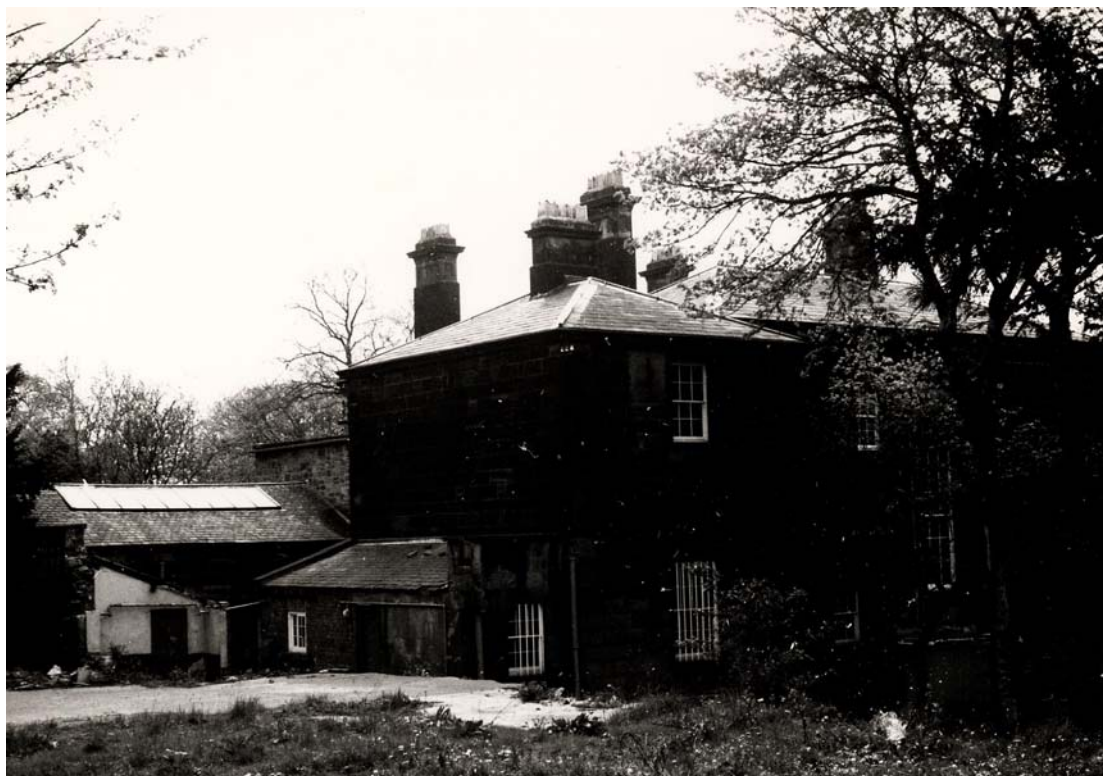
Figure 12 – 1960s(?) photograph of North Dene House form north east (Gateshead Central Library)

A photograph, apparently from the 1960s, shows the view looking towards North Dene House from the north east corner of the site. The photograph seems to have been taken at the time of demolitions. A block has been demolished which joined on to the eastern end of the north wall of the billiard room. A new block has been built in this position since. It also shows the original arrangement of the chimneys, complete with their square chimney cans and moulded cornices. The upper part of all the chimneys has since been removed down to the moulded offset course. This means that about three courses of ashlar, a cornice course and a blocking course has been removed from each chimney. The square ceramic chimney cans have also been lost.

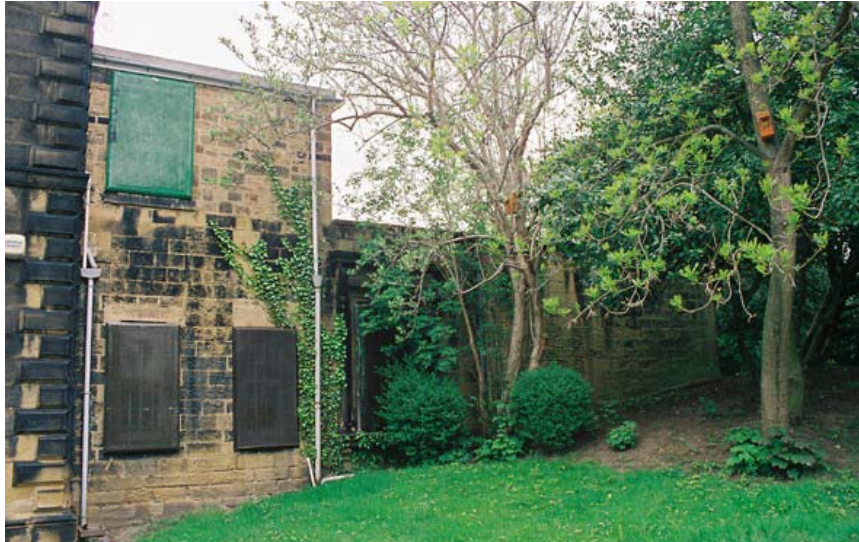
Figure 18 – Southeast extension block and south elevation of billiard room, 2008. S&B.

Adjoining the eastern side of this face is a slightly set back two-storied block; this extends to approximately three quarters of the height of the main building. The lower (ground floor) section of the wall is constructed from honey-coloured stugged ashlar whilst the upper storey is built from squared and coursed rubble (this floor is a later extension, see previous section). There are two narrow rectangular windows at ground floor level, the lintels of which appear to be later replacements. There is a single window at first floor level set on the western side of the face. This block connects the main building with the former billiard room (see billiard room section).

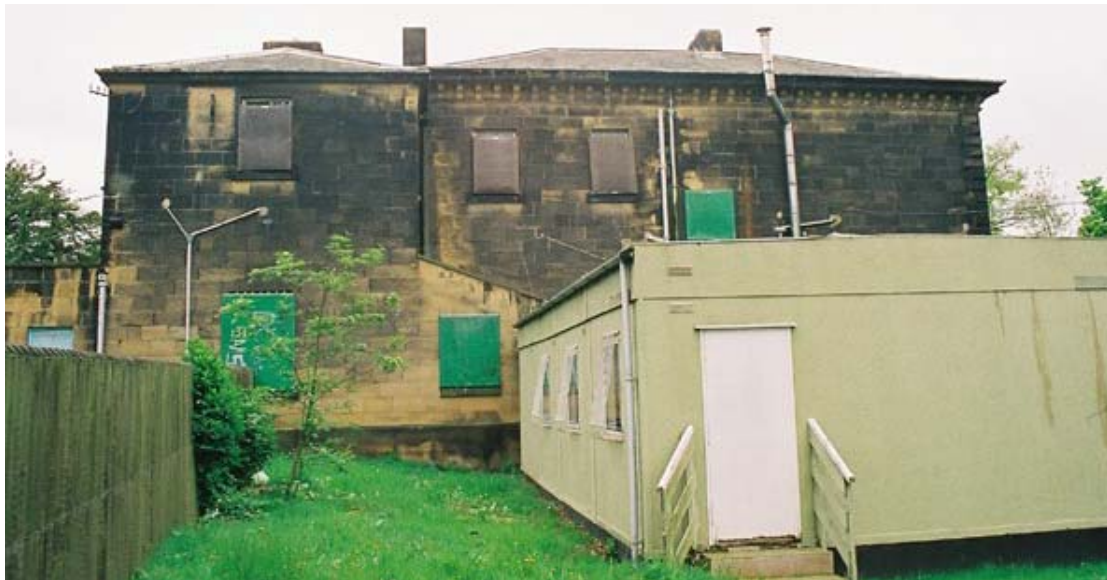
Figure 19 – North elevation of north Dene House, 2008. S&B.

Extending from the northeast corner of the elevation is a two-storey roughly square plan block, which does not feature any of the architectural detailing seen on the main building. This block has centrally placed windows at ground and first floor level. To the east of the first floor window is a metal fixing which would have held a square shaped feature, as seen from the surrounding paint line and holes for fixings. This may have been a clock. On the western return is a single storey block with slate lean-to roof. This lean-to block has a centrally placed sash window protected by vertical glazing bars.

Adjoining the eastern side of the northeast block is a single storey flat coped ashlar wall which forms the façade of an extension block with a lean-to roof (see eastern elevation). This frontage originally contained a square headed window but this has now been extended to form a doorway (alteration occurred post 1960s as the window is visible in a photograph of this date). The upper four blocks at the eastern corner of this wall have been clawed back on the northern side, suggesting that there may have originally been a wall extending northwards from this point.

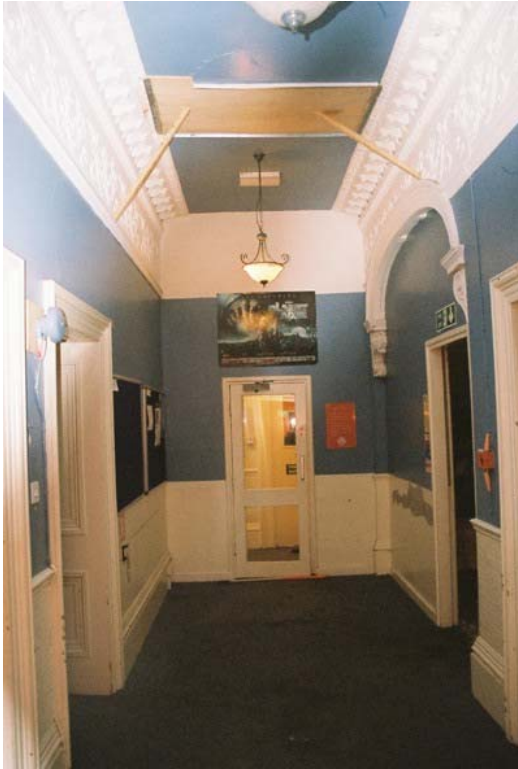
Figure 24–First floor corridor. 2008. S&B.

The corridor provides access to the principal rooms on this floor. These are accessed through modern replacement doors set in original panelled reveals and moulded architraves.
