**THE WEIR GARDEN,
SWAINSHILL,
HEREFORD & WORCESTER**

**ARCHAEOLOGICAL FIELDWORK
1991-1995**

Cotswold Archaeological Trust

C.A.T JOB: 0156
C.A.T REPORT: 95298

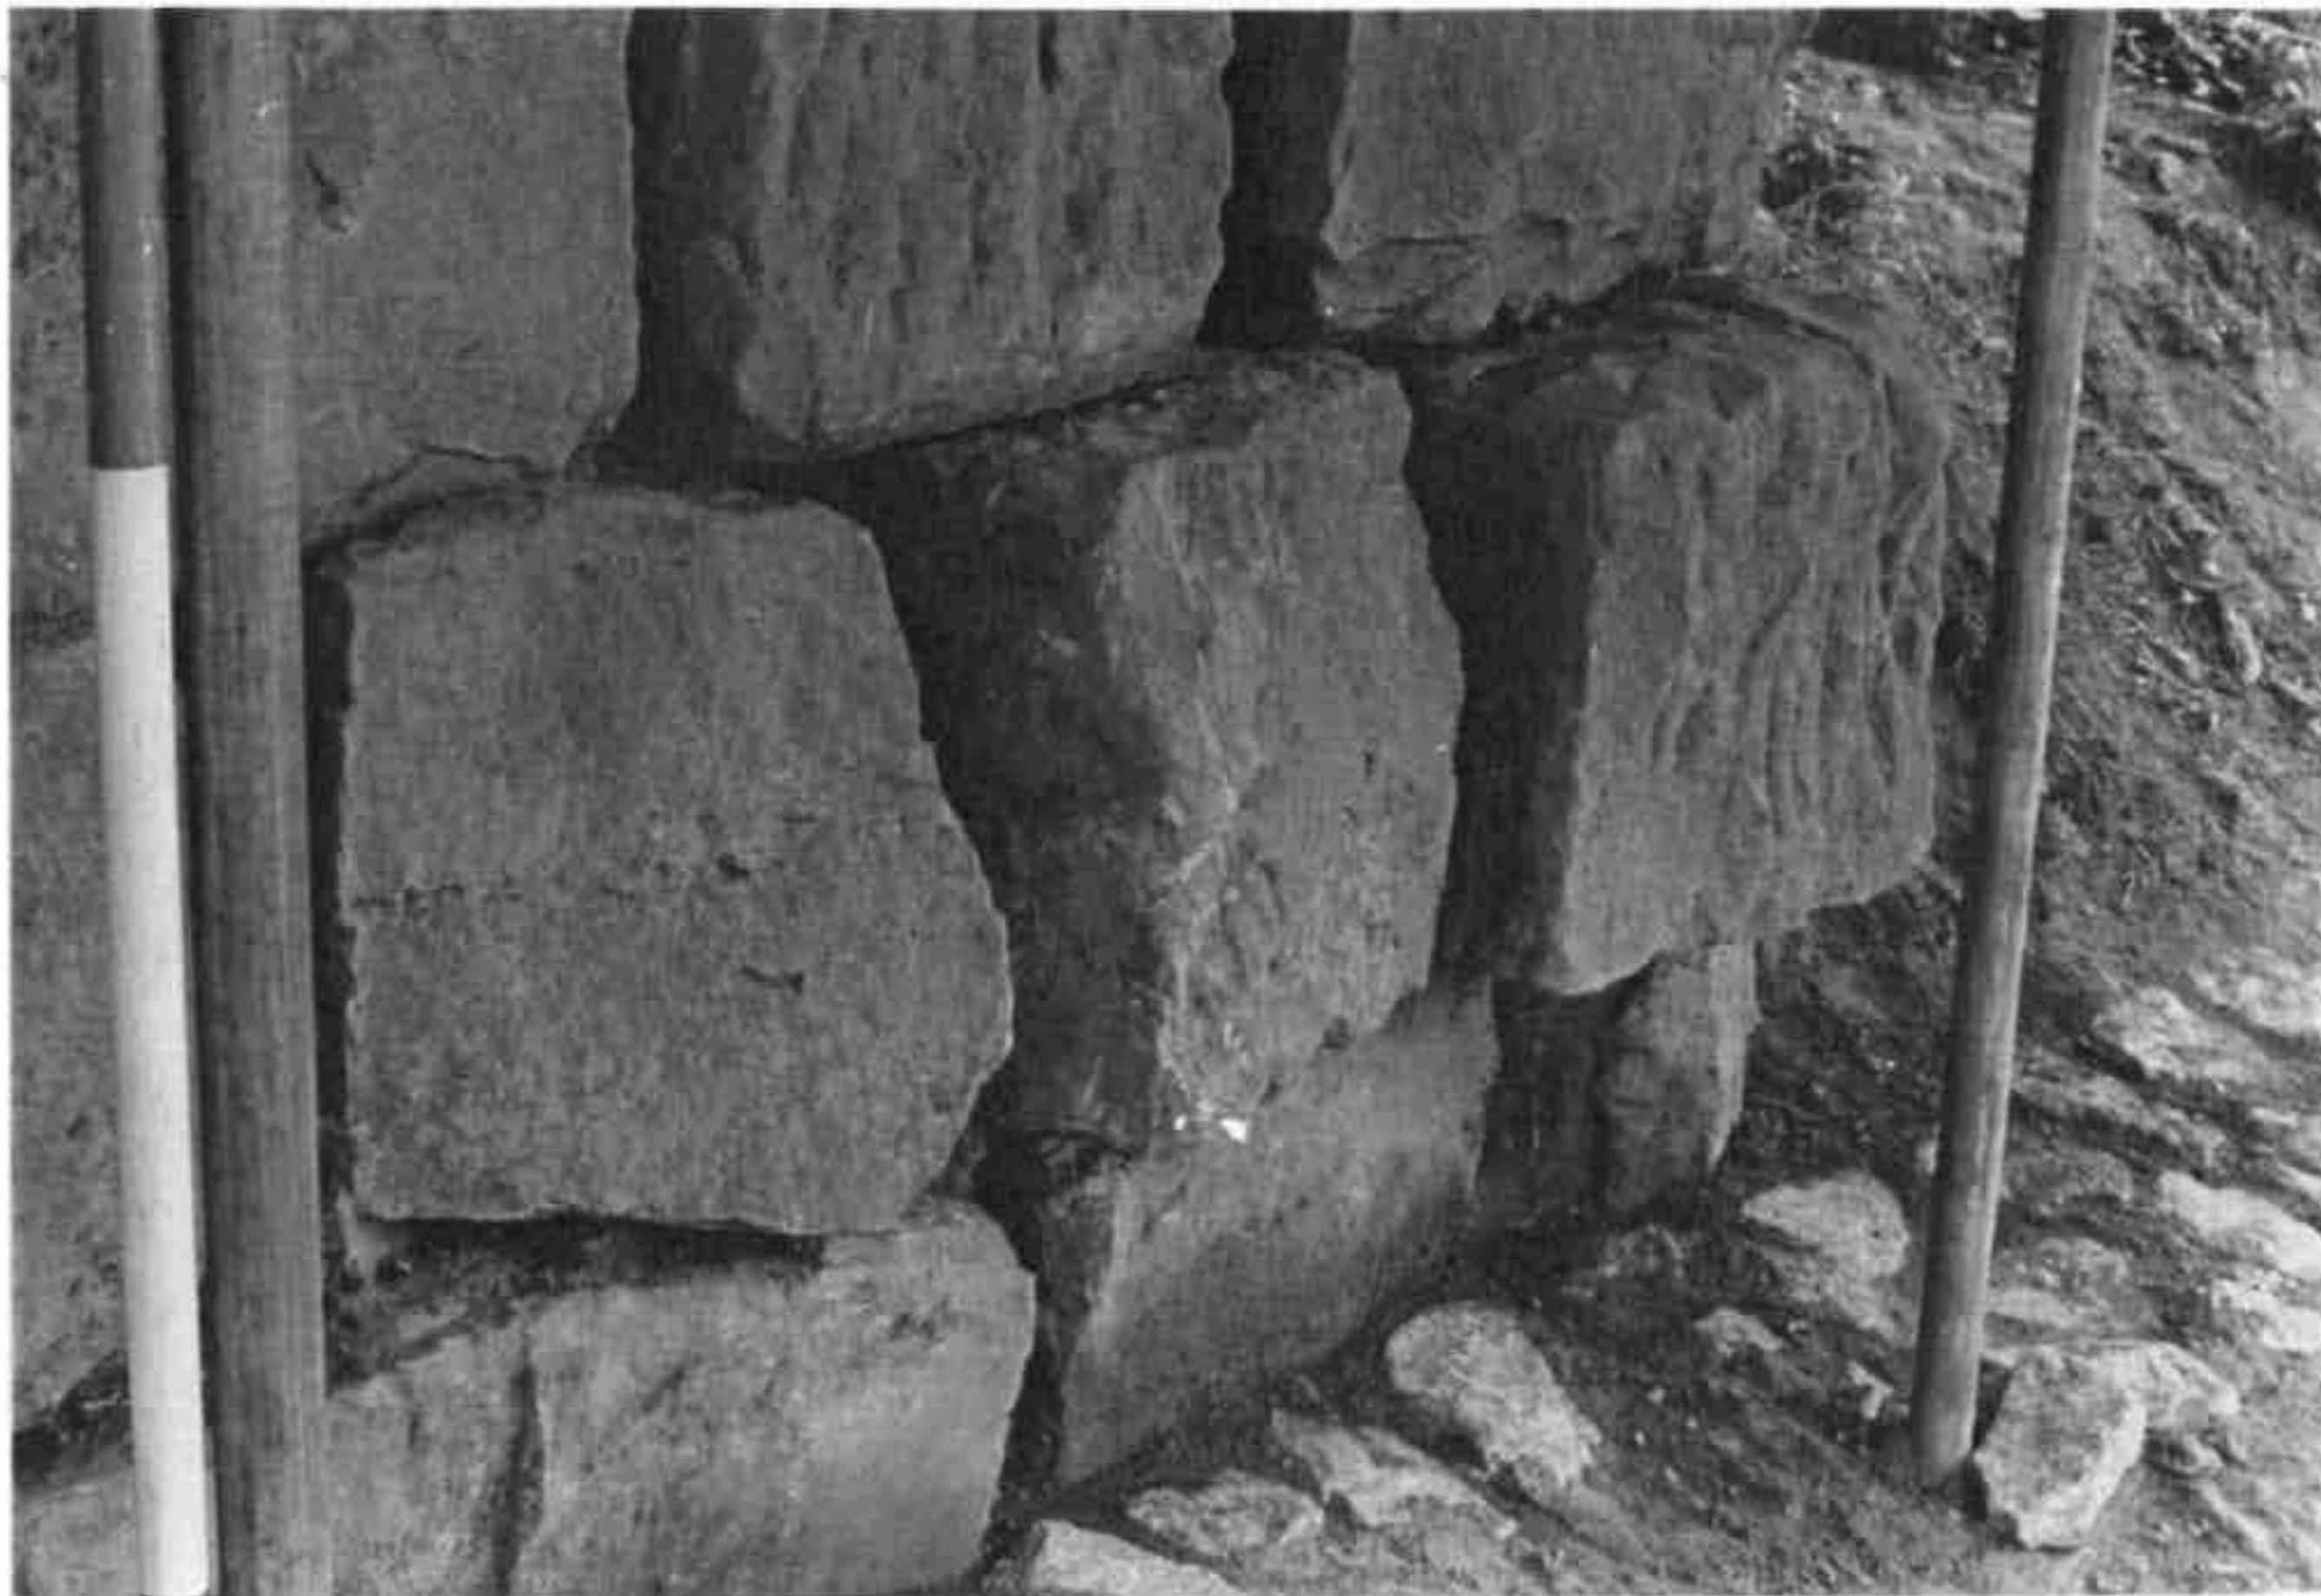
Plate 5

Partial view of front elevation of Upper Buttress, showing the cutwater effect built into the second course of basal blocks.

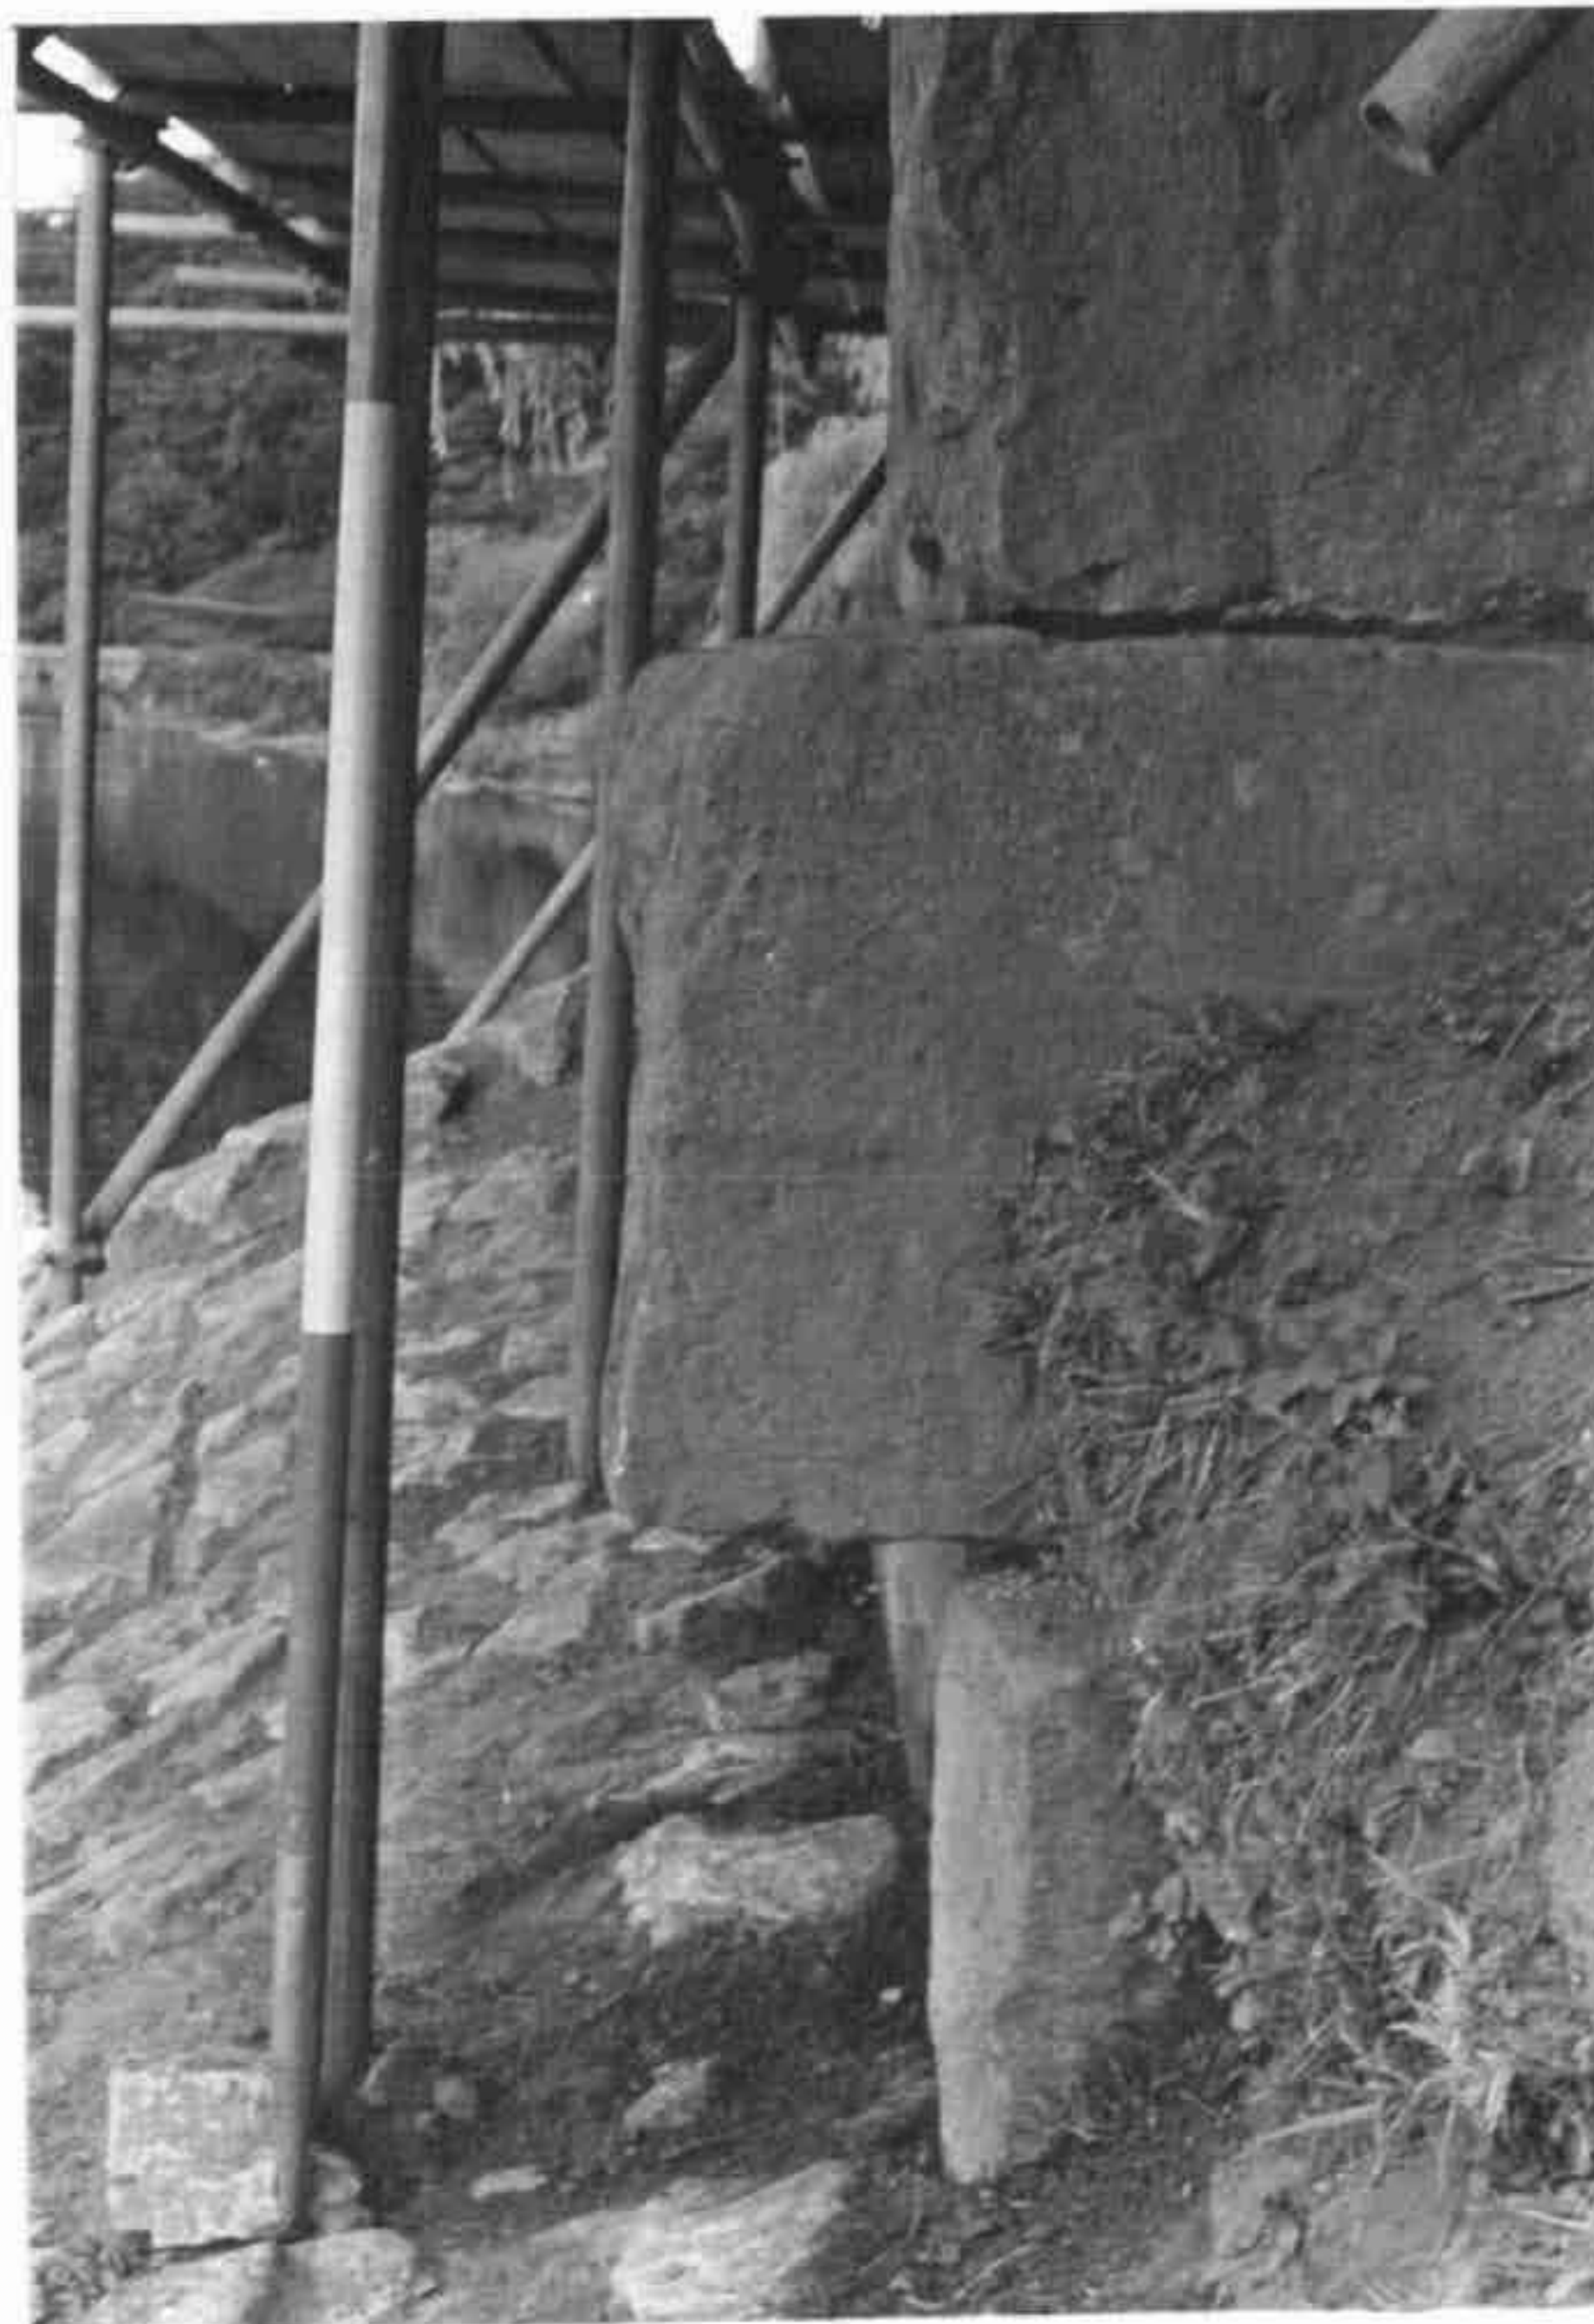
Plate 6

View, looking south-west, showing the cutwater effect in the second basal-block course in profile.

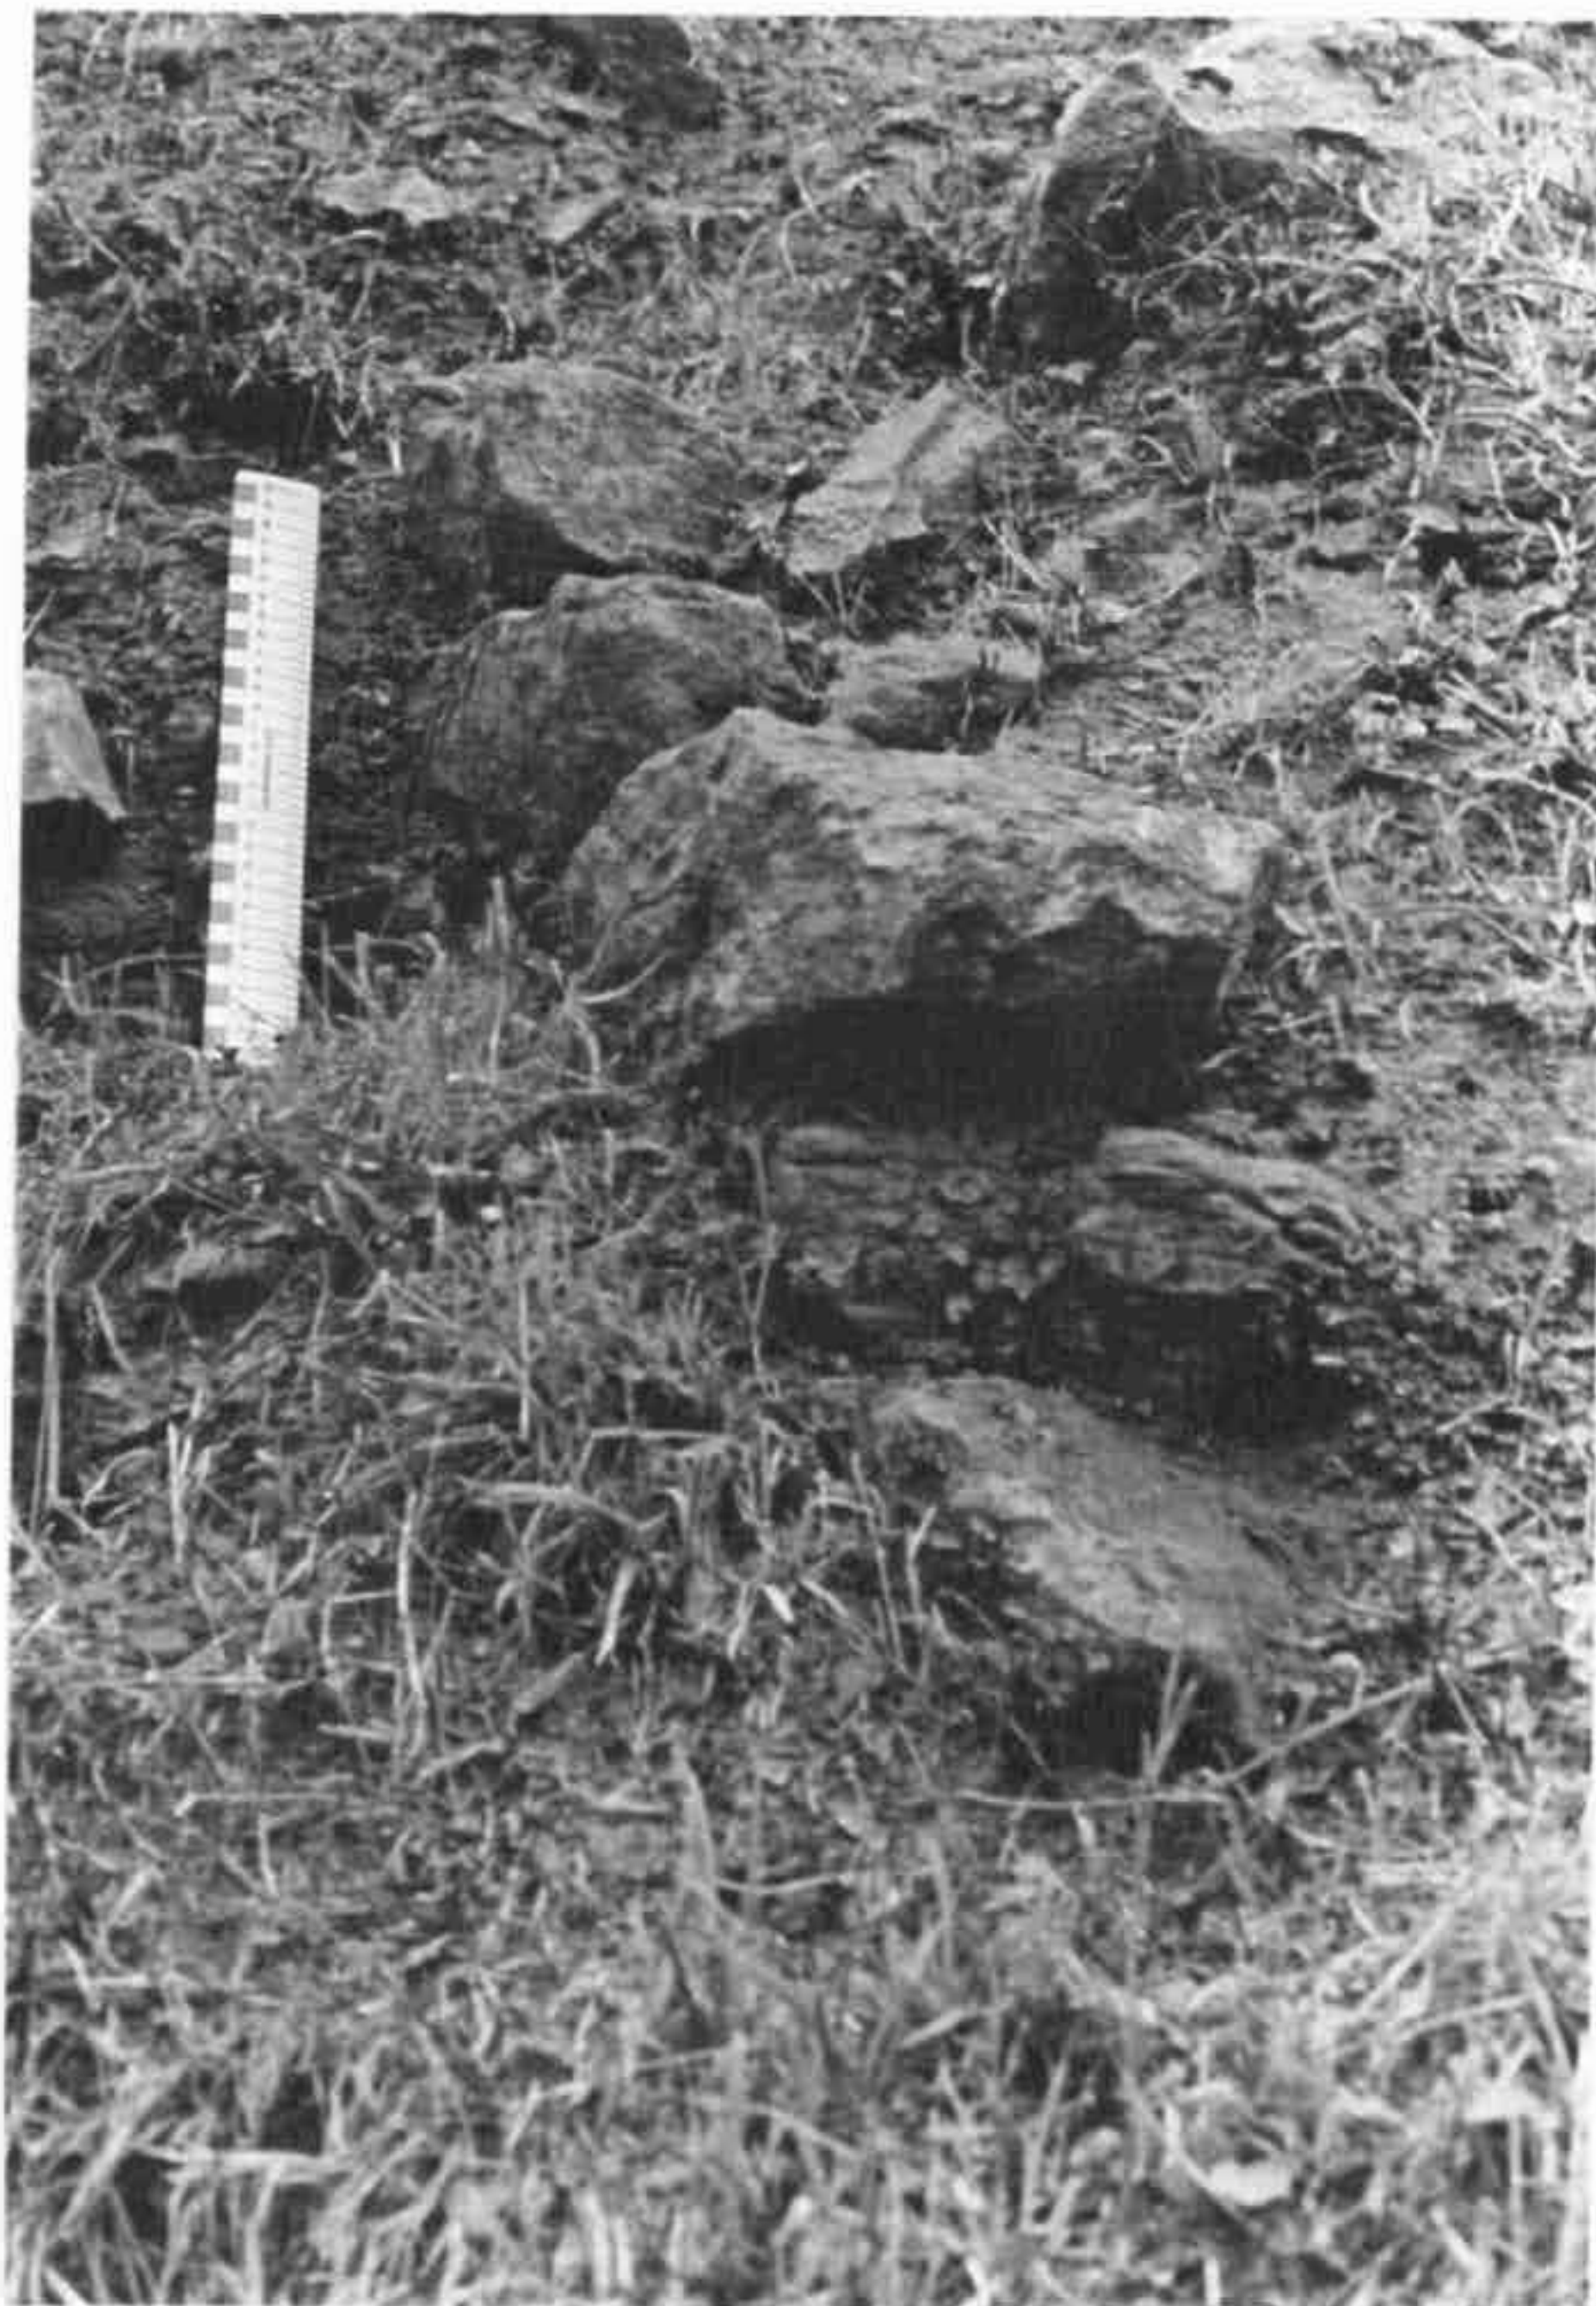
Plate 8

Detailed view of smaller, upper, coursing of emergent ?retaining wall. This might have followed the natural contours of the riverbank, protecting the main building complex against river erosion, or formed part of a structure linked to the Lower Buttress.

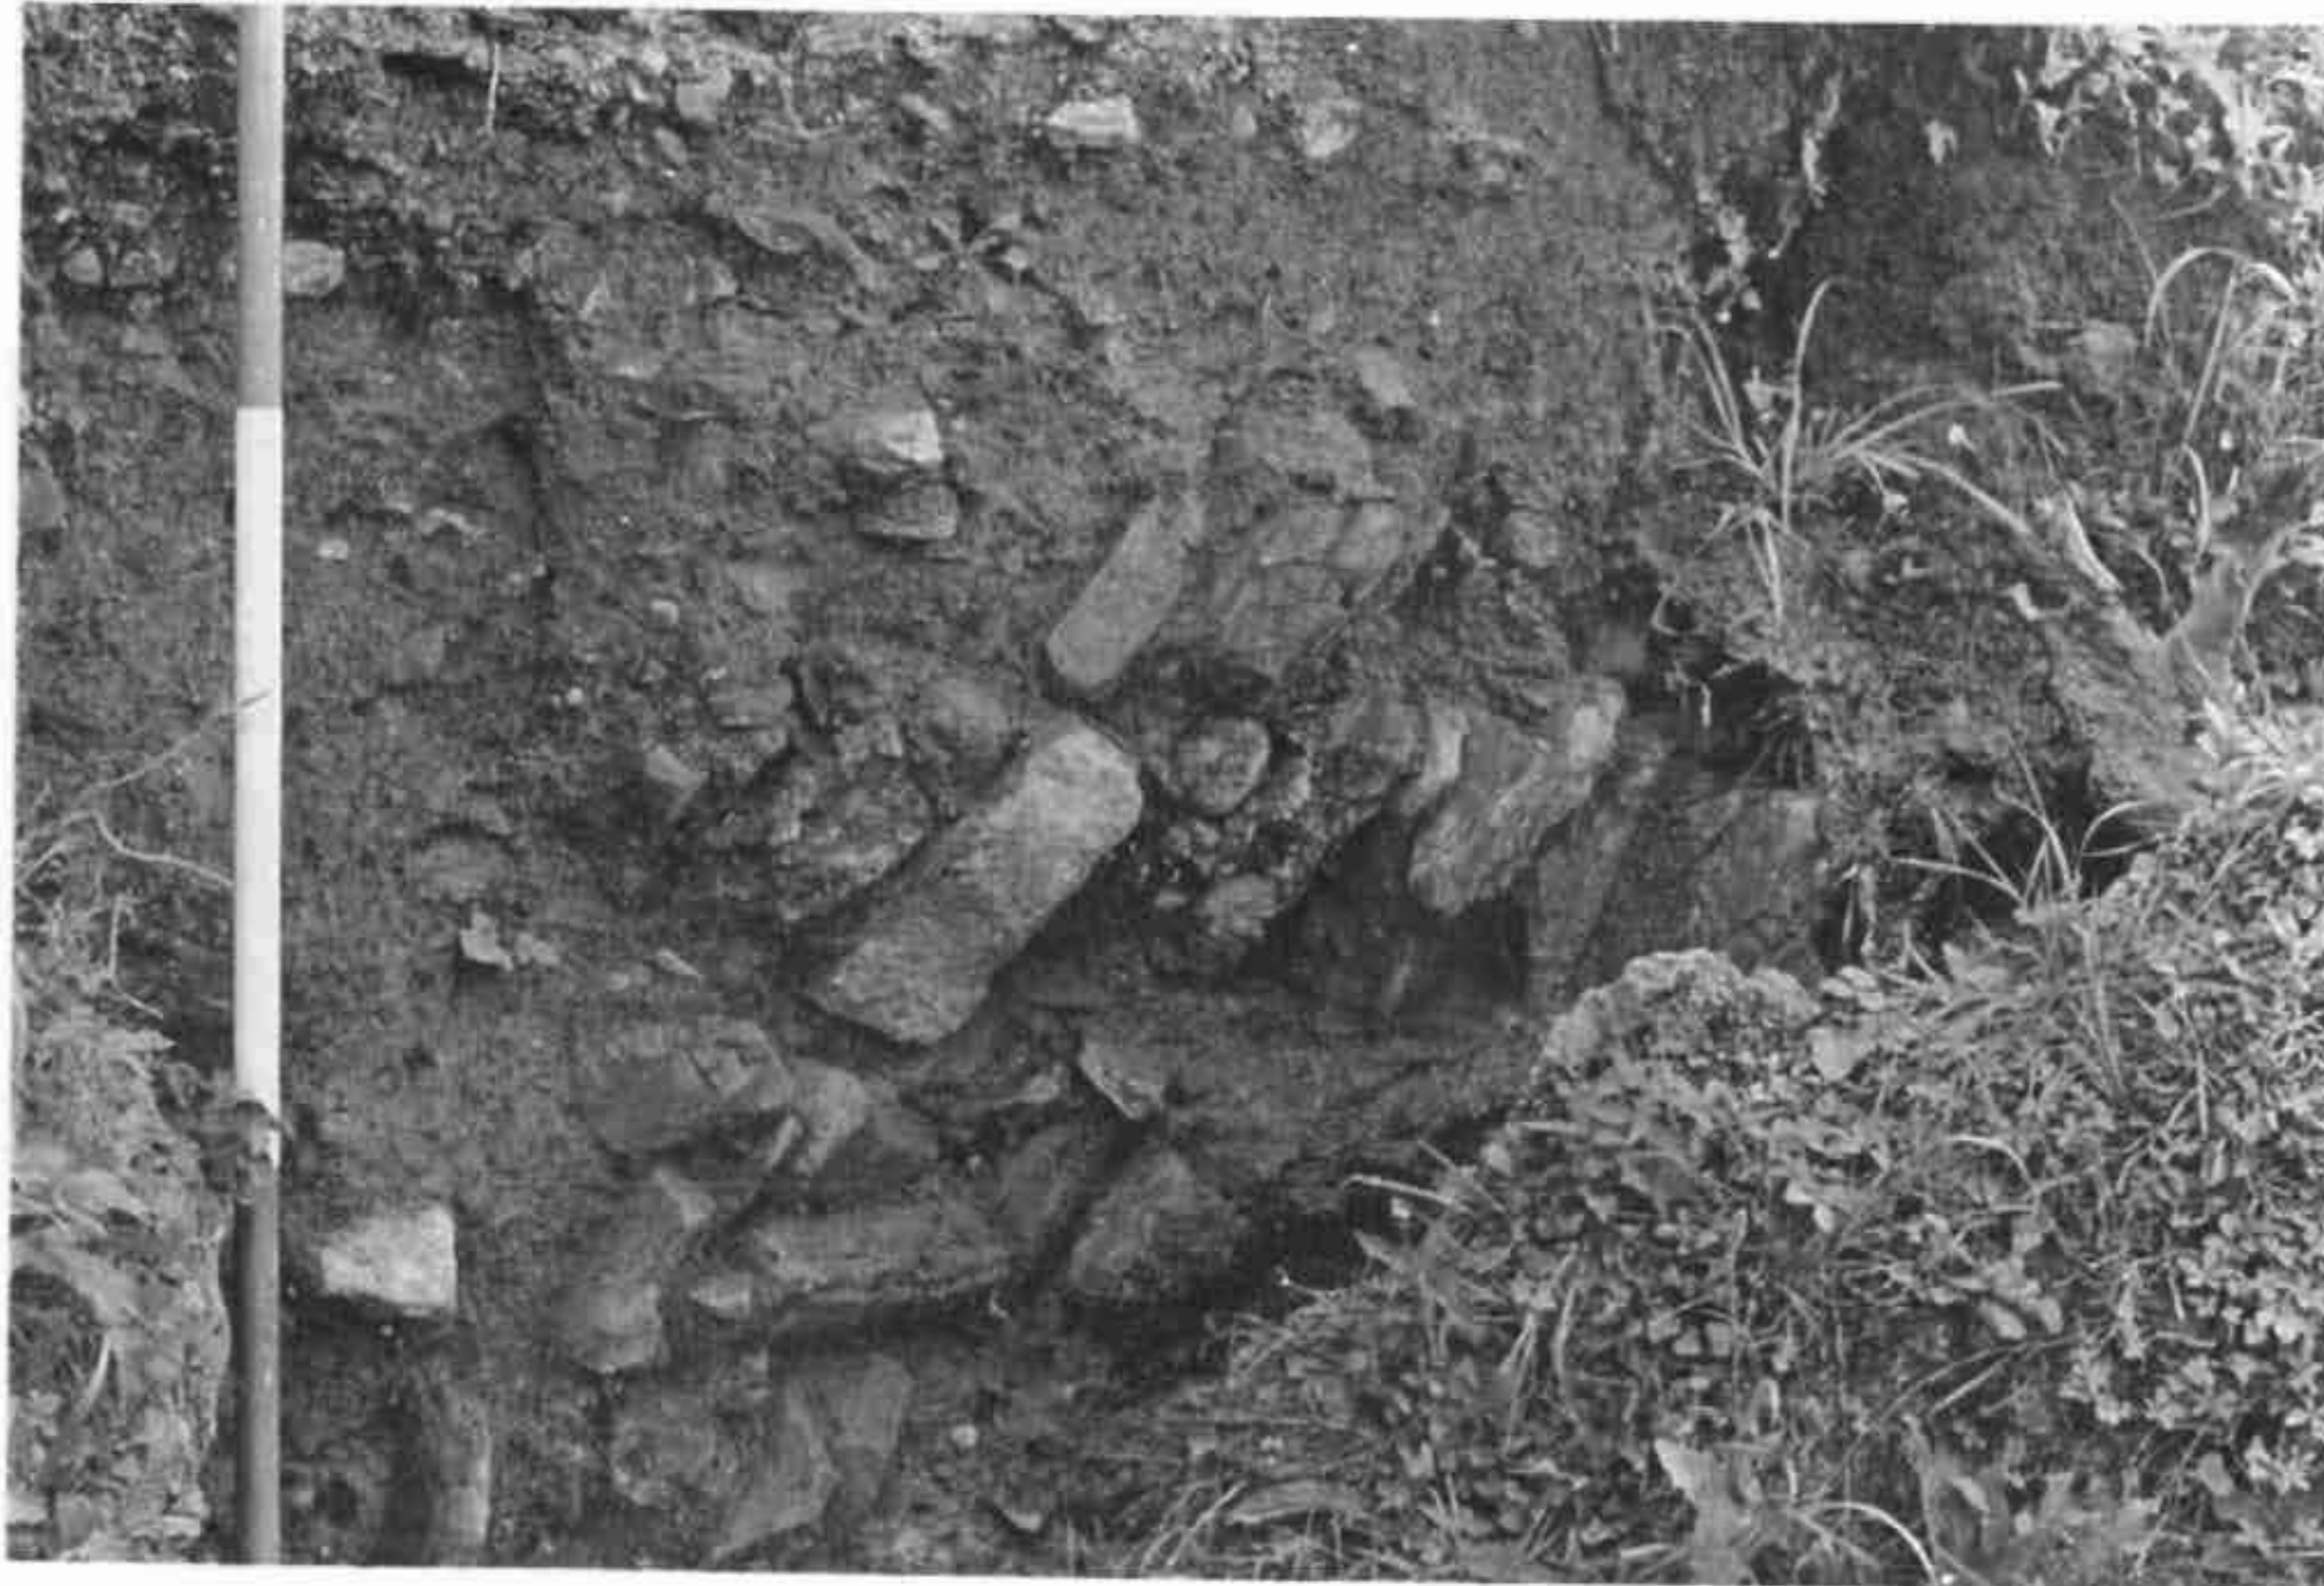
Plate 10

Coursed blockwork seen in bank section immediately behind and upstream of the Lower Buttress (point A on plate 9 above). This walling overlies a concrete ?floor level, and may come from collapse of a structure or steps, in part supported by the buttress.

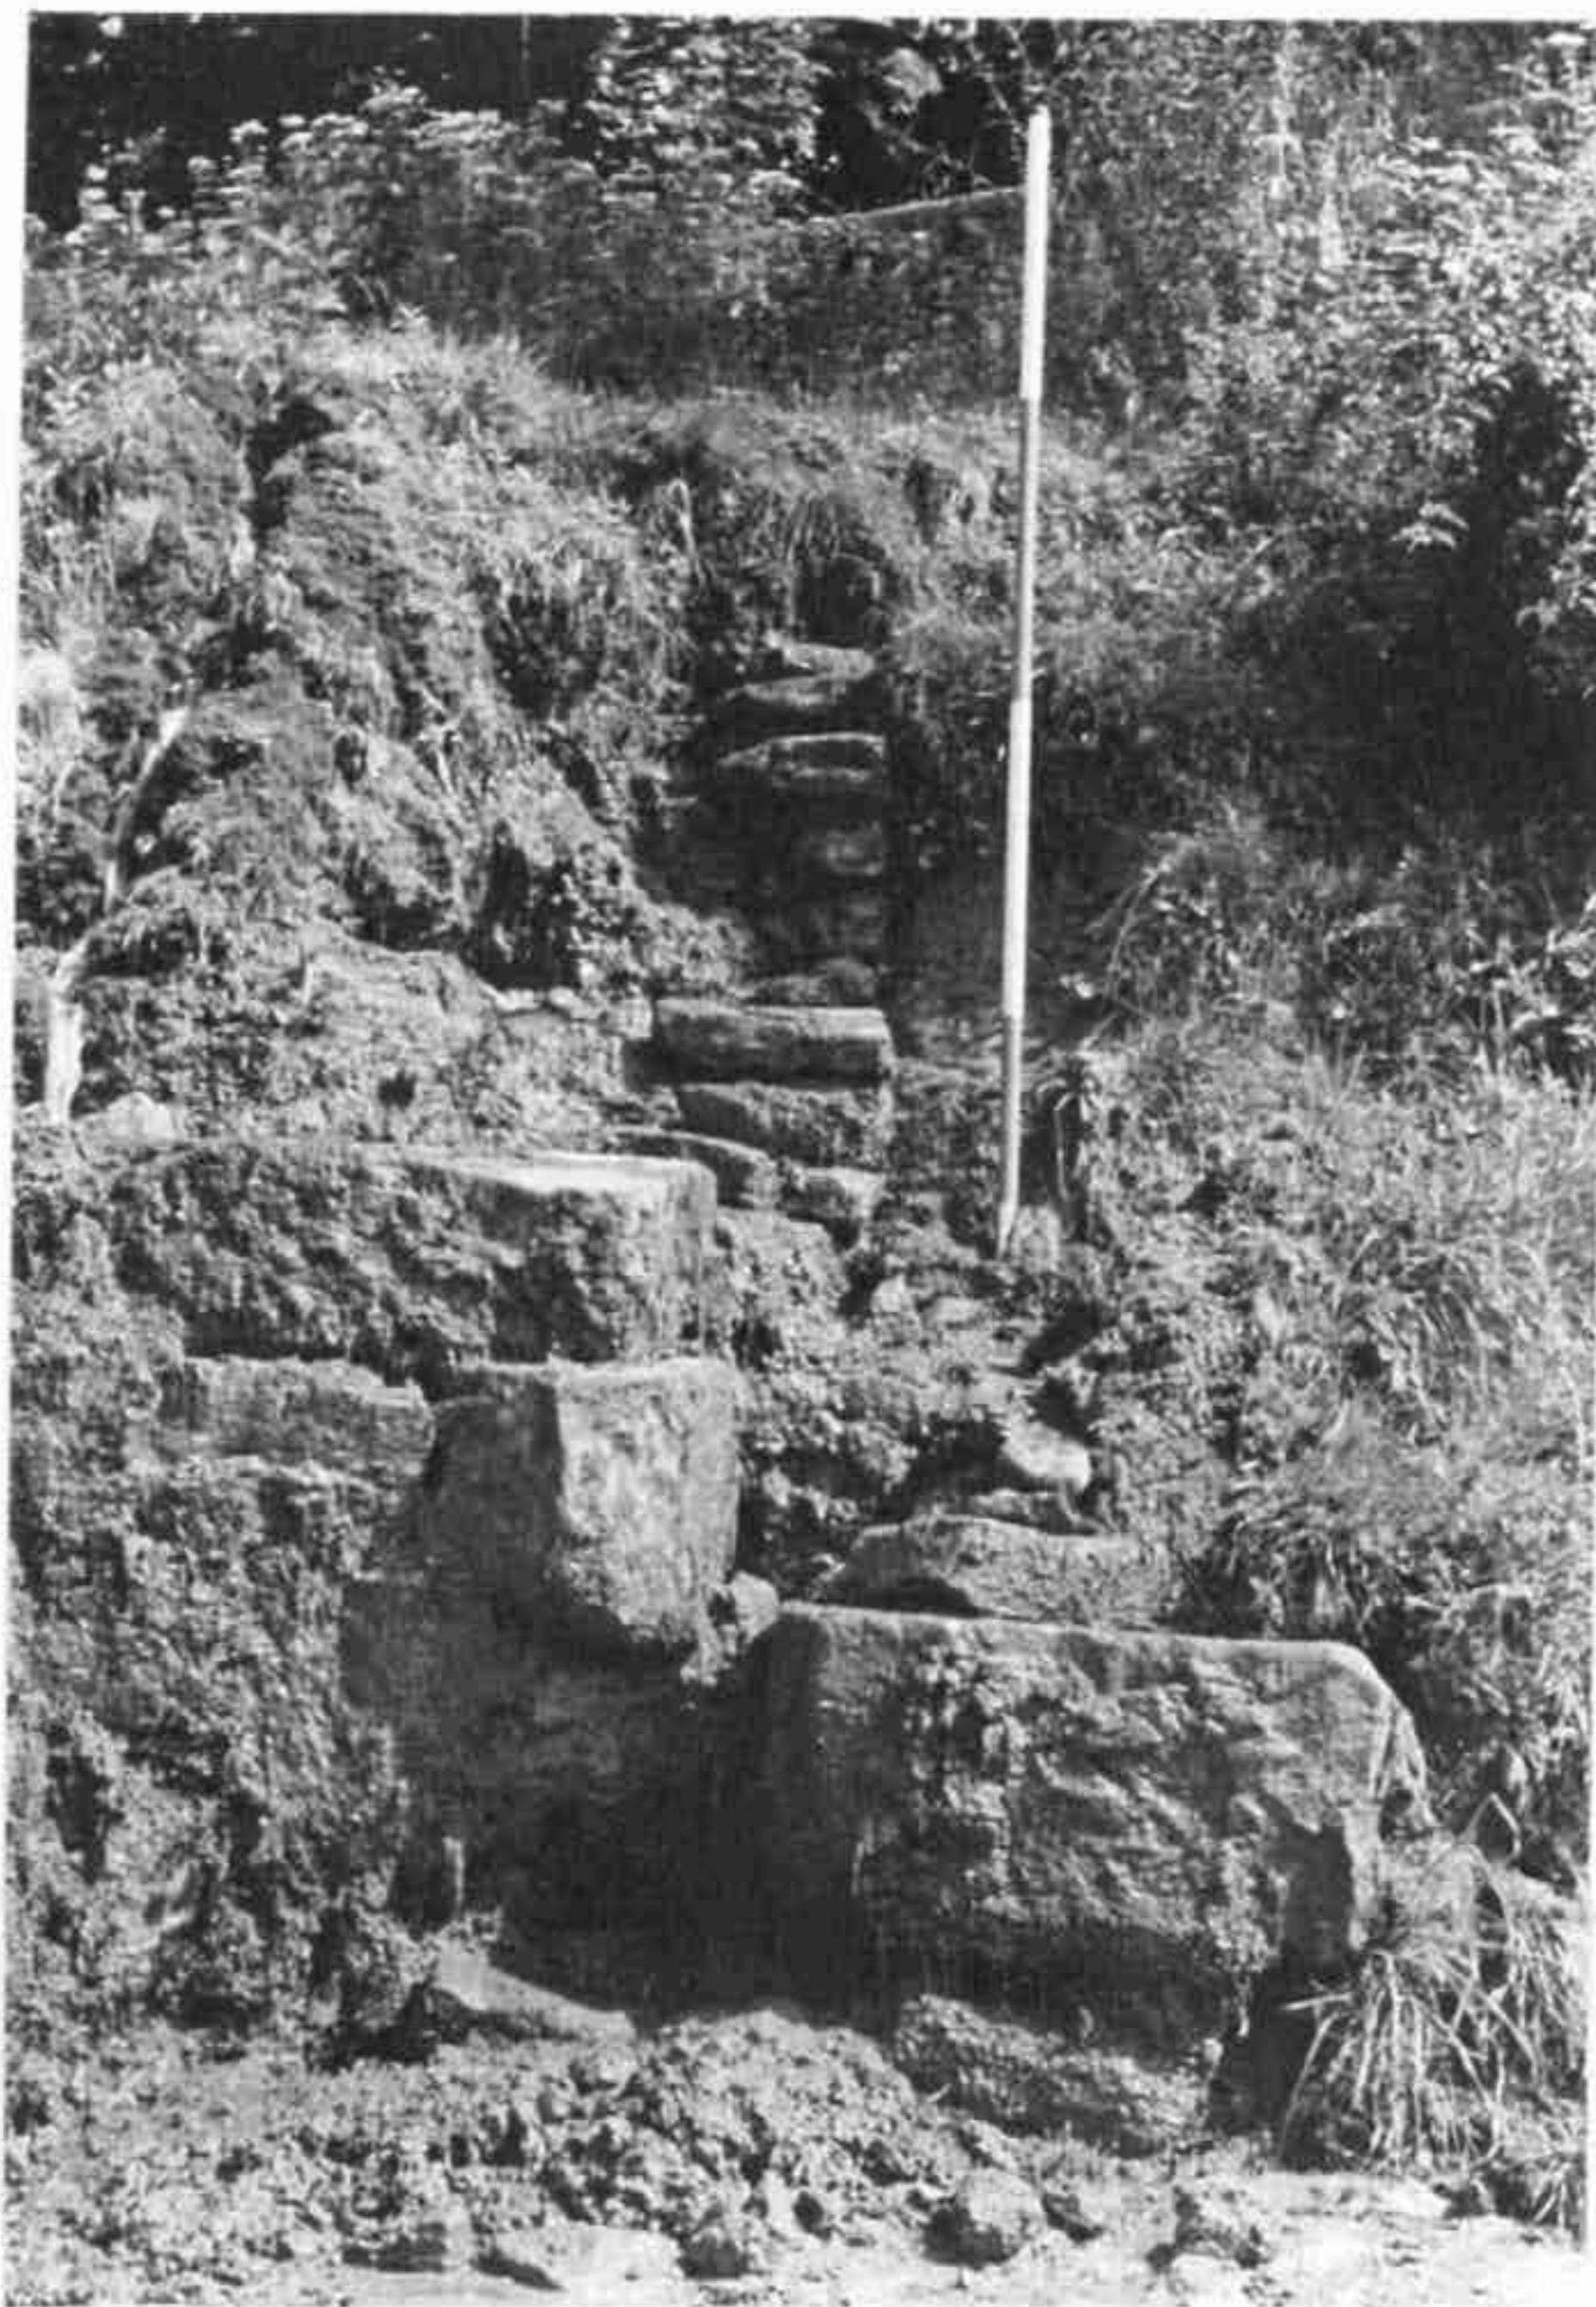
Plate 11

View, looking north, of the downstream edge of the Lower Buttress; with nine surviving wall-courses (facing a concrete/rubble core) supported by the buttress. Its function is unclear but may have formed part of a step-structure or link to buildings on the terrace.

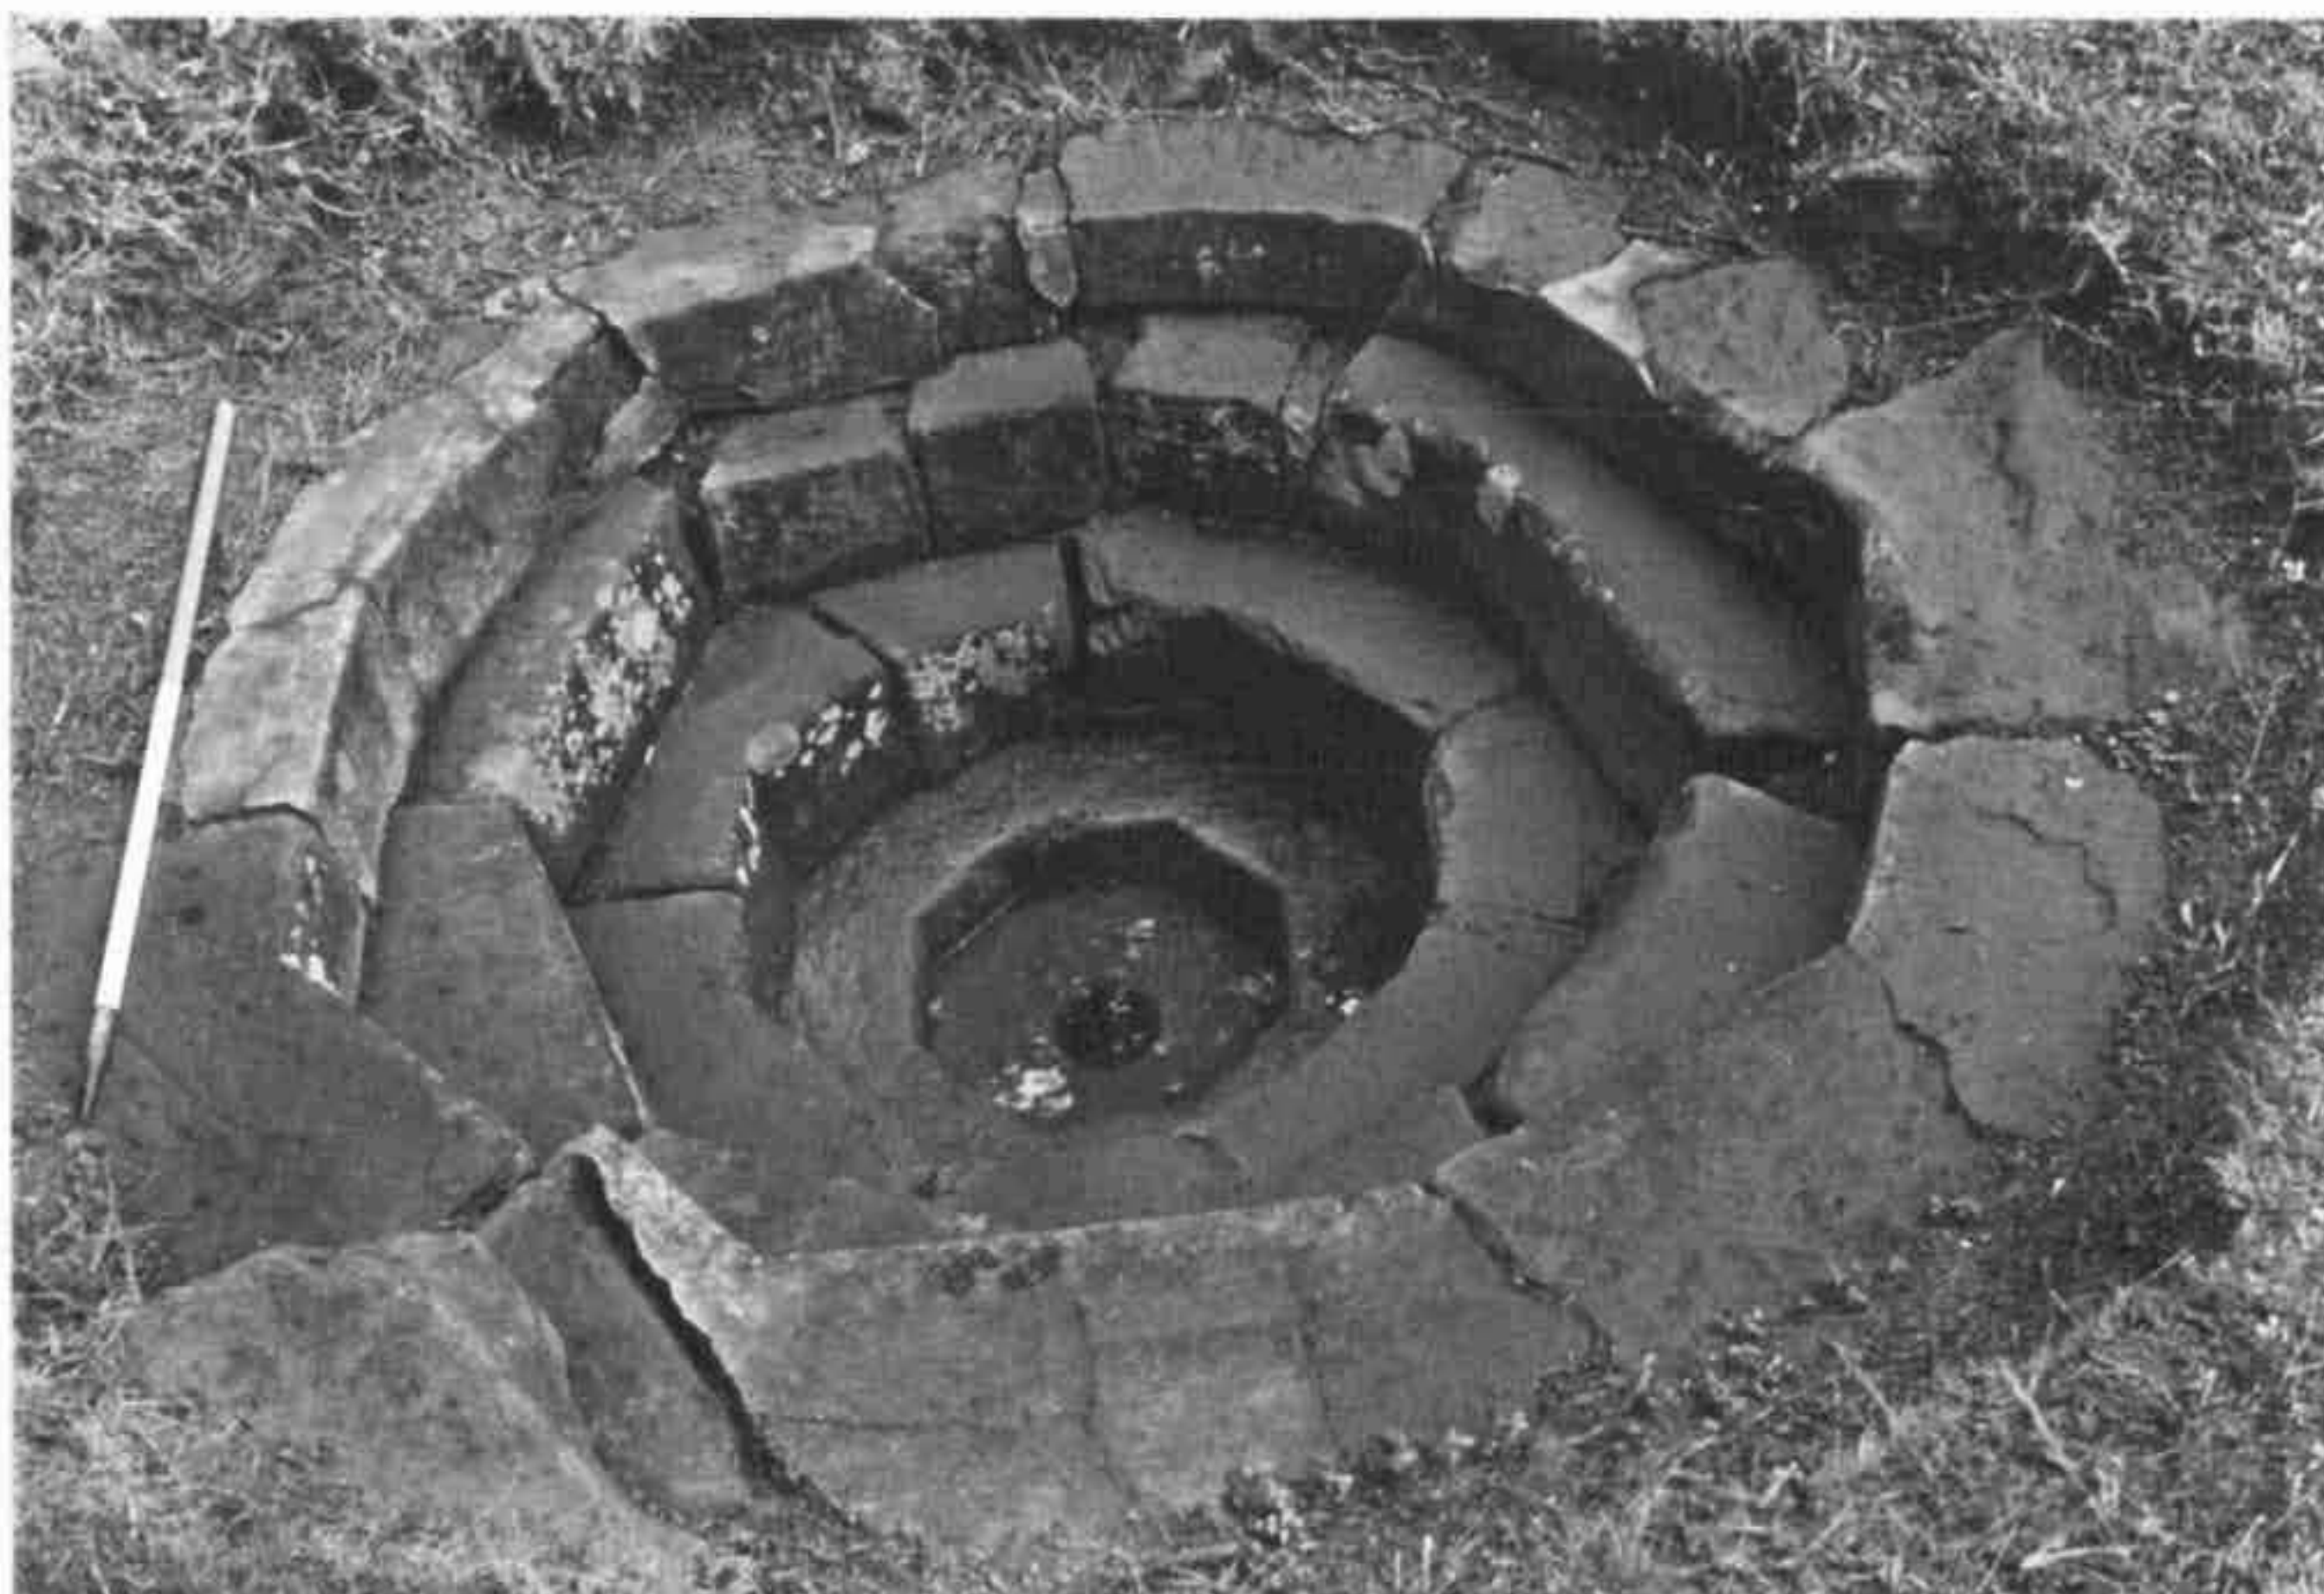
Plate 12

Octagonal cistern, of probable Romano-British date, on the terrace. The much-disturbed structure contains both curving and angular blocks, and in reconstructed form may be a combination of more than one structure.
