**THE WEIR GARDEN,
SWAINSHILL,
HEREFORD & WORCESTER**

**ARCHAEOLOGICAL FIELDWORK
1991-1995**

Cotswold Archaeological Trust

C.A.T JOB: 0156
C.A.T REPORT: 95298

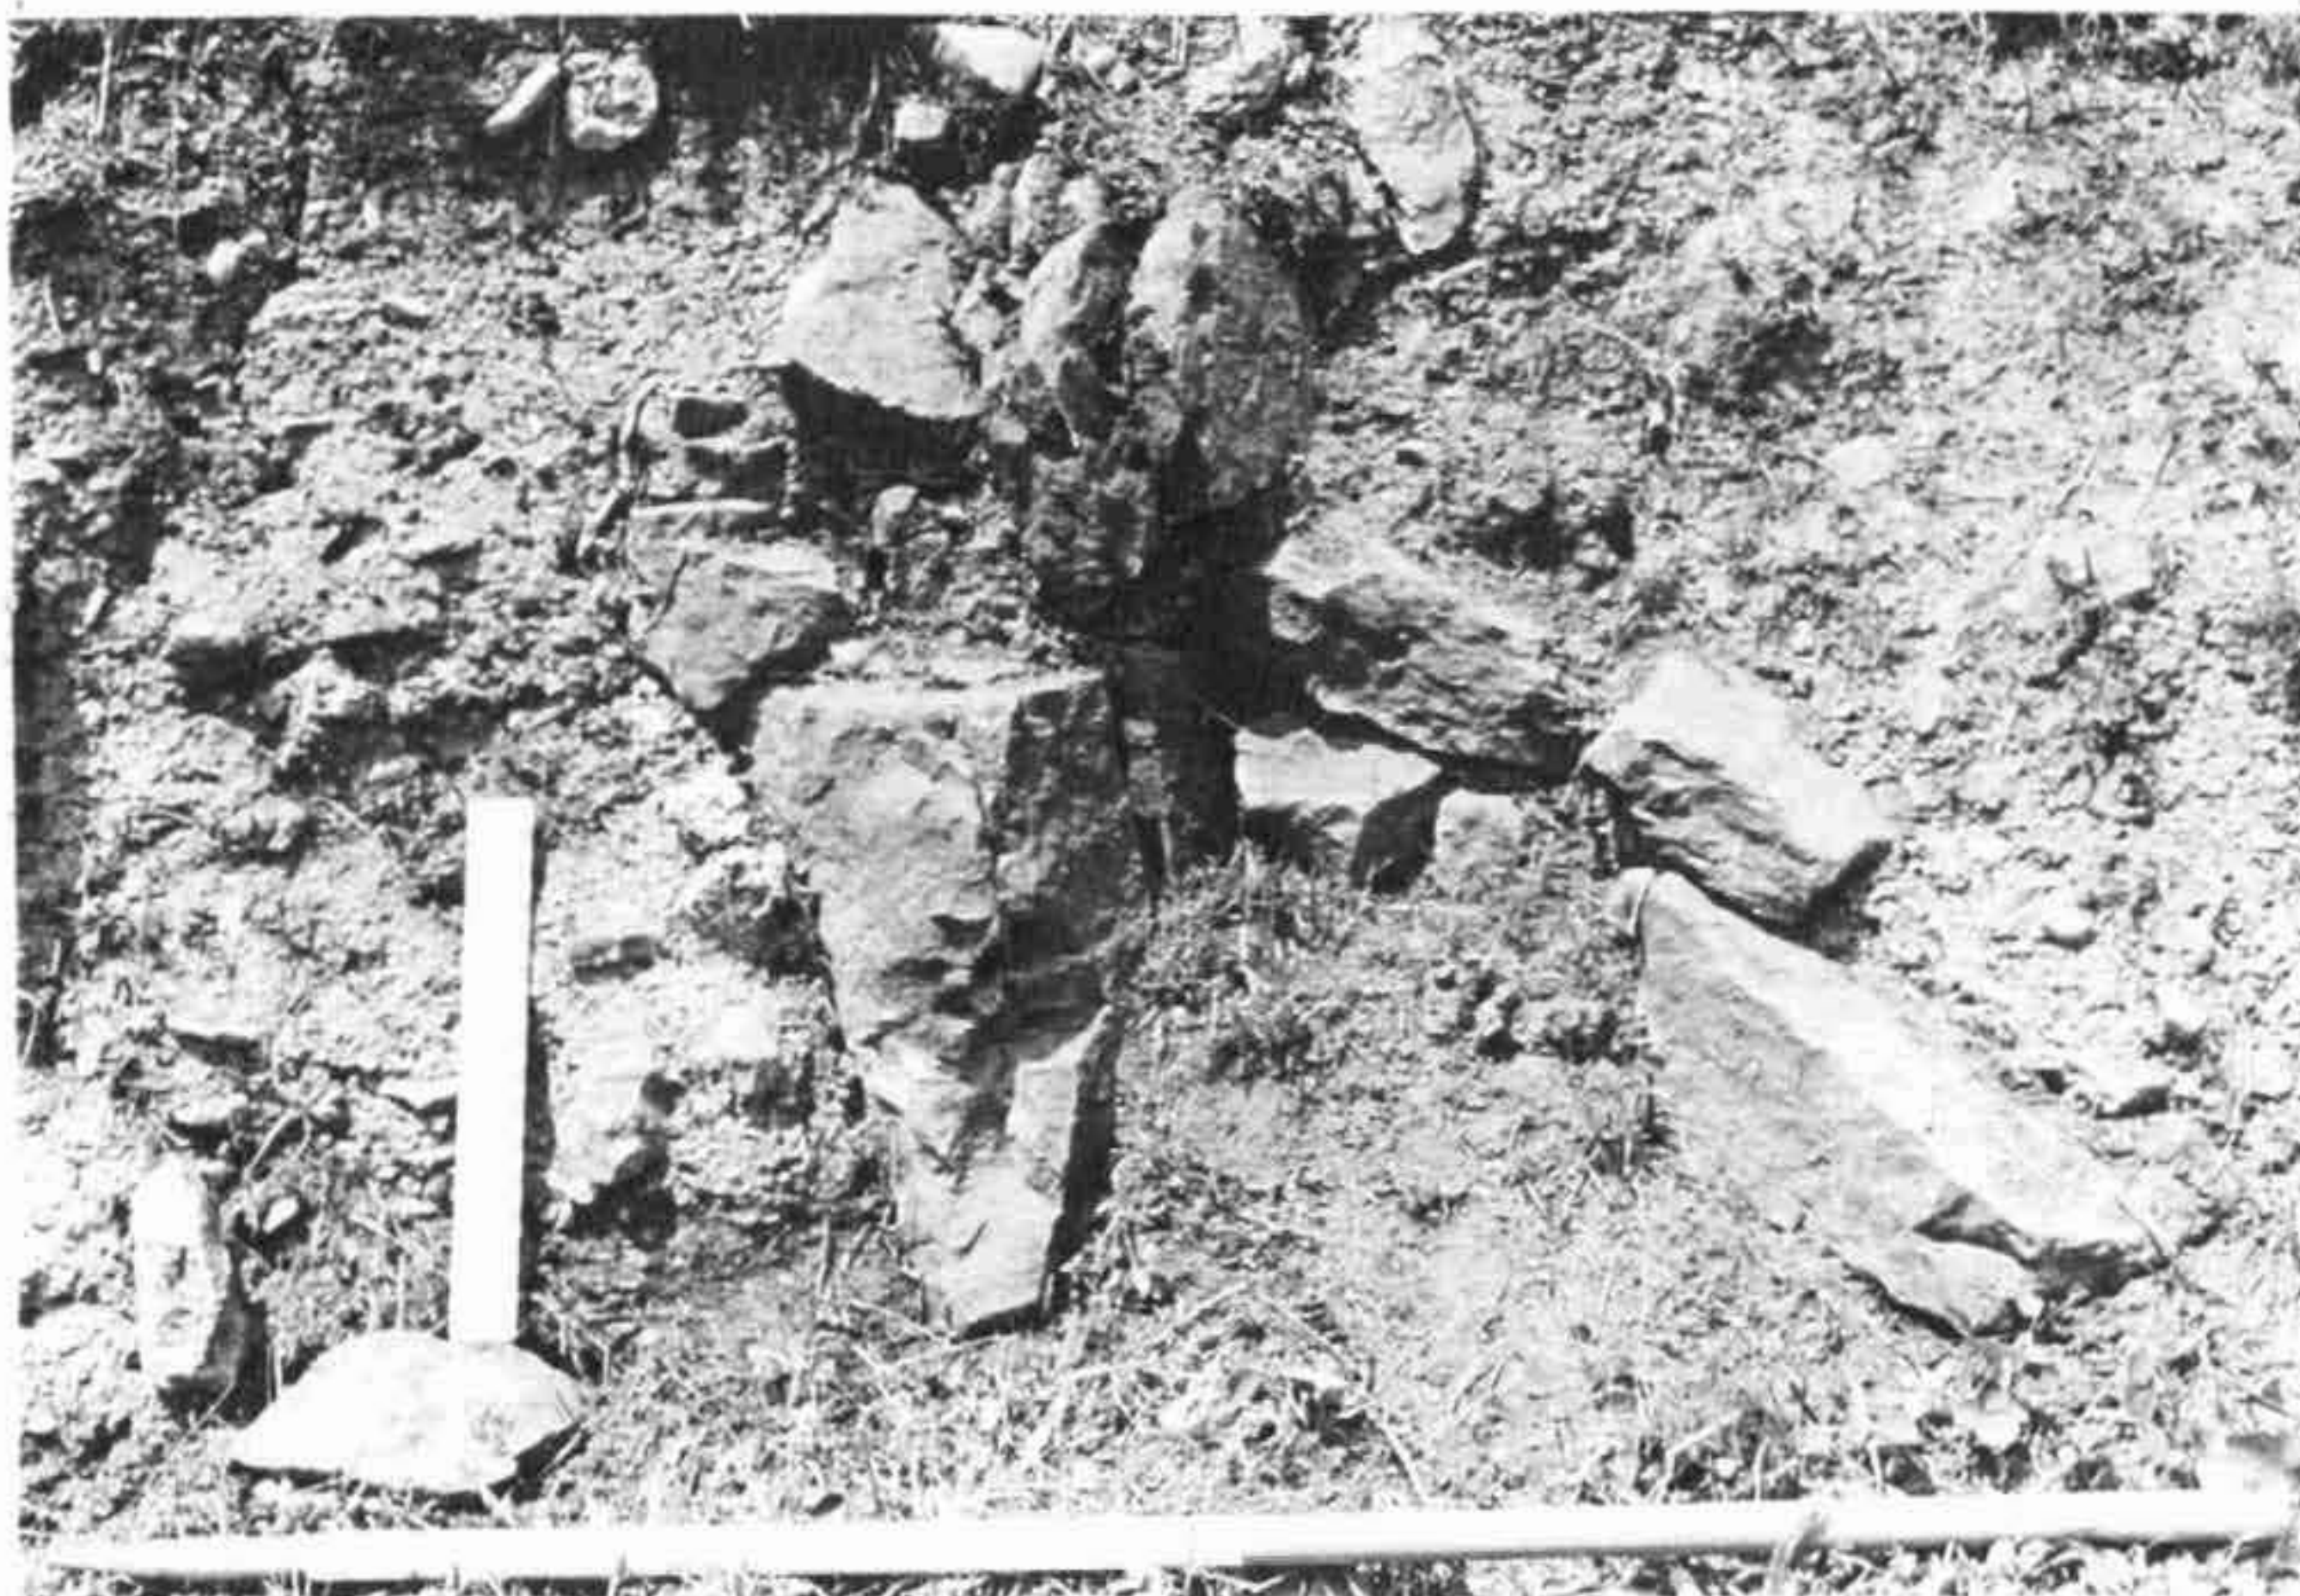
Plate 13

Two abutting Roman walls and demolition debris (section C, plan 4).
exposed on the scarp face of the riverbank.

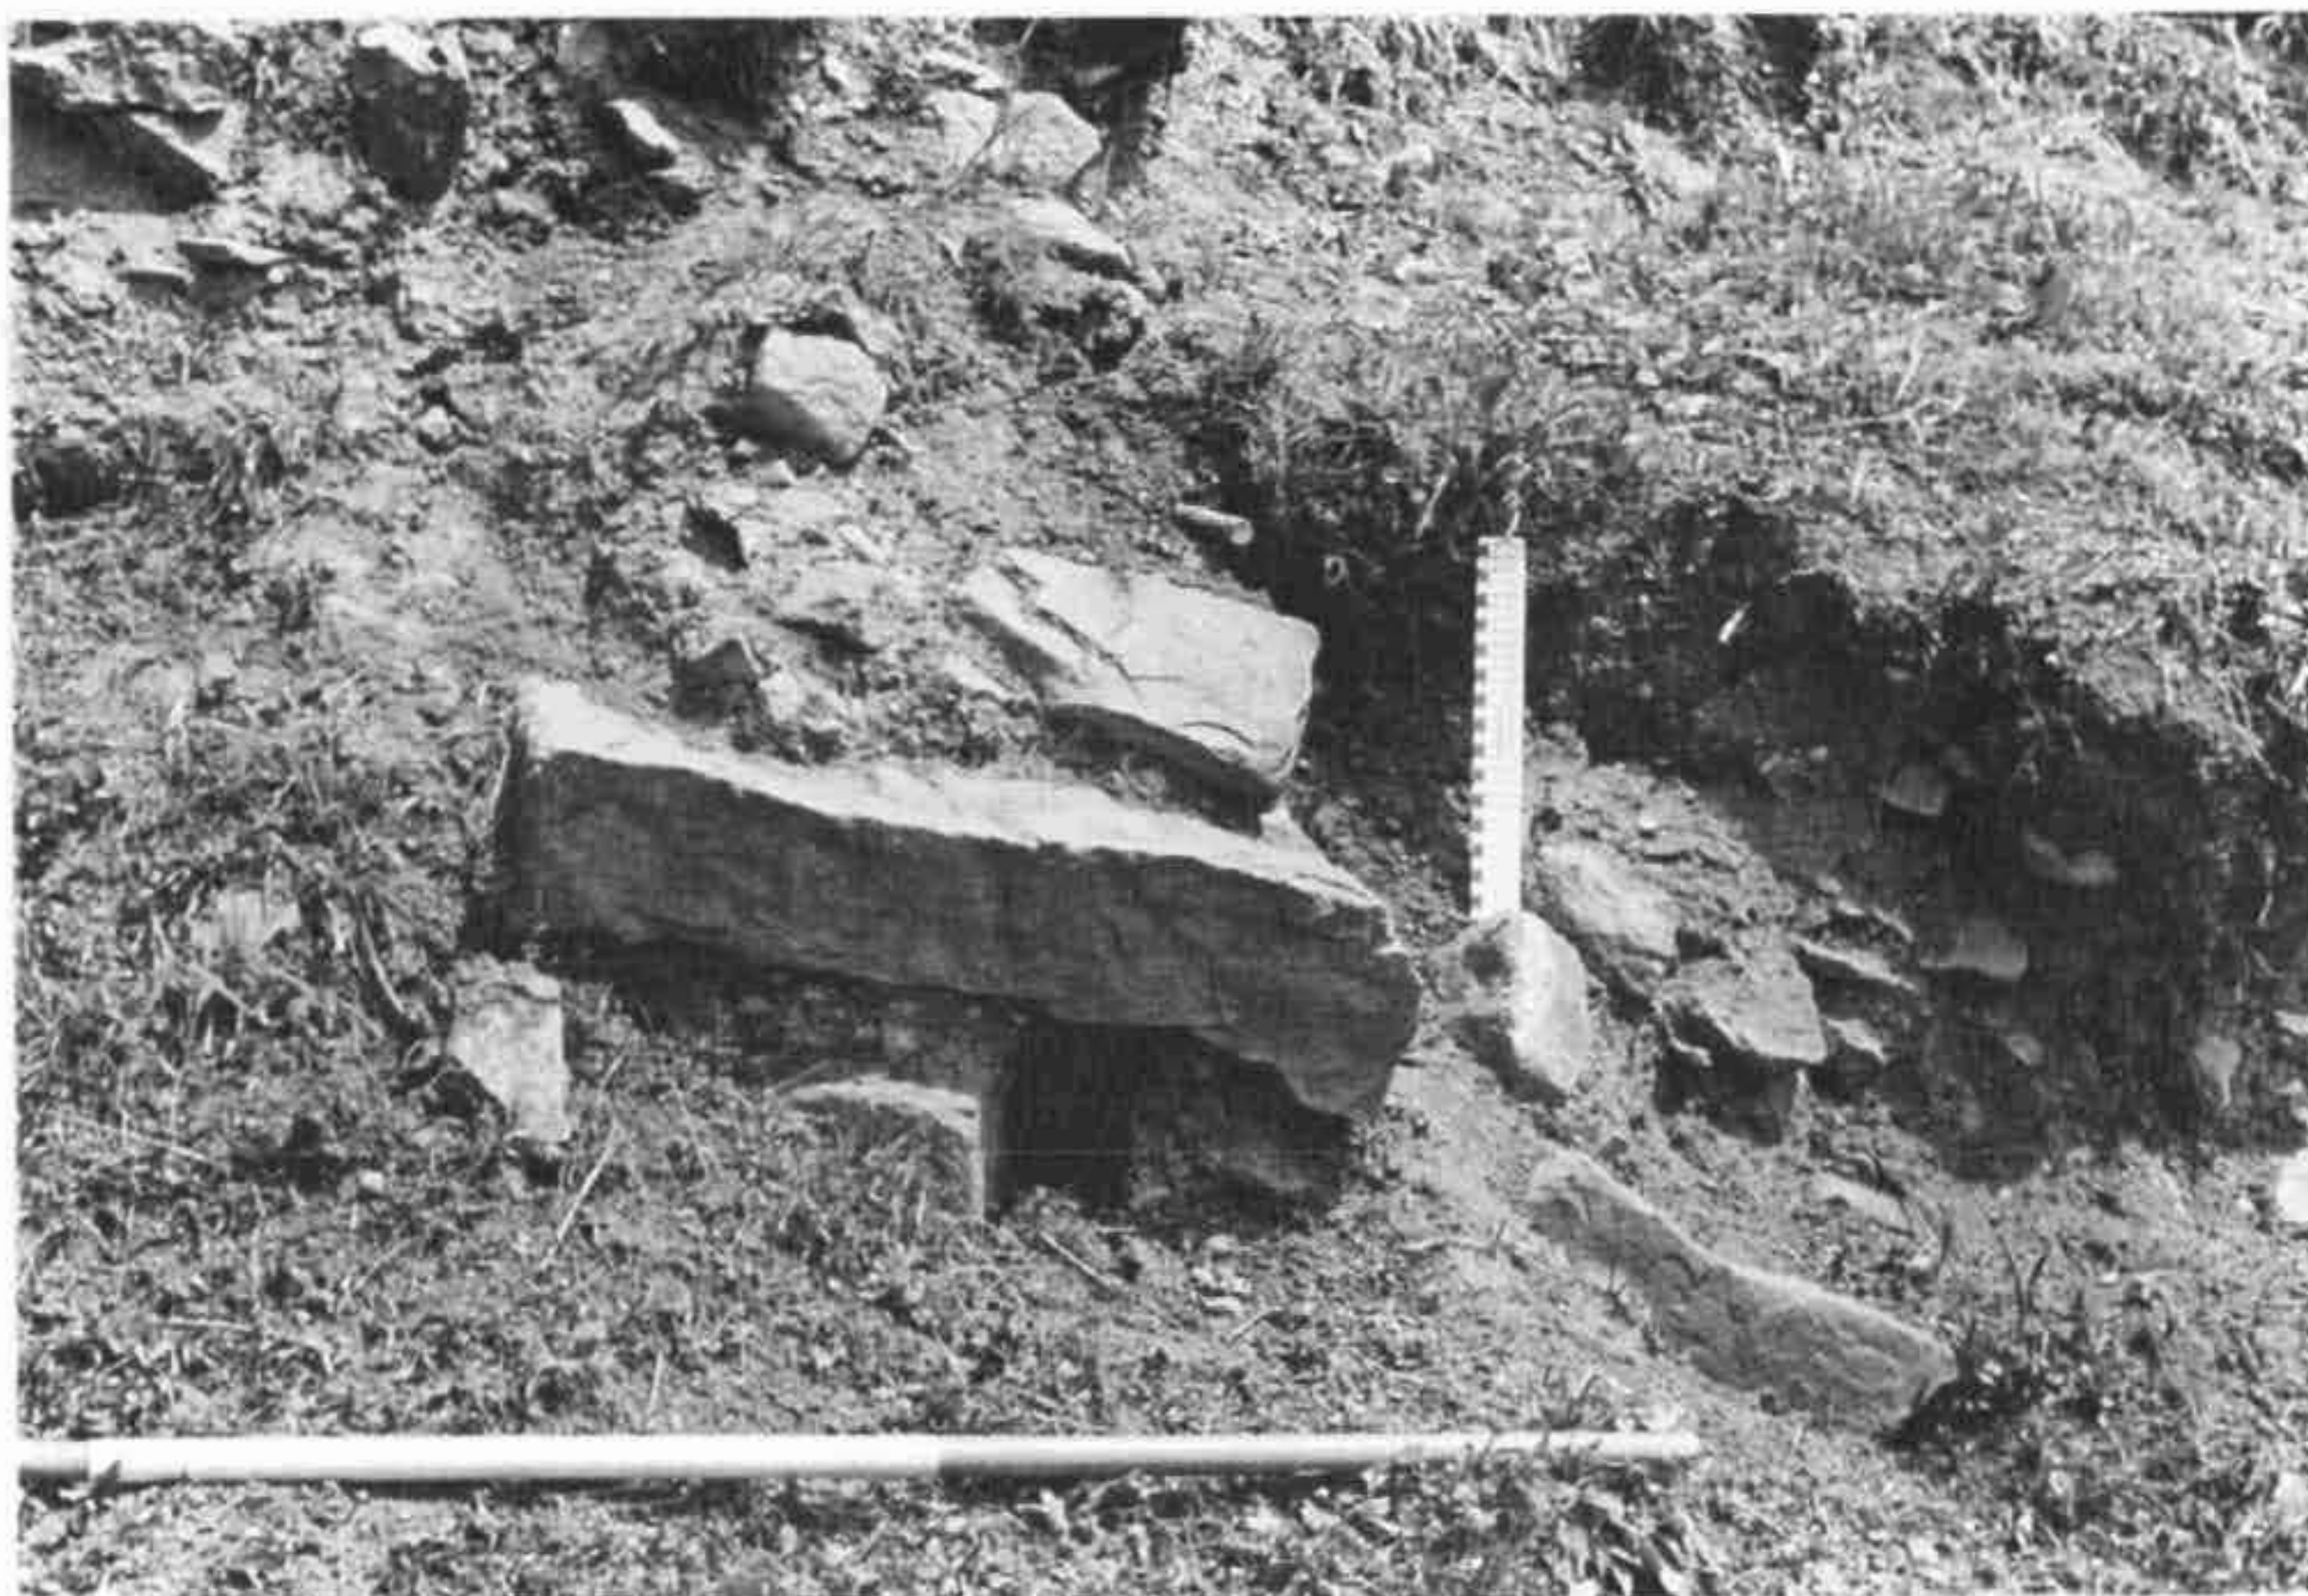
Plate 14

A second section of exposed Roman walling and debris (section B, plan 4).

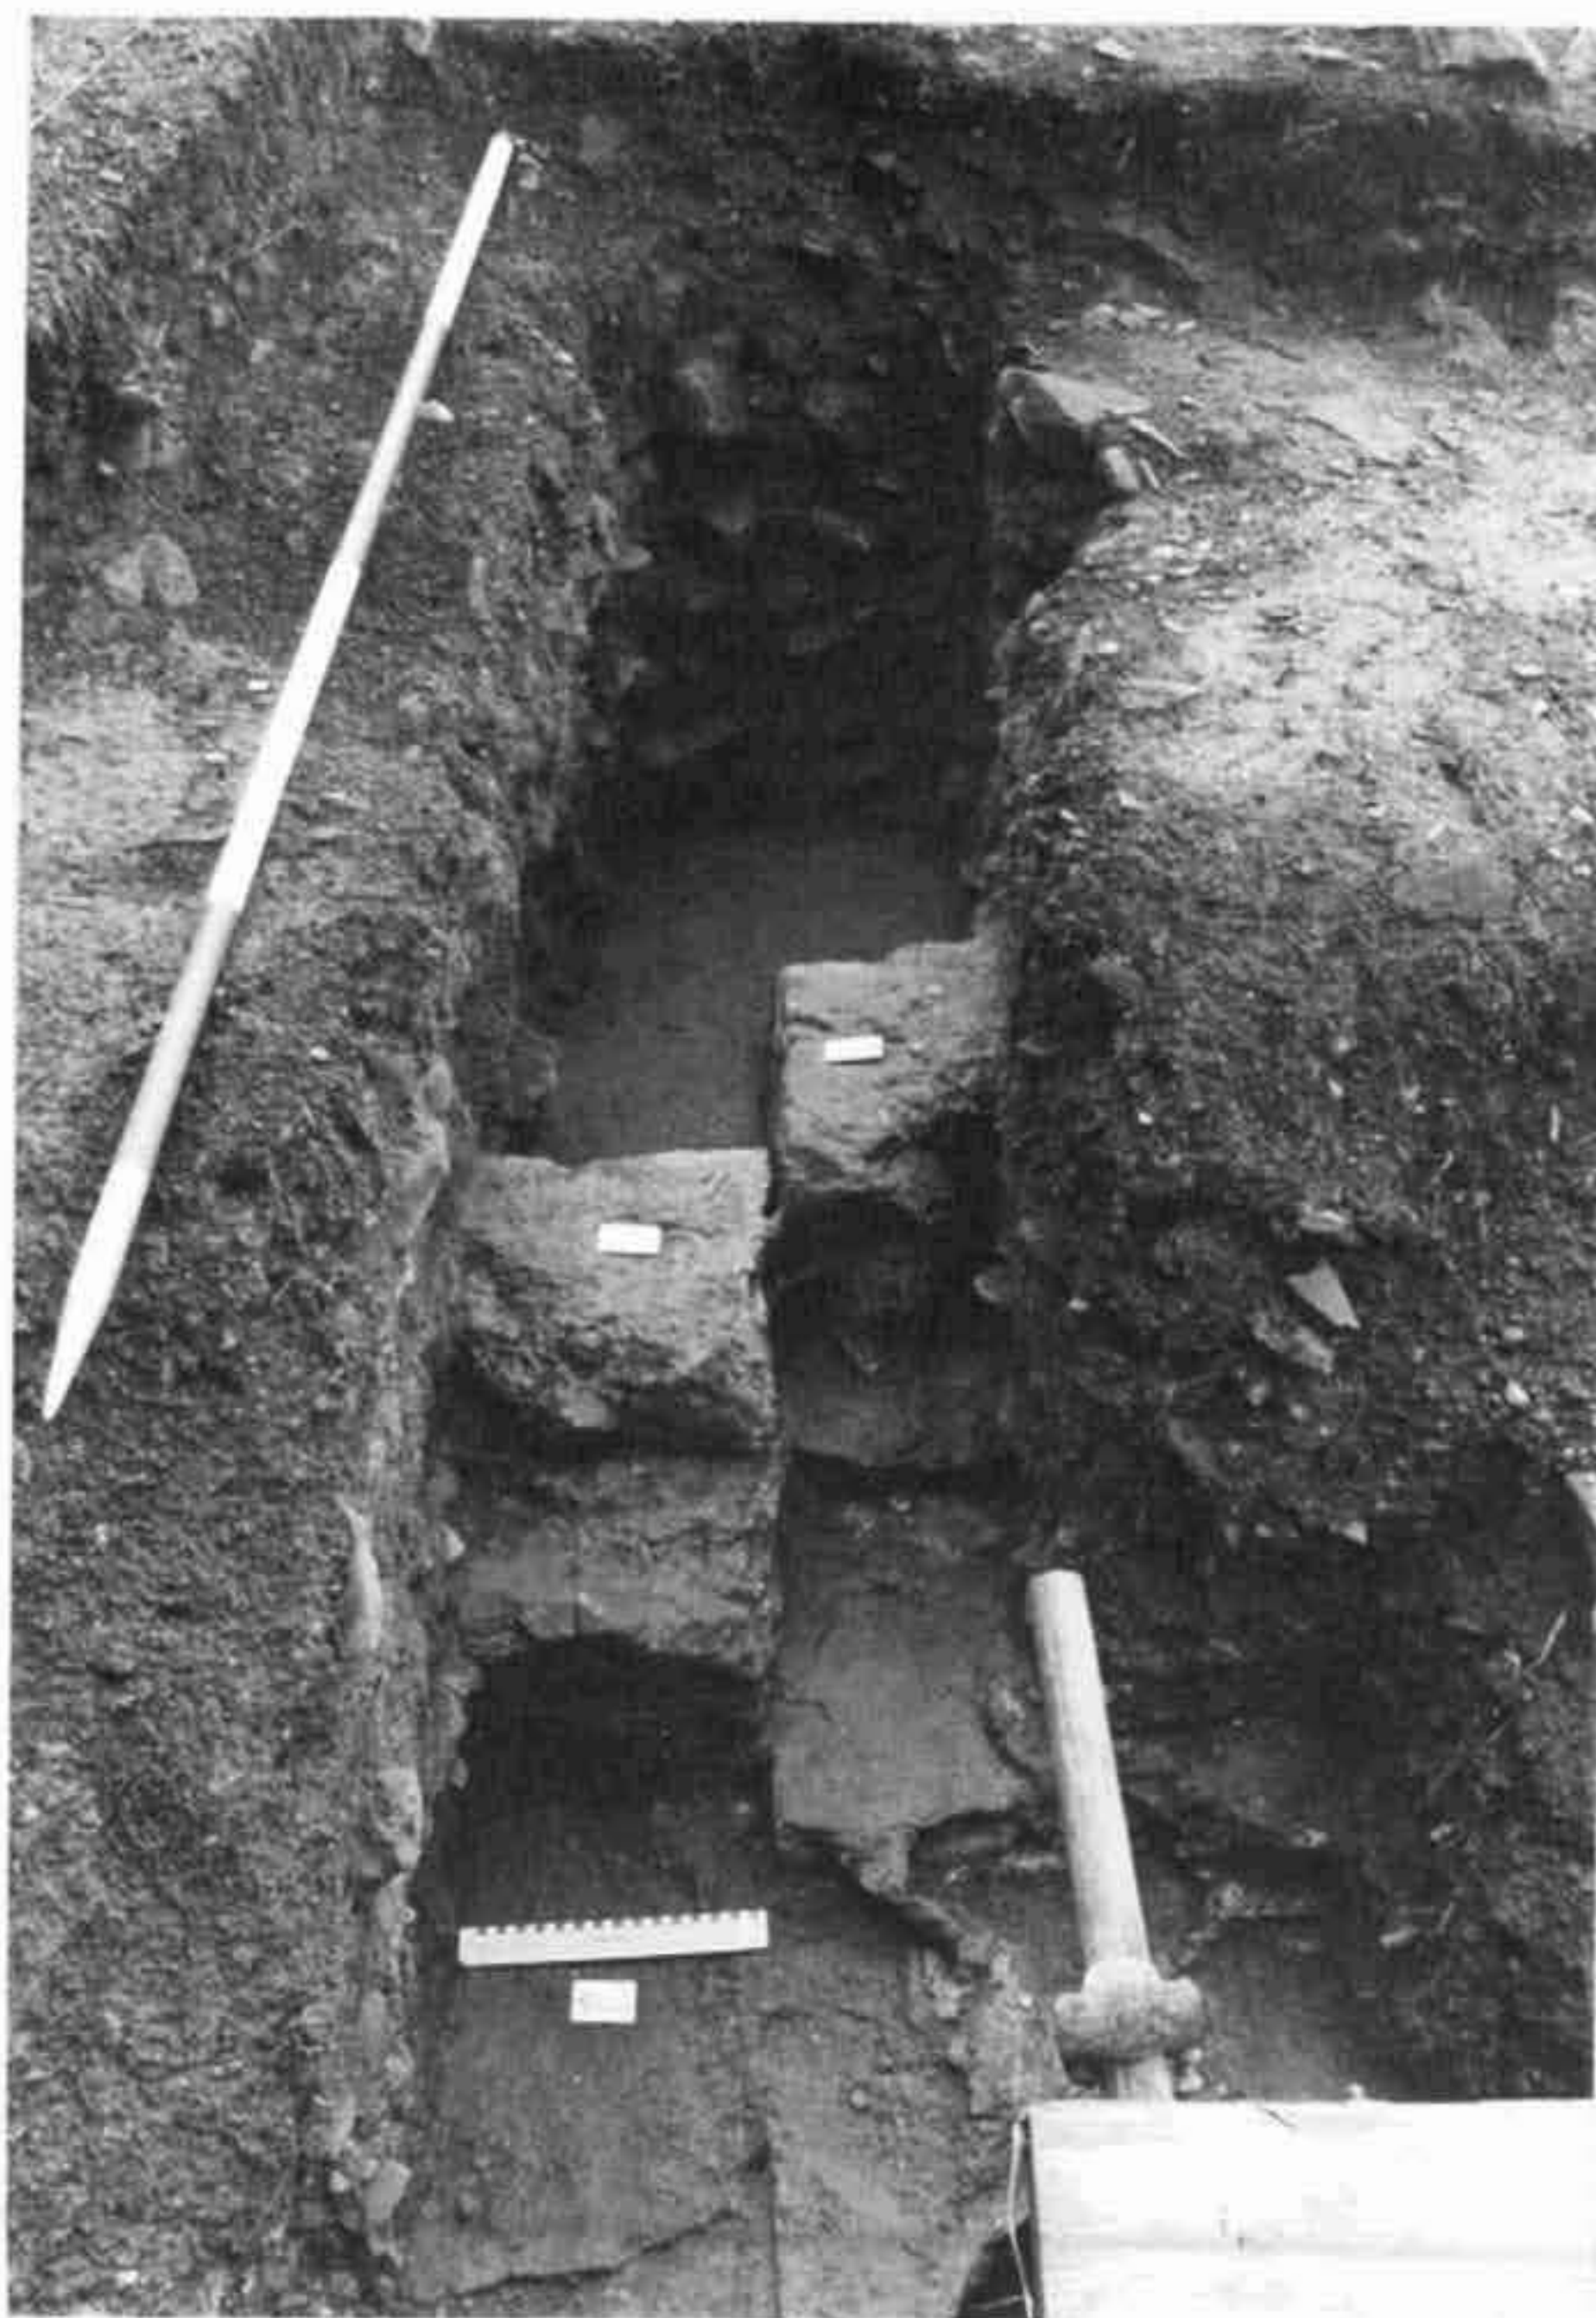
Plate 15

View of Upper Buttress excavation, looking east, across trench I; showing the fine internal floor, a parapet wall (005), the blocked doorway (006) and corridor floor (004), with subsequent wall-robbing and resultant debris (003).

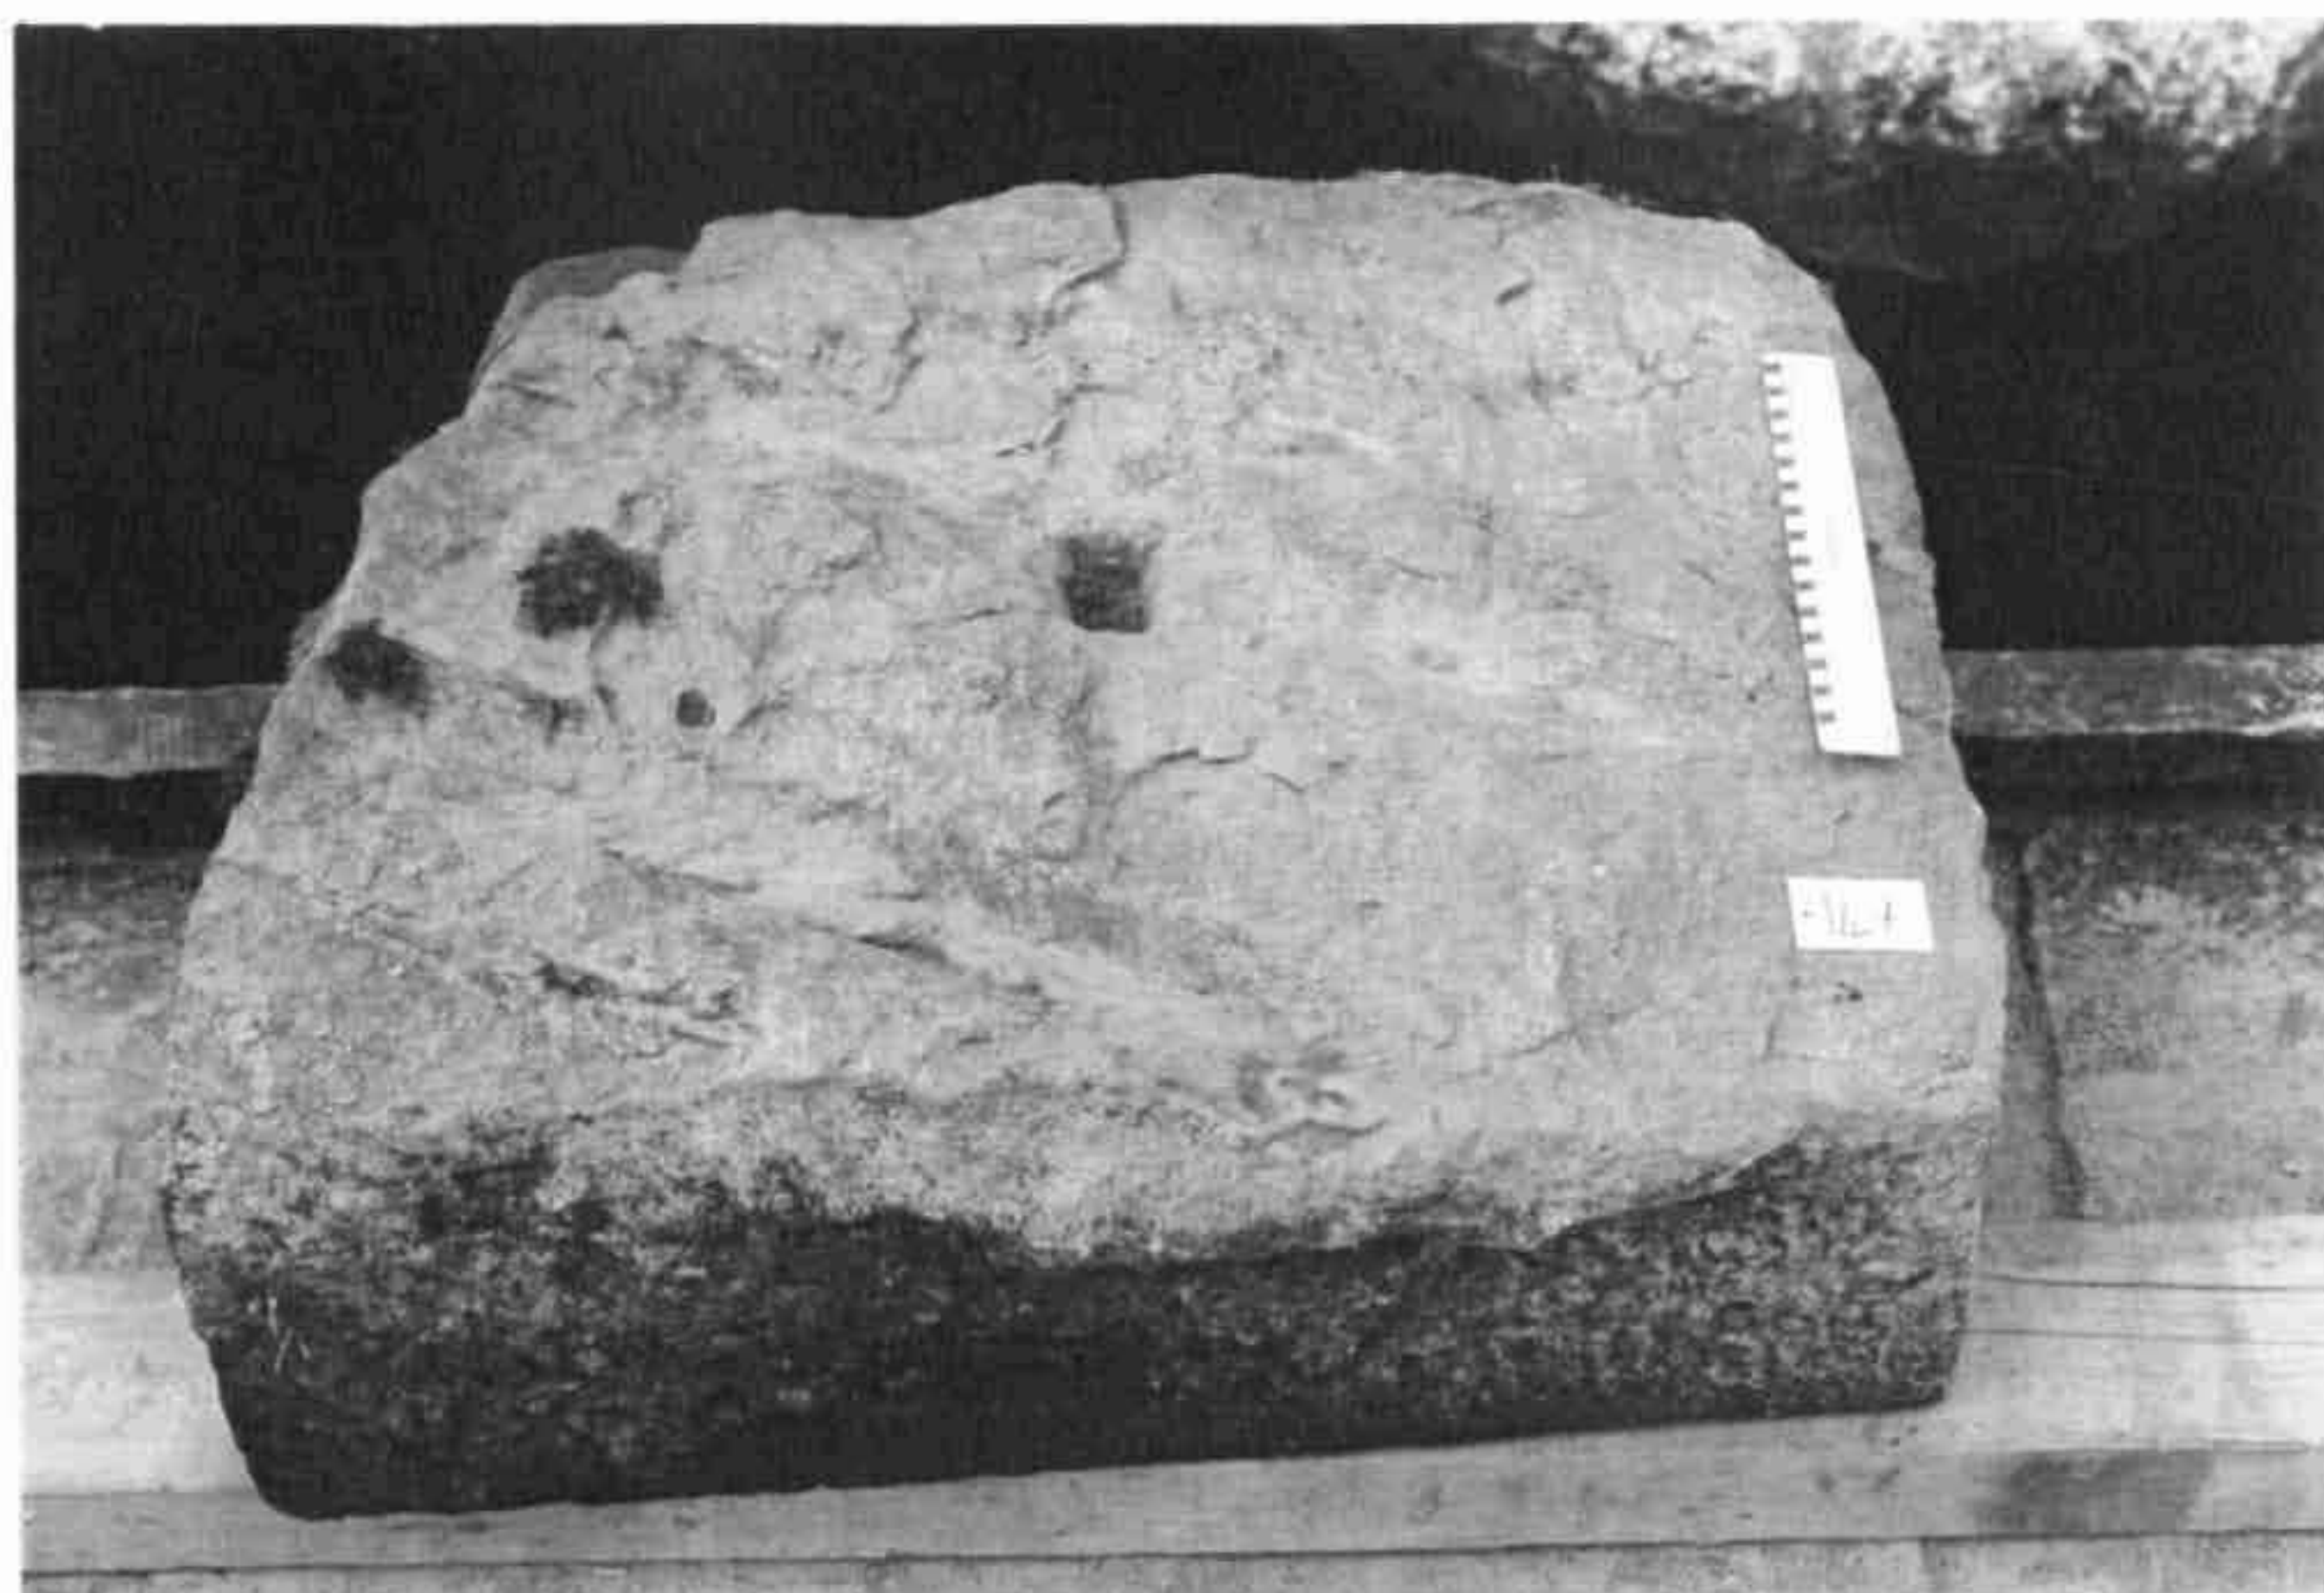
Plate 17

Block 147 with parallel linear quarry-marks. This also shows a typical lewis-hole cut for block handling.

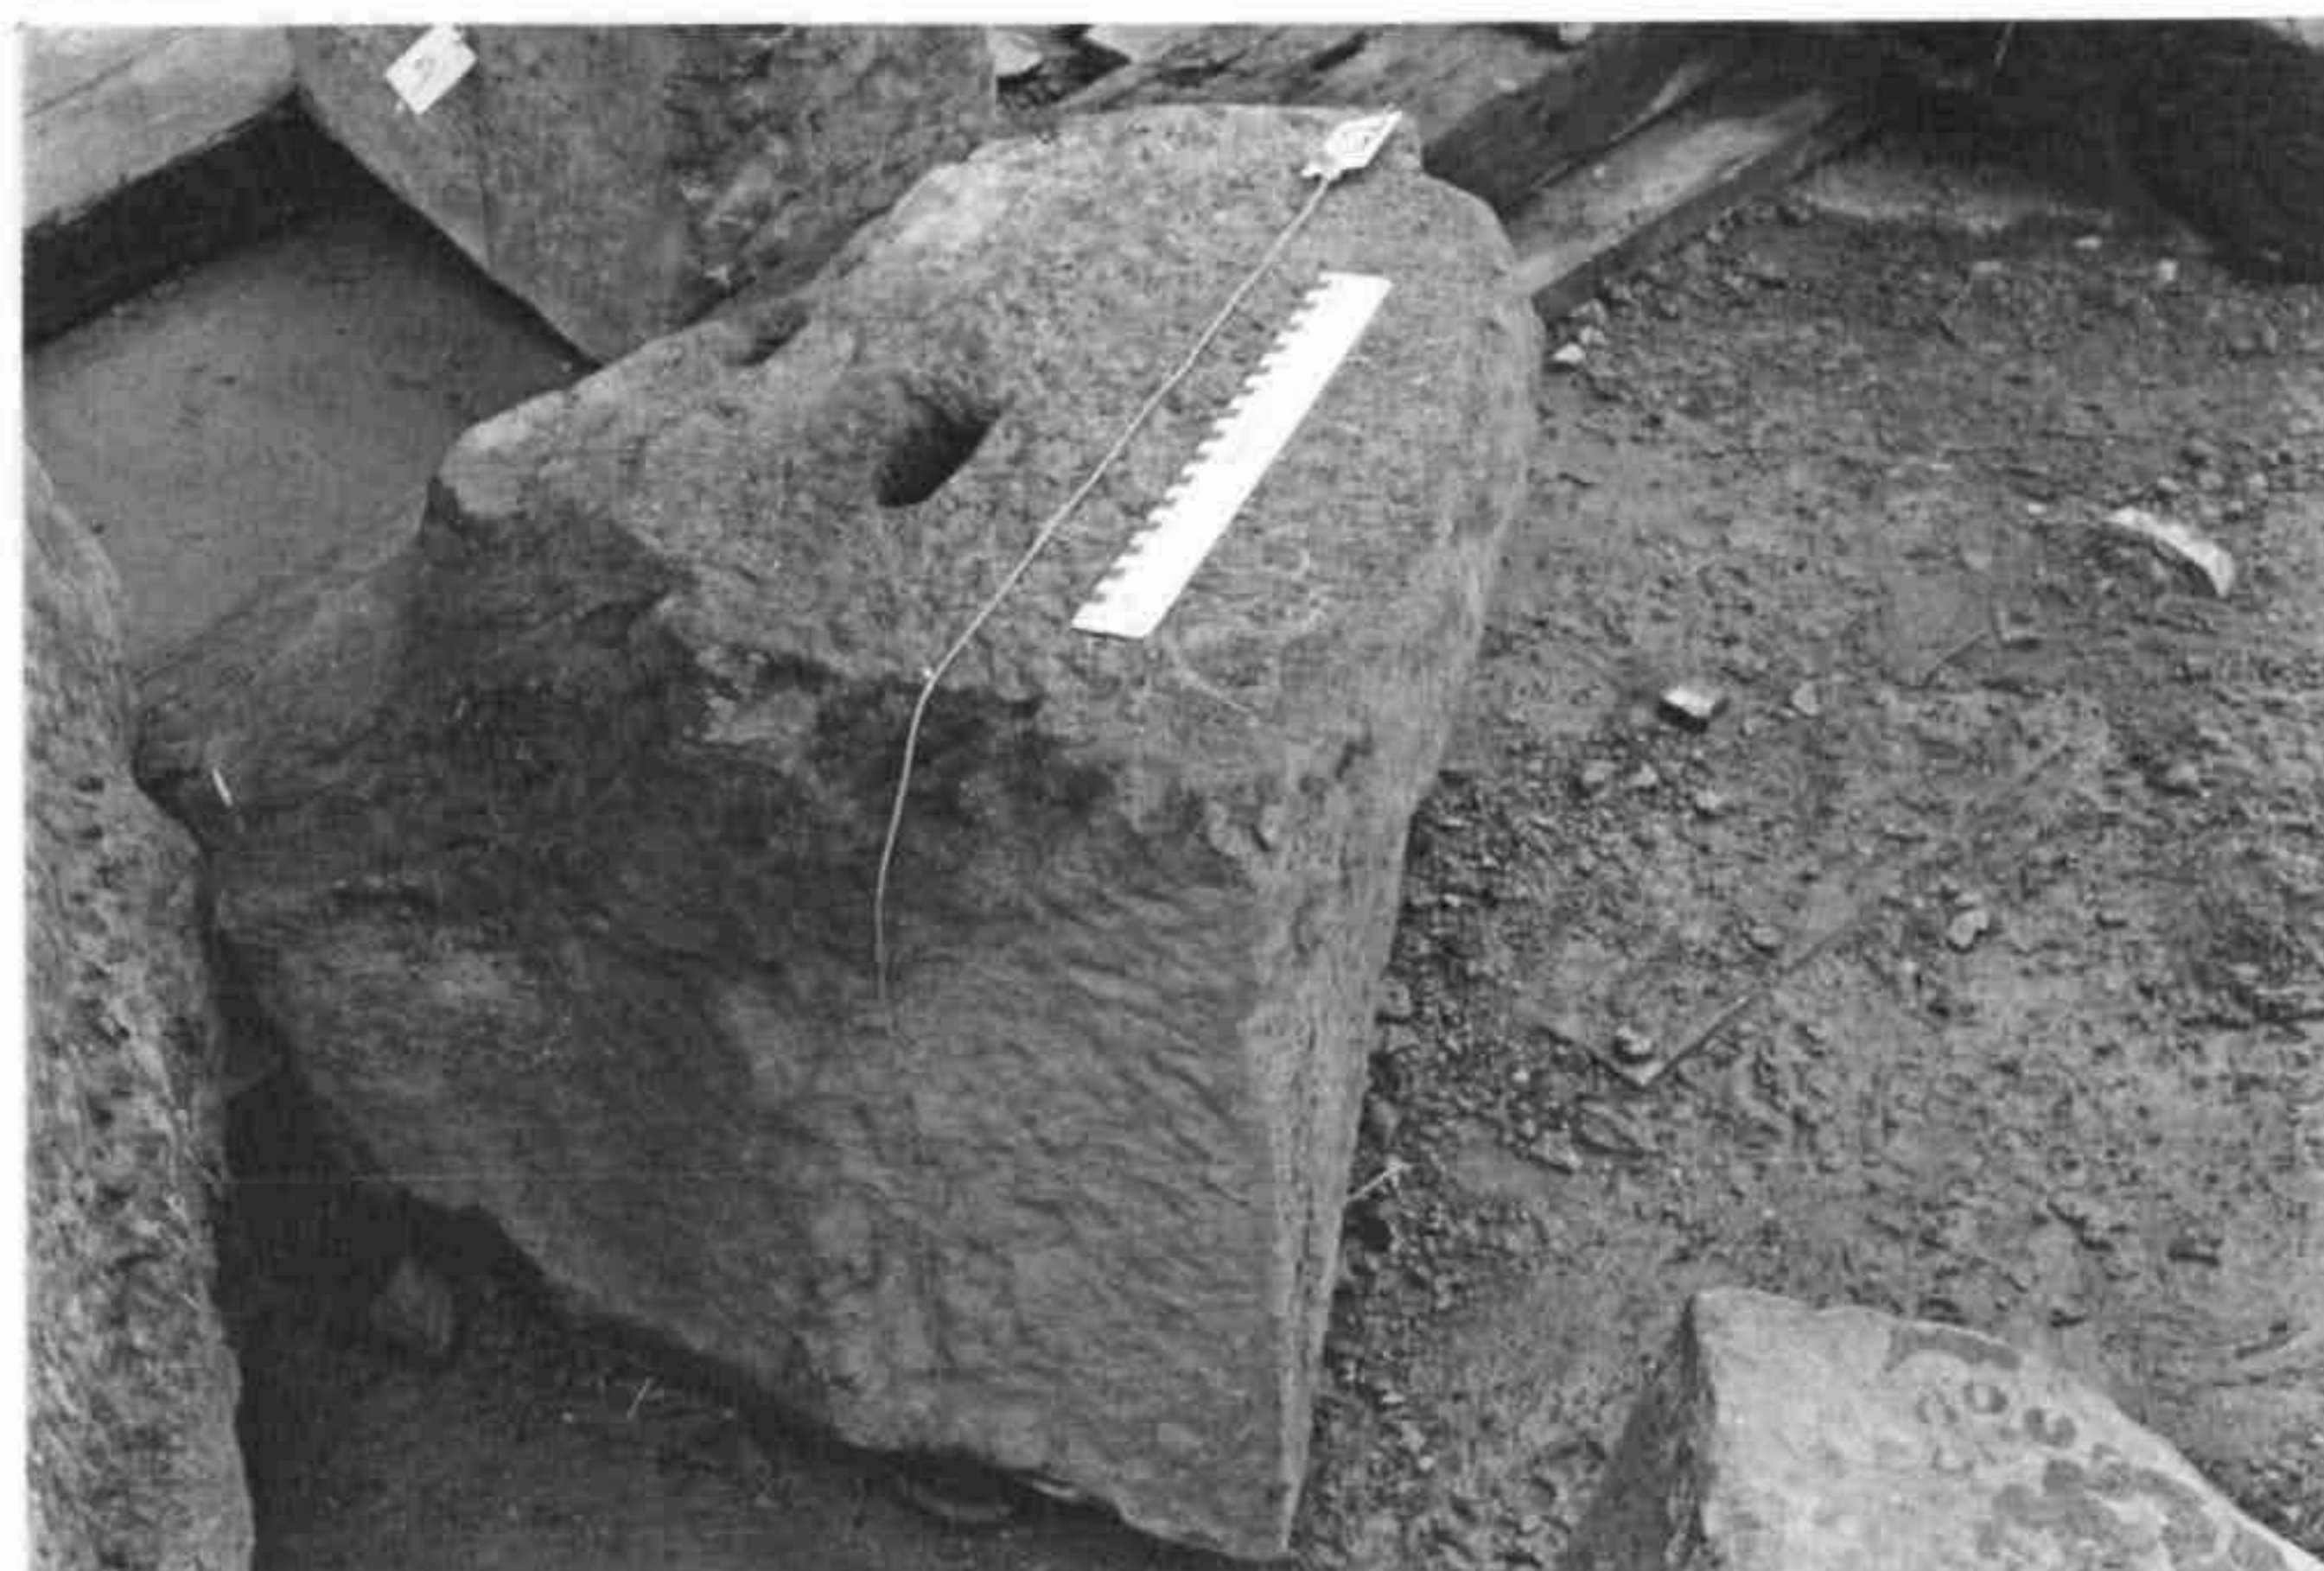
Plate 18

Block 142 with unusually angular shape and showing the presence of a crowbar slot, in addition to a lewis hole, to provide purchase in moving to position an overlying block.

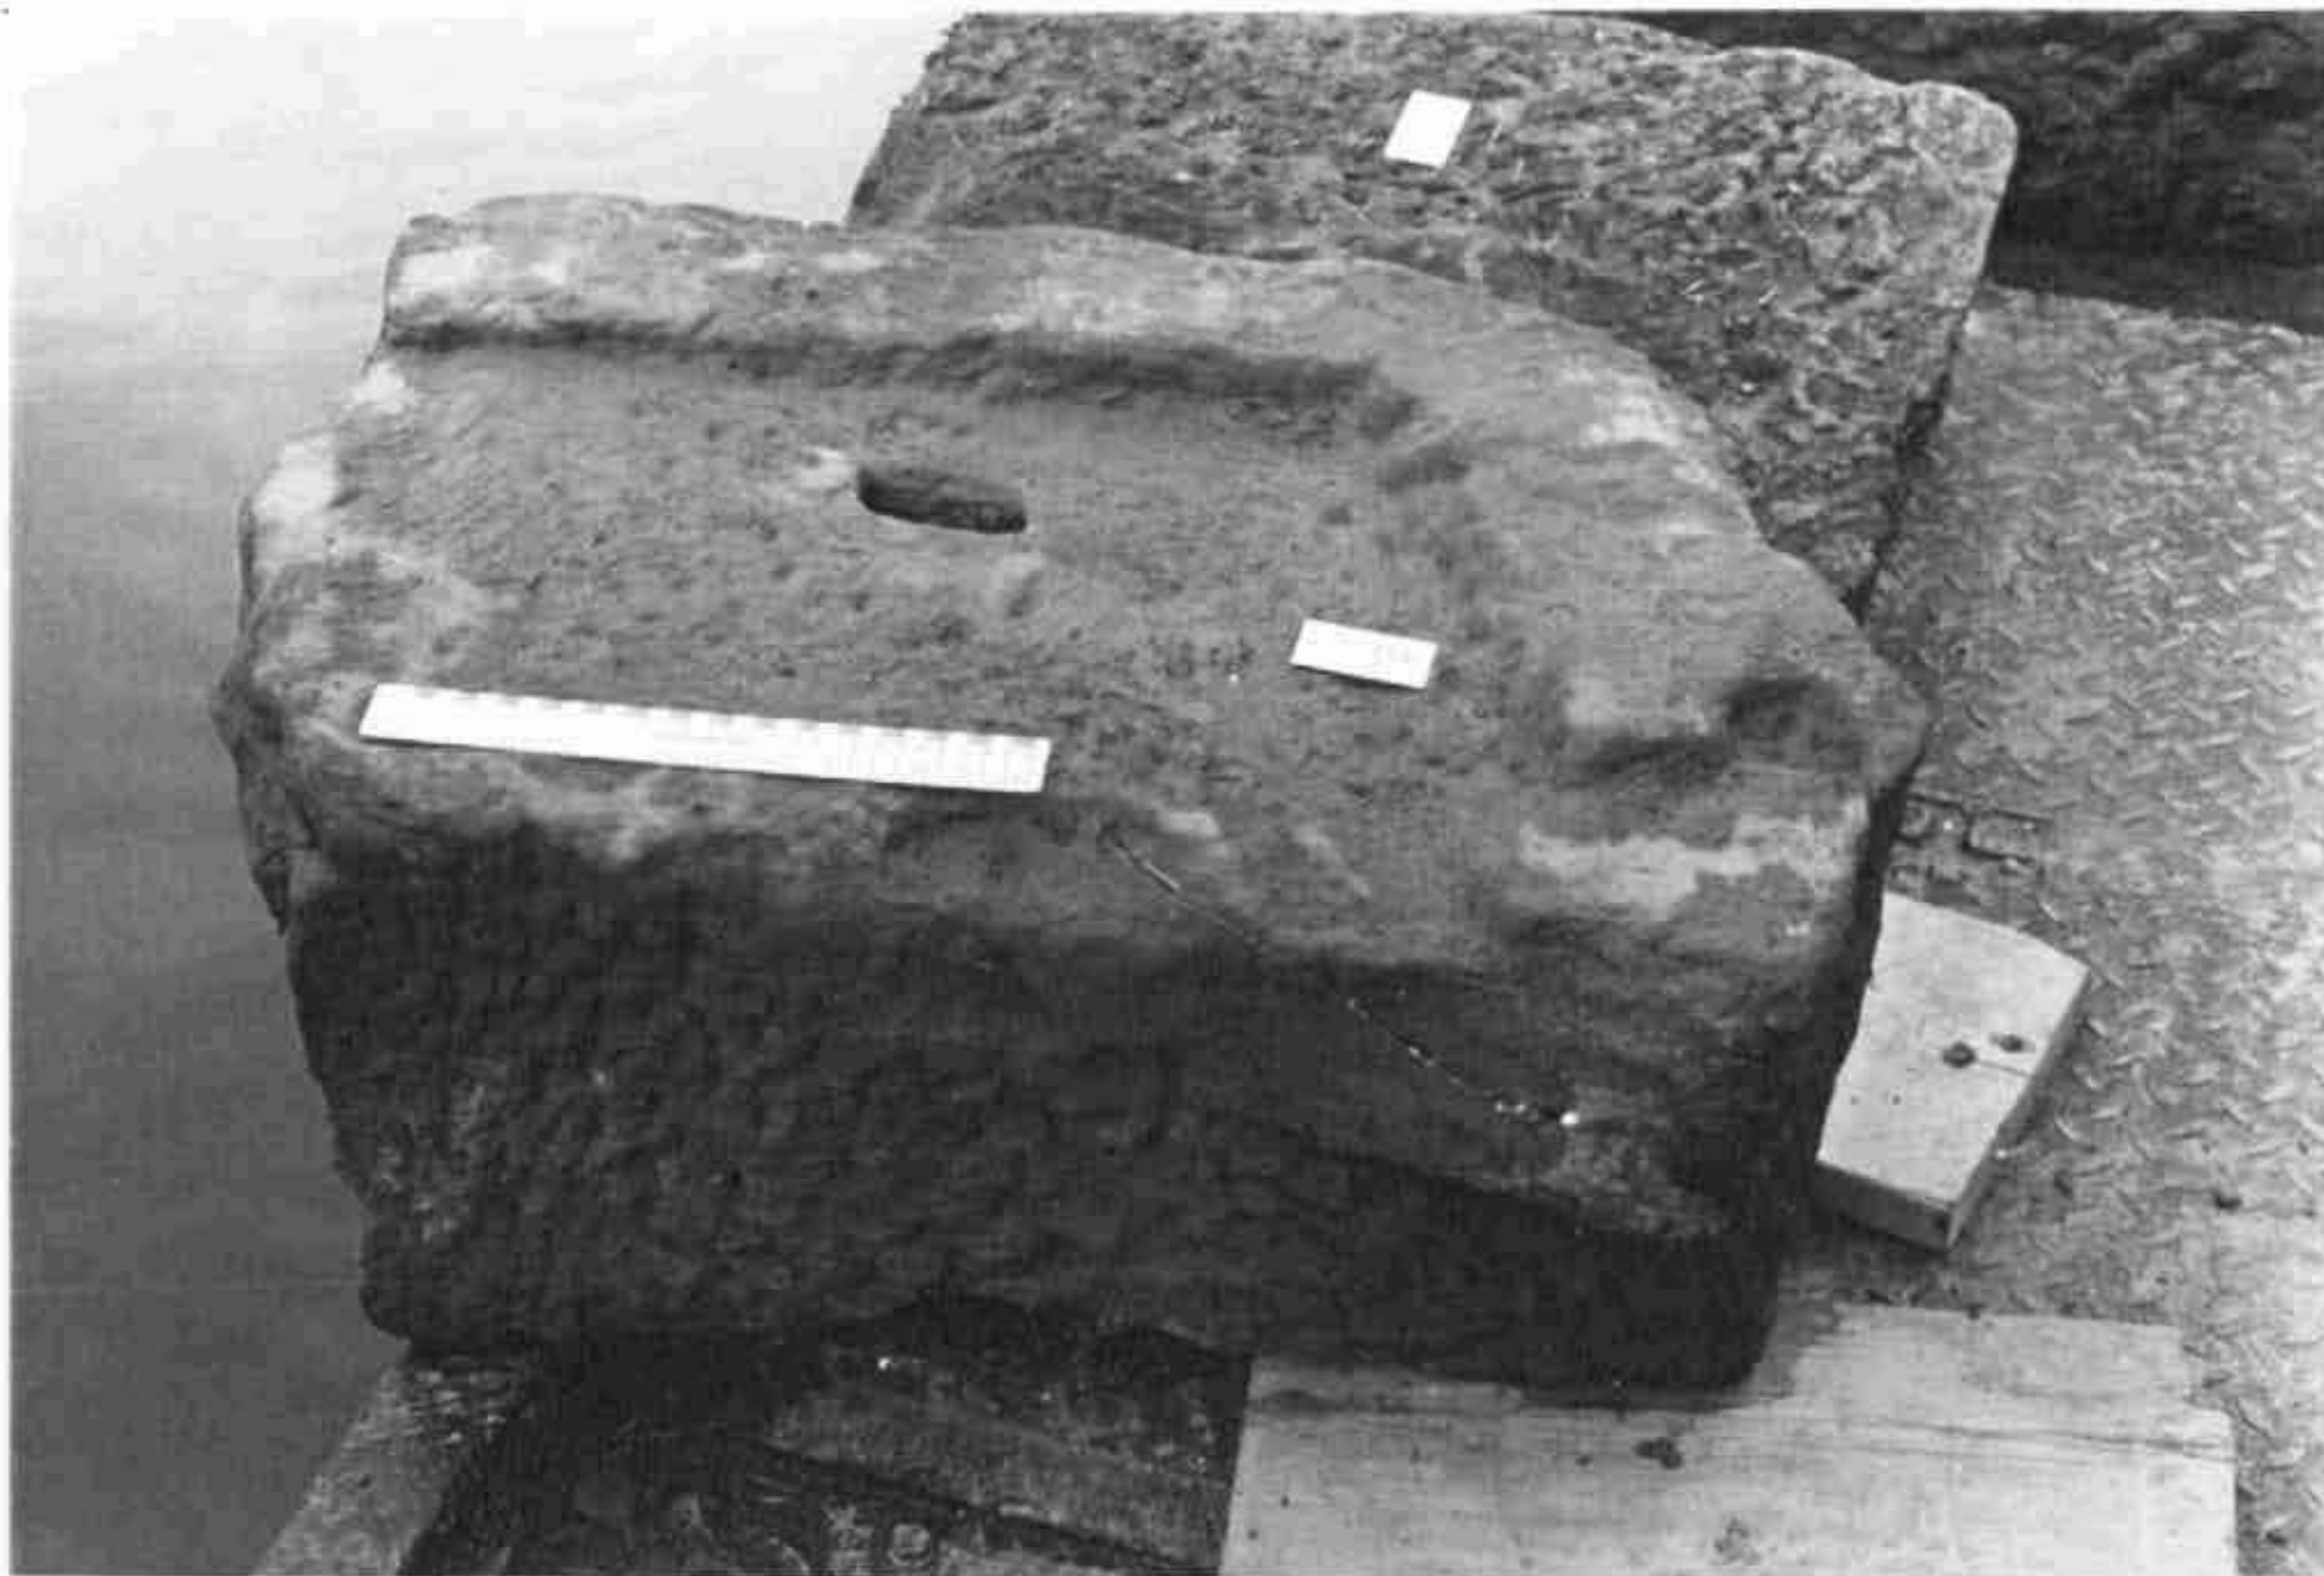
Plate 19

Block 139 with a shallow recess perhaps designed to joggle with a block above, to create a stepped effect to the Lower Buttress.
