**THE WEIR GARDEN,
SWAINSHILL,
HEREFORD & WORCESTER**

**ARCHAEOLOGICAL FIELDWORK
1991-1995**

Cotswold Archaeological Trust

C.A.T JOB: 0156
C.A.T REPORT: 95298

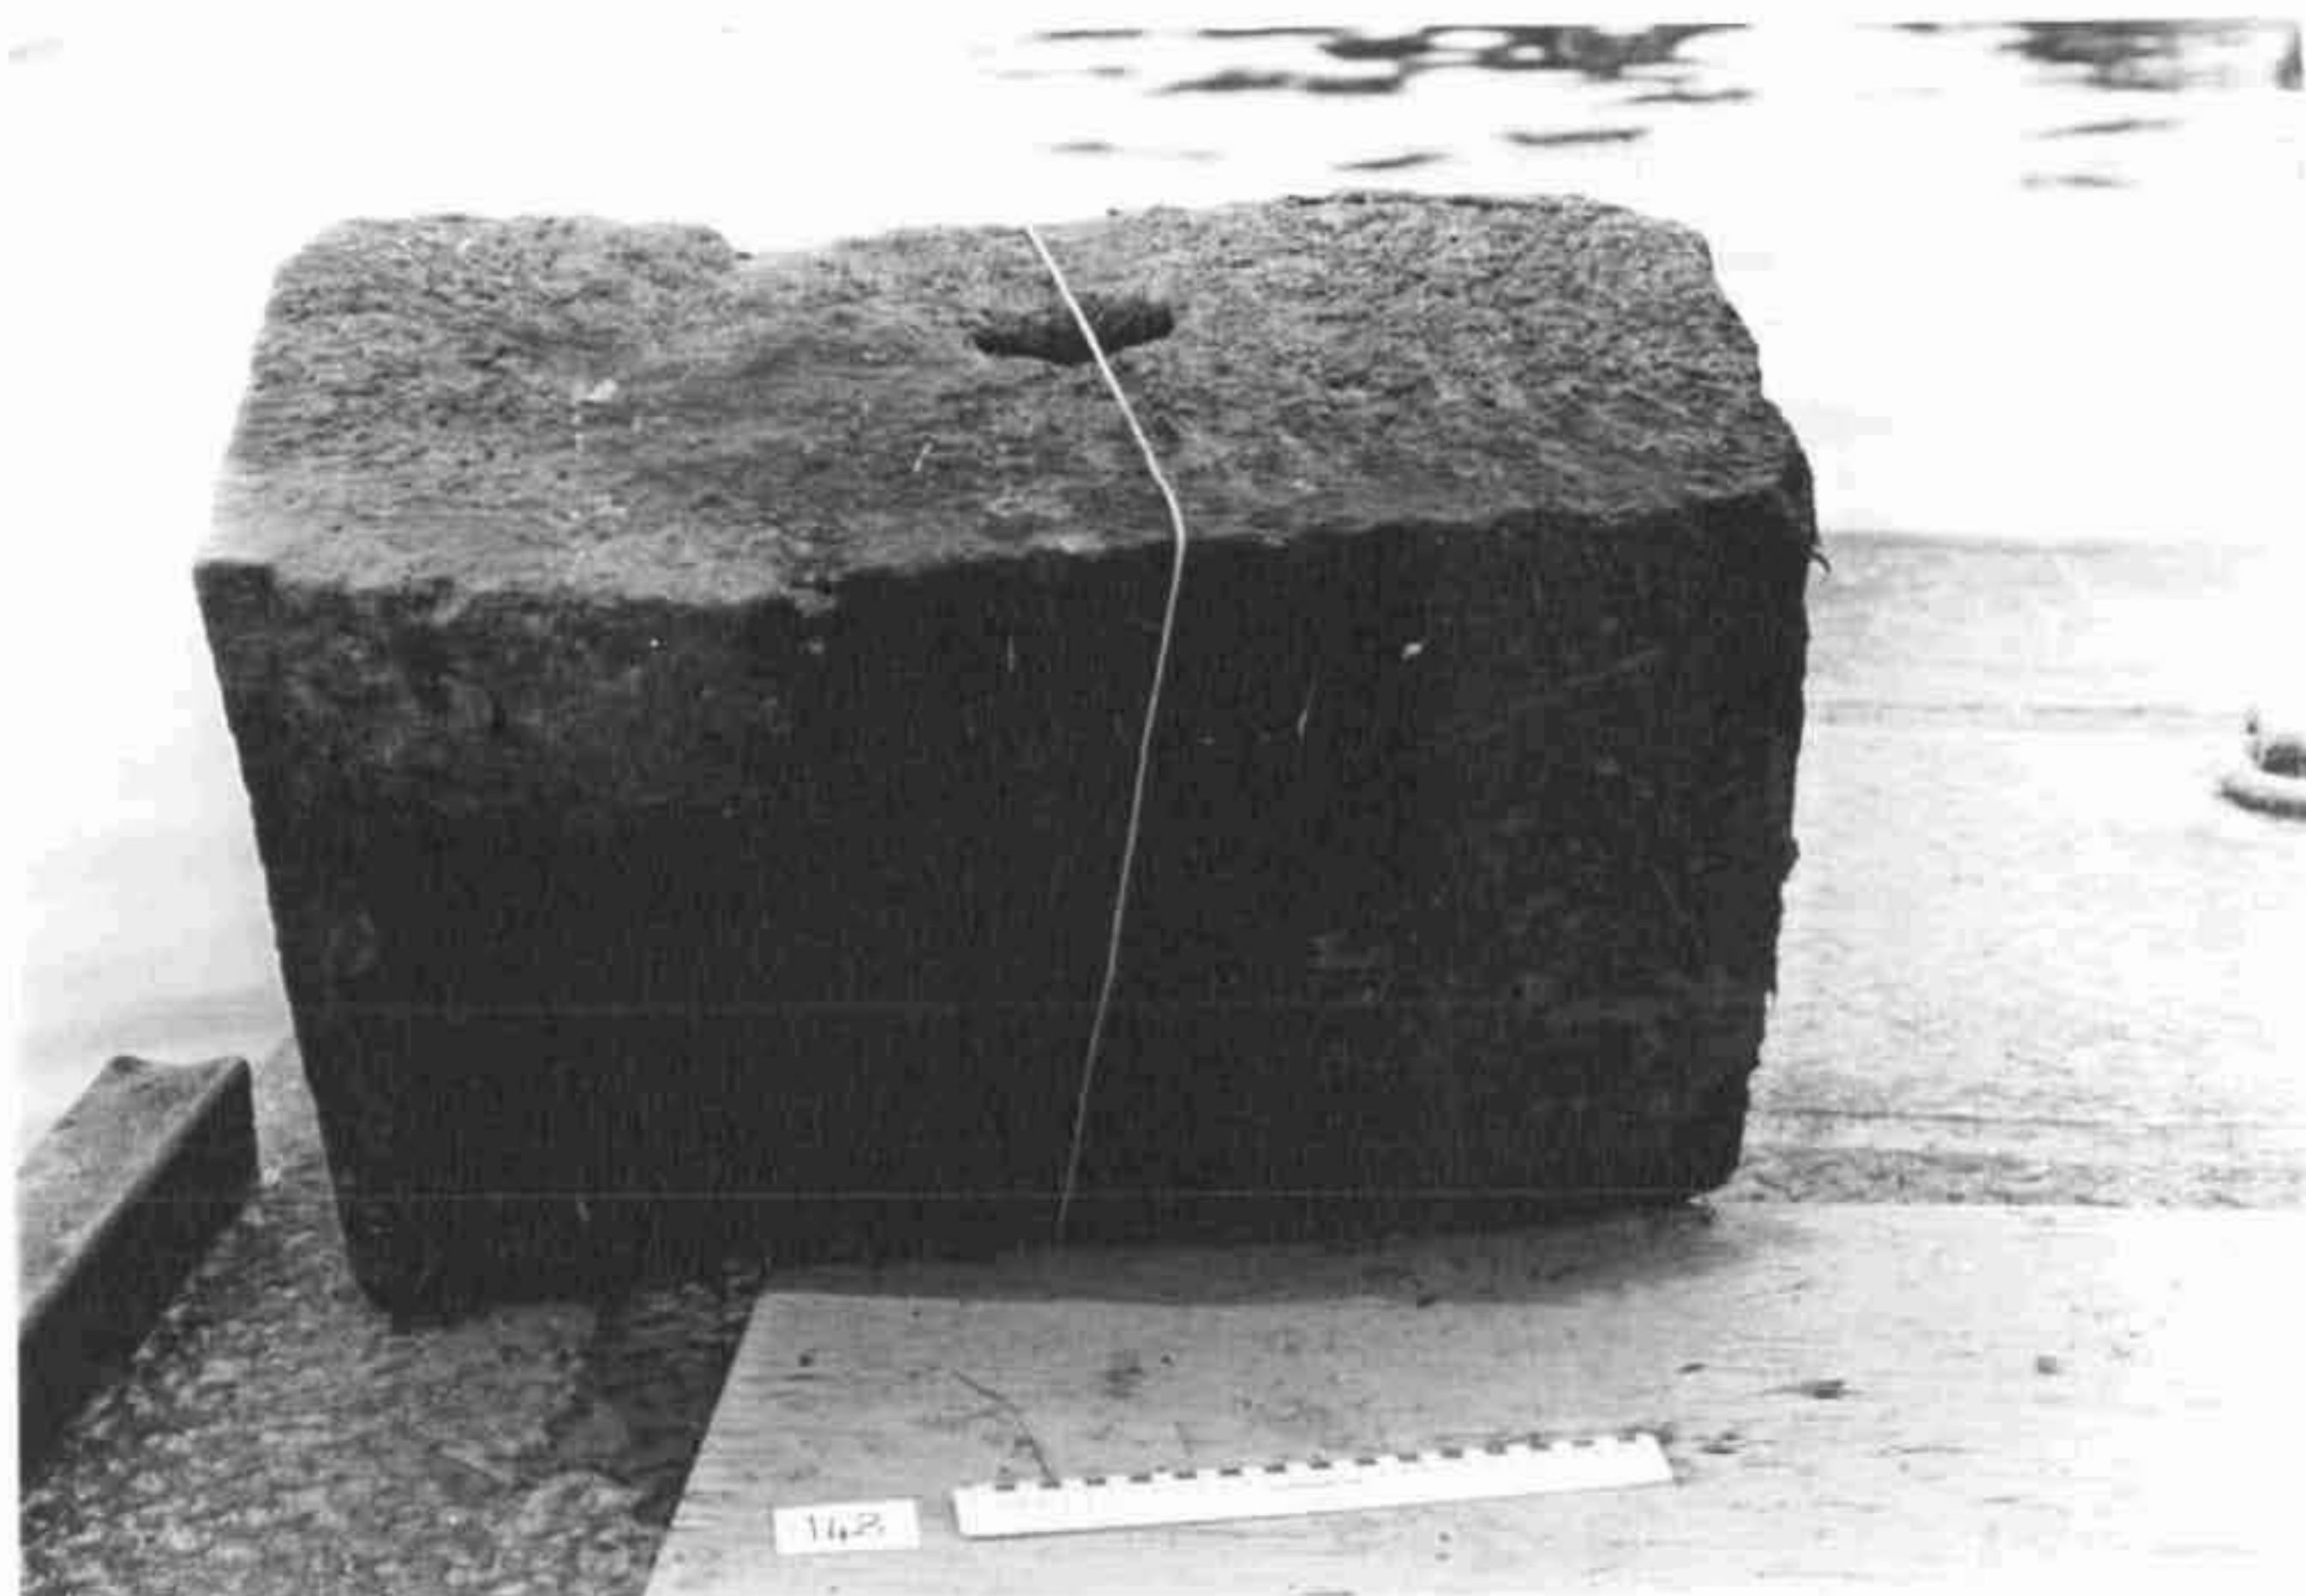
Plate 20

Block 148 with a rough but pronounced central lip. This may have formed an exterior face, or otherwise been a hidden face joggled with an adjoining block.

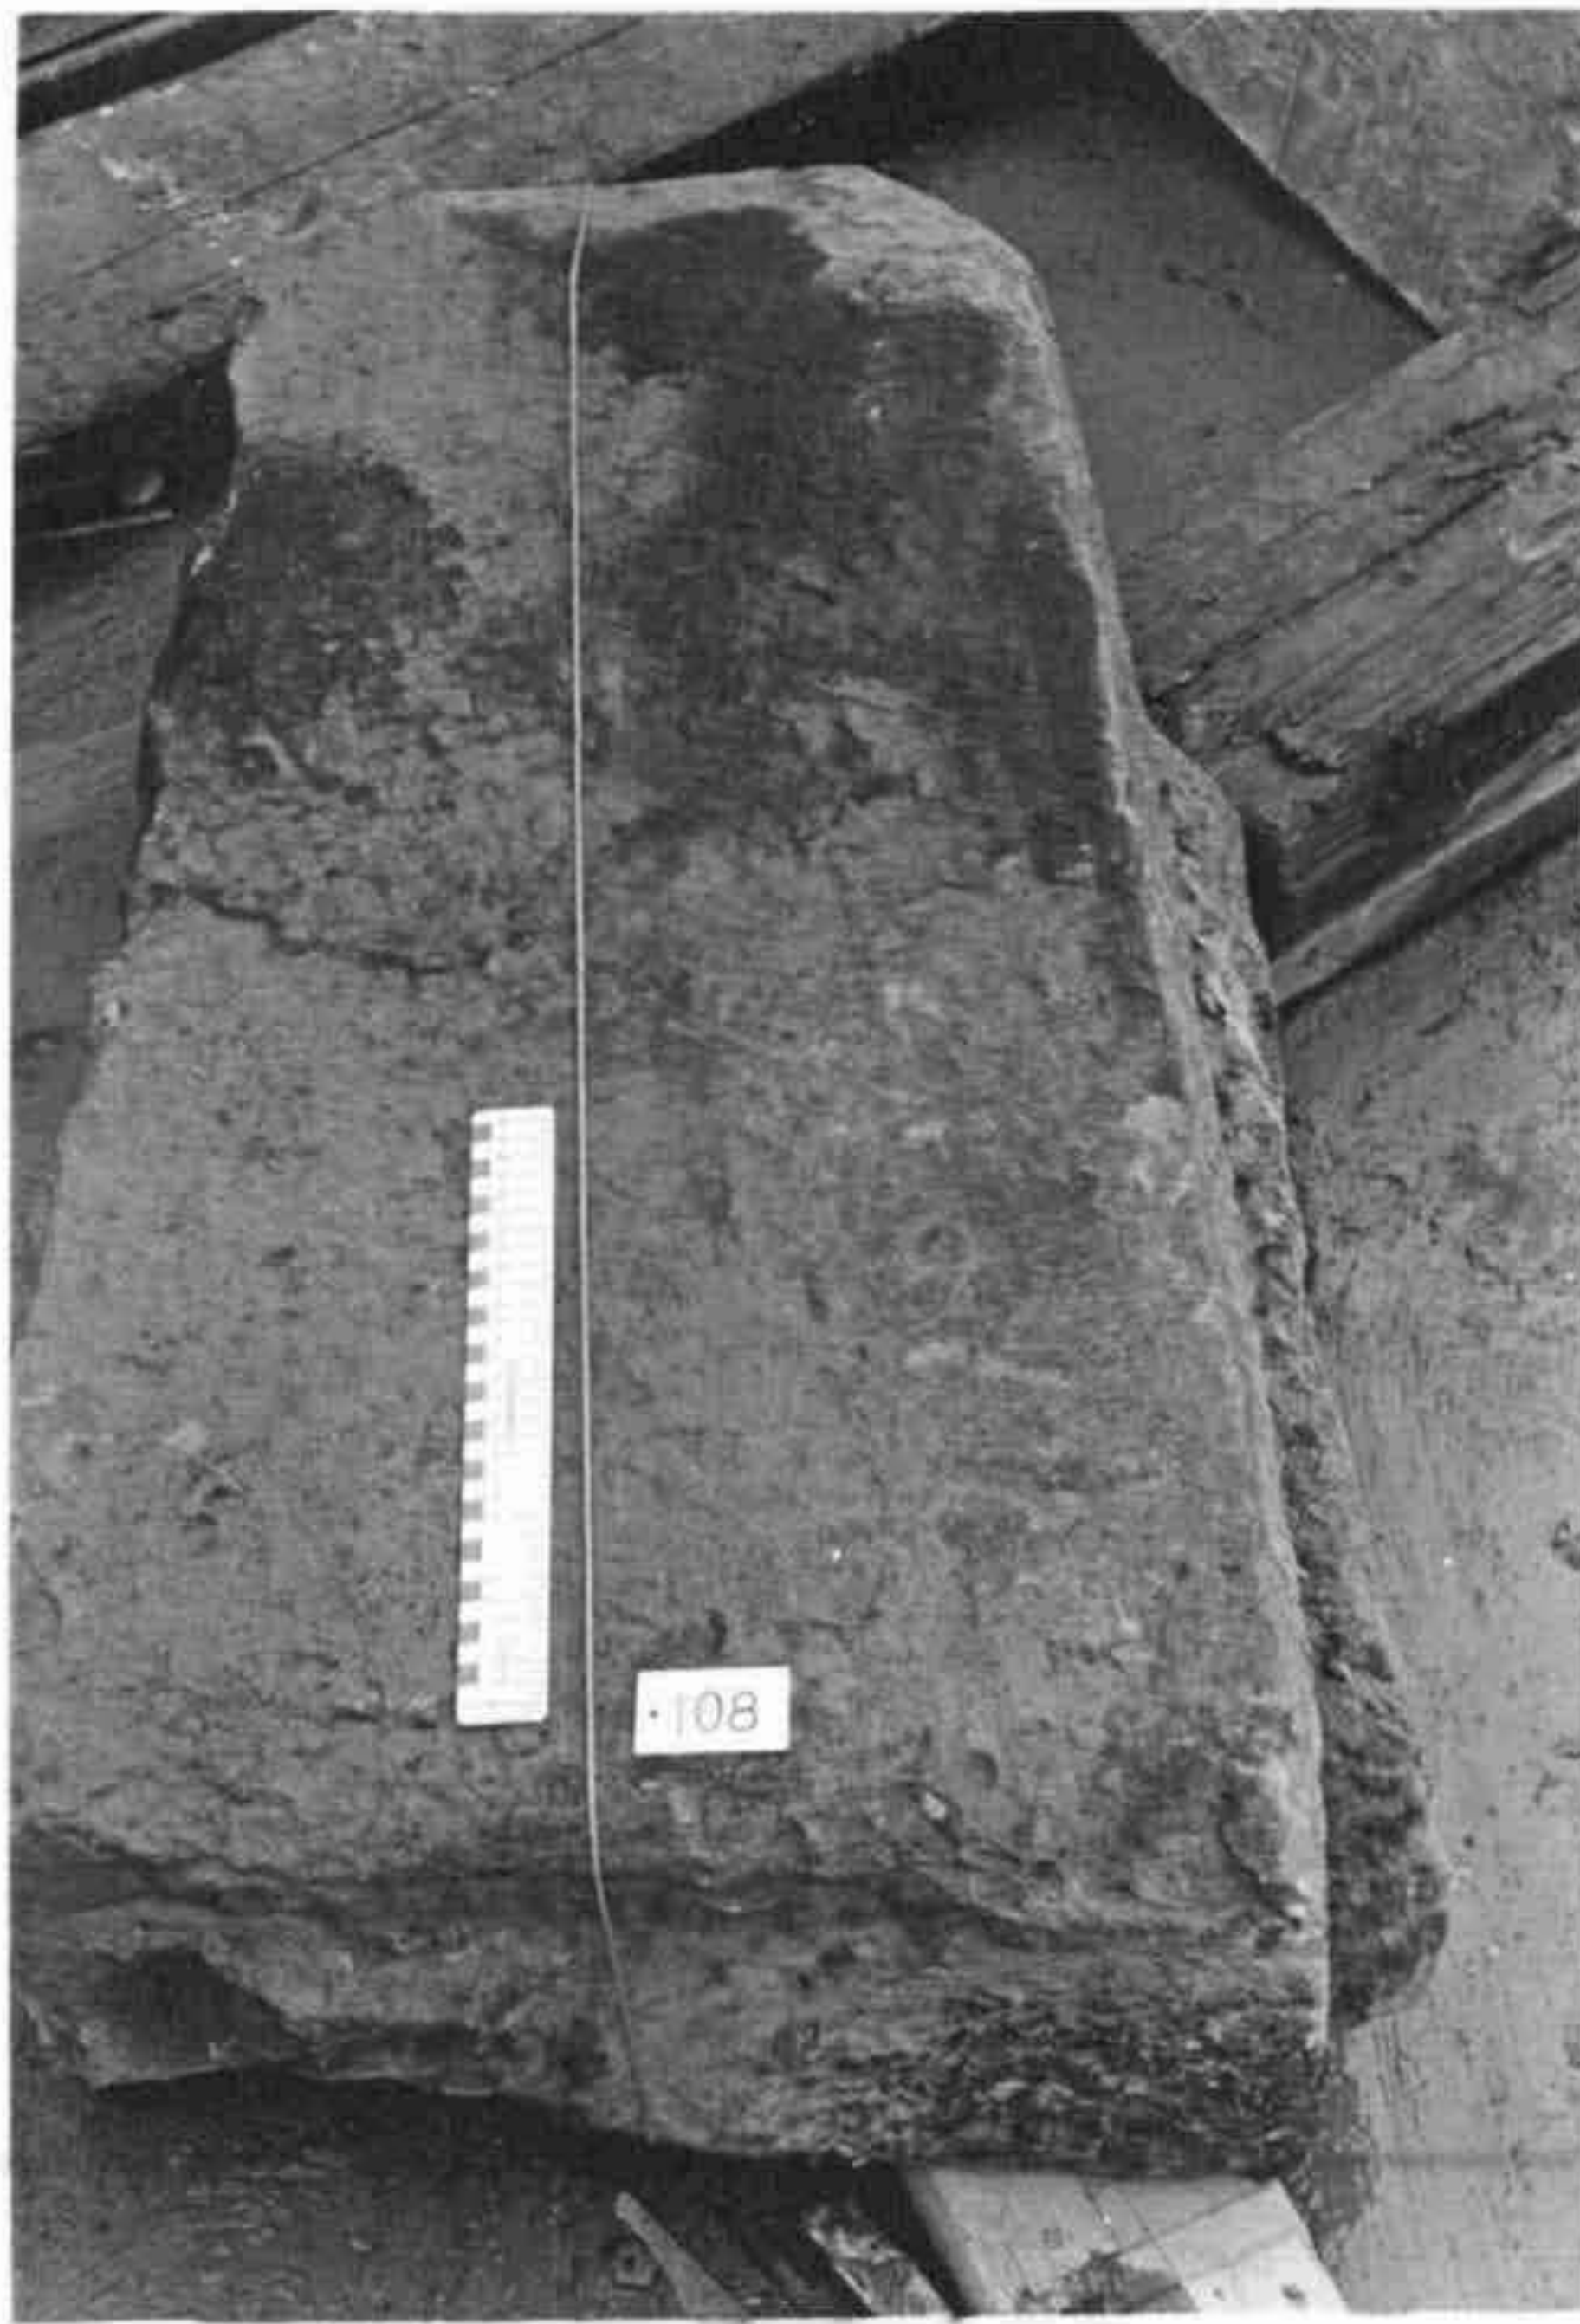
Plate 21

Block 108 with a stone lip on the lower part of its vertical face. The smooth nature of its long, tapered, lewis-free surface suggests this may have been a fine capping stone to the Lower Buttress.

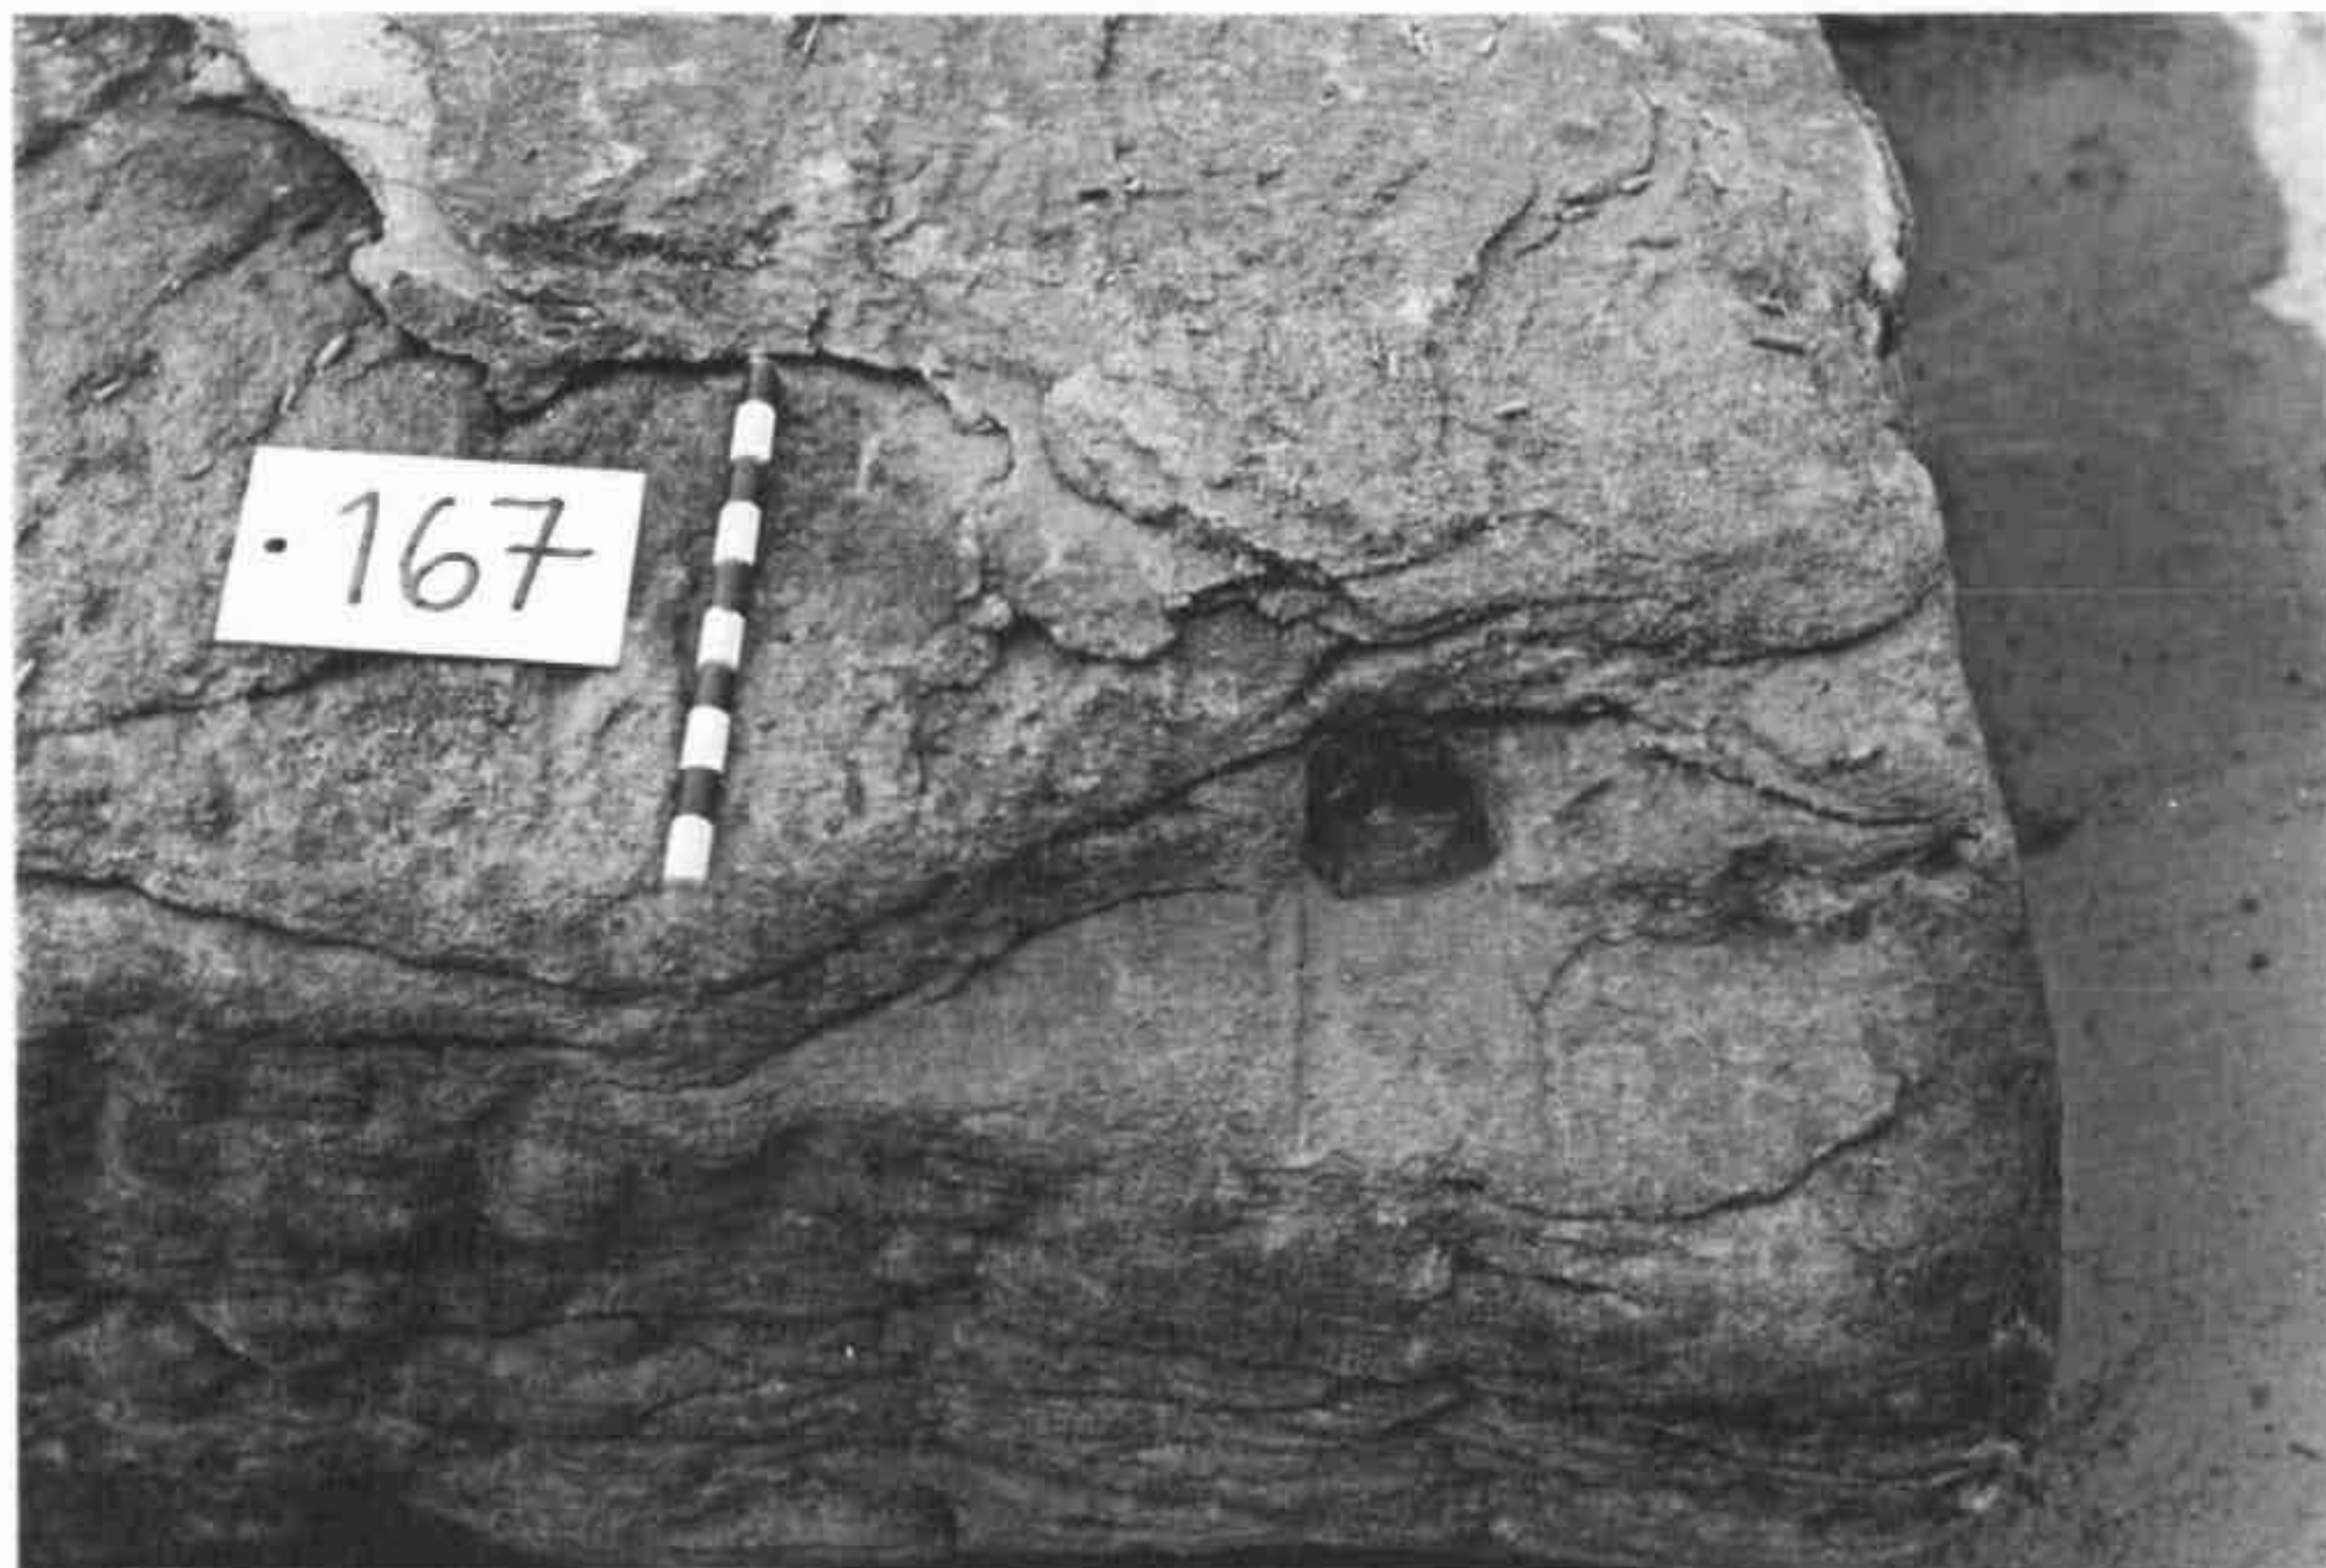
Plate 22

Block 167 with a clamp-mark on upper face.

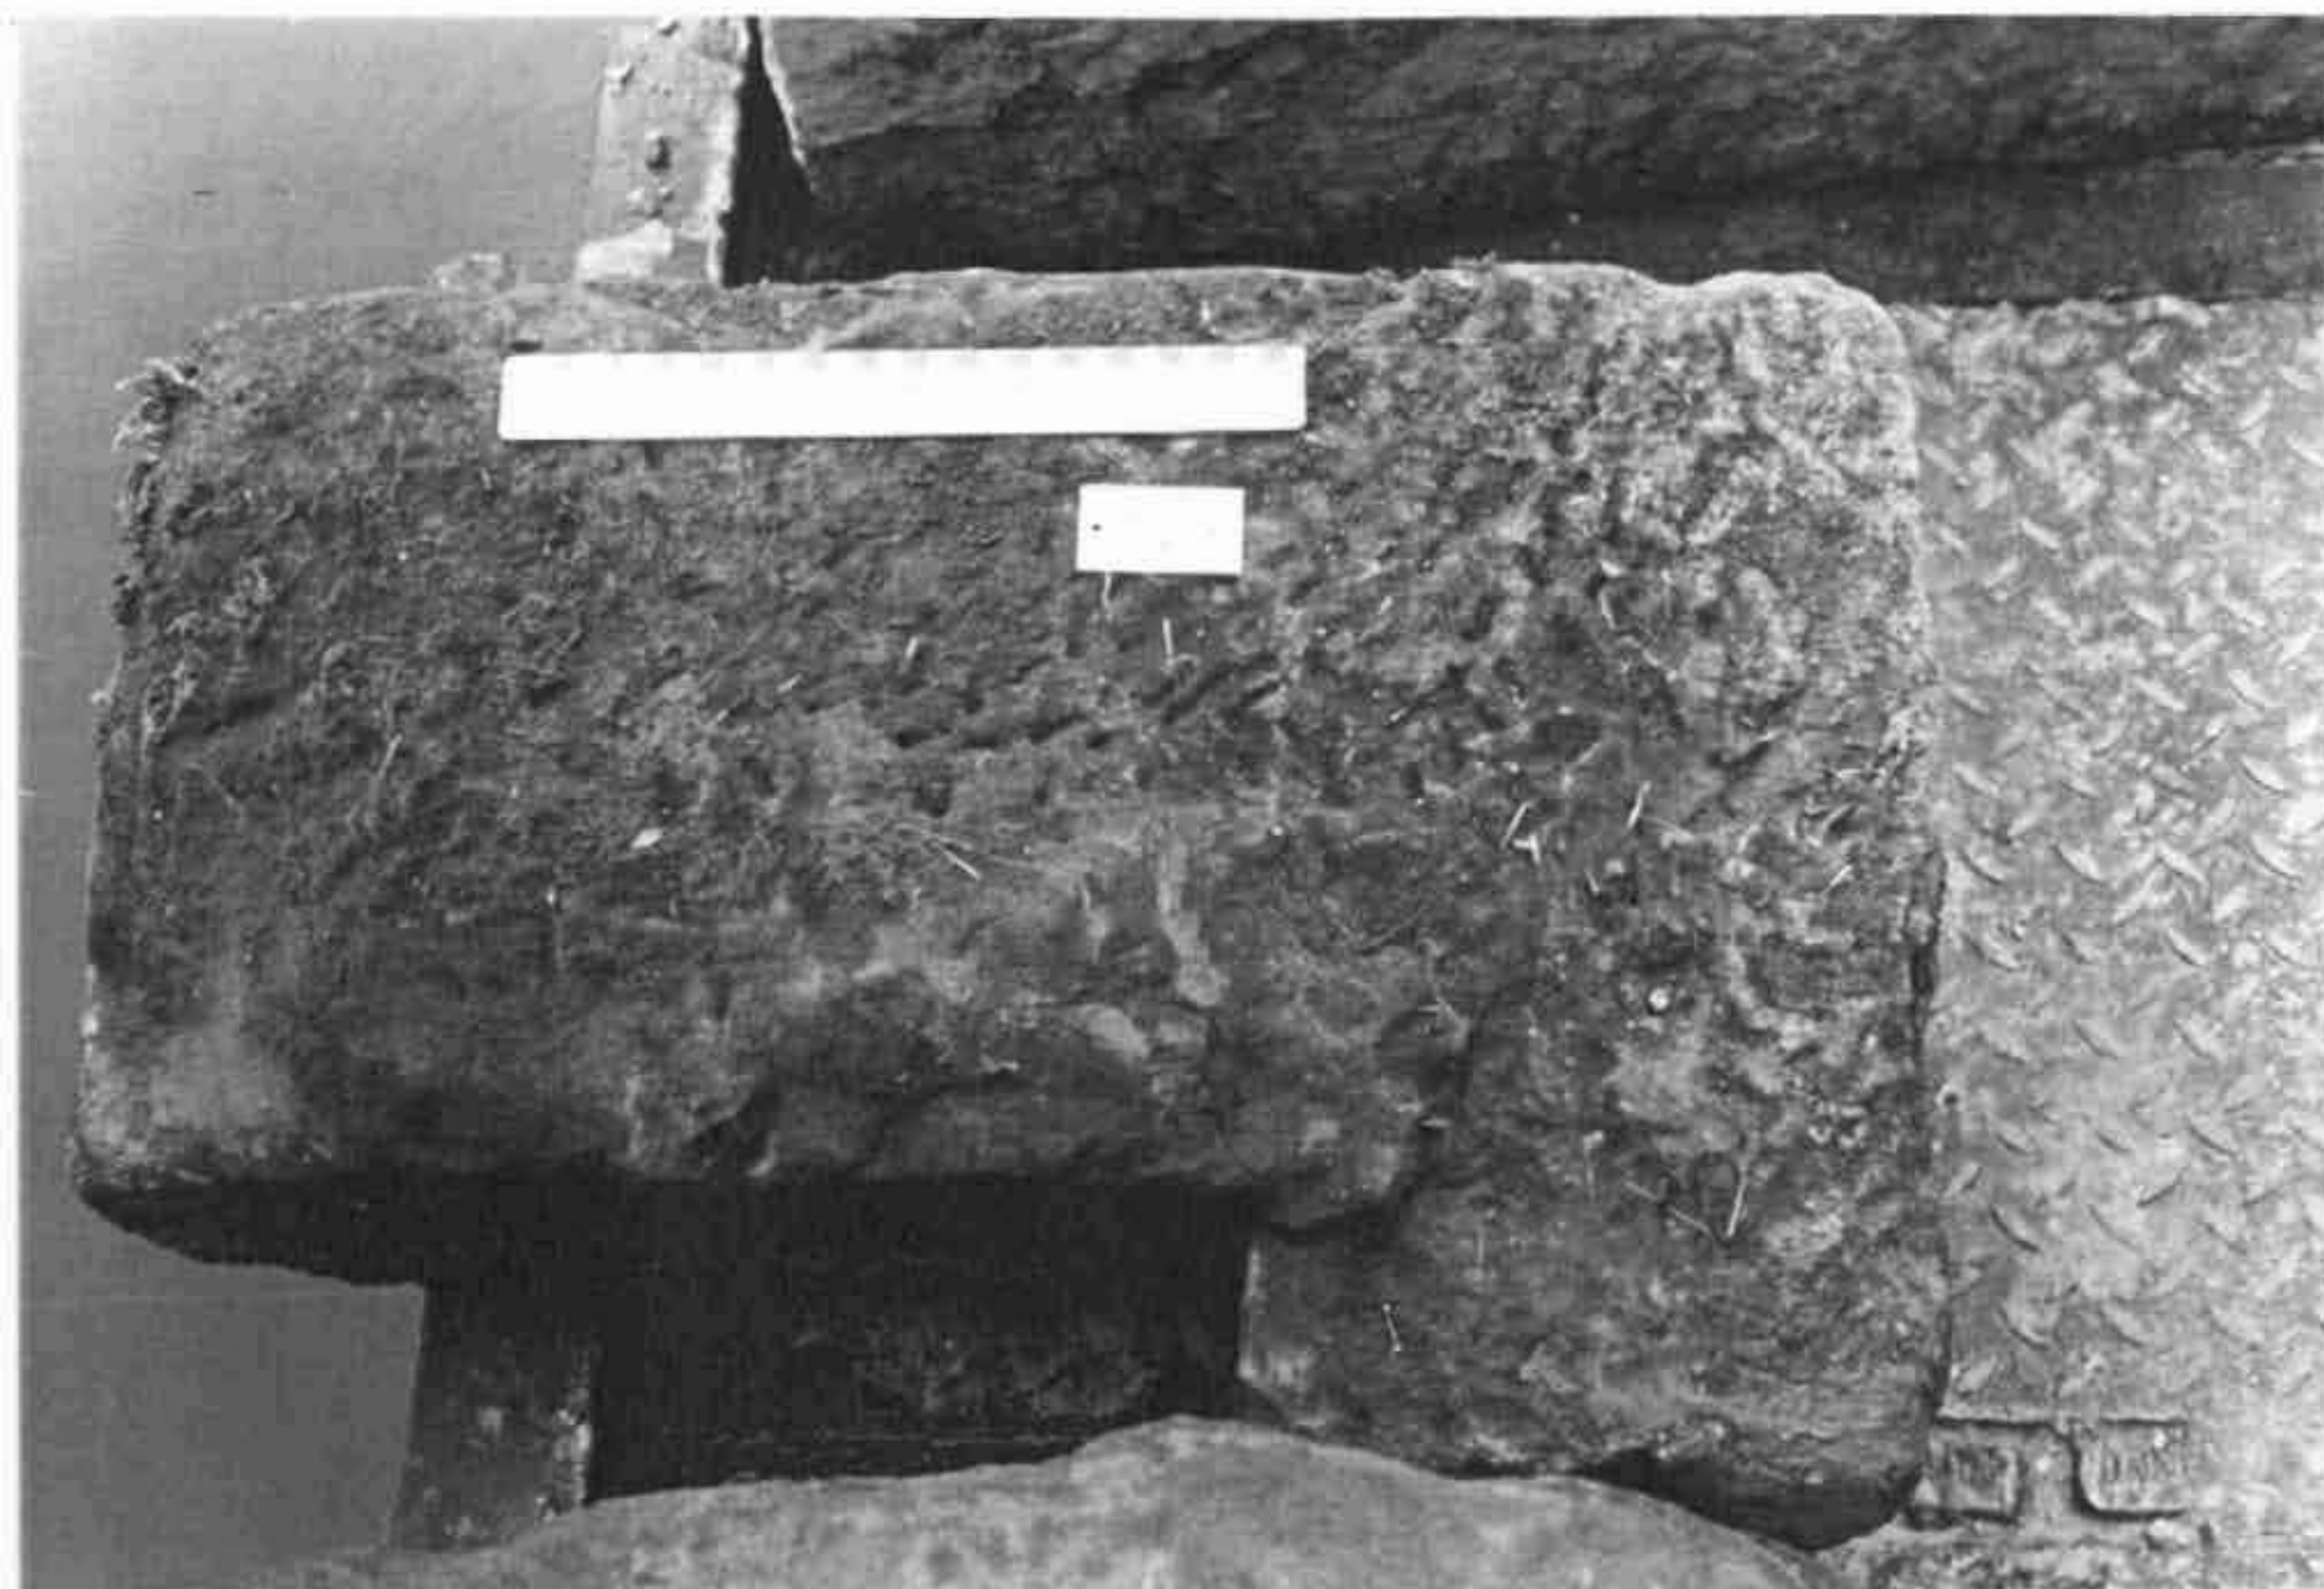
Plate 23

Block 145 with a clear, deliberate, rebate designed to joggle with adjoining stones.

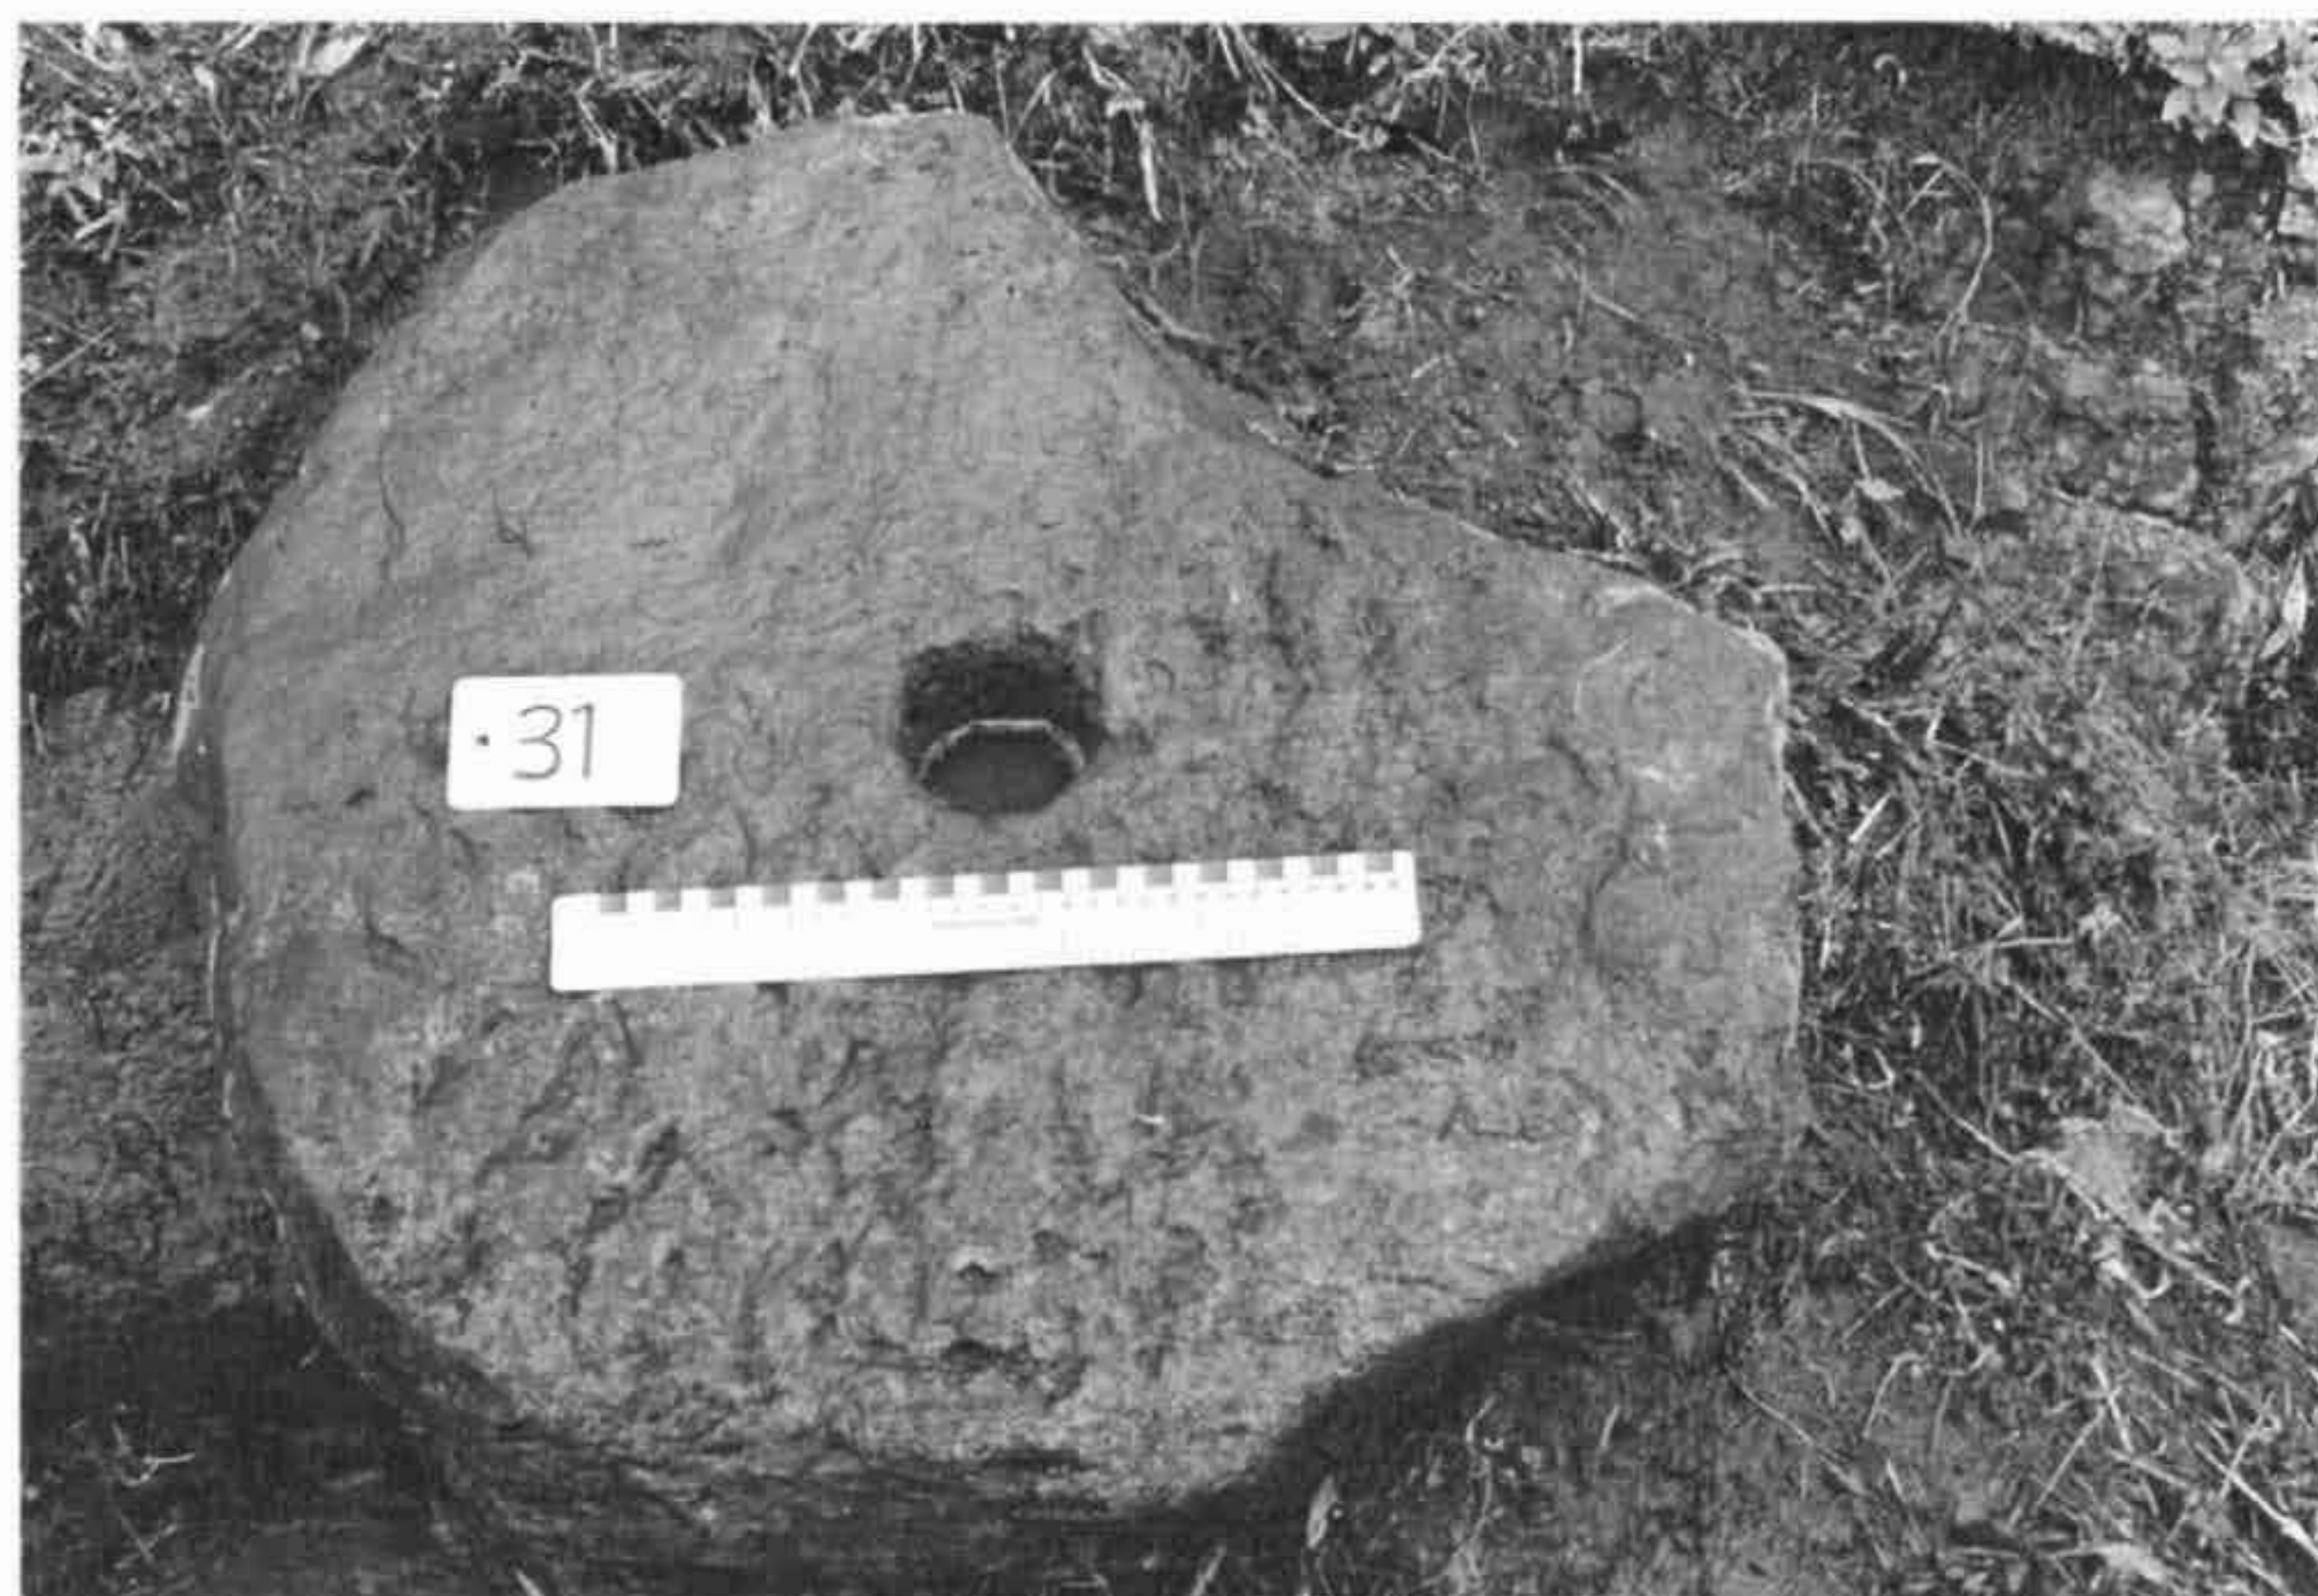
Plate 24

Block 31 was a rough circular stone with central dowel hole, probably a discarded column drum base.

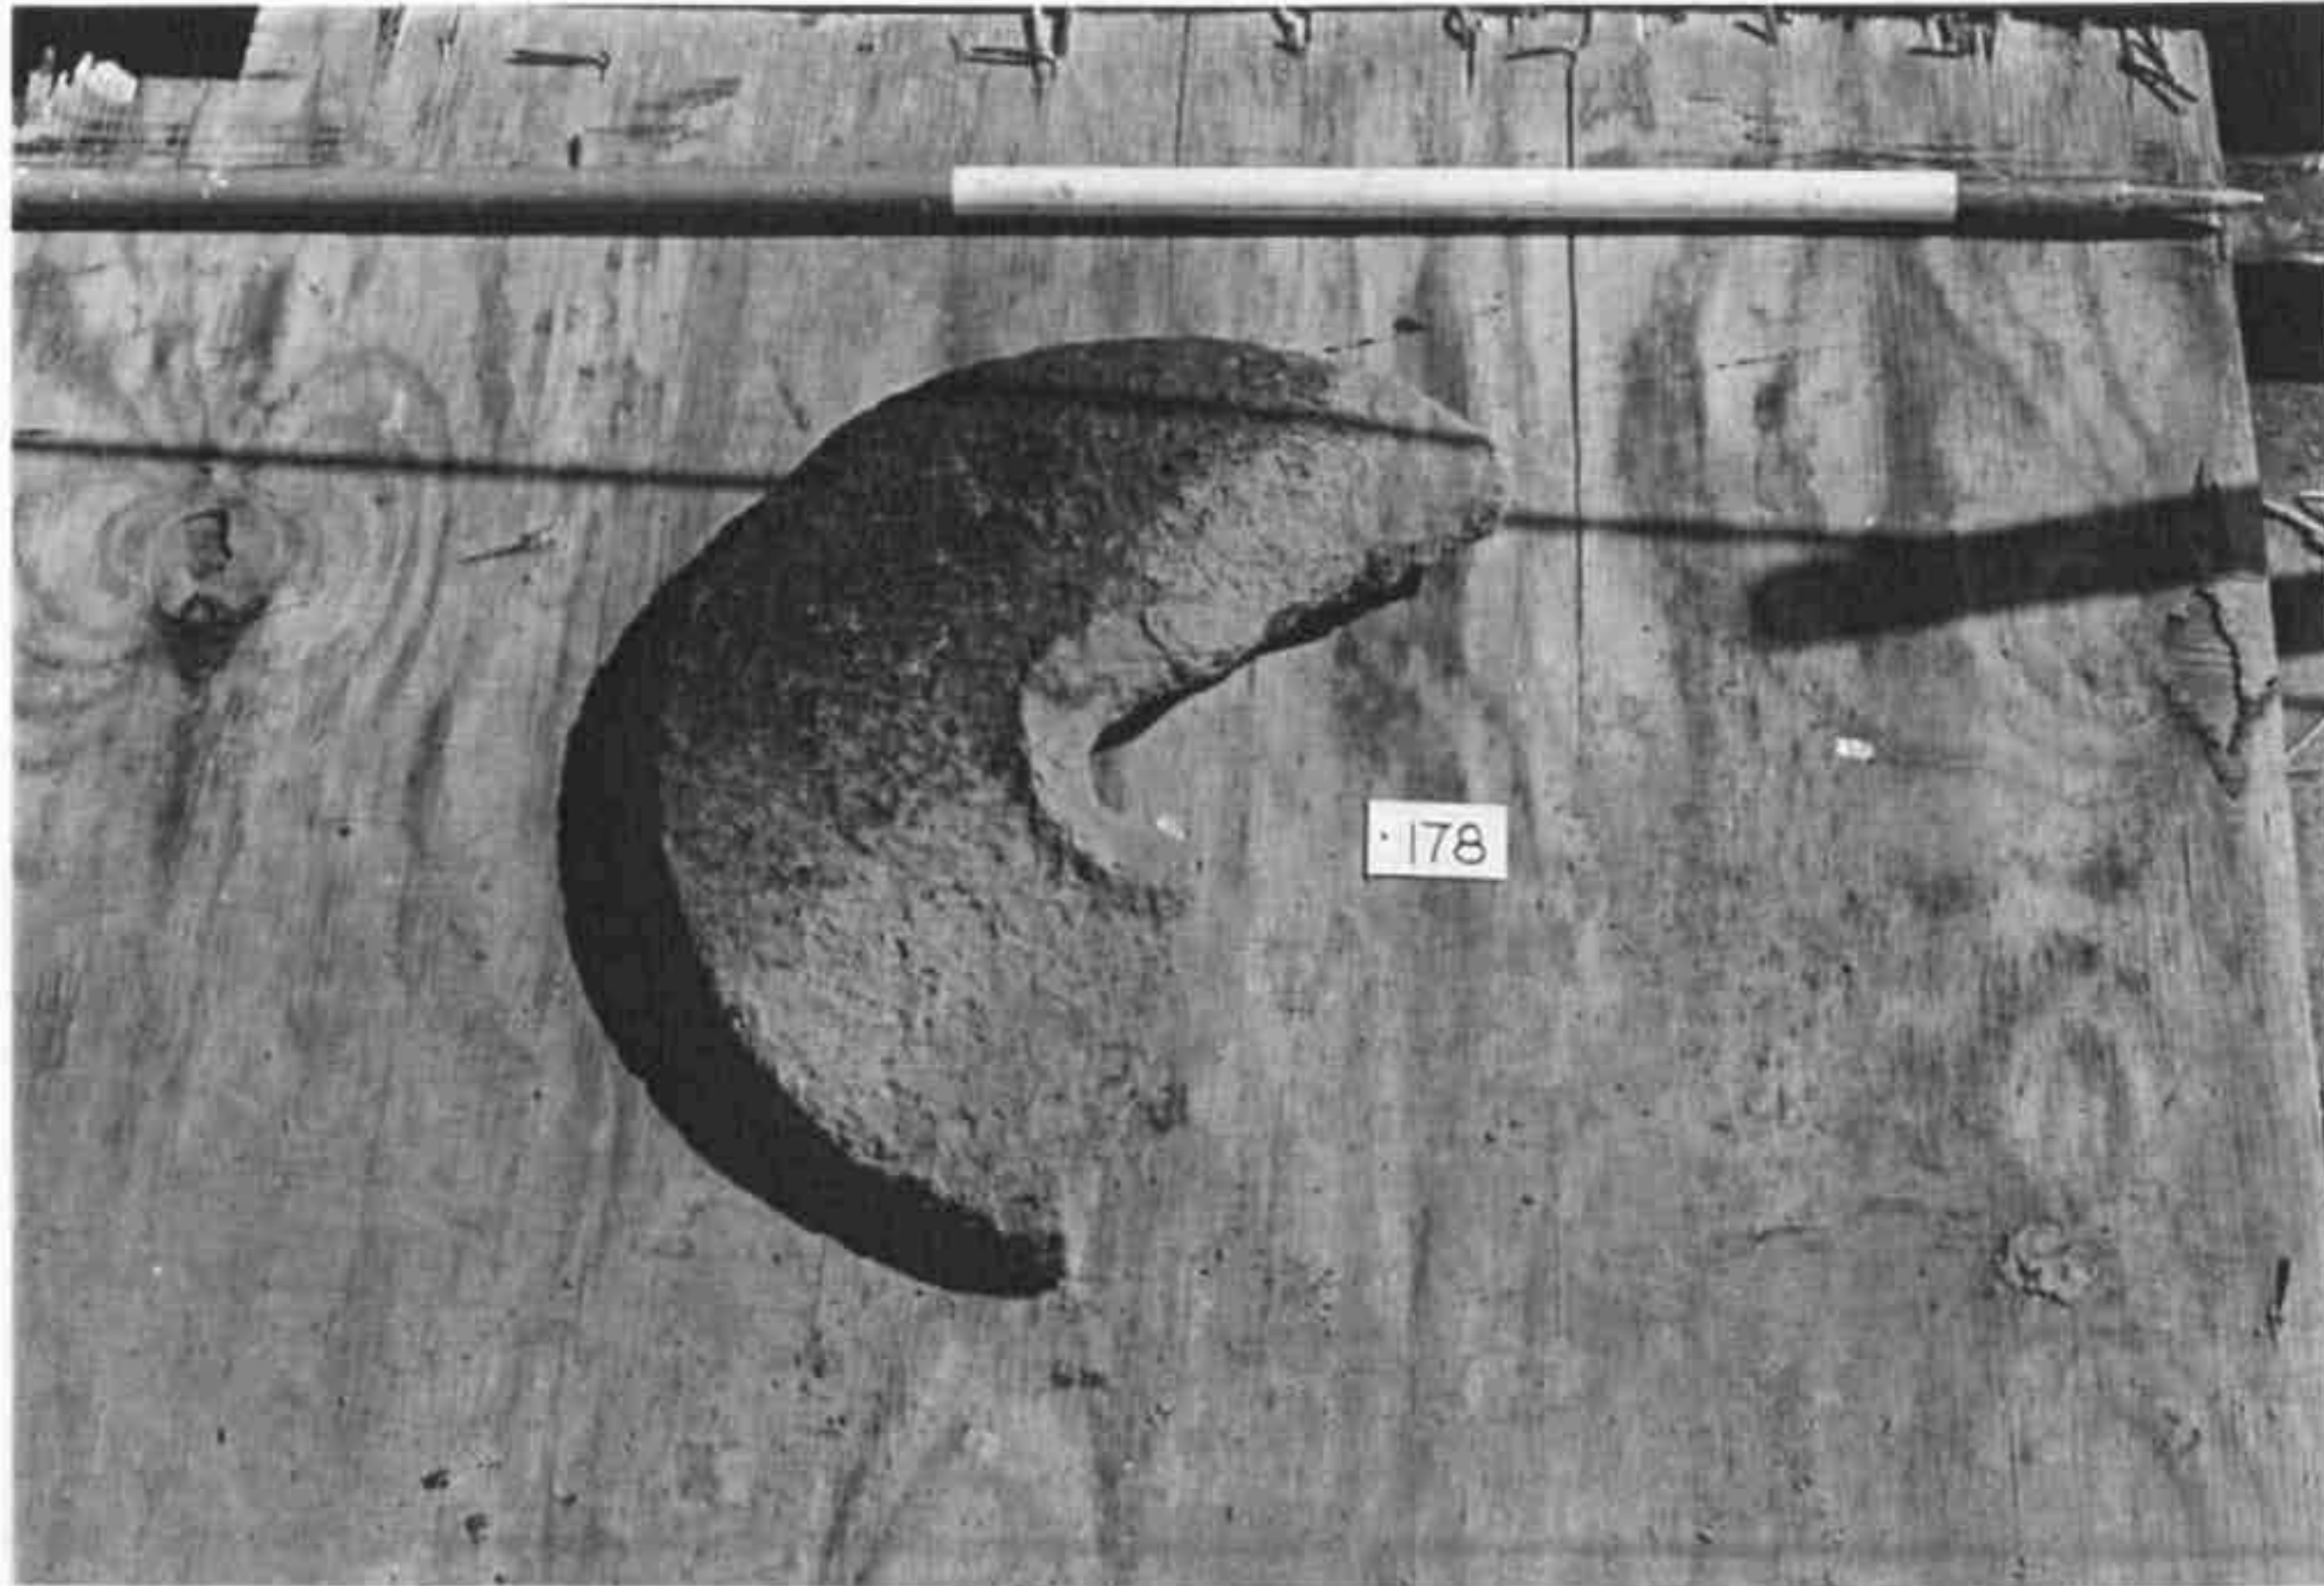
Plate 25

3.5.37 In addition to architectural fragments the riverbed watching-brief revealed a small amount of artefactual material, comprising fragments of *opus signinum*, worked tufa and a single fragment of quernstone (plate 25). No Romano-British pottery or animal bone was encountered on the riverbed, any such material probably having been swept downstream by the current. Material of this type was recovered, during inspection in 1991 of the eroding scarp faces of the riverbank, downstream of the Lower Buttress. The relative paucity of pottery and bone may reflect the limited extent of excavation on the site, and the probable disposal of refuse into the fast-flowing river, rather than a significant absence of occupation-related waste from the complex.

3.5.43 The small quantity of occupation debris recovered (discounting building materials) sheds little light on whether the complex was of a predominantly domestic or religious nature. The quern fragment (plate 25) from the river would be a common find at villa locations but such domestic items need not be out of context on temple sites, since corn might equally be ground on site for a resident priest. Only further fieldwork, recovering artefactual material from across the terrace, could help resolve the character of the site; the finds to date being too limited to clarify how much waste was generated on-site, how it was disposed of and whether there was a principally domestic or religious nature to the complex.

Quernstone fragment recovered from the riverbed.
