The Old Hall, Walton, Leicestershire

Photographic Recording

Archaeology Warwickshire Report No 1348
September 2013

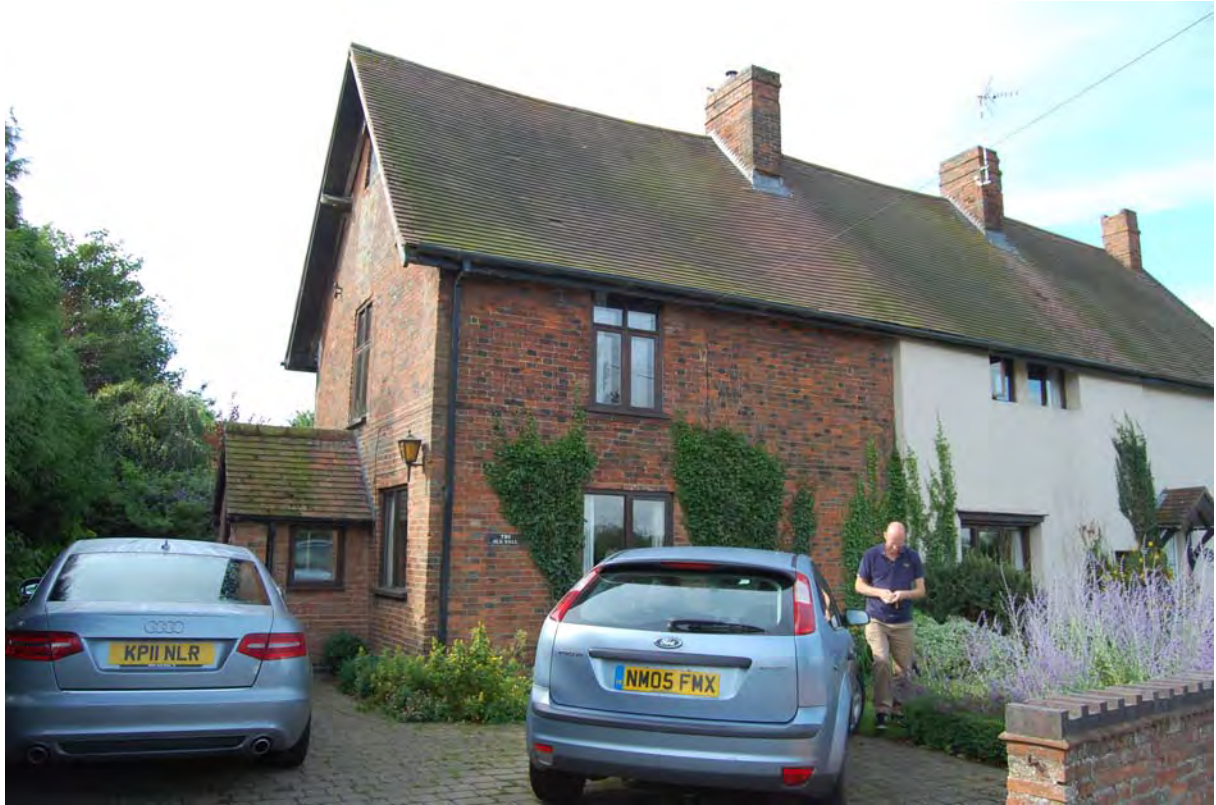
Fig 2: The Old Hall

5.1 The Old Hall has seen many changes to its structure over the centuries. At present the western part, along with Old Hall Cottage, is rendered, while the eastern third is exposed brick (Figs 2-5). The chimneys are off-set to the north of the apex of the roof, indicating they are later additions. The window frames are all replacements and the only window in an original position is the first floor window in the central part of the property. Other windows in the Old Hall are in the secondary brick openings, or are later insertions such as that on the gable at ground floor level (Fig 6). The upper window on the gable, which accesses the attic, is shuttered, while a first floor door opening has been replaced by windows (Fig 8).

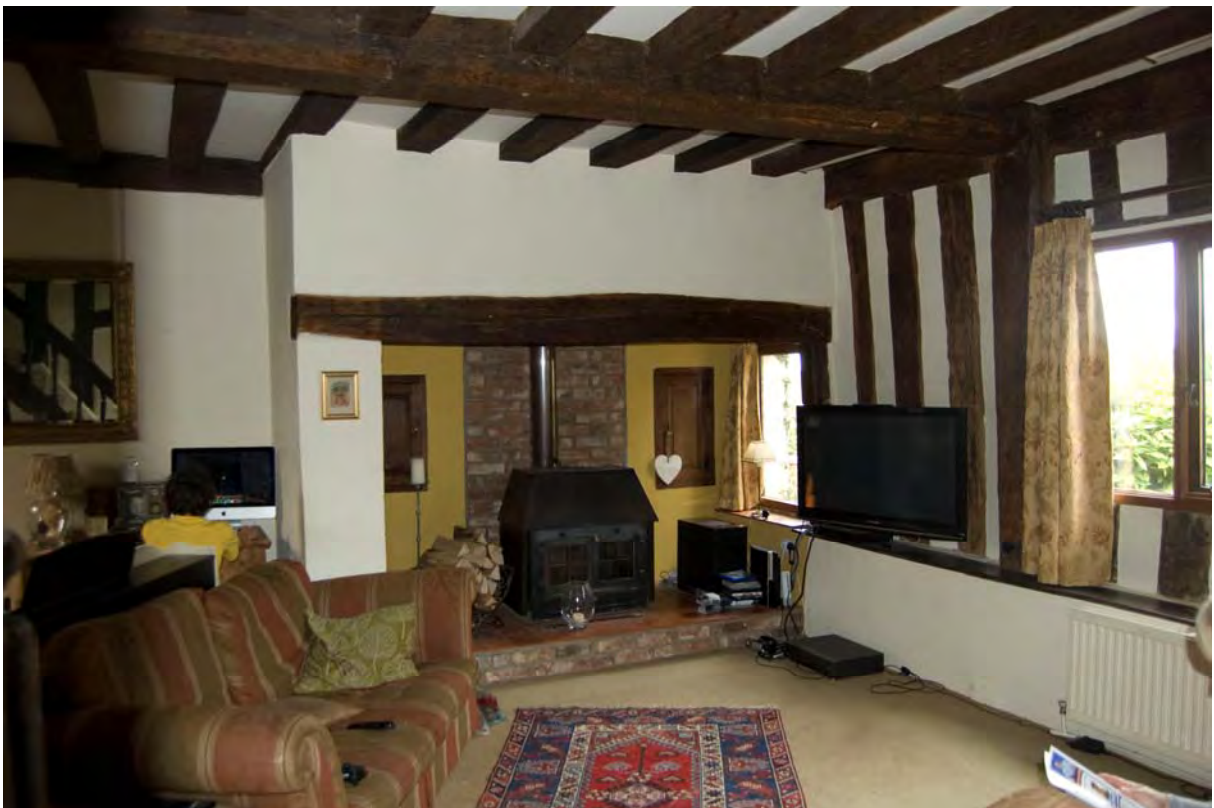
Fig 17: Living room with inglenook fireplace

5.4 The living room has a large inglenook fireplace, again in the north-west corner of the room. Close studding exposed along north wall (Fig 18), and east wall, with a small amount on the south wall (Fig 19). The cross beam has chamfer stops (Fig 20) and the insertion of the staircase in the corner of the room has required the chamfering of the leading edge of a ceiling joist (Fig 21). There are few period fixtures and fittings left in the building. Hooks set into one of the beams are of unknown purpose (Fig 22), while a stair-rail bracket in the former cross-passage (now toilet) indicates where the stair used to run along the south wall (Fig 23), from the kitchen, before the present staircase, with period newel post (Fig 24) was inserted.

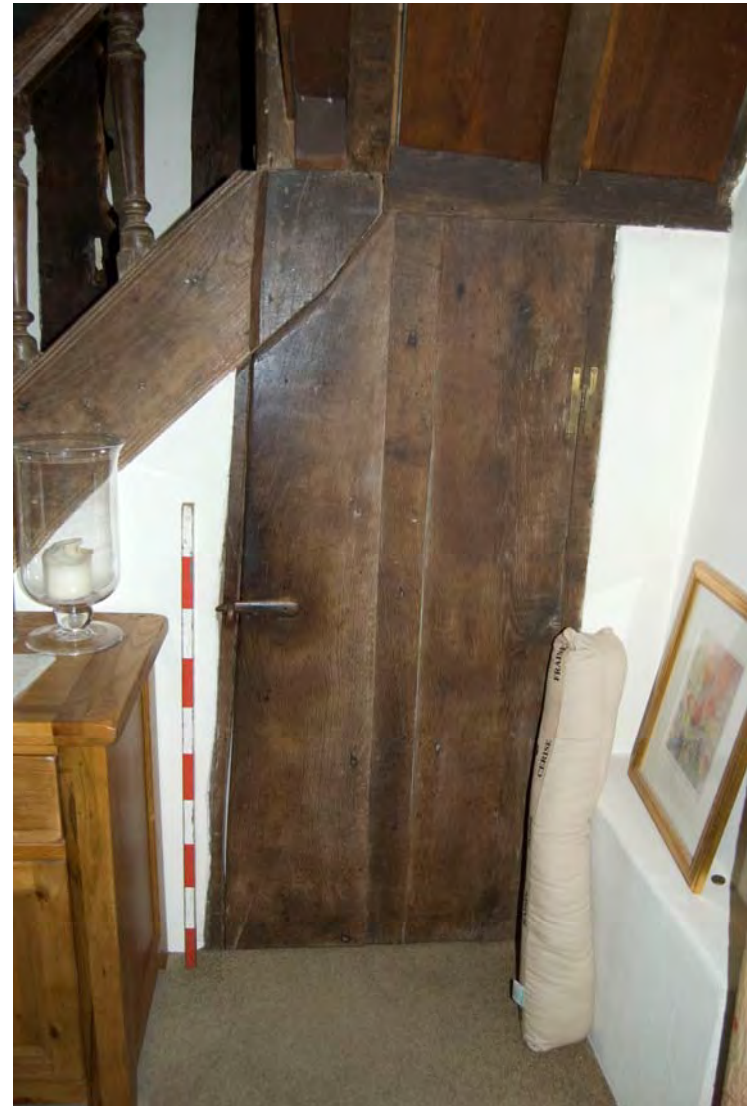
Fig 25: Door to cellar

5.5 The cellar door has been shaped to fit below the stair (Fig 25) and the stone cellar steps are worn and brick-patched (Figs 26-27). The cellar is a curious room, smaller than the kitchen room below which it lies, with walls constructed of rough, whitewashed, stone (Fig 28). The floor is now concrete, but Palmer (no date, see Appendix) states that at the time of his examination was of brick 'similar to those used in the hall section'. The cellar walling supports the area of the kitchen fireplace. The recess in the rear wall suggests a possible alternative entrance to the cellar from outside (Fig 29).

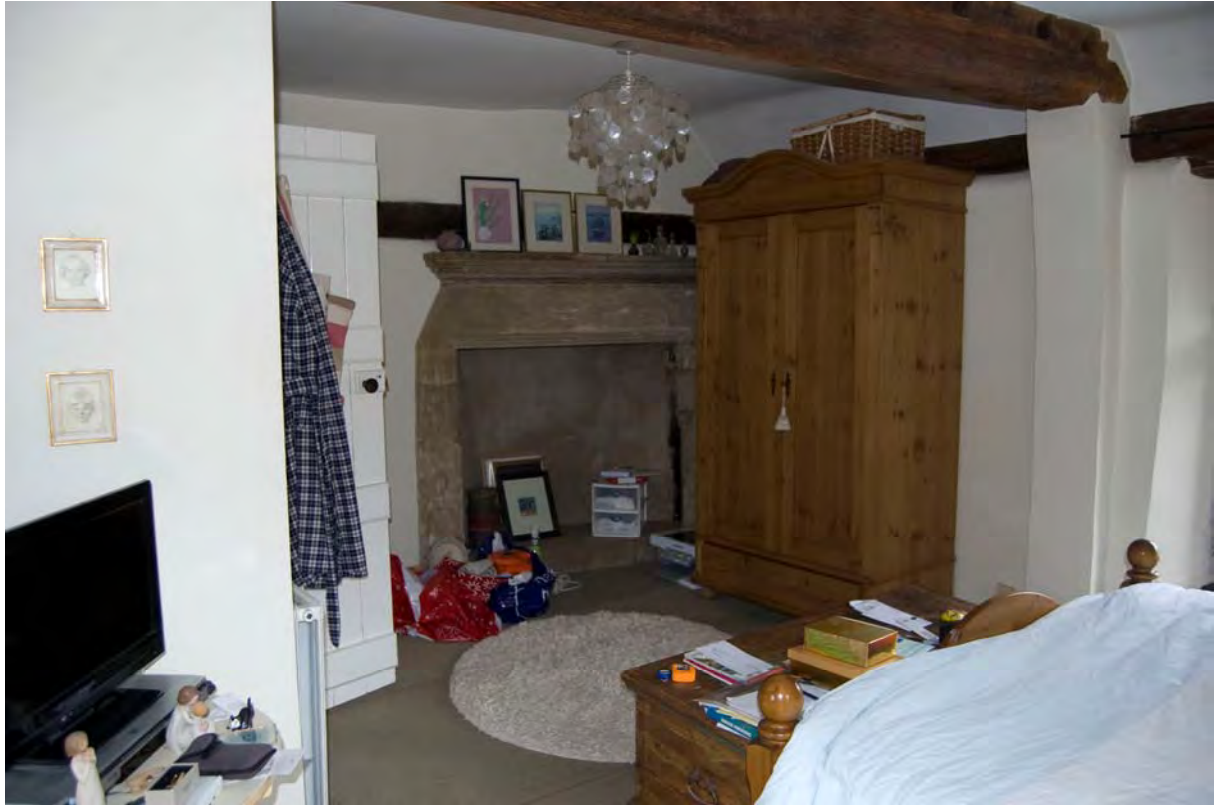
Fig 30: Main bedroom with fireplace

5.6 Upstairs the space has been divided into a bedroom, bathroom and passage in the north-east part and hall, stairs and two bedrooms in the south-west part (see Fig 52). The main bedroom, which occupies the northern part of the house, has a stone fireplace (Fig 30). The central ceiling timber is exposed, as are other timbers in the walls (Fig 31). The central beam has mortises visible for joists, suggesting the ceiling level has been raised (Fig 32).

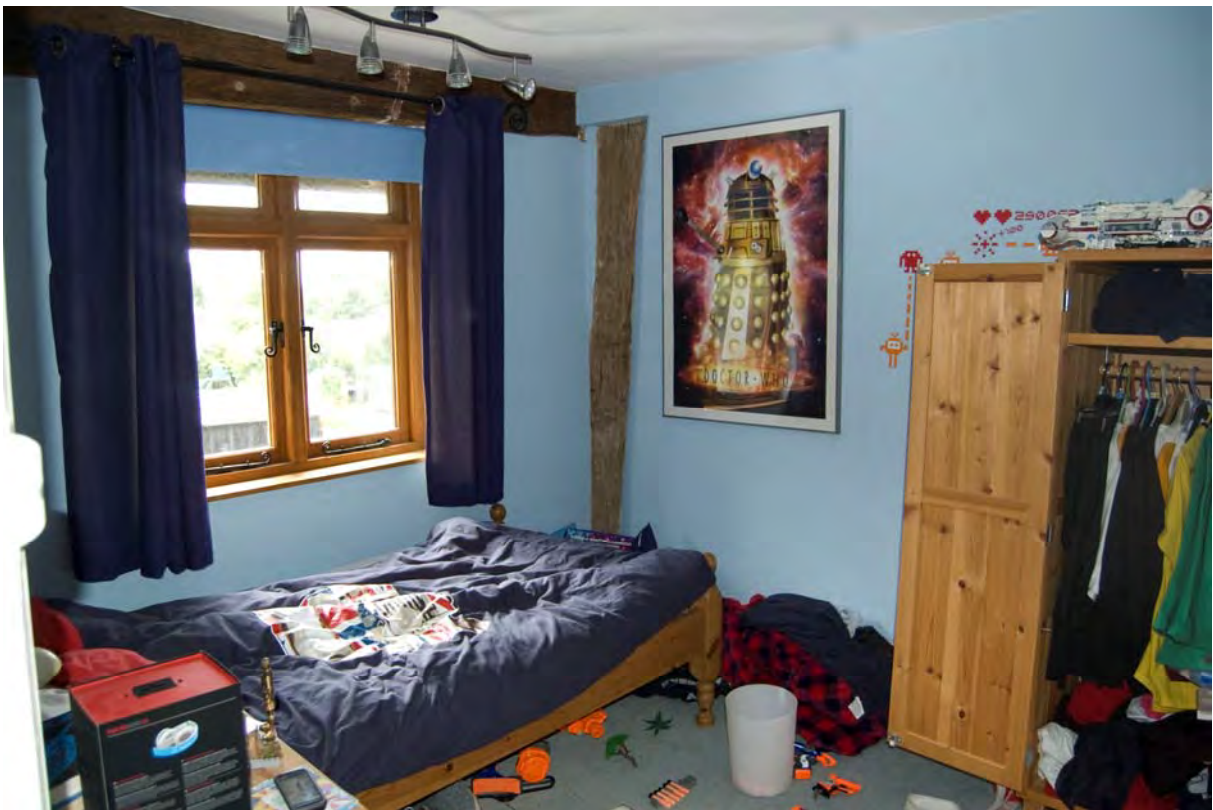
Fig 33: Rear bedroom

5.7 The small rear bedroom shows little of its original structure other than a timber in the corner and above the window (Fig 33). The front bedroom, however, has exposed close studding (Fig 34), an original window mullion and beam, the latter with exposed mortises and a heightened ceiling (Fig 35). The dividing wall with the hall has infilled staves (Fig 36), while on the south-west wall there appears to be the recess of a fireplace (Fig 37).

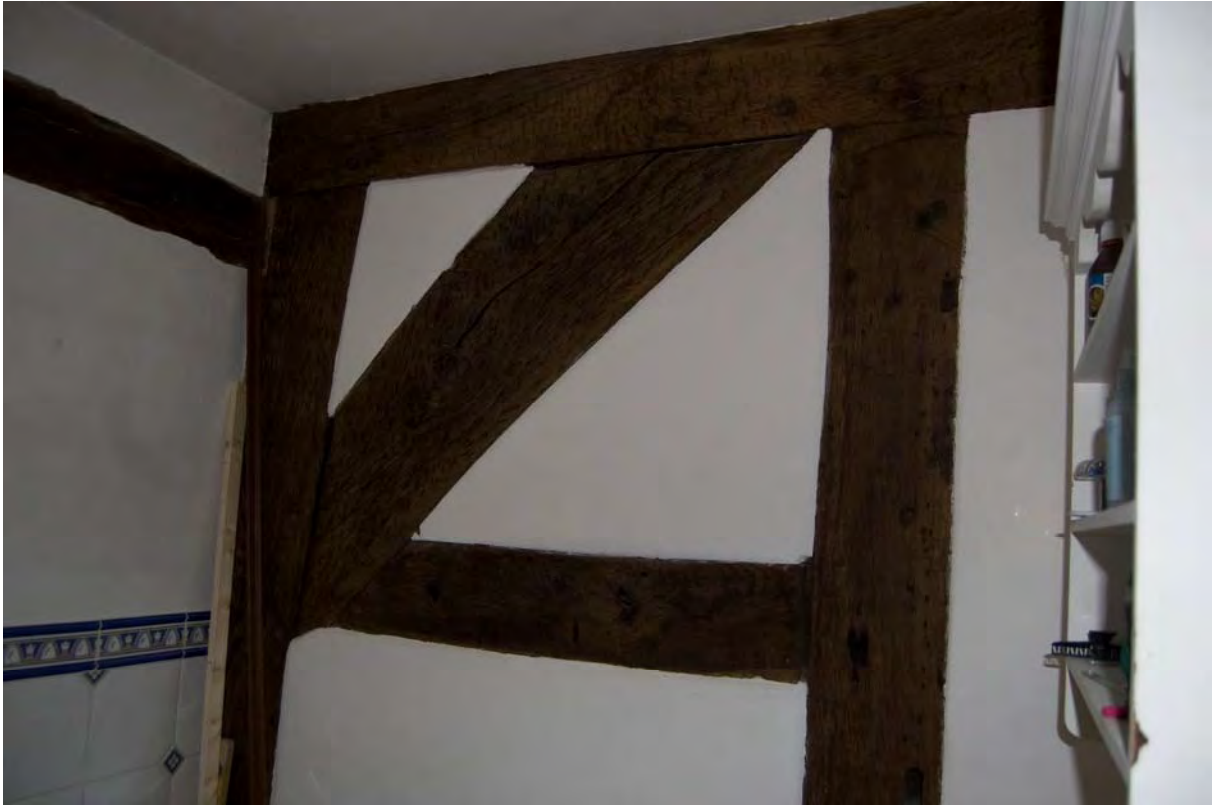
Fig 40: Timber-framing in bathroom

5.8 In the upper hall, the balustrade is made up of a curious mixture of old and newer balusters (Fig 38) and the cross-beam shows a number of carpenter's marks incised on its upper surface (Fig 39). The dividing wall between the bathroom and hall has large structural timbers (Figs 40-41).
