Historic Building Recording at
Fields Farm, Featherbed Lane,
Hunt End, Redditch, Worcestershire

Report 0809

March 2008

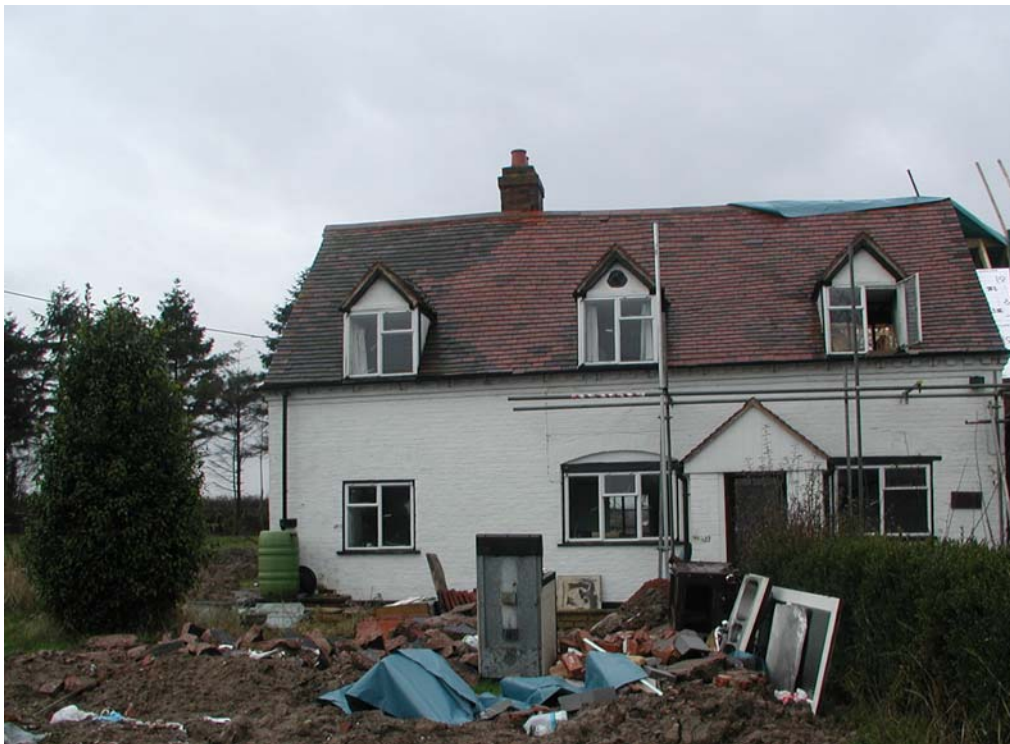
Fig 4: View of Fields Farm house

5.2 A photographic survey (see Appendix) was conducted during three visits to the site when internal and external features of the building were recorded and a phase plan with descriptions was completed. At the time of the recording the two modern extensions on the north and west sides of the original building had been partially demolished and the internal floors partly removed. The interior was largely cleared and plaster had been removed from some surfaces. However, some of the walls throughout the building were plastered or decorated and showed little structural detail (Fig 4).

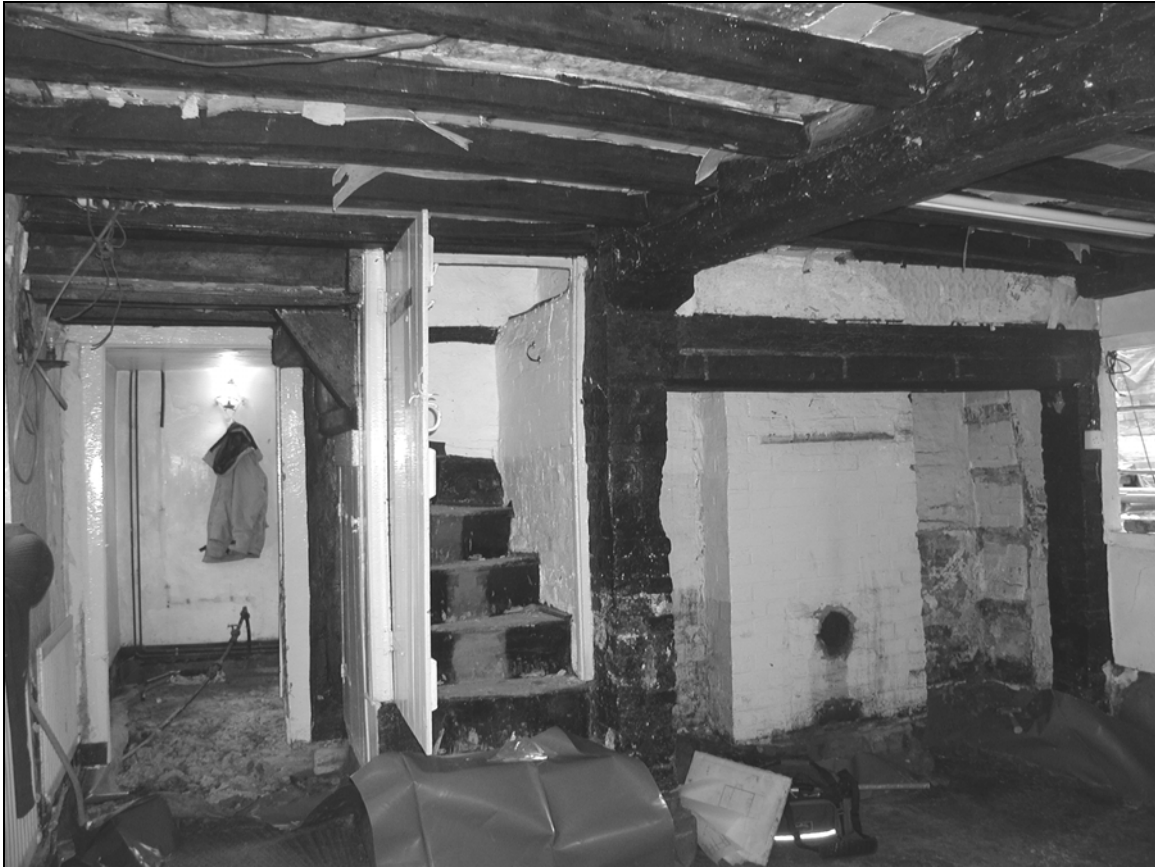
Fig 6: Room G1 showing exposed beams, stairs and fireplace

5.6 The room was accessed directly from the front of the house through a small porch (Fig 5). The room was 4.8m long and 4.2m wide with a visible axial chamfered ceiling beam and associated joists. A fireplace and adjacent staircase were positioned on the south side of the room (Figs 6, 8 and 9).

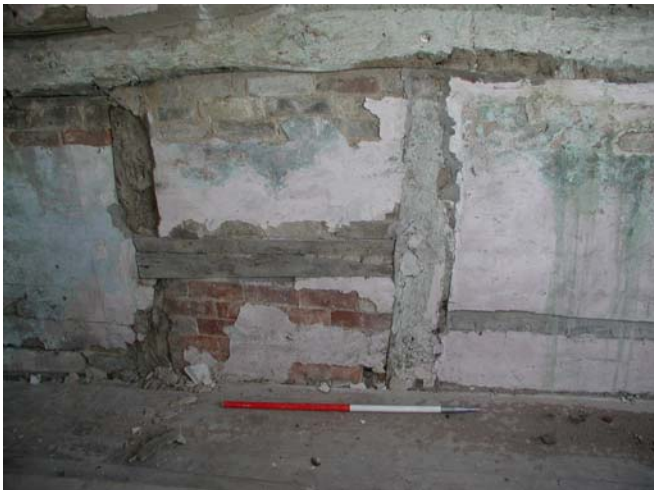
Fig 14: Detail of timber frame in north gable wall (U2)

5.23 The room was 2.4m long and 4.4m wide. The north and west walls had been stripped of paint and paper and showed evidence of timber framing, including posts, wall beams and collar rafter (Fig 14). Brick nogging was also recorded in the visible square panels.

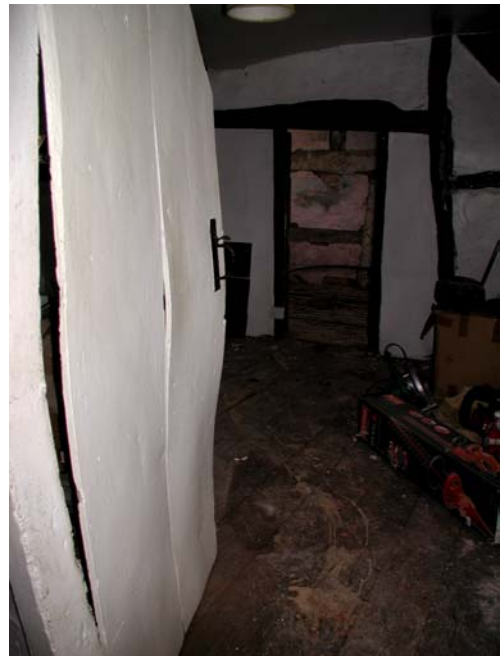
Fig 16: Planked door (U1)

5.19 Three separate rooms had been created on the upper floor (Fig 5). The largest of the upstairs rooms was accessed directly from the staircase and a small landing. The door was constructed of two vertical planks and was probably an original feature (Fig 16). Timber frame panels were visible on the west and north walls of the room where decorative paper or plaster was absent.

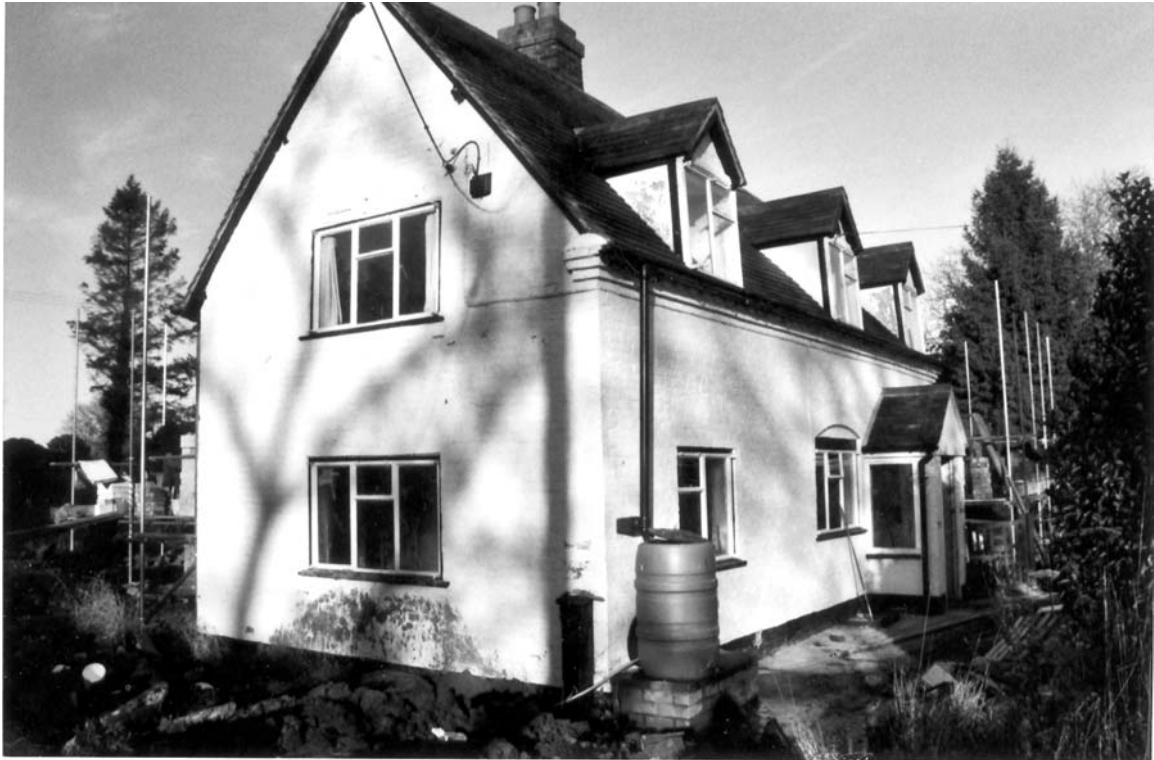
Fig 17: View to the north-west of Fields Farm house

5.27 The building had a brick-built front elevation on the east side with three ground floor casement windows (Fig 17). The three windows were each positioned under a shallow brick arch and had metal frames and fittings. The smaller and most southerly positioned window had two casements and was set at a slightly lower level than the other two. The wall was painted and had no apparent evidence for timber frame or other timber features.

5.30 The brick porch was built on the front elevation at the front door and was 1.5m wide and 1m deep with a pitched tiled roof (Fig 17). The porch includes two single casement windows and was probably added in the 20th century.

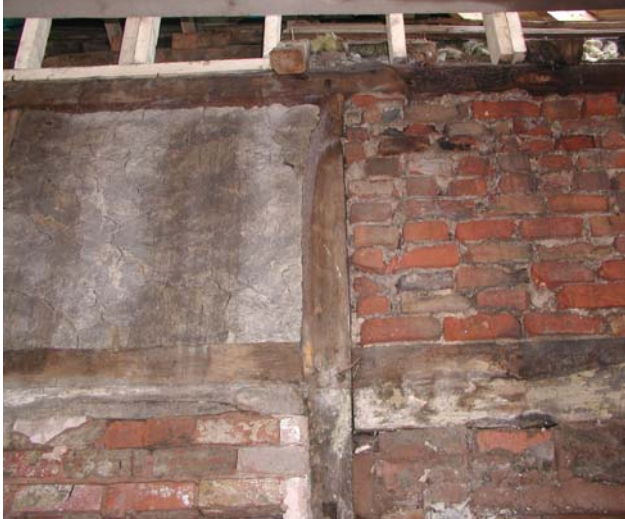
Fig 21: Detail of timber frame showing brick nogging infill

5.31 The west wall formed the original rear wall of the building and was mostly rendered, but some timbers were visible except at the southern end, which is a later extension (Fig 23). Wall timbers, including wall posts and beams forming the timber framing were visible. Part of the upper element of the wall immediately beneath the eaves had the render removed and details were evident, including a brace between the corner post and the wall plate in the northern-most panel. Three other square panels were visible and these included both brick nogging and wattle and daub infills (Figs 21 and 24).
