**PITSLIGO CASTLE**  
**ROSEHEARTY**  
**ABERDEENSHIRE**  
**-TEST PITS-**

**- Excavation and Recording of Test Pits -**  
April 2010

by  
**Murray Archaeological Services Ltd**

**Report No: MAS 2010-09**

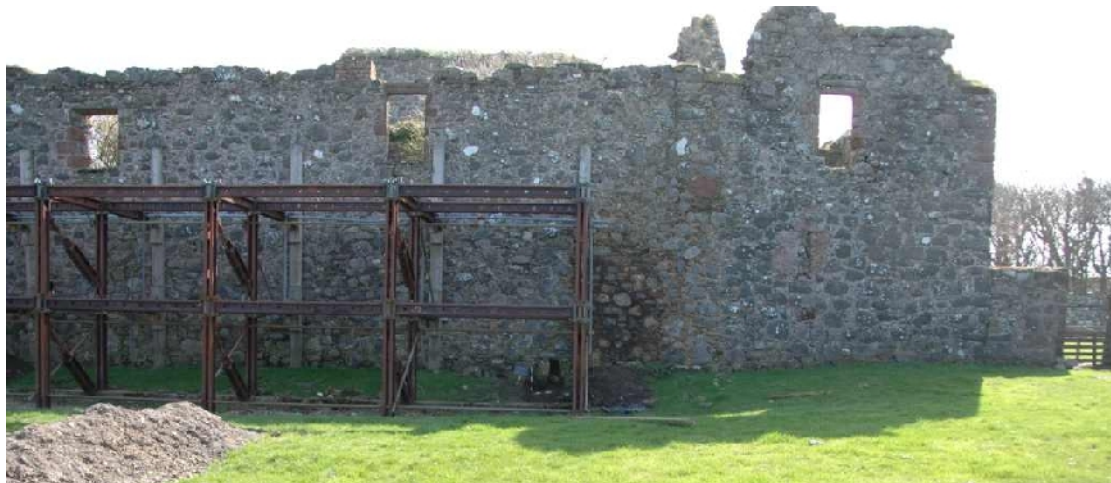
Illus 3 TP 1 location

*Location:* At right angles to the N face of the N wall of the N range, between 8.65m and 9.45m from the NW corner of the building, extending between the wall face and the face of the concrete foundation of the scaffolding buttress. The wall face included a drain outlet through the wall.

*Results:* The main wall extended only 180mm below the present surface and was built directly on natural, the drain outlet extended to 280mm below the present surface, being cut c 100mm into the natural – this cut had been made to accommodate the side stones of the drain and only extended c 100 mm away from the face of the wall. The drain itself was partially blocked with rubble and silt.

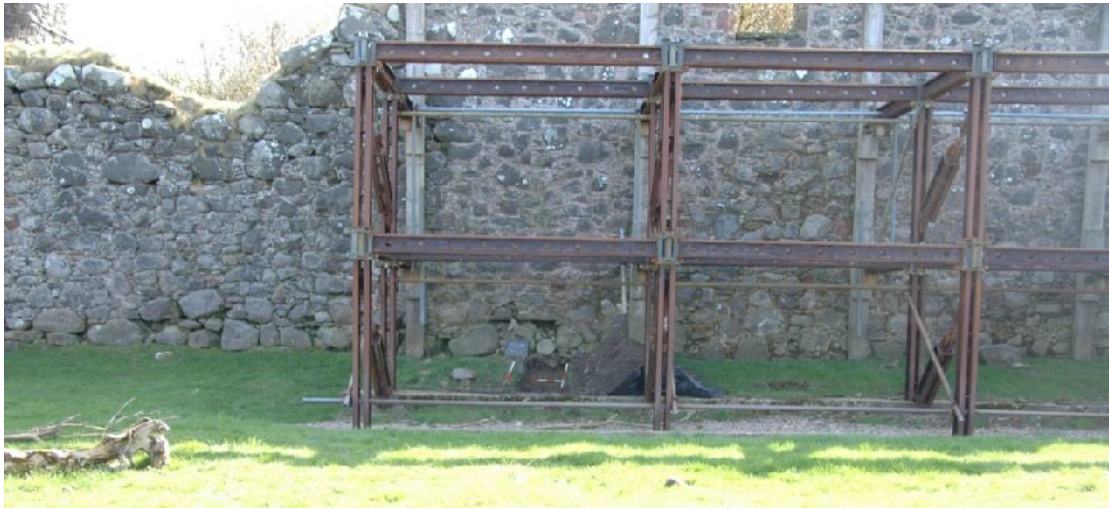
**Illus 8 TP 2 location**

*Location:* At right angles to the N face of the N wall of the N range, between 20.8 and 21.4m from the NW corner of the building, extending between the wall face and the face of the concrete foundation of the scaffolding buttress. The wall face included a drain outlet through the wall.

*Results:* The main wall extended only 160mm below the present surface and was built directly on natural with some crushed stone and mortar (construction surface) below the base stones. The drain outlet extended to c 300mm below the present surface, being cut c 150mm into the natural – this cut, made to accommodate the side stones of the drain, did not extend away from the face of the wall. The drain itself was partially blocked with rubble and silt – as this rubble was loose it was not cut right back to the wall face.

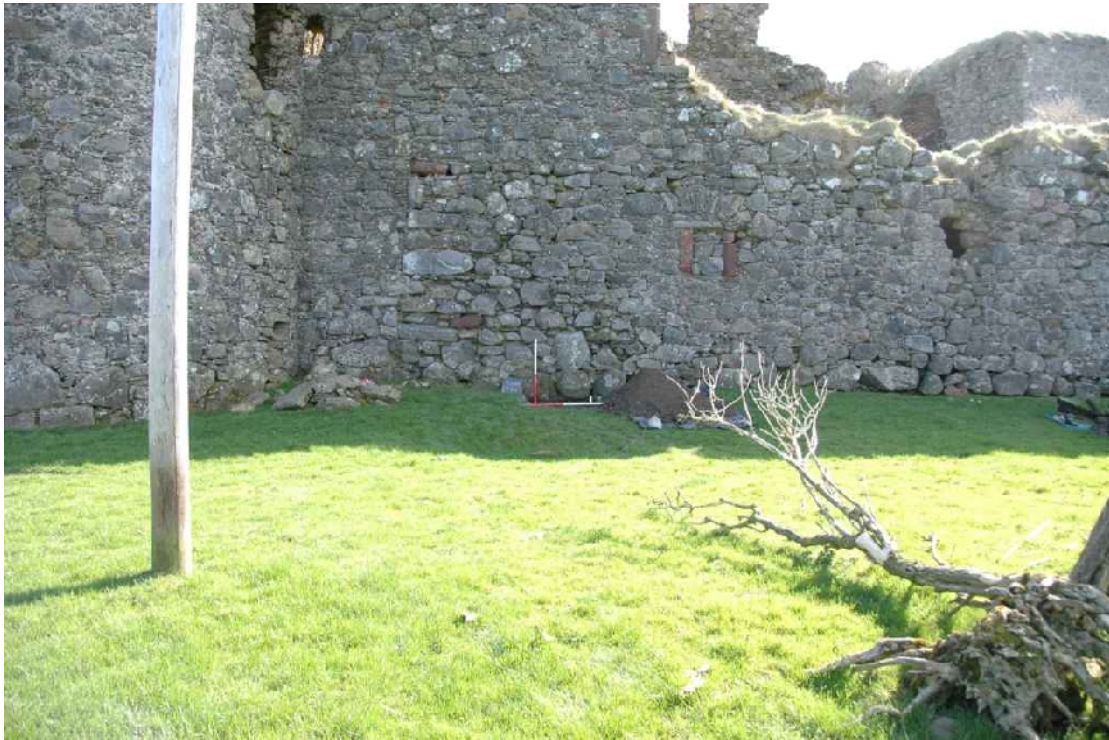
**Illus 15 TP 4 location**

*Location:* At right angles to the N face of the N wall of the N range, between 37.4 and 38.4m from the NW corner of the building, extending N from the wall face. It was 3.3m from the junction between the round tower and the N wall and c. 2m E of the E side of the blocked door (and window) below the gallery stair. It was also 1.85m W of the vertical break of build which would appear to be the end of the original N courtyard wall (the wall between this and the round tower being presumably infill when the tower was built). This should therefore illustrate the foundations of the main section of this N wall.

*Results:* Two of the wall foundation course boulders were exposed, they extended 100-150mm below the present surface. The gap between the boulders was packed with small filler stones. The W foundation boulder was directly on natural boulder clay. The front (N) face of the E boulder was on 100-120mm of disturbed boulder clay with some mortar fragments – this is likely to be the construction surface. It merged into undisturbed natural boulder clay.

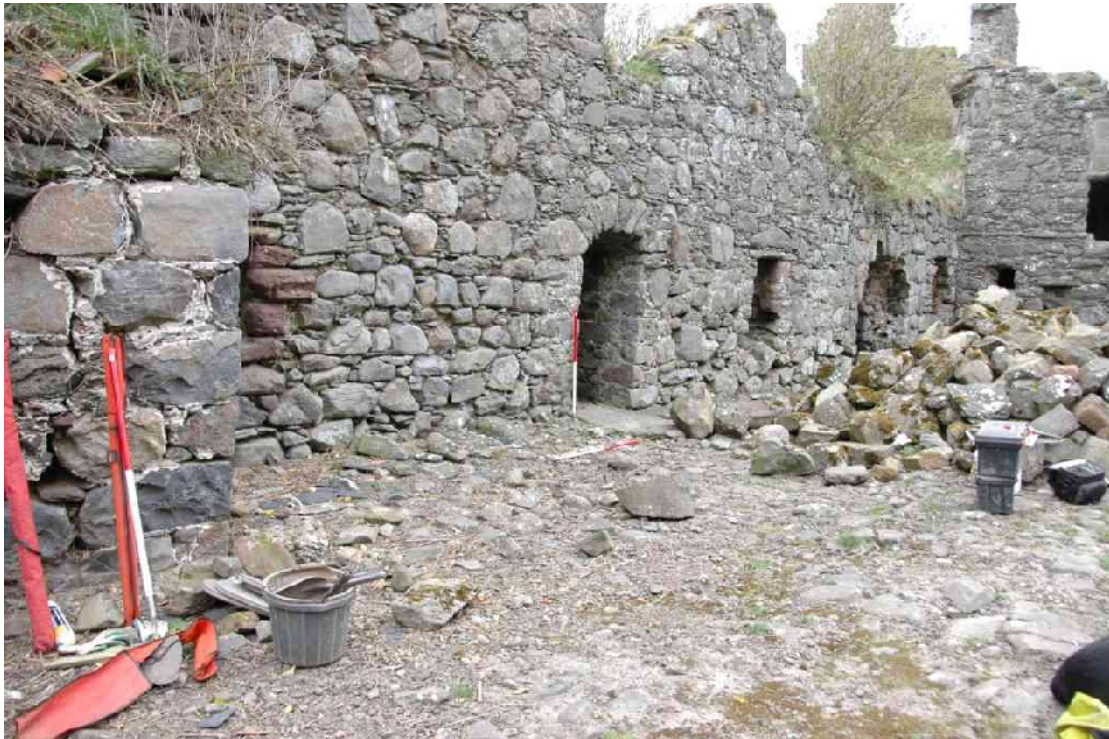
**Illus 20 TP 5 location**

formed an earlier drain base. These were all set within an earlier stone drain. The stone drain which was 200-240mm wide internally was well built with up to 3 courses of mortared stone surviving to 400mm depth. It ran below the line of the larger stones noted in the yard surface which appear to have been the original capstones. Within TP 5 these had been partially removed when the clay pipes were put in. However, TP 5 was extended by 350mm to the E to test that the drain ran below the very large threshold stone of the guest chamber doorway. It is worth noting that the capstone next to the threshold runs below the S wall of the N range, indicating that the construction of the stone drain almost certainly pre-dates the construction of the N range accommodation- although possibly only as different stages in the building process.

The re-use of part of the drain with clay pipes can be linked to the farmhouse in the 19<sup>th</sup>/20<sup>th</sup> century.

It would be worth planning the original drainage system indicated by the capstones- and attempting to see if this drain linked to the outflows in each of the guest chambers (as seen in the N wall of the N range in TPs 1 and 2).
