# GLASSHOUSE BRODIE CASTLE MORAY

**- Building Recording -**  
Carried out 13<sup>th</sup> May 2014  
by  
**Murray Archaeological Services Ltd**

**Report No: MAS 2014-27**  
by  
H K Murray and J C Murray

1. Background
  - 1.1 An early 20<sup>th</sup> century glasshouse in the walled garden at Brodie Castle, Moray was in a state of collapse and required to be taken down. In consequence it was decided by the National Trust for Scotland that a standing building survey of the structure should be undertaken.
  - 1.2 It was requested that special attention should be placed on joints and structural elements so that should a replica of the glasshouse ever be considered, the construction would be as accurate as possible.
  - 1.3 Murray Archaeological Services Ltd was commissioned to undertake the work by the National Trust for Scotland. The field work was undertaken on 13<sup>th</sup> May 2014.

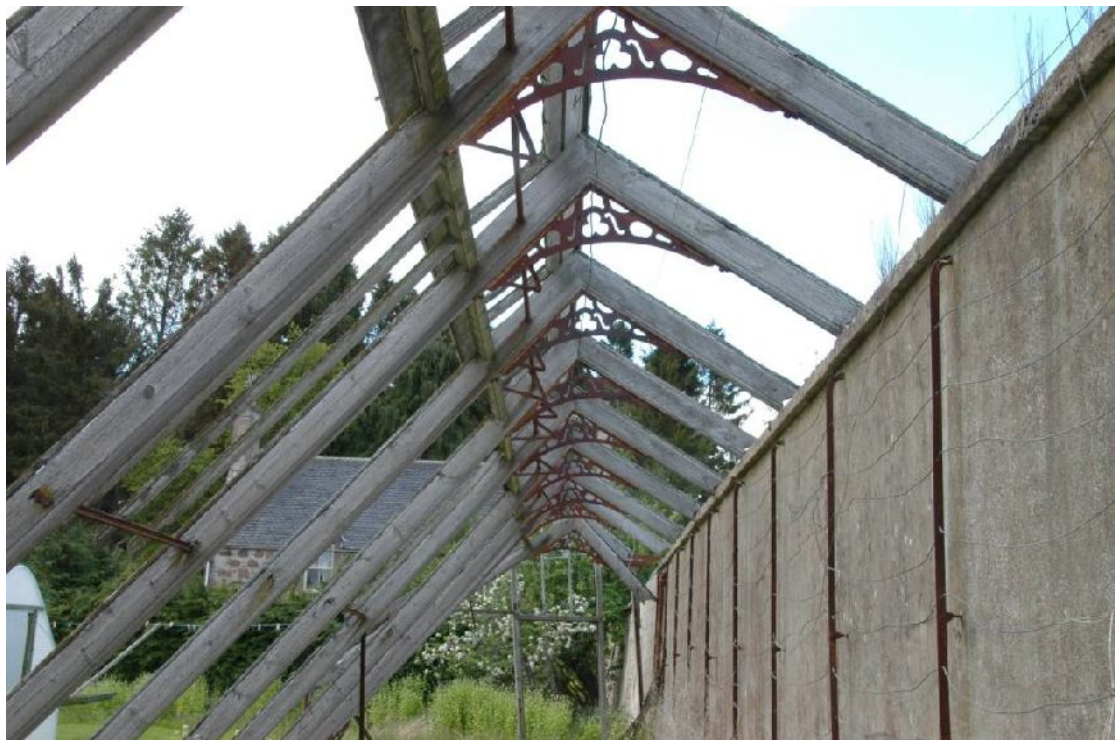
**Illus 17** Rod (B) running along length of building, opening levers (A) at each bay (LHS of apex).

A horizontal iron rod (B) ran the length of the 6 bays, through drilled holes in the rafters. It was c 400mm from the top of the roof, just above the horizontal timber that formed the base of the top windows and the top of the middle glazed section. This rod was fixed to a series of elbow joint levers (A), one beside the first glazing bar to the S in each bay. At the S gable, the bar was jointed to an angled lever (C) attached to the top of the wall, which moved up and down when rod (D) was moved by Y-shaped lever (E) as a partly threaded vertical bar (D) was wound up or down by a (missing) handle which would have attached to the socket at the bracket (E) bolted to the W door jamb.

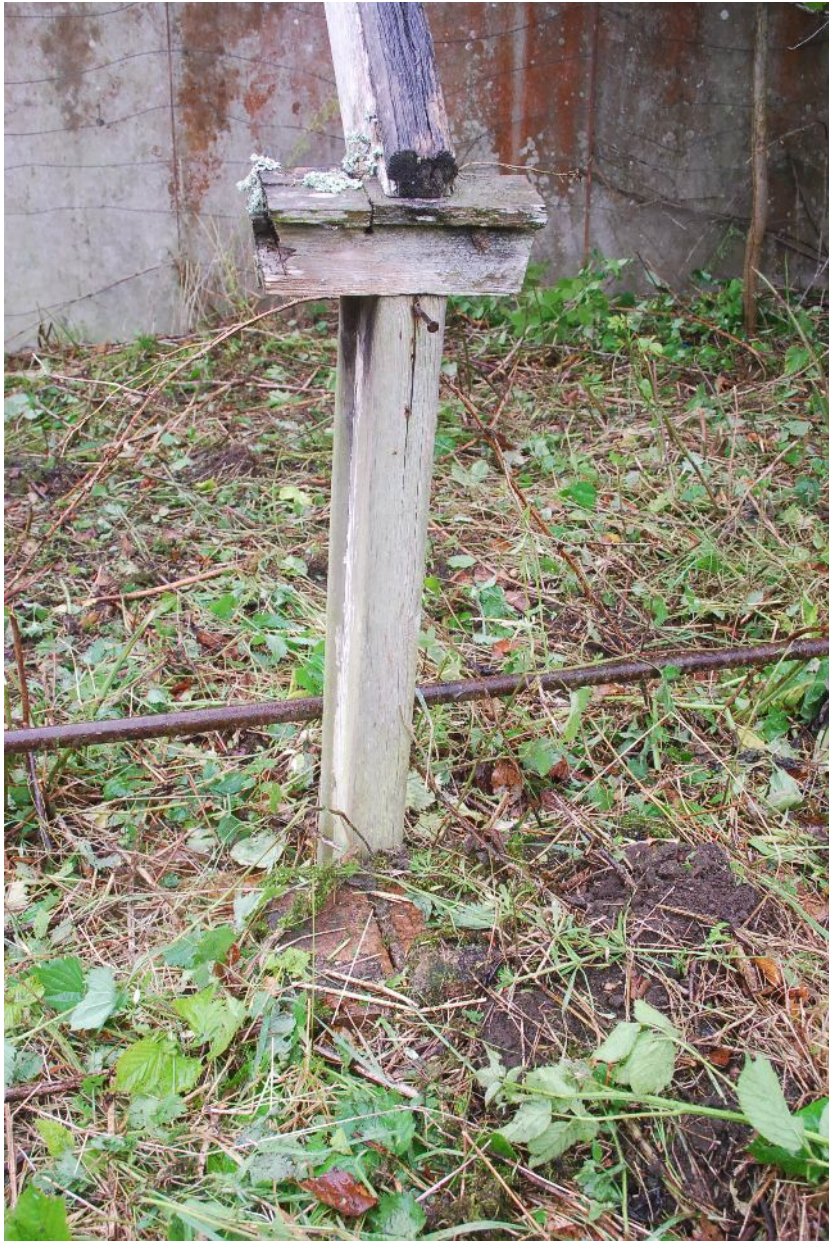
**Illus 26 Horizontal metal rod for opening the lowest (vertical) windows. (Photograph R Grant).**

- The iron rod and winding mechanism for the upper windows for the N six bays of the glasshouse had been removed for re-use at Pitmedden. This resulted in further skewing of the NW gable end and the N two bays. At some point a fence post was used as a replacement support at the NW corner. Prior to the removal of the window mechanism the structure had been photographed in detail in 2009 and some of these photographs are included to illustrate features no longer extant (Illus 22-26).
