## BELDORNEY CASTLE GLASS ABERDEENSHIRE

# - Archaeological Watching Brief Carried out July 30<sup>th</sup> & August 5<sup>th</sup> 2014 by Murray Archaeological Services Ltd

Report No: MAS 2014-29 by H K Murray & J C Murray

### BELDORNEY CASTLE GLASS ABERDEENSHIRE -Archaeological Watching Brief-

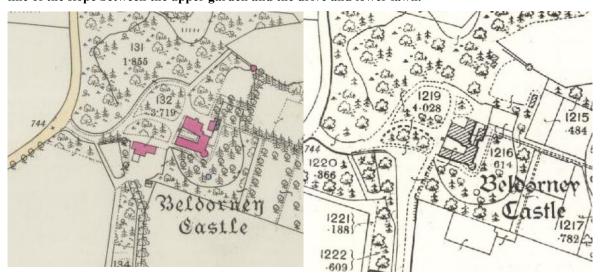
The instability of the existing wing is likely to have been caused by the terracing of the ground level directly to the W between the drive and the haha (illus 6). This layout is shown on the 1<sup>st</sup> and 2<sup>nd</sup> OS maps (illus 7) and is likely

to relate to the late 18<sup>th</sup>/early 19<sup>th</sup> century fashion for removing formal 17<sup>th</sup> century gardens and re-modelling the grounds around castles or mansions in a more open, parkland landscape.

Illus 7 1<sup>st</sup> OS map (LHS: Banff sheet XXVI.13 1869 pub. 1872.) and 2<sup>nd</sup> OS map (RHS: Aberdeenshire 025.13. 1900 pub 1901) showing the layout of the ground to the W of the castle..
