DRIVEWAY REPAIRS
DRUM CASTLE
ABERDEENSHIRE

Archaeological Watching Brief
Carried out between February and May 2015
by
Murray Archaeological Services Ltd

Report No: MAS 2015-9
by
H K Murray and J C Murray

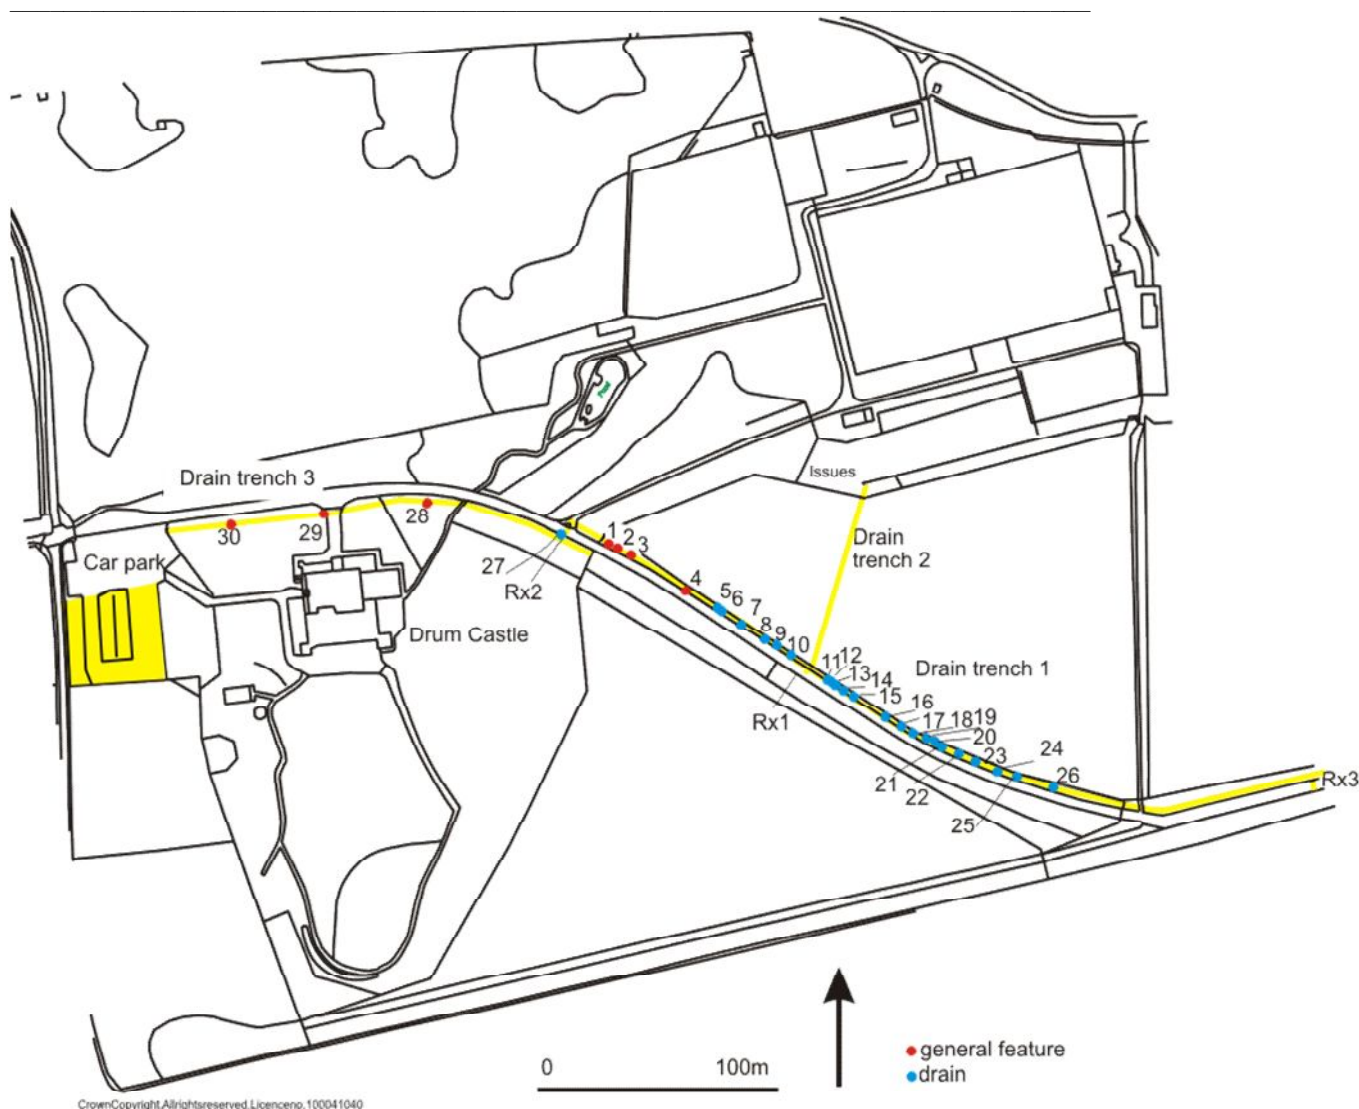
Illus 5 Plan of areas observed (yellow) and all features recorded red and blue dots). Crown copyright: All rights reserved Licence No 10004140

Location No	Work observed	GPS	Stratigraphy	Context no	Context detail
Drain trench 1	Drain trench along N side of drive from path to gardens east to road crossing 3. Width of drain trench:c.700mm Depth: c.1.2m	Extends from W side of track to garden to E end opposite road to farm W:379710,800537 E:38022,800434	Deep infill from Context 1-4. Most of trench c. 600mm loam topsoil over hard yellow natural.		
		379732,800523	100mm topsoil over 100mm redeposited natural over c.300mm grey disturbed soil,	1	Deep infill to level road side

379830,800462		15	From this point to 13 ceramic 4" field drain (broken) visible in S side of trench
		379845,800454	c.900mm below road	16	Stone drain. E/W. W:500mm
		379851,800450	c.900mm below road	17	Stone drain. E/W. W:500mm
		379854,800448	950mm below road	18	Ceramic drain (4") E/W. Functioning
		379857,800446	900mm below road	19	Stone drain. E/W. W:250mm
		379862,800444	900mm below road	20	Stone drain. E/W. W:400mm
		379867,800442	950mm below road	21	Stone drain. E/W. W:350mm
		379874,800439	900mm below road	22	Stone drain. E/W. W:300mm
		379881,800437	850mm below road	23	Stone drain. NW/SE W:400mm. Widens into soakaway c 250mm x 1.5m
		379890,800431	900mm below	24	Ceramic field drain

road		cut into earlier stone drain. E/W. W:200mm
		379897,800429	900mm below road	25	Stone drain. NW/SE. W:200mm.
		379914,800425	900mm below road	26	Stone drain. E/W. W:250mm
Drain trench 2	Drain installed from drain trench 1 extending N 80m into field to drain to burn. Trench W:400mm 700mm deep	N:379815,800475 S:379835,800551	250mm grass and topsoil over beige/yellow sandy ,silty natural		No features
Drain trench 3	Drain trench along S side of drive from opposite the path to gardens and W to car park. The E end of this trench from the manhole in the road through the arch of the courtyard to road crossing 2 was cut into an existing pipe trench and the old pipe removed. The W end from the manhole to the carpark was a new track. W:c500mm except around manhole W:<1.5m Depth: c.900mm	E end (E of manhole in archway road) W:379615,800541 E: 379721,800520 W end (across N lawn W of manhole in archway road) W: 379545,800533 E:379613,800540	Only around wall 28 was the E section away from the old pipe which ran further S. W section: Between manhole and c37m to W (379579,800536) there was c 1m deposited topsoil, mostly very clean with no slate or building debris. 1 19thC bottle base. W of this point natural rising and only c.300mm topsoil (ridge visible in grass)

379655,800546	28	Wall (details see below)
			379612,800539	29	Two water mains running N/S to below archway. Drain above pipes. Below pipes several v large natural boulders (<1.25 x0.75m). These are in disturbed context, and possibly form part of infill.
			379572,800535	30	Black alcatheane water pipe NW/SE at 700mm below grass.
Car Park	The soil strip of S end of car park was observed (35m x 35m). Levels were reduced between 200 and 350mm.	NW:379499,800504 NE:379539,800508 SW:379509,800469 SE:379543,800480	On the W edge, which was in grass, there was c 200mm topsoil over natural. Elsewhere there was c100mm		In E half a N/S fuel line and NW/SE electricity cable and 1 possible stone drain (not logged).
