**DRIVEWAY REPAIRS
CASTLE FRASER
ABERDEENSHIRE**

Archaeological Watching Brief
Carried out between April and June 2015
by
Murray Archaeological Services Ltd

Report No: MAS 2015-18
by
H K Murray and J C Murray

-Archaeological watching brief-

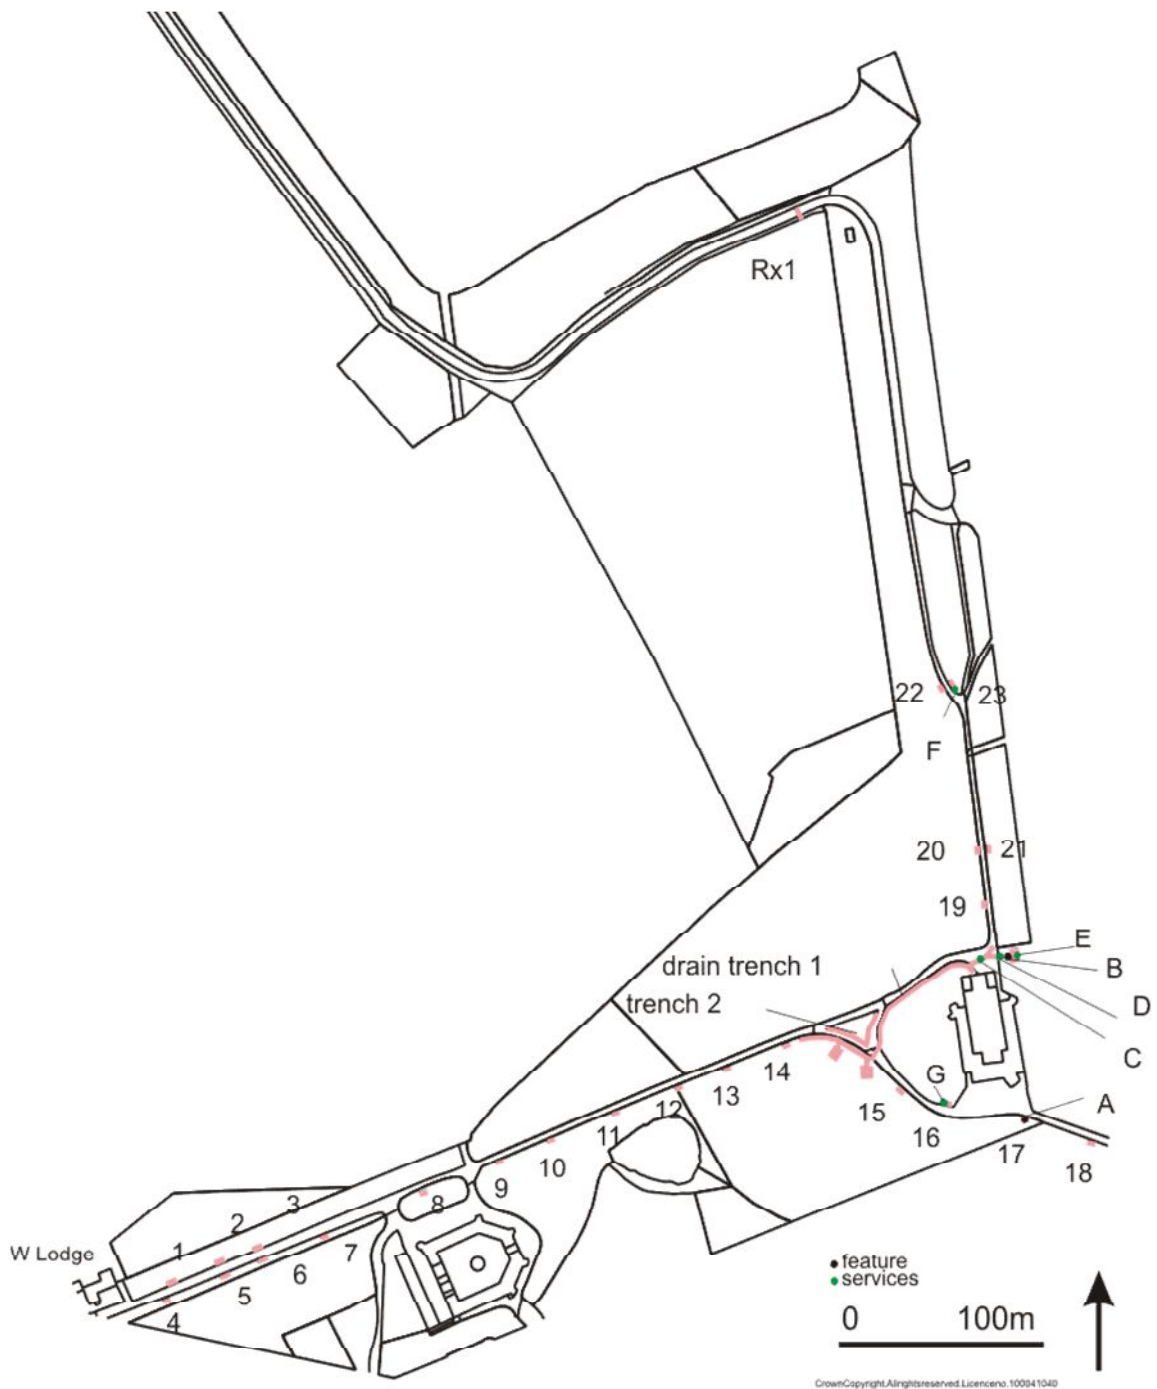
Illus 3 Plan of areas observed (pink and numbered) and all features recorded (black and green dots with letters A-G). Crown copyright: All rights reserved Licence No 10004140

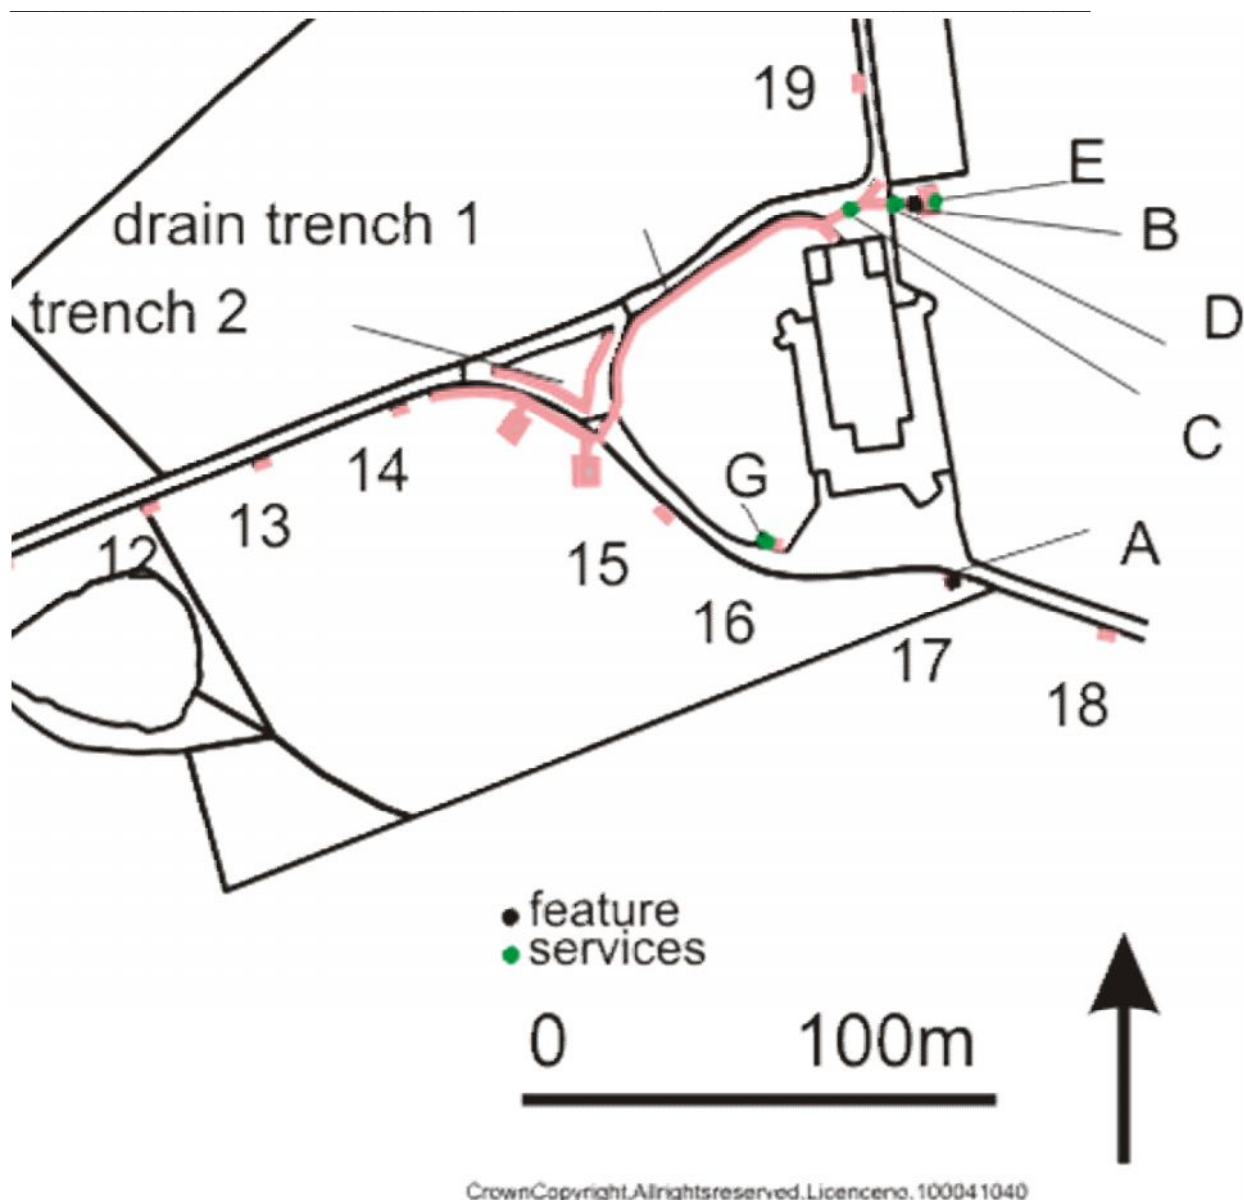
Illus 4 Detail of area near castle with areas observed (pink and numbered) and all features recorded (black and green dots with letters A-G). Crown copyright: All rights reserved Licence No 10004140

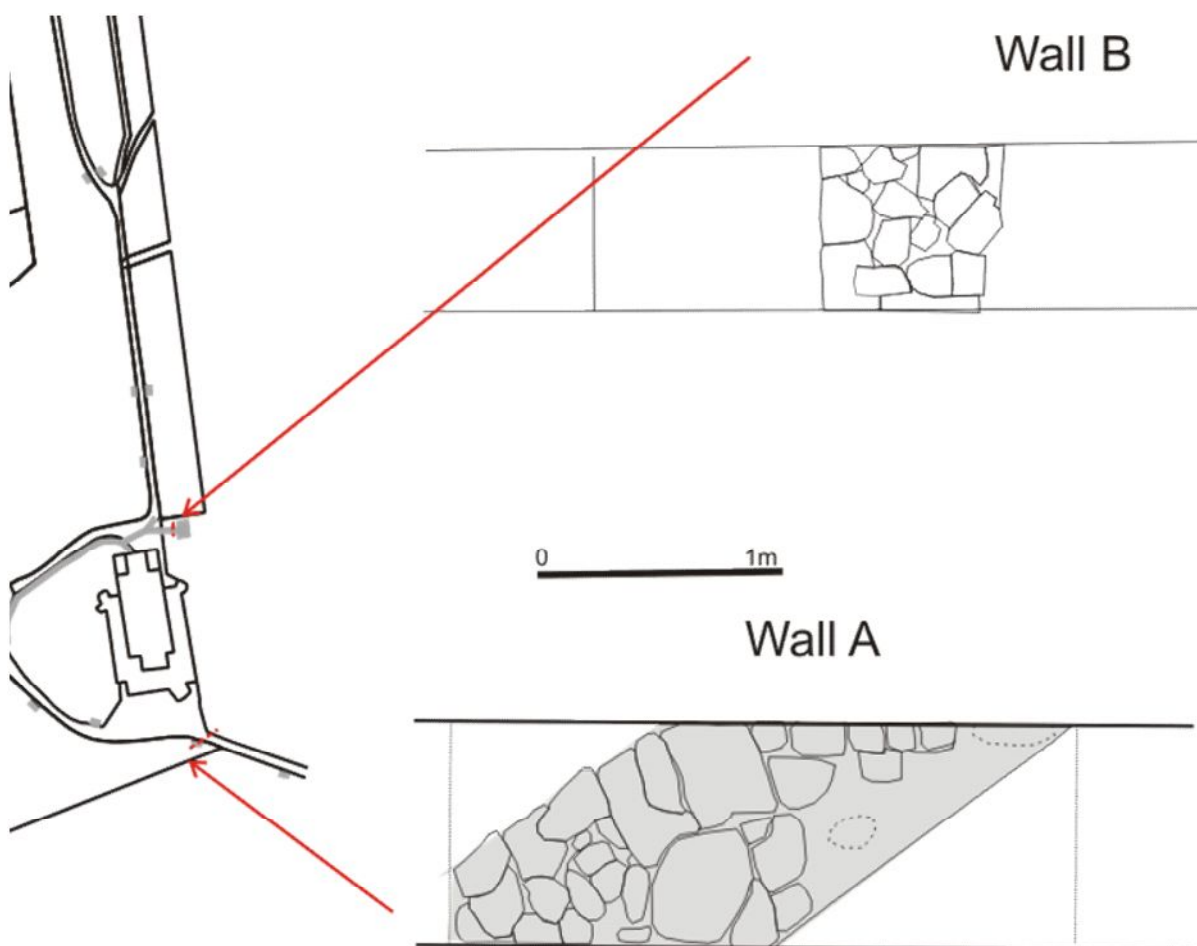
Drainage grip 15 showed only shallow (300mm) topsoil, but the three grips (16-18) S and SE of the castle all had up to 1m of deposited topsoil and rubble, indicating perhaps some of the levelling of the immediate castle environs in the late 18th century. This is likely to have happened in or around 1796 when the old garden at the E of the castle was dismantled and moved and the present landscape developed (Murray & Murray 2010). Wall A in grip 17 is not shown on the 1799 estate map or subsequent OS maps. Nor is it shown on the 1788/9 estate plan that shows the earlier garden layout. It does not appear to relate to the stone culvert found further E in 2014 during drainage works (Murray & Murray 2014). It is possible, therefore that this may be a late medieval wall.

Illus 15 Detail of plan to indicate approximate direction of each of the excavated walls (trenches shown grey in main plan)

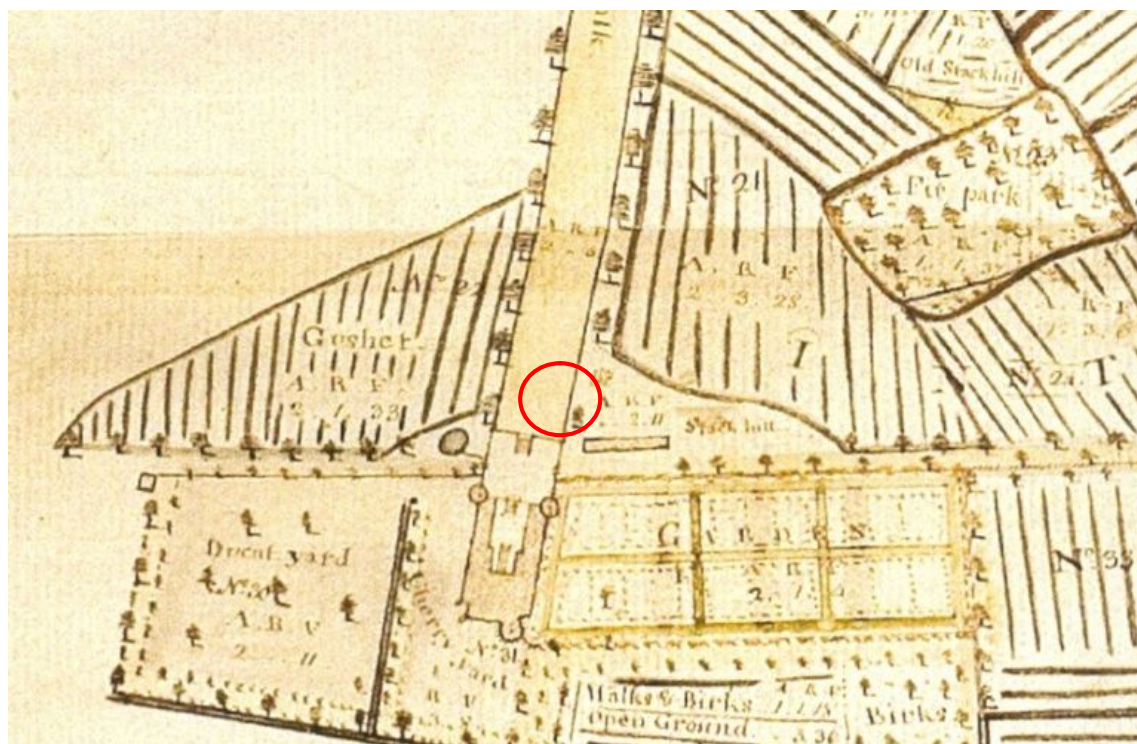
Illus 17 Detail of 1788/9 Estate Plan. © Copyright Aberdeen University. Reproduced with permission. Red circle indicates possible revetting wall.

While it is possible that wall B might be the W wall of the building/structure shown on the 1788/9 estate map in this area N of the original formal gardens (Illus 17), this seems unlikely given the fact that the natural was cut back on the W side and that the good face of the wall lay on the W. It is perhaps possible that this is a revetting wall as indicated on the 1788/9 map and still retained on the OS maps of 1864 (Illus 18) and 1899.
