GARDEN WALL PITMEDDEN HOUSE ABERDEENSHIRE

- Test pits and watching brief -
Carried out 18th -23rd March 2016
by
Murray Archaeological Services Ltd

Report No: MAS 2016-5
by
H K Murray & J C Murray

-Test pits and Archaeological Watching Brief-

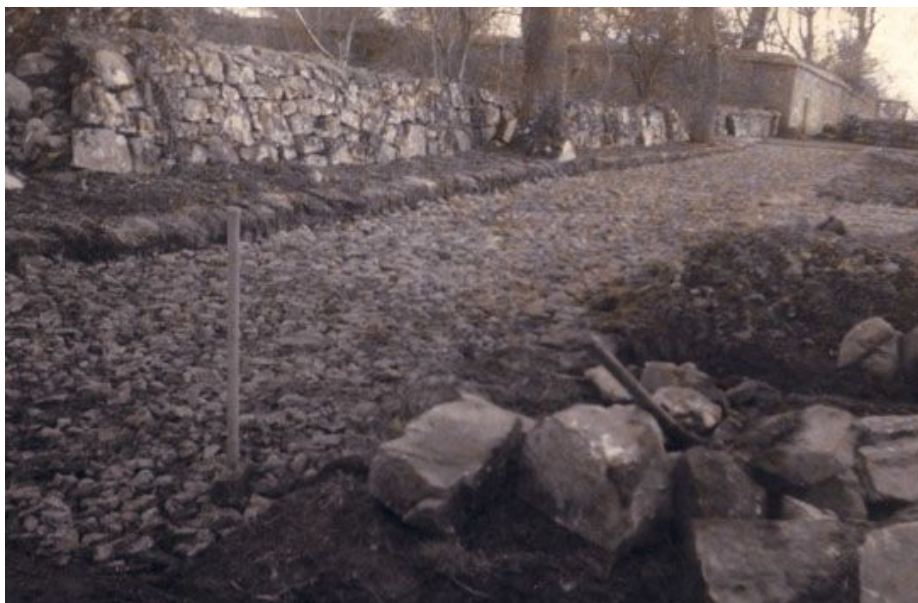
After the National Trust for Scotland took over the property in 1952, works were undertaken to allow public access. A photograph from 1957 during the creation of the car park looks along the line of the drystone dyke that formed the W continuation of the S wall line (illus 5). The gateway in the S wall and the SW corner of the wall are clear.

Illus 5 Road to car park 1957, showing the SW corner with drystone dyke continuing the S wall line W. (NTS archive photo 0340 from HLS)

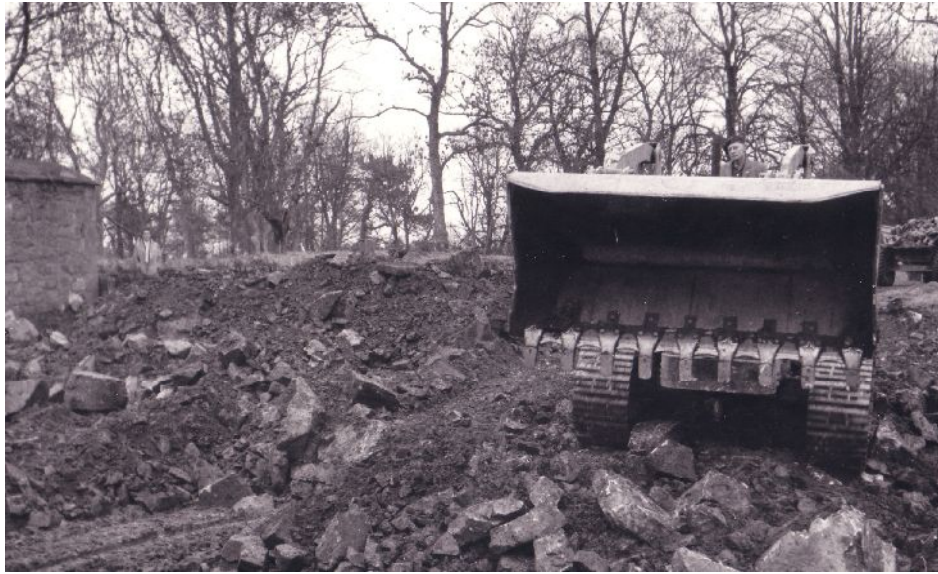
Illus 6 Major earthworks removing the drystone dyke 1961 (NTS archive photo 0366 from HLS)

Photographs from 1961 (NTS archive photos 0366, 0368 from HLS) show the removal of the drystone dyke (illus 6) and a road roller compacting the pathway alongside the W face of the W wall. The ivy has been cut away from the wall. One, possibly two, trees can be seen on the E side of the wall. The pathway appears to be gravel or similar.

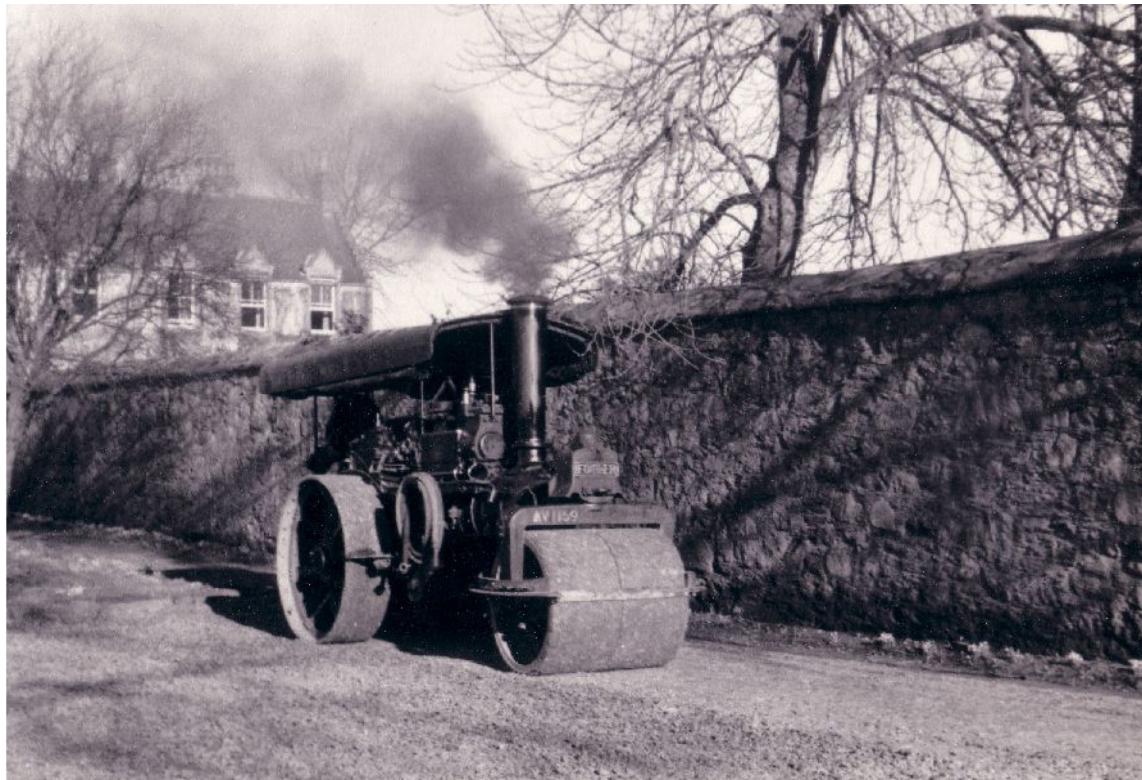
Illus 7 Road roller beside walled garden 1961 (NTS archive photo 0368 from HLS)

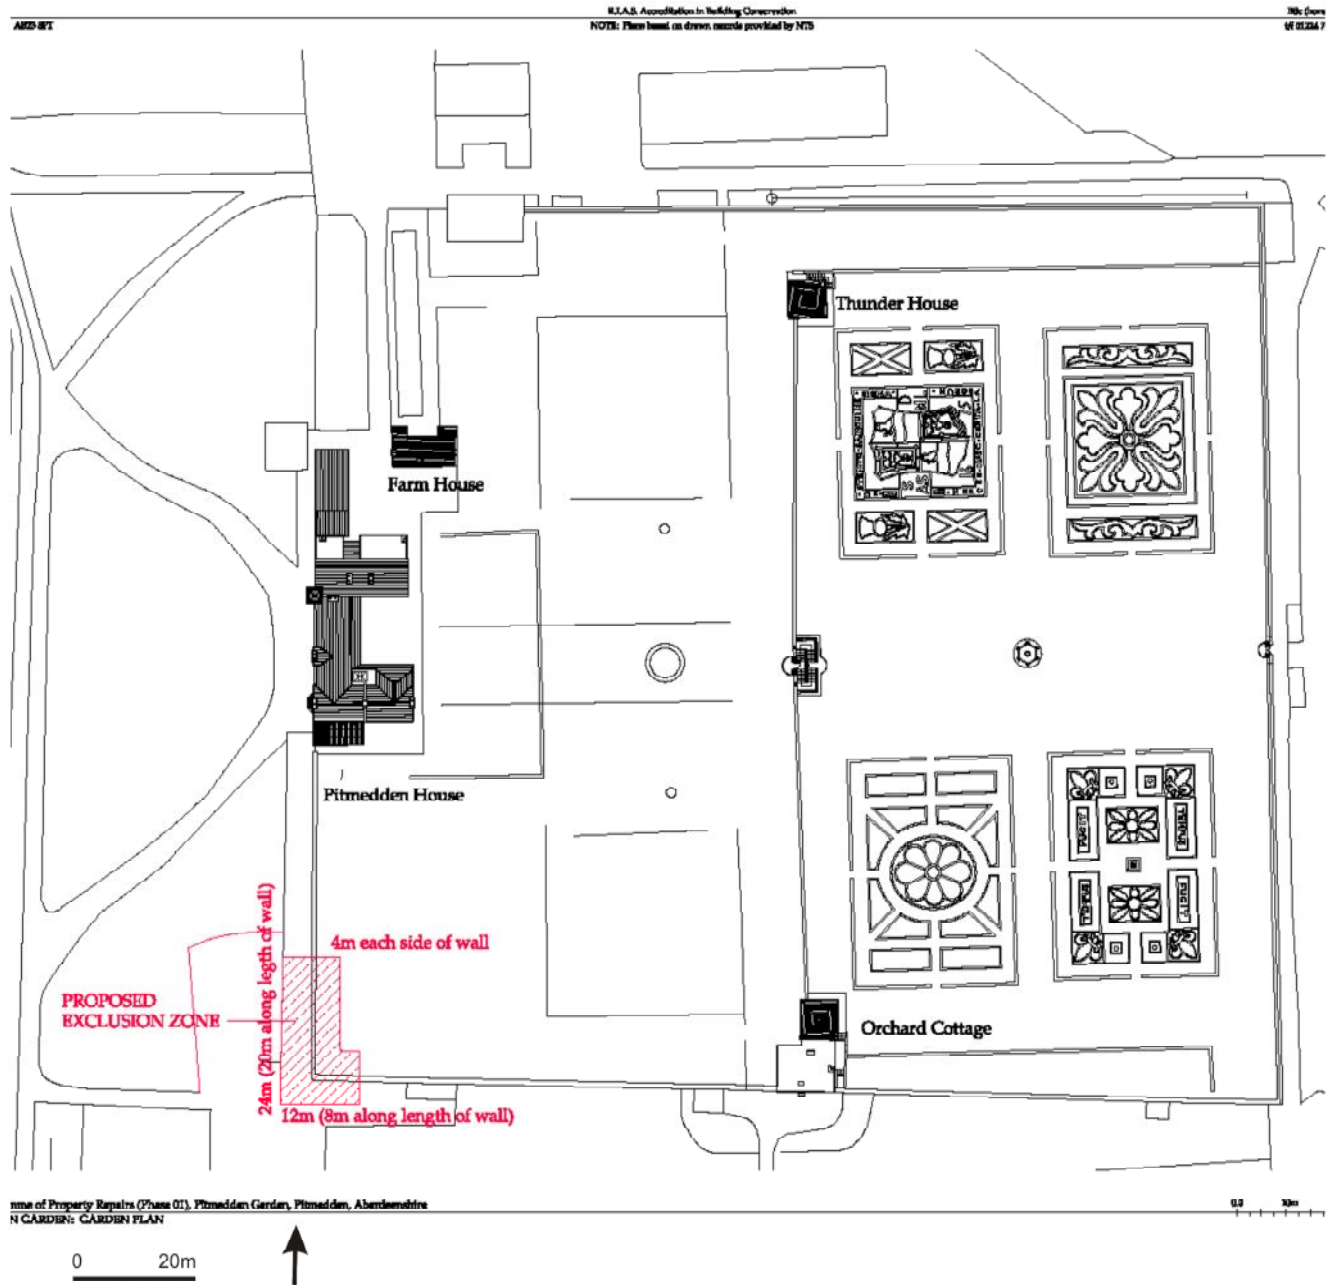
Illus 17 Location of watching brief (Plan courtesy of David Chouman).

The section of wall under consideration is the S end of the W wall from the SW corner (illus 17).

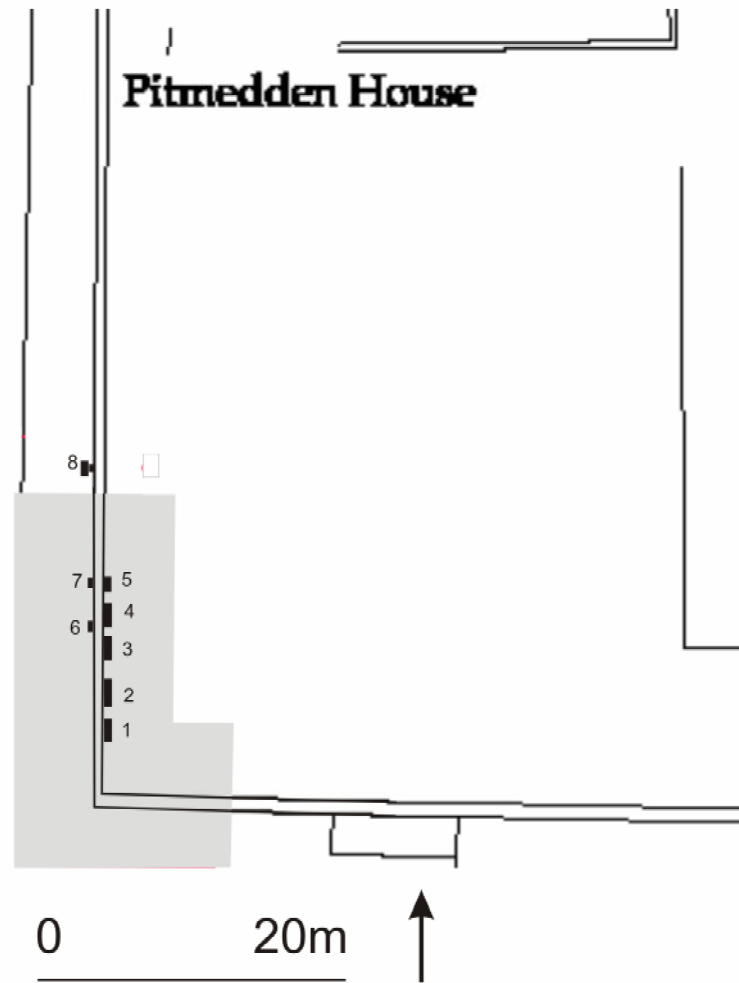
Illus 18 Location of test pits

A number of test pits (illus 18) were excavated at the base of the wall to establish the nature of the ground below the wall and the depth of the foundations. As part of the process of stabilisation, the horizontal cracks in the inner face were wedged while pressure was placed on the outer face of the wall to straighten it; photographs were taken at the beginning of this process.
