**DRAINAGE  
DRUM CASTLE  
ABERDEENSHIRE**

**Archaeological Watching Brief**  
Carried out between October and November 2016  
by  
**Murray Archaeological Services Ltd**

**Report No: MAS 2016-27**  
by  
H K Murray

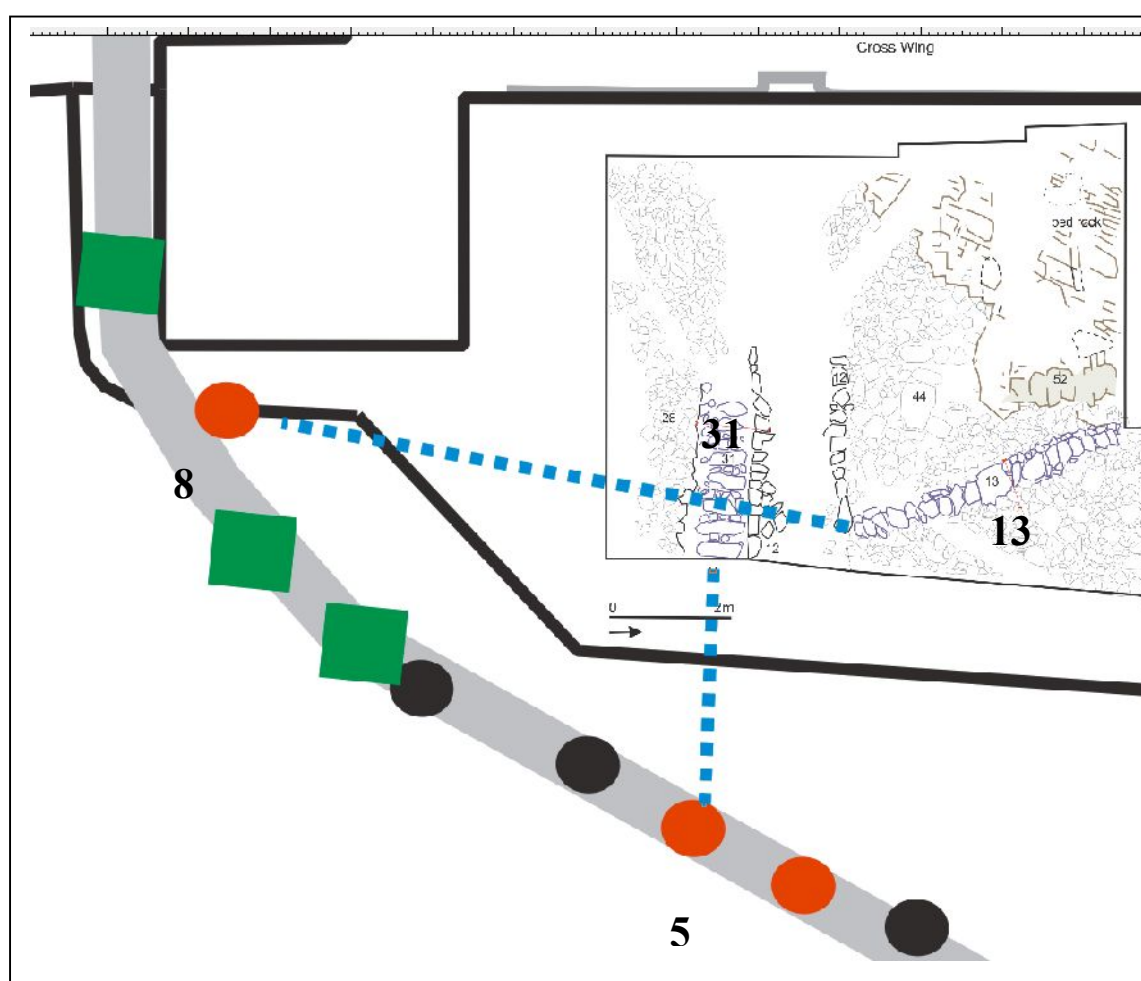
Illus 3 Features recorded in 2016 set against plan of features excavated in 2014

A stone drain ran SW/NE obliquely across line of earlier trench for c 800mm. It had been destroyed on the trench line (although the line of its cut was visible across the base of the trench) and was only clear in the W section. The capstone on the W side of the earlier trench was sealed by 150mm of topsoil. The drain was c. 300mm wide and c 300mm deep set in a cut in natural c 900mm wide. The base of the drain was 400mm below the present surface. It was not possible to get a full section of the drain. It may be a continuation of the V-shaped drain (31) excavated to the W in 2014 (illus 3) although this is uncertain as drain 5 appears to be smaller in internal dimensions than 2014 drain 31 (Murray & Murray 2014, 27, 57).

This may equate to drain (13) excavated to the N in 2014 (Murray & Murray 2014, 25, 54) which was of similar size and construction (illus 2).

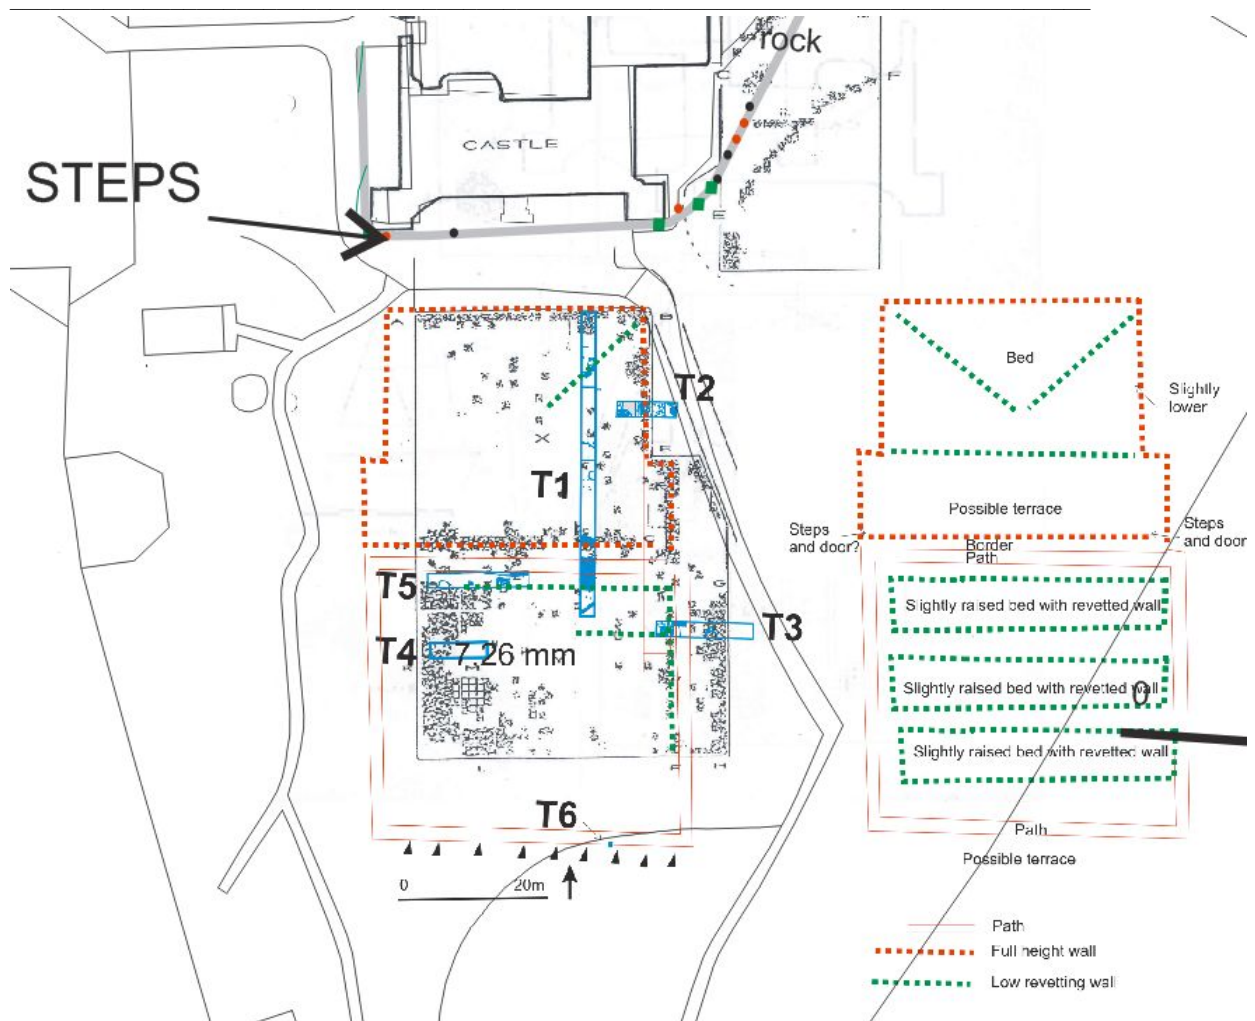
Illus 22 Steps in relation to garden excavation in S lawn (Murray & Murray 2008,illus 21)

They may relate to the formal 17<sup>th</sup>-century gardens, although it may appear an odd direction from which to approach the garden at that period.

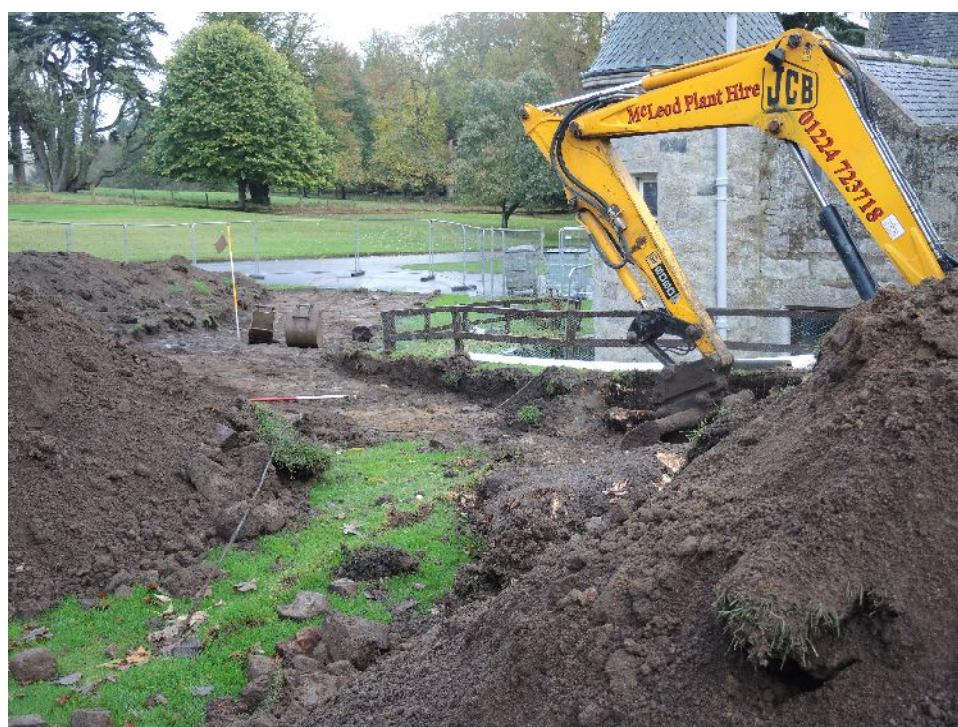
**Illus 27 General view , N of path, looking N to drive**

There is still considerable potential in all of this area and interventions in this area should be monitored.
