BEVAN HOUSE, CRAIGHOUSE, EDINBURGH

ENHANCED BUILDING SURVEY

September 2015

DATE ISSUED:	September 2015
JOB NUMBER:	CP11336
OASIS REFERENCE:	wardella2- 223687
REPORT NUMBER:	RPT-001/1
GRID REFERENCE:	NT 2335 7068

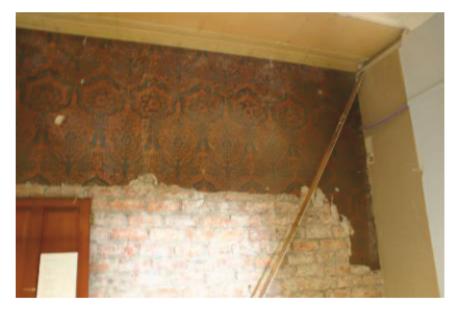
- 4.4.3 *R 10:* Previously part of the hallway, some possible remains of the original wall plaster, coloured red and black and gold, have been uncovered on the west elevation (Plate 12), previously hidden by a wall unit. The classical style coving is present for all elevations.

Plate 12: R 10, detail of wall covering.

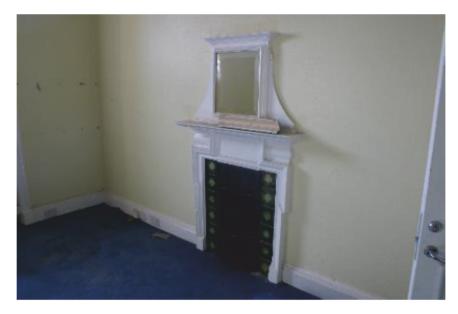
- 4.4.6 *R 13:* This large room used to be two rooms (Plate 13). Remains of the partition wall (north to south) are still visible; one doorway has been blocked on the western elevation. The room was only partly accessible, as water damage effected the structural stability of the flooring. The two chimneypieces are of the same design, but differ in the tiled fire surround. One fire surround contains blue-green tiles with floral decoration (Plate 14), while the other is comprised of white tiles with yellow and green floral décor.

Plate 14: R 13, detail of chimneypiece.

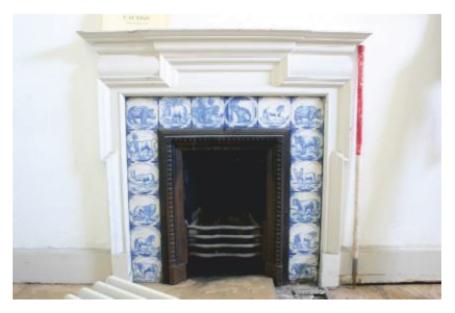
4.4.11 *R 18:* A medium sized room with classical coving. The chimneypiece of R 18 is of a distinctive style (Plate 17). The hand painted fire surround tiles of the fireplace on the west elevation, featuring different animal motifs, are of particularly high quality.

Plate 17: R 18, detail of chimneypiece.

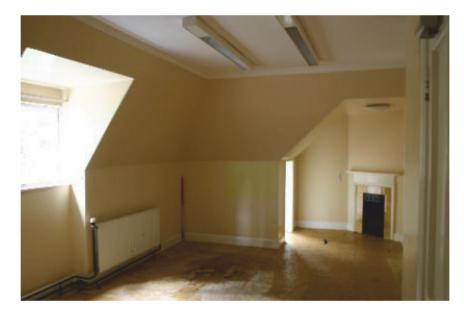
Plate 18: R 24.

- 4.5.7 R 23: No further archaeological material is visible.
- 4.5.8 *R 24:* This room is set apart slightly in its appearance. In the south-west corner a small door opens into a small space with a 12 light, timber framed French window in its west elevation (Plate 18 and 19). It is opposed by a slightly larger than usual chimneypiece in the north-west corner. It is likely that the distinctiveness of this room and similar room R 24 sets them apart as having had higher status occupants than rooms R 20 to R24 and possibly R 26.

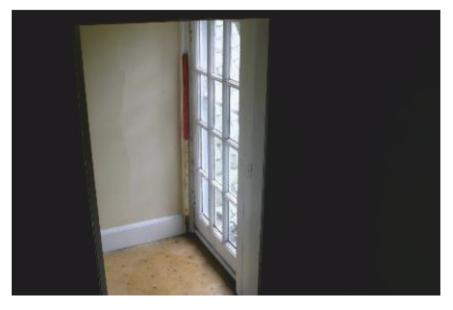
Plate 19: R 24, detail of window.

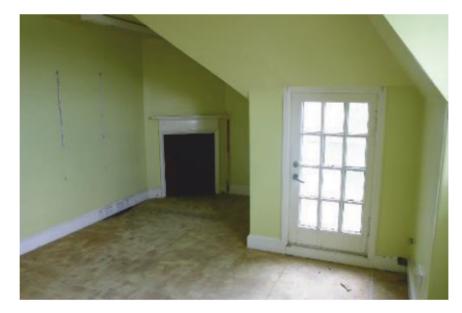
Plate 20: R 25.

- 4.5.9 *R 25:* The room is similar to R 24 in its floorplan, with a French window in the northern west elevation (Plate 20).
- 4.5.10 *R* 26: The room is mostly blocked by the modern water tank. No further archaeological material is visible.

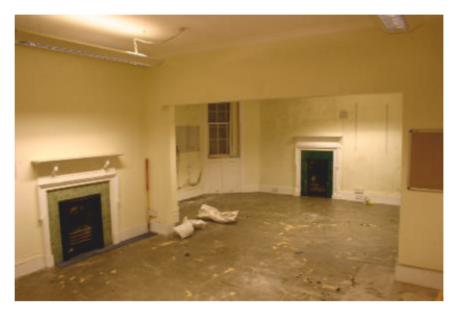
- 4.5.13 *R 28*: has the same layout as R 13, incorporating two original rooms (Plate 21). The two chimneypieces are of completely different styles. The first consists of a simple white mantel with mantelshelf, large green glazed brick/tiles fire surround and a simple cast iron fireplace. The second one is slightly larger, with a white timber mantel with neo-classic ornamentation, a light green tiled fire surround with floral/ vine elements, and a cast iron fireplace with egg dart element.

Plate 21: R 28, general view.

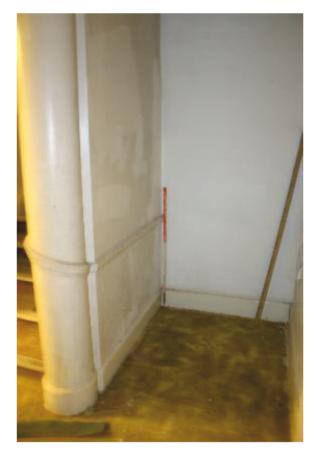
- 4.5.11 The basement floor is heavily effected by mould infestation and damp in all rooms.
- 4.5.12 *R 27:* An important feature is the blocked entrance to the tunnel system to the north of the elevation of the hallway, next to the staircase to the upper level (Plate 22). No

Plate 22: R 27, blocked up entrance to tunnel.
