**HAUSE GILL, SEATOLLER, BORROWDALE, CUMBRIA**

**Measured Photographic Survey**

**DATE ISSUED:** July 2016  
**JOB NUMBER:** CP11842  
**OASIS REFERENCE:** wardella2-259291

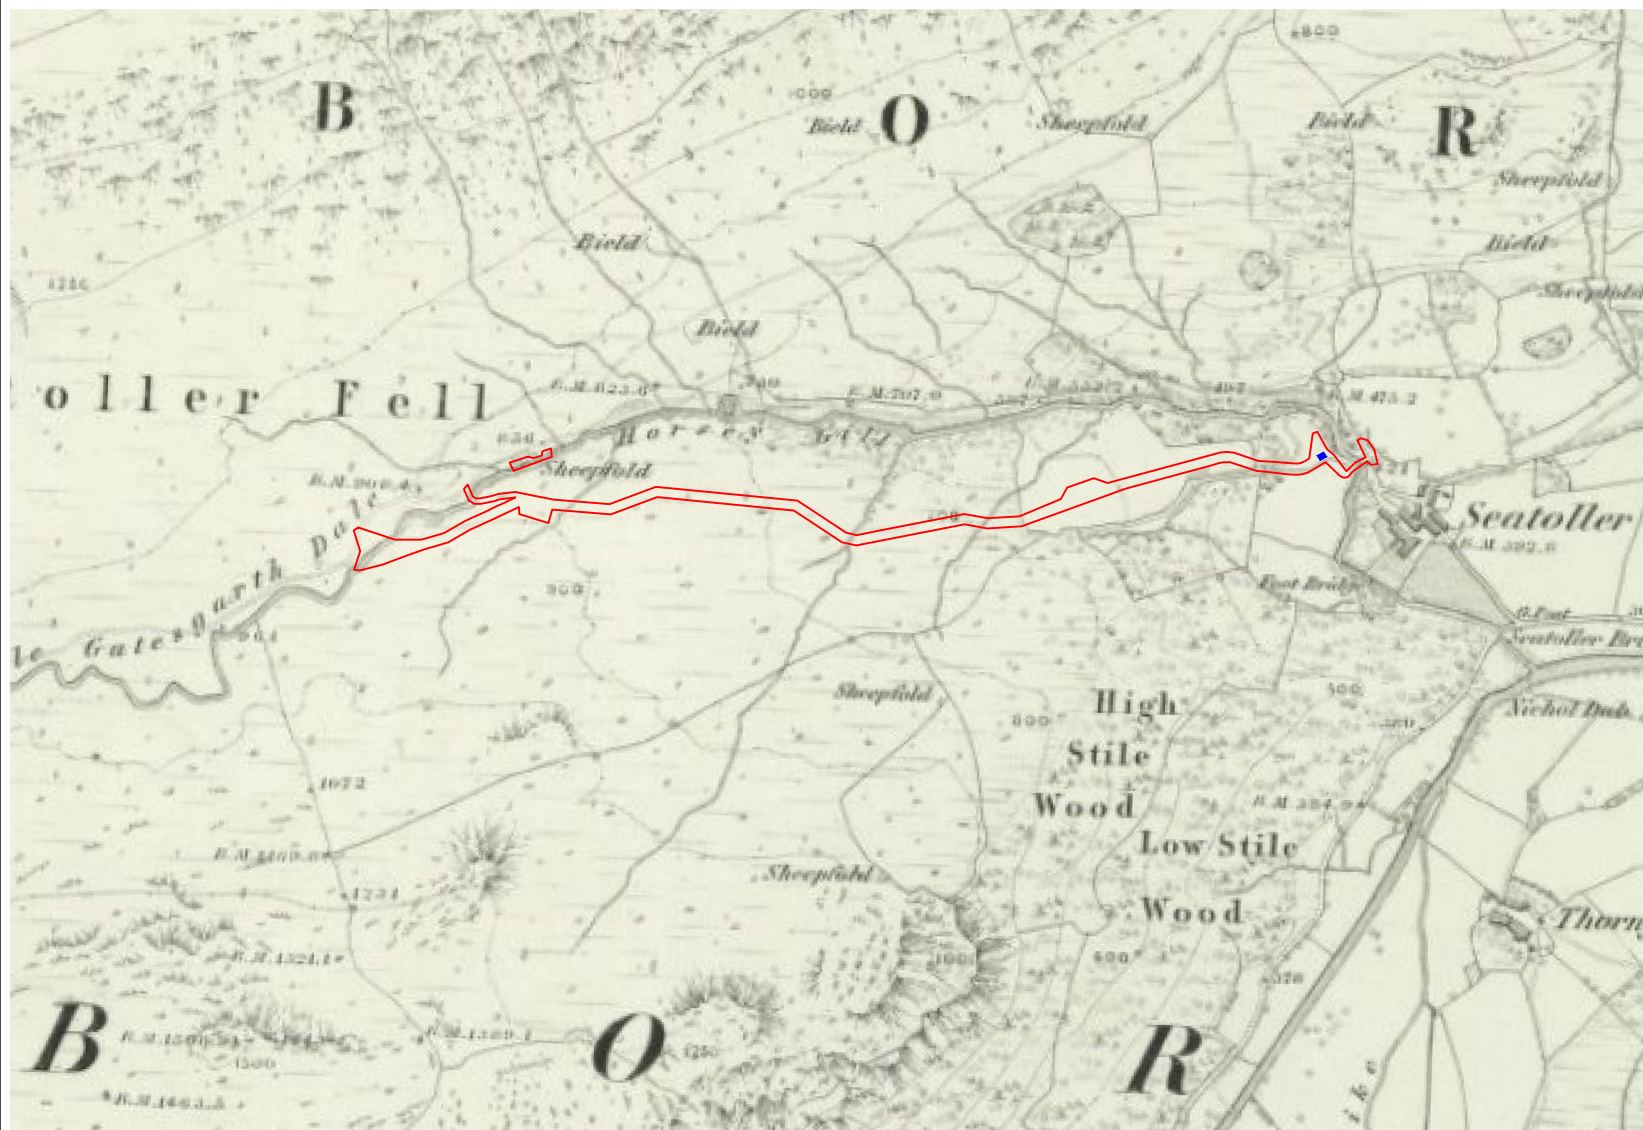
Figure 3: First Edition Ordnance Survey Map, 1862 (1 foot to 80 chains).

4.4.1 On the 1862 First Edition Ordnance Survey Map (Figure 3), the ruinous building is depicted as a rectangular structure at the east of the site. No indications are given to the existence of the quarry, cairn, fields and sheepfold.

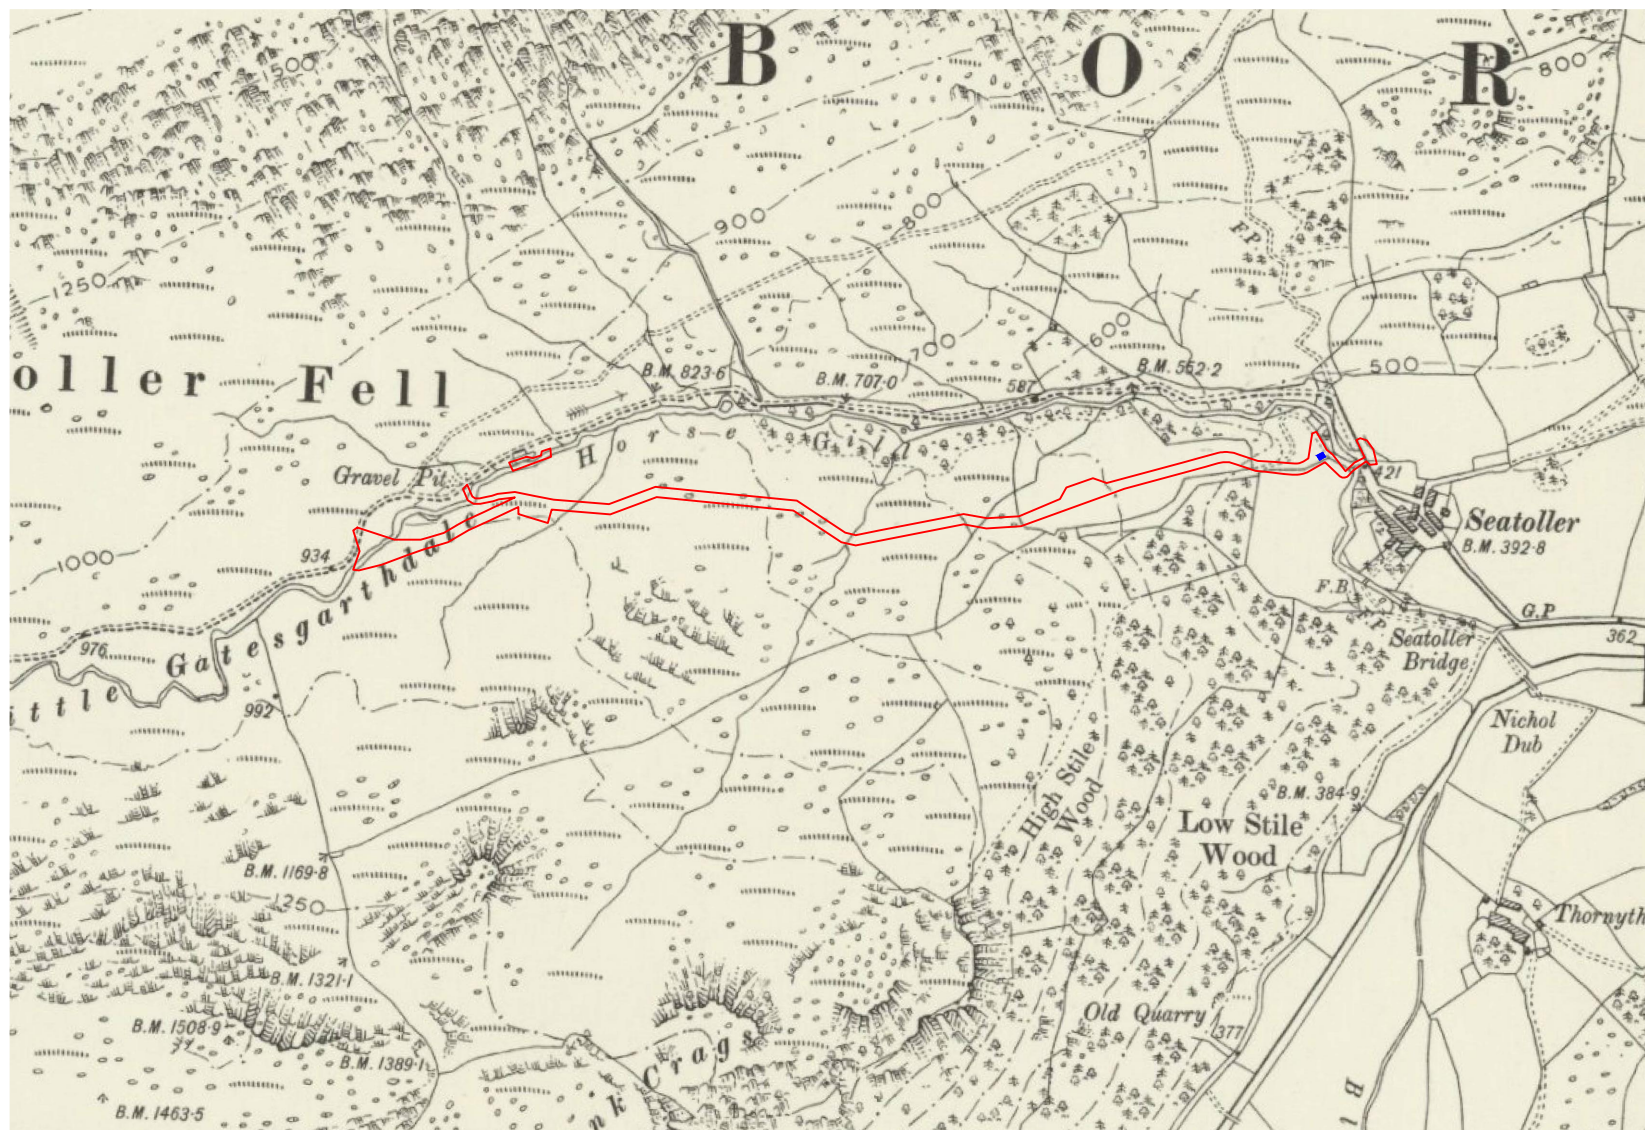
Figure 4: Second Edition Ordnance Survey Map, 1897 (6 inches to 1 mile scale).

4.4.2 A similar situation is shown on the 1897 Ordnance Survey Map (Figure 4). By this time, the sheepfold had been built as a U-shaped structure with a north to south aligned extension to the south.
