**FORMER CARRS BILLINGTON PREMISES,  
23-25 HIGH STREET,  
ANNAN**

**Archaeological Building Survey report**

**DATE ISSUED:** February 2018  
**JOB NUMBER:** CL12092  
**OASIS REFERENCE:** wardella2-308485  
**PLANNING APPLICATION REF:** 17/2051/FUL and 17/2052/CAC

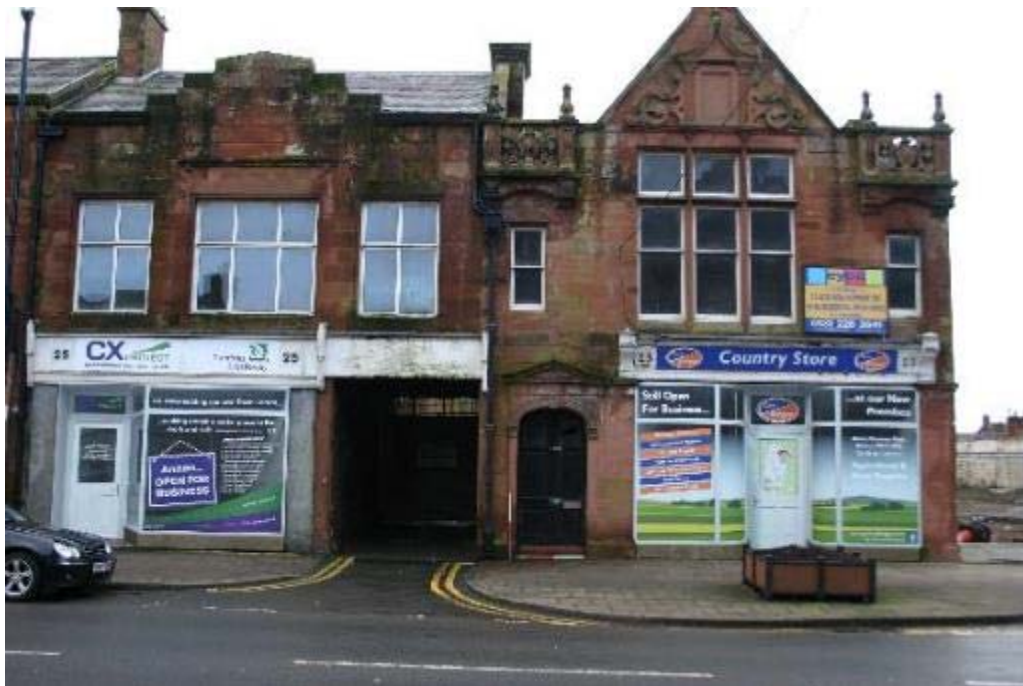
Plate 1: North facing elevation of No 23 and 25

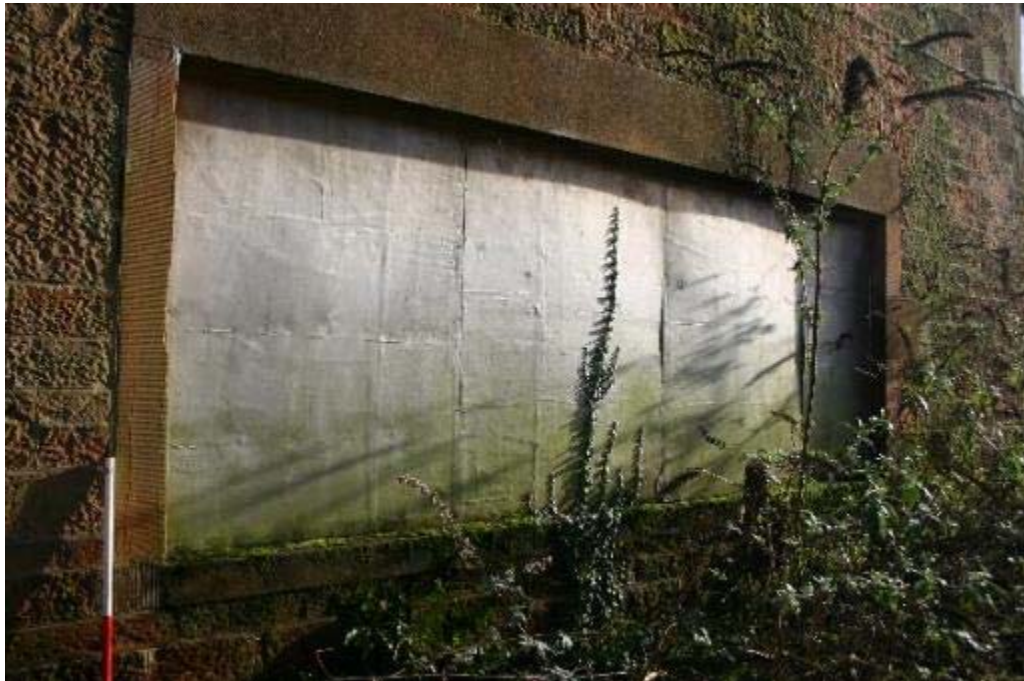
Plate 15: West facing elevation, boarded up large window front at No 25

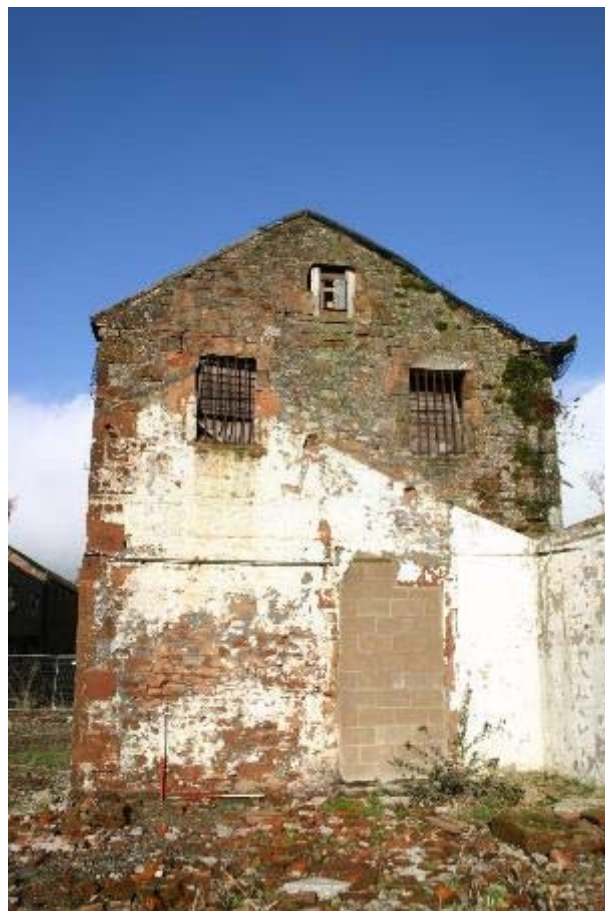
Plate 23: South facing elevation of No 25 with roof scarring

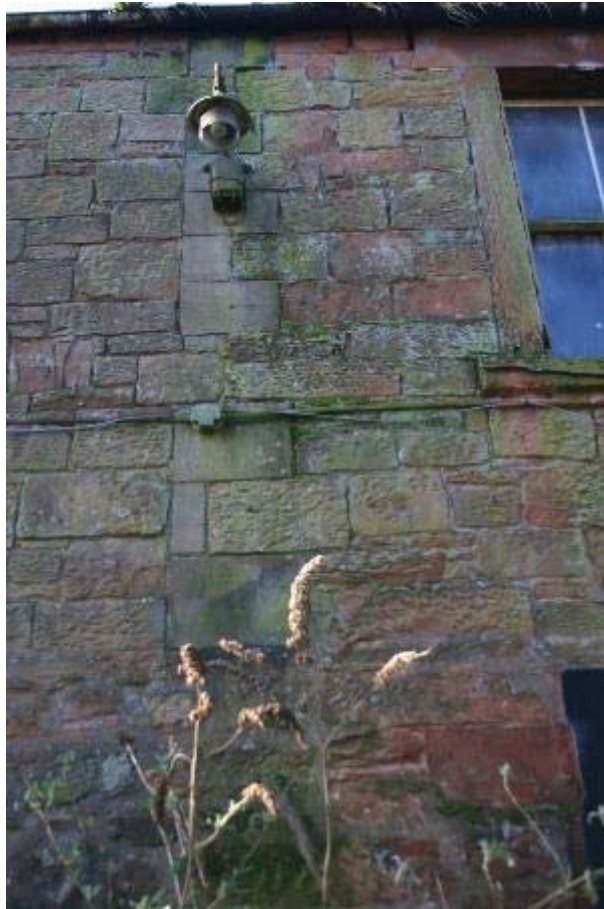
lamp of possible early to mid-modern date, with modern alterations to fit a new style of lightbulb (Plate 26). A doorway underneath the interconnecting first floor gives access to the building.

Plate 26: East elevation, visible break in fabric and modernised historic lamp at No 23

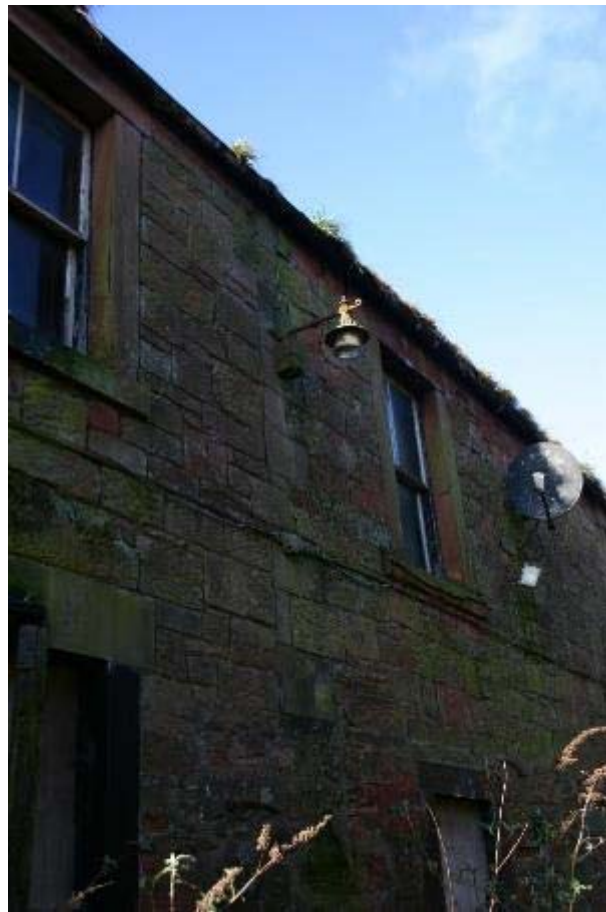
Plate 27: East elevation, visible break in fabric and modernised historic lamp at No 23

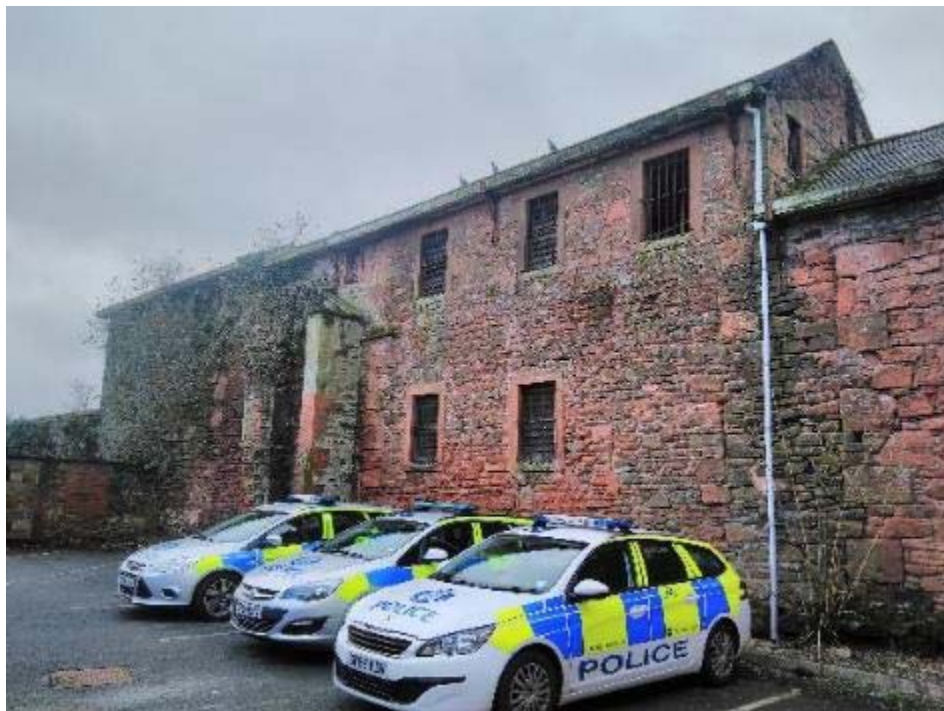
4.2.13 The east facing elevation of No 25 is mostly blocked by the neighbouring police station. However, some parts were visible along the police car park (Plate 30-32). It shows the east facing elevation of the in 4.2.8 mentioned older southern structure. There is a visible disturbance where the lower structure meets the taller structure to the south, and around the two windows at the ground floor level. Two buttresses are located at the southern structure. There is noticeable roof scarring from a demolished structure along the elevation. There is a possible break in the fabric, which could not be seen on the west facing elevation. A further four windows with metal bars are situated at the first floor level.

Plate 30: East facing elevation of No 25 from police car park

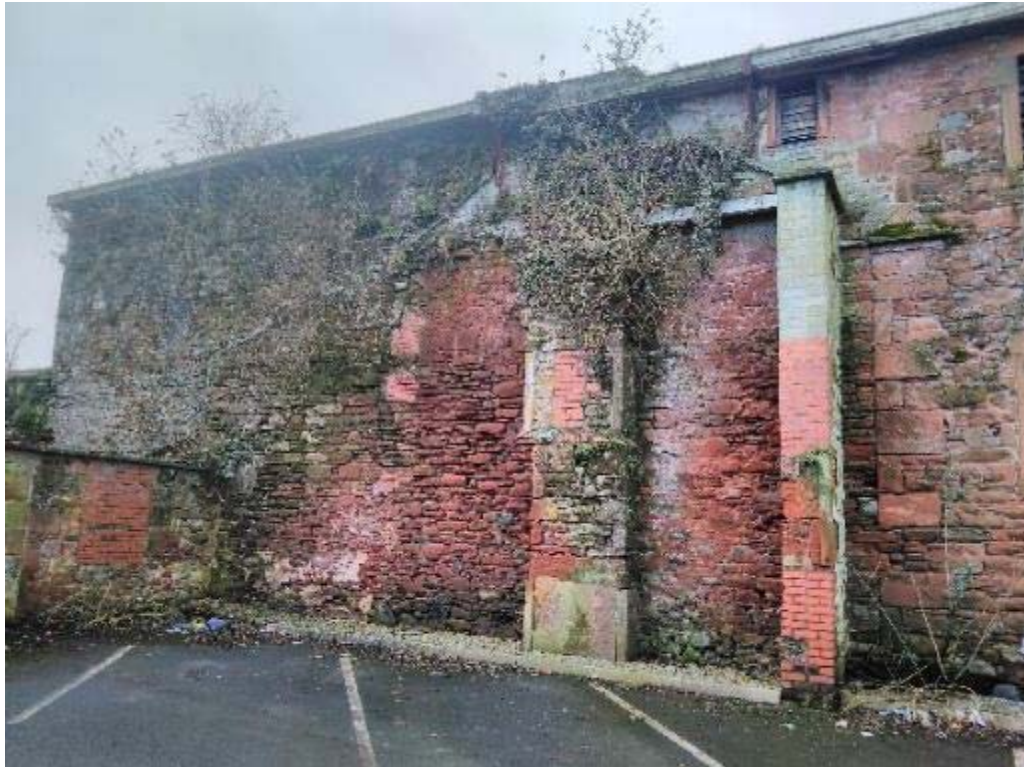
Plate 31: East facing elevation of No 25 from police car park

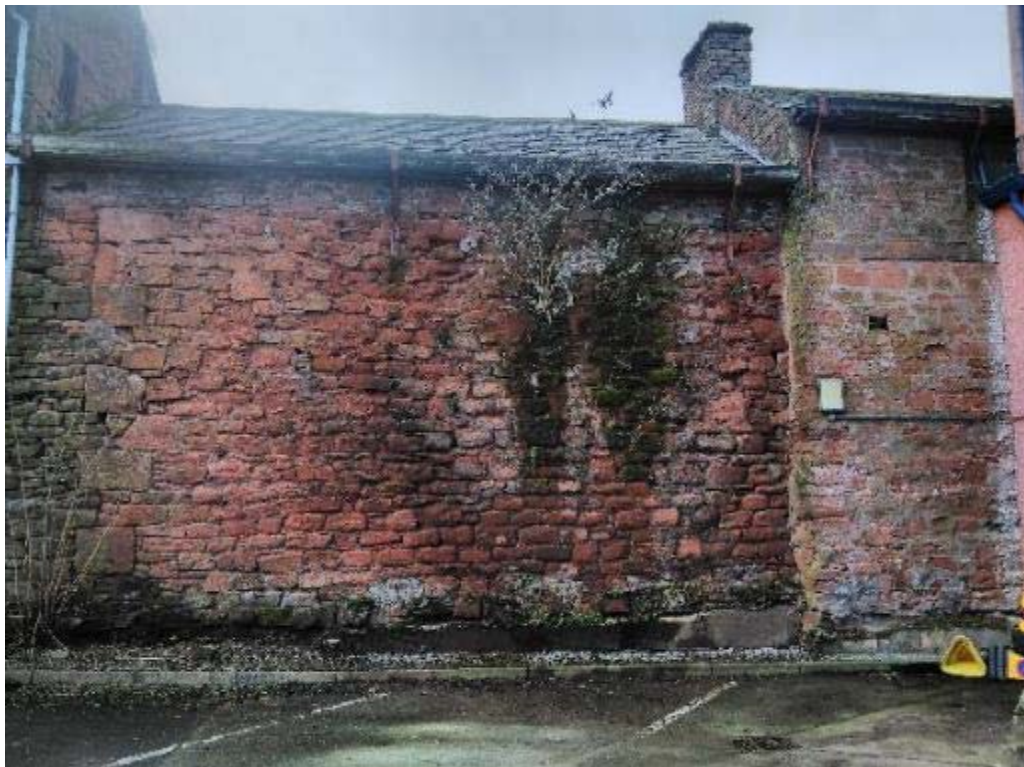
Plate 32: East facing elevation of No 25 from police car park

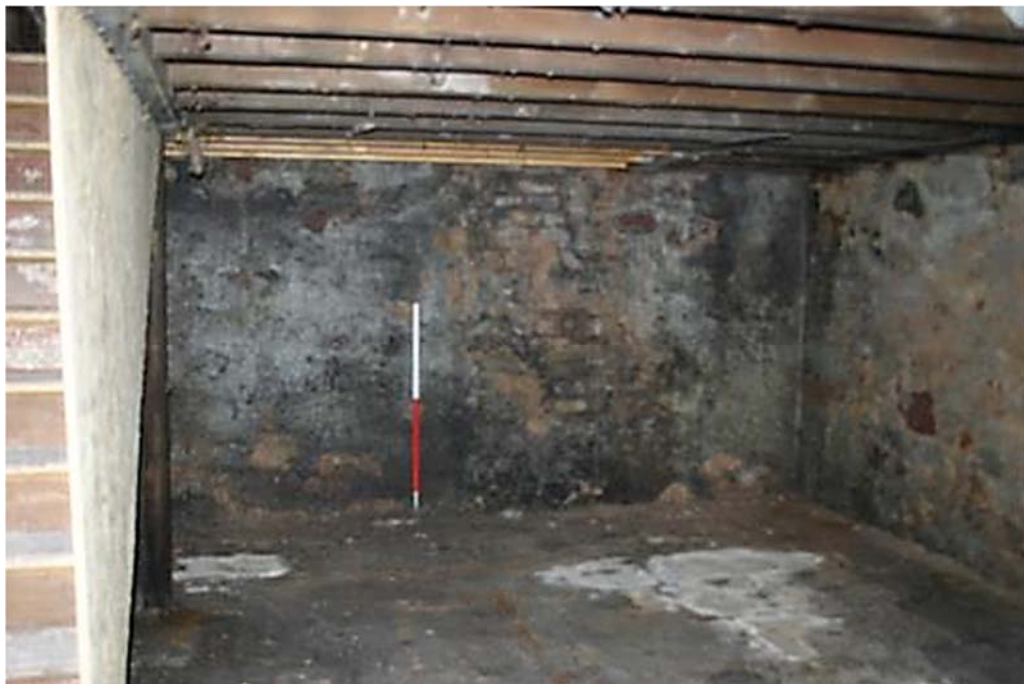
- 4.3.2 *Cellars:* Below the northern structures of both No 23 and No 25 are cellars. The cellars of No 23 were accessible via an inserted timber staircase at GF5. The cellar comprised two rooms interconnected with a hallway (Plate 33 and 37). The cellar is paved with flagstones (Plate 35), while the elevations show remnants of several layers of paint. Within the hallway are the remnants of the original staircase into the cellar (Plate 36). Only one and a half flights of stairs are still present. Parts of the ceiling (flooring of GF5) were replaced due to moulding and decay of the timber (Plate 34).

Plate 33: Southern cellar room of No 23

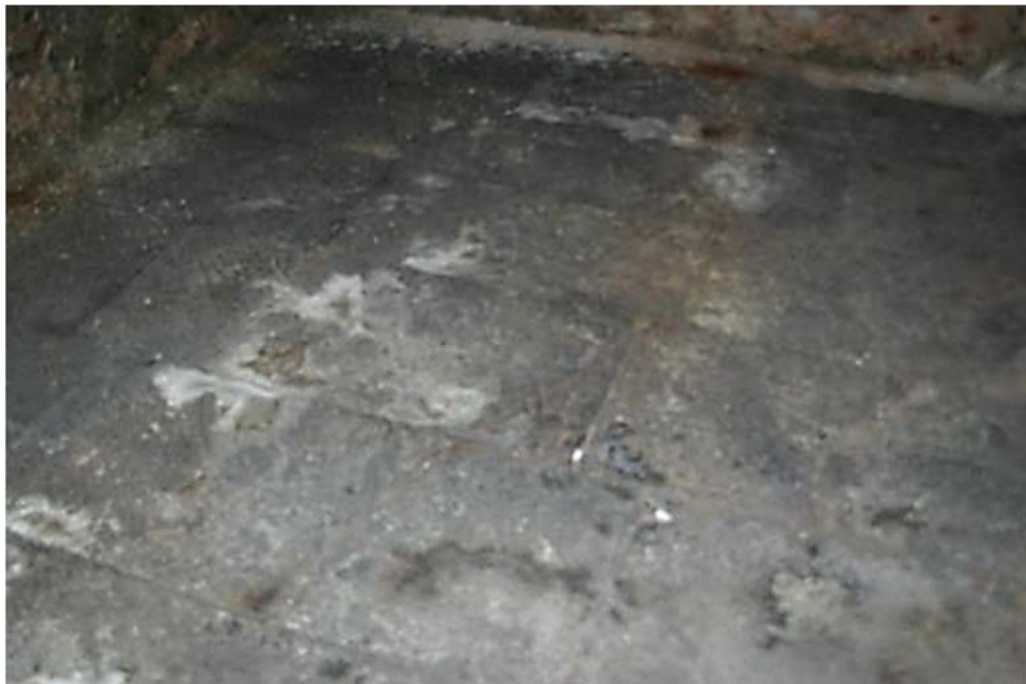
Plate 35: Cellar flag stones in southern cellar of No 23

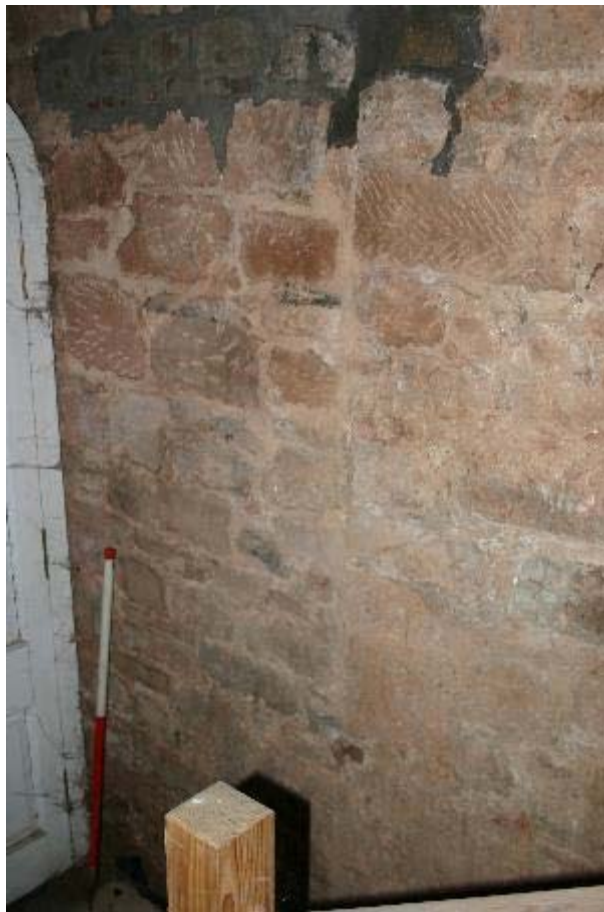
Plate 39: No 23, GF1 blocked off opening

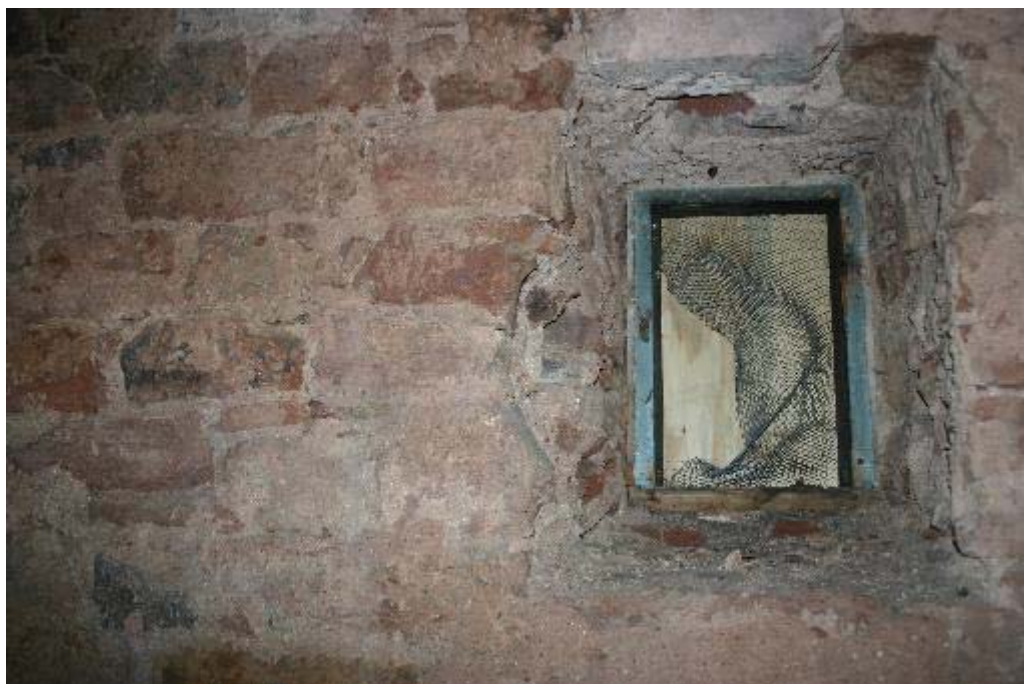
Plate 40: No 23, GF1 boarded up small window at east elevation

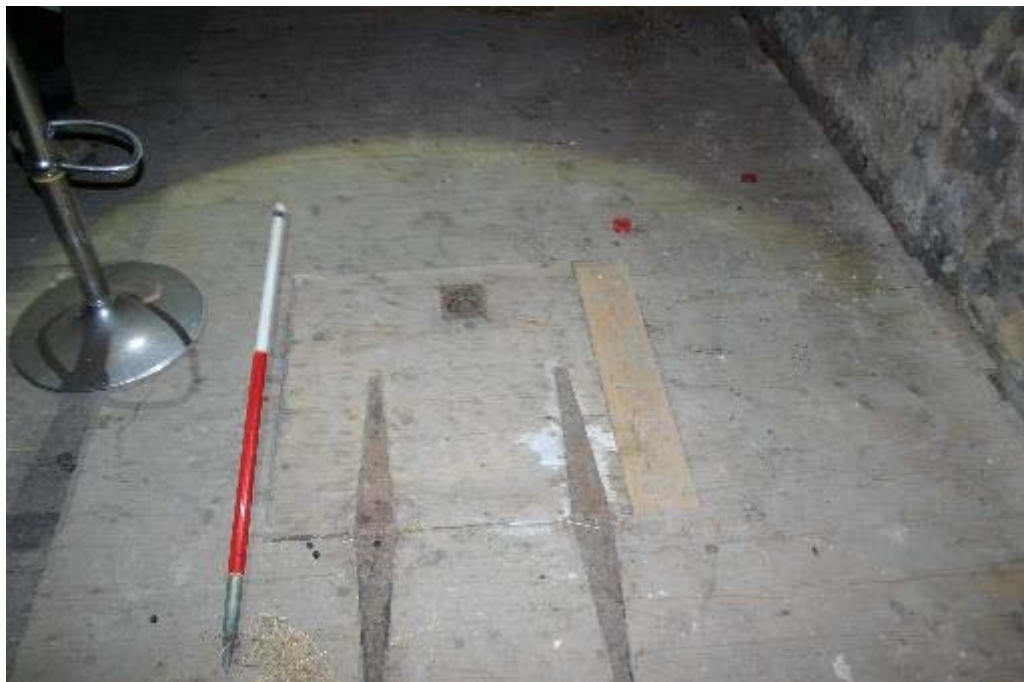
- 4.3.3 The cellars below No 25 were accessible via a small hatch and ladder (Plate 42). They were not accessed during the course of the survey.

Plate 42: No 25, GF2 hatch towards the cellar

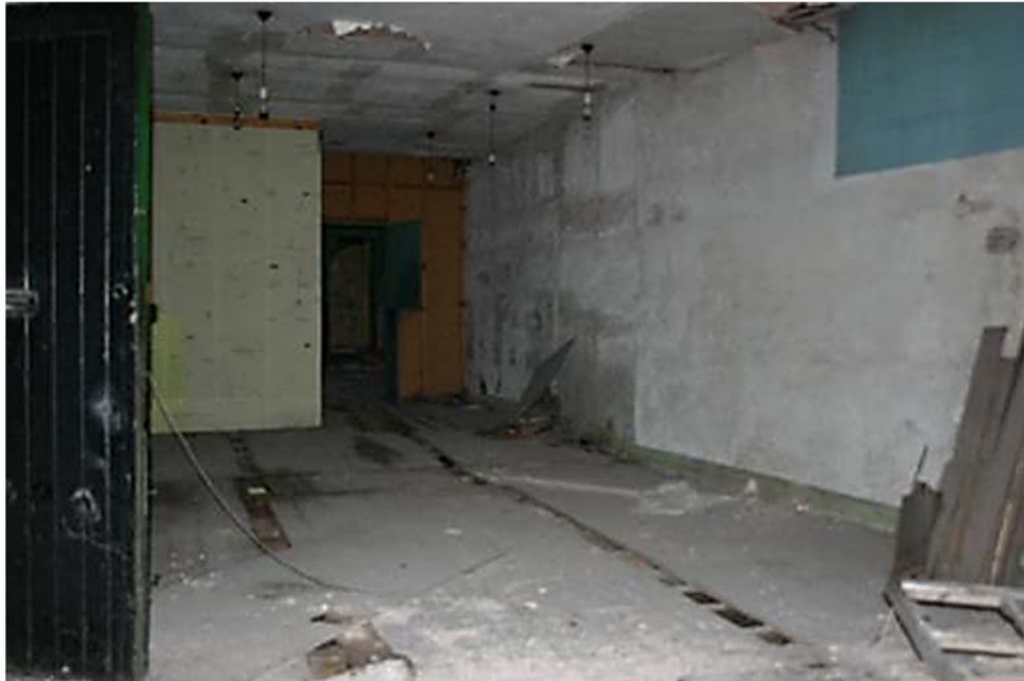
- 4.3.10 *GF6*: This room was accessible via a doorway at the south elevation of GF5 (Plate 57). Due to the bad condition of the interior structures, the room was not entered during the survey. Parts of the floorboards were missing (Plate 58), as was a section of the ceiling. It is an elongated room, with a modern partition wall at the southern end.

Plate 57: No 23, GF6 general view

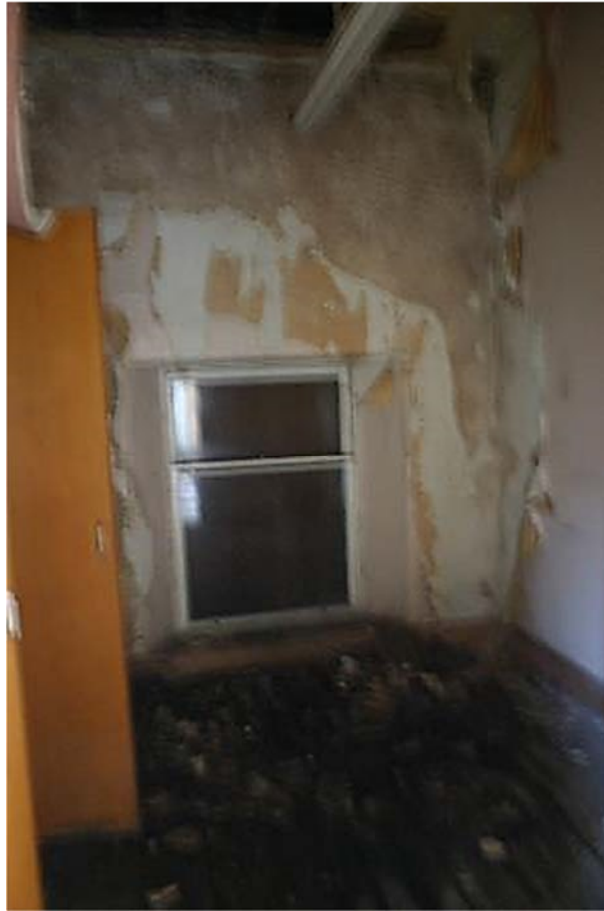
- 4.3.14 *FF3*: This small room was not accessible due to water damage. On the west elevation, the upper level of the boarded up staircase window noted in *GF5* can be seen (Plate 64).

Plate 64: No 23, view into not accessible FF3 with blocked off staircase window

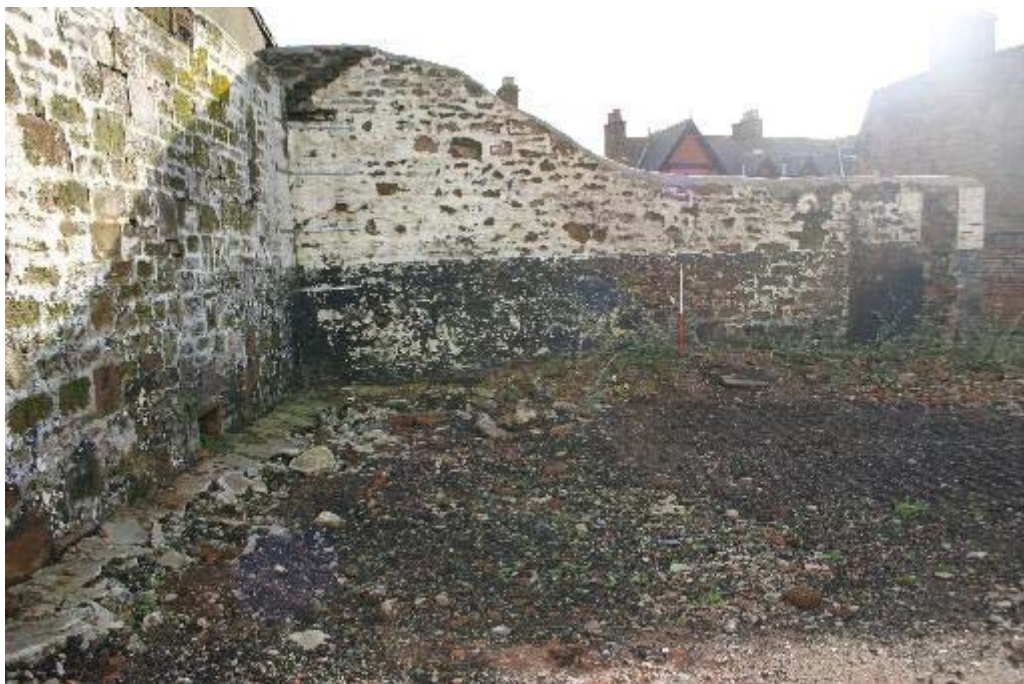
- 4.4.4 This eastern boundary wall interlocks with the eastern section of the southern boundary wall, the upper level of which curves downwards to the west (Plate 89). The entire southern boundary wall comprises roughly coursed sandstone masonry, which in recent times had been painted black and white (Plate 90).

Plate 89: Eastern section of southern boundary wall

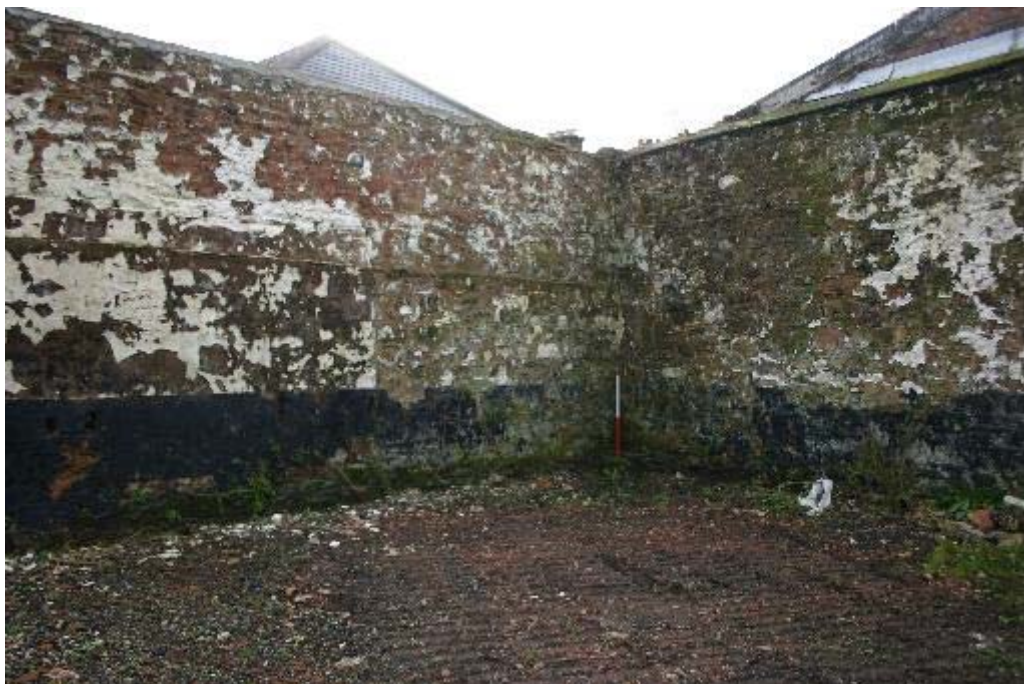
- 4.4.5 This wall is interconnected with the southern end of the western boundary wall (Plate 91), which is of a contemporary style as the south elevation (Plates 92 and 93). Some brick repair works are visible at various places of the boundary wall. The northern end comprises a modern concrete and brick wall (Plate 94).

Plate 91: Corner of southern and western boundary wall

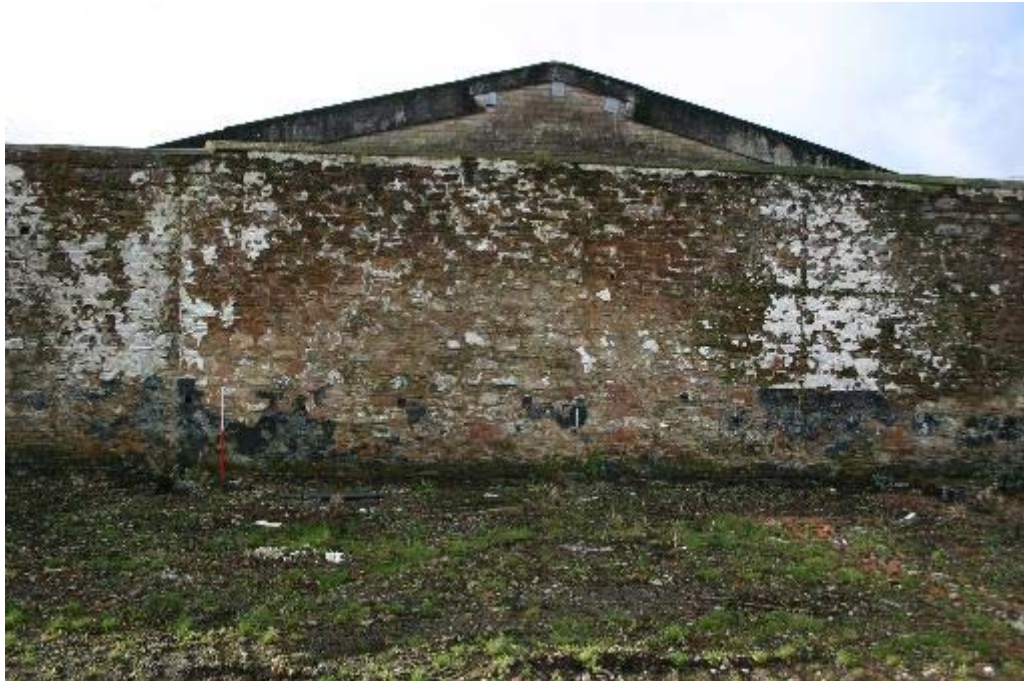
Plate 92: Western boundary wall

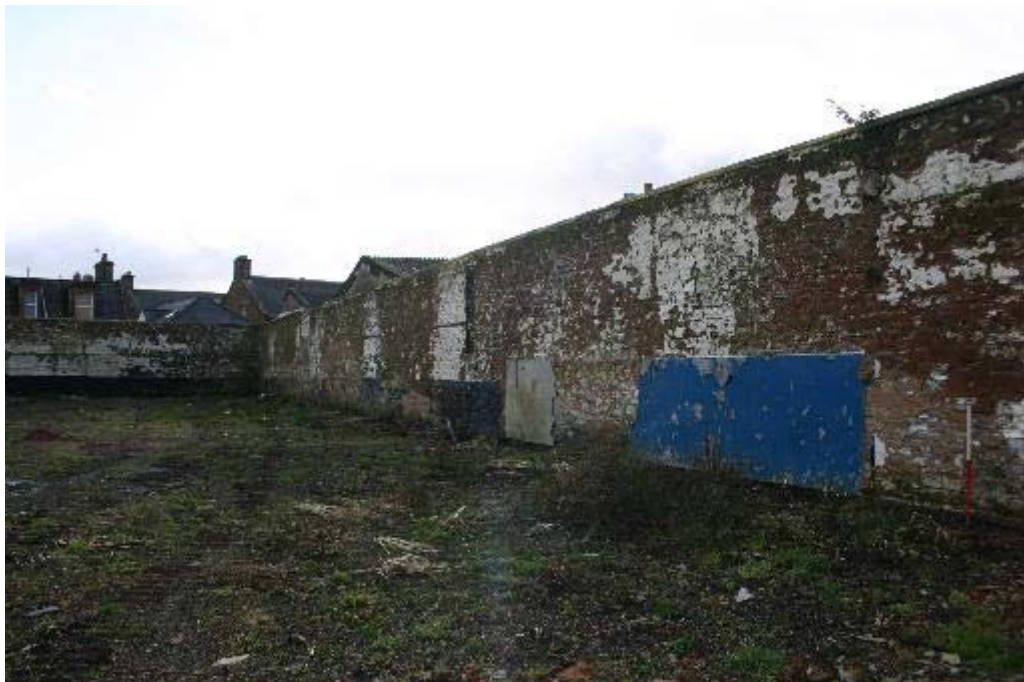
Plate 93: General view of western boundary wall

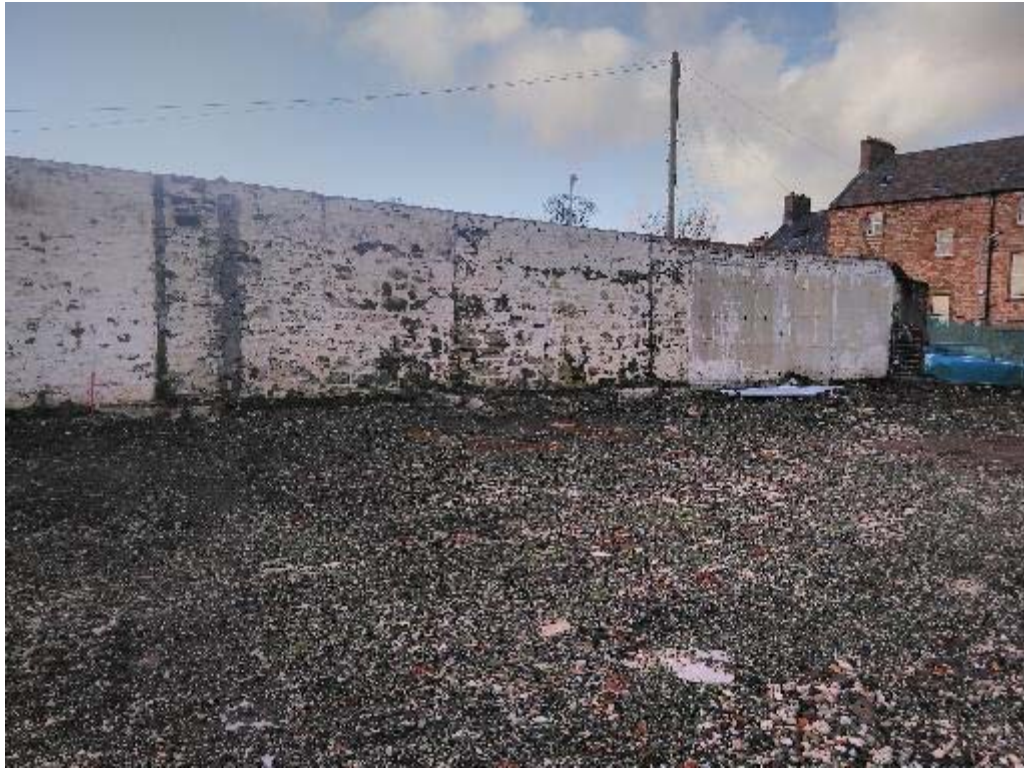
Plate 94: Northern section of western boundary wall

5.1.8 Some areas, however, are associated with the 20<sup>th</sup> century redevelopment of the site into a garage. These comprise concrete and brick structures of the northern section of the eastern boundary wall and the northern section of the western boundary wall.
