Archaeological Building Survey report

DATE ISSUED: May 2018
JOB NUMBER: CL12154
OASIS REFERENCE: wardella2-317322
PLANNING APPLICATION REF: 2/2018/0090

Church Hill Farm, Westward, Wigton, Cumbria

Archaeological Building Recording

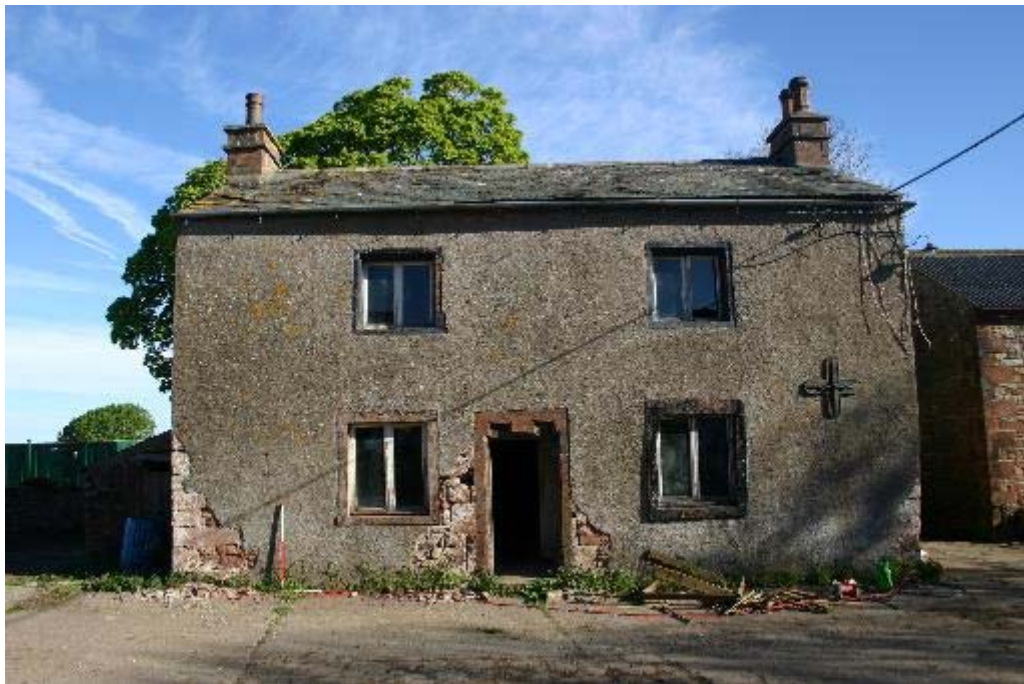
4.2.2 *South Elevation:* The front elevation, facing south towards the farmyard, is mostly rendered with some areas of ashlar sandstone masonry exposed at the western corner and around the central doorway (Plate 1). A datestone is situated within the lintel of the doorway (Plate 2), with the inscription of *R W M 1715*. There are two windows at each floor. A metal bracket is located at the eastern section of the building.

Plate 1: South facing elevation

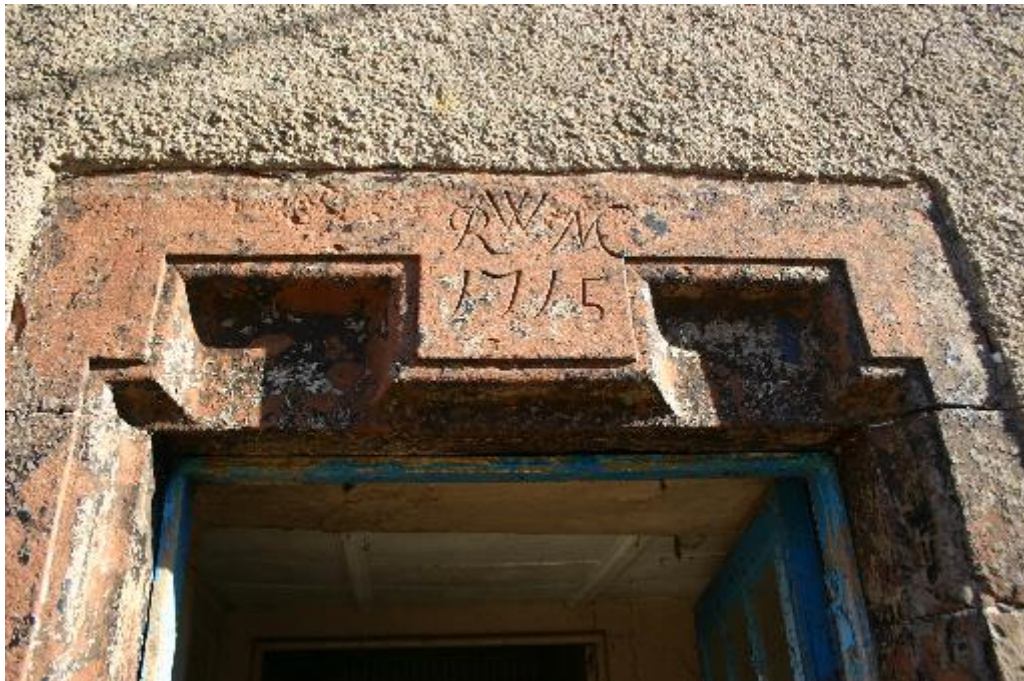
Plate 2: Detail: datestone in lintel

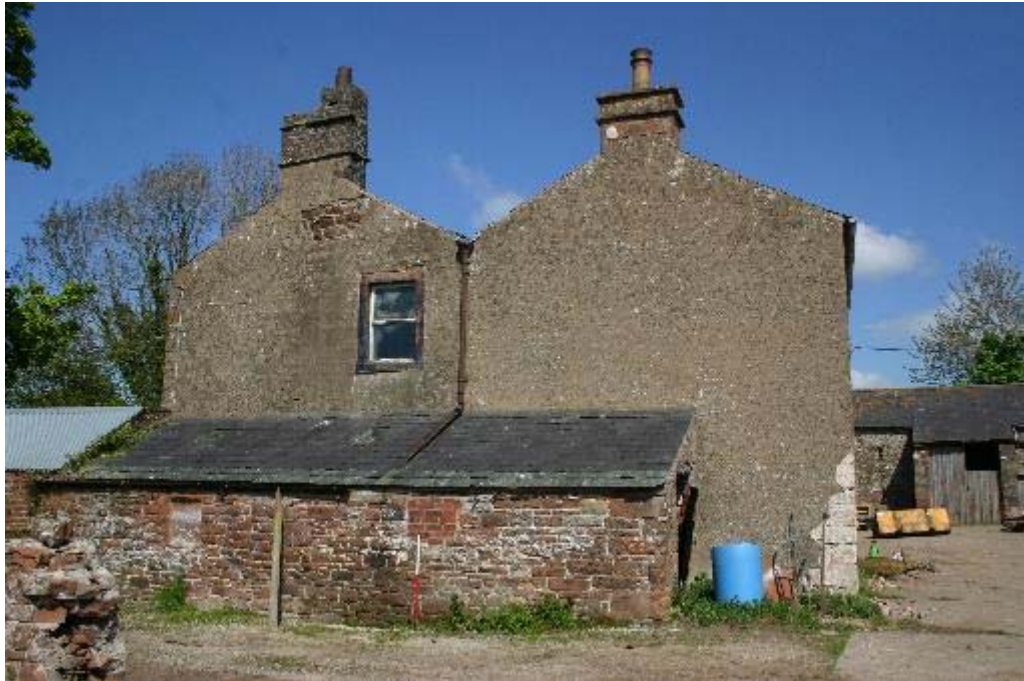
4.2.3 *West Elevation:* The west facing side presents a two gable ended elevation with two chimneystacks, once made of sandstone and one of black brick (Plate 3). The elevation is rendered with only small areas of sandstone masonry exposed. There is one window at first floor level. The ground floor level is nearly completely covered by a sandstone lean-to with a modern red brick extension to the north.

Plate 3: West facing elevation with lean-to

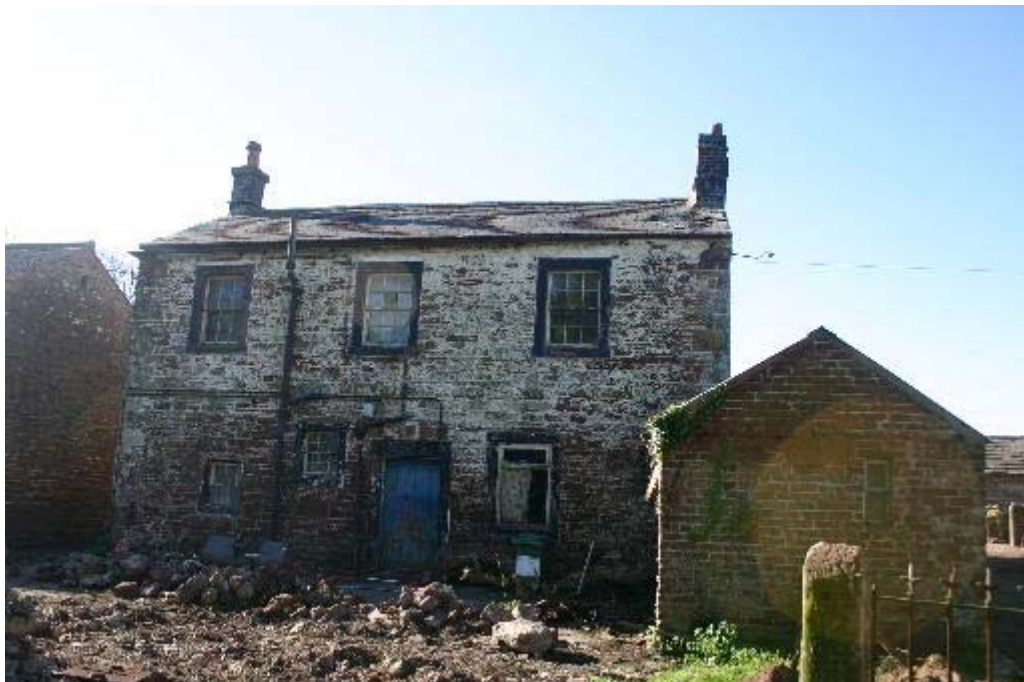
4.2.4 *North Elevation:* The north facing elevation (Plate 4), towards the back yard, presents roughly coursed ashlar sandstone masonry, which may have been whitewashed or painted white at some point. There are three windows of various sizes at ground floor level, as well as a central doorway to the back yard. There are a further three six over six sash windows at first floor level. There is a late 19th to early 20th century drainage pipe to the east of the doorway.

Plate 4: North facing elevation with modern brick extension of lean-to

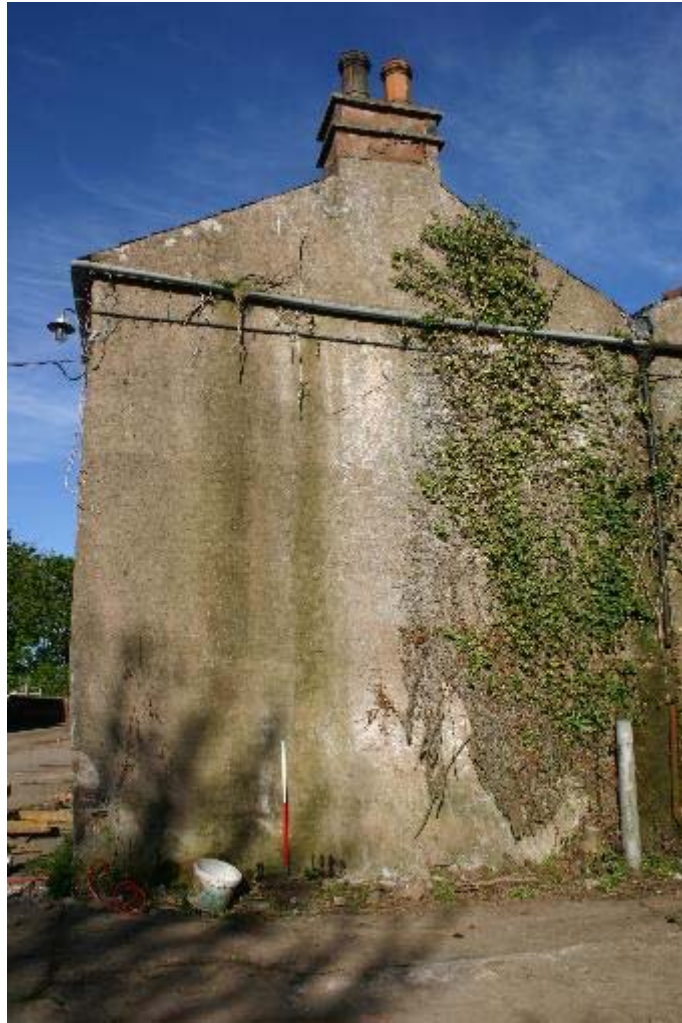
Plate 5: Southern section of east facing elevation

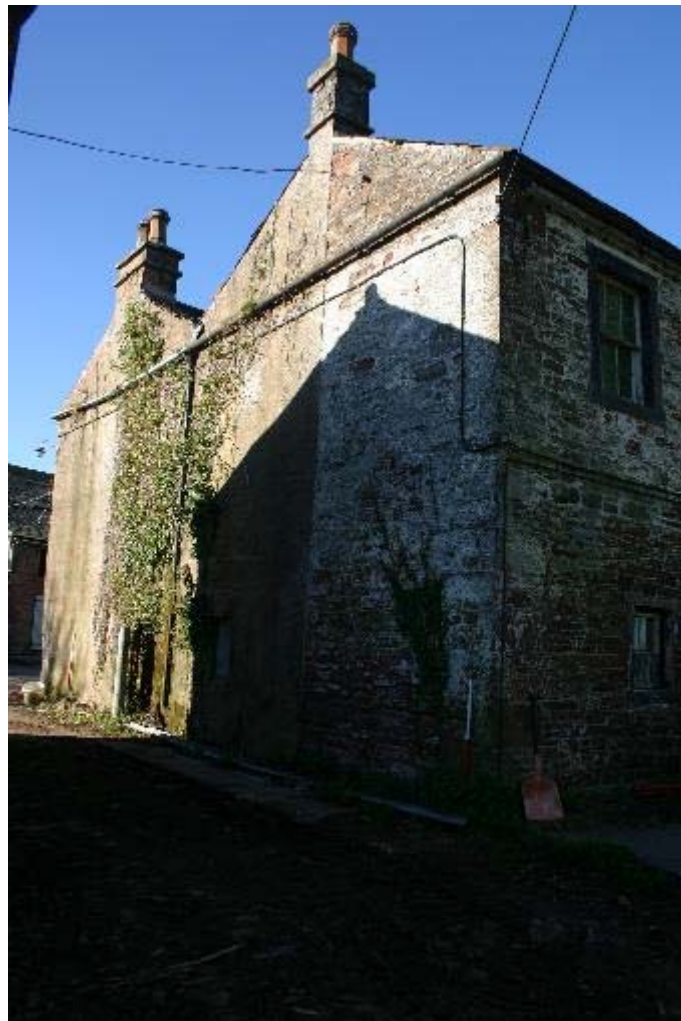
4.2.5 *East Elevation:* The side presents a two gable ended elevation with modern render (Plate 6). Part of the render has been removed at of the northern section, exposing the sandstone masonry. There is one small window at ground floor level. The northern section has a small chimneystack made of brick, while on the southern section is a larger sandstone chimneystack (Plate 5). There is a late 19th to early 20th century drainage pipe to the east of the doorway.

Plate 6: East facing elevation

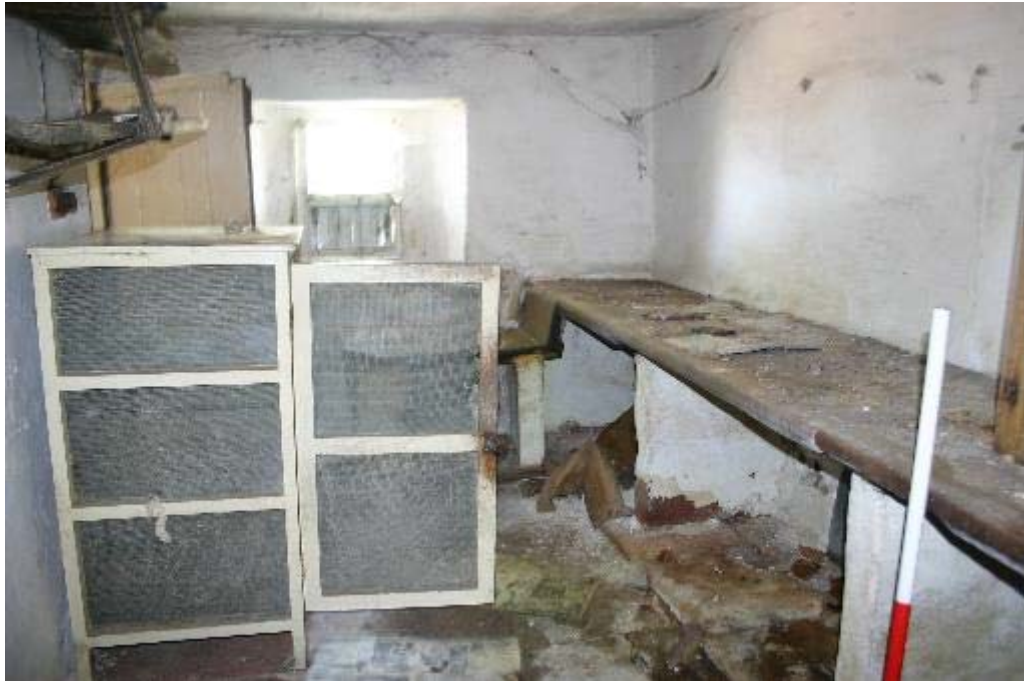
- 4.3.8 *GF-6*: The old storage room still retains its stone workbench along the north, east and south elevation (Plate 23). The floor is covered in large, rectangular flagstones (Plate 26). The timber door with round headed strap hinges is situated at the east elevation (Plate 25). A small section of the ceiling has collapsed at the southern end of the room. Along the ceiling are several cast-iron meat hooks, once used for storage. Part of the sandstone masonry is exposed at the south elevation. There are three wooden shelves held with wooden pegs at the west elevation (Plate 24). A small window with wooden panelling at the lower section for ventilation is situated at the north elevation. A

Plate 23: GF-6 storage room with workbenches

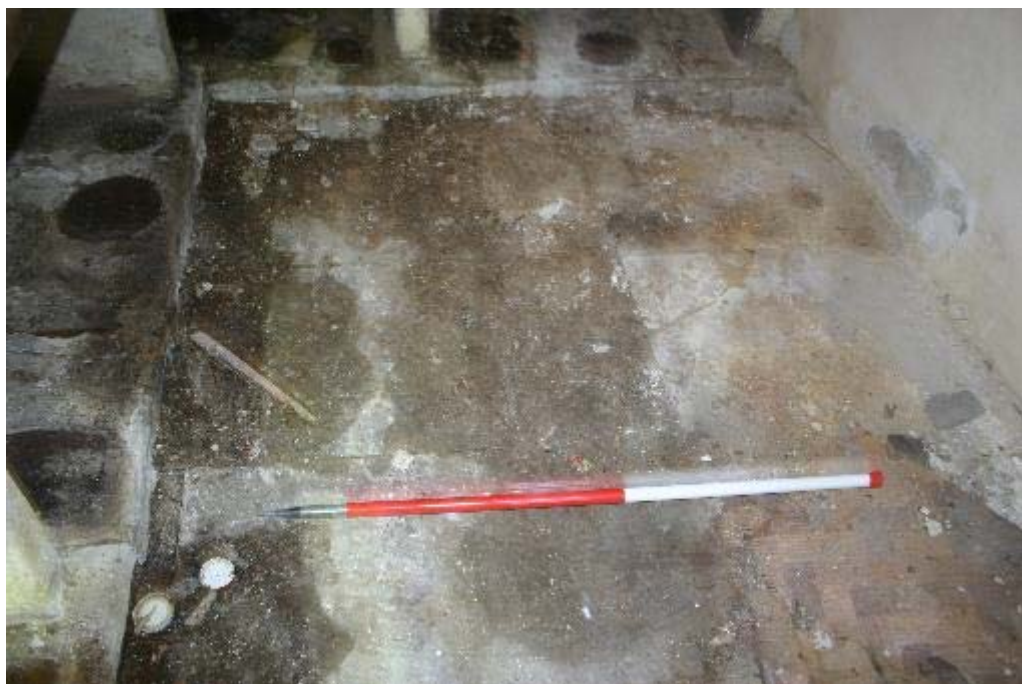
Plate 26: GF-6 flagstones flooring

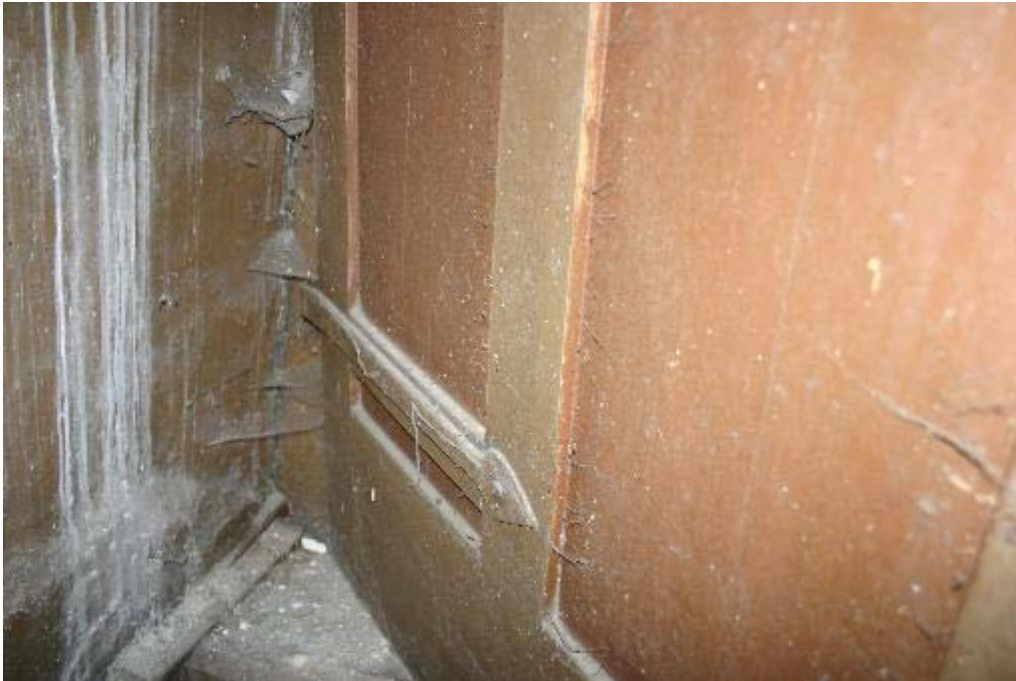
- 4.3.15 *FF-6*: A narrow, medium sized room, accessible via three steps downwards from *FF-1*. The timber door is fastened to the wall with cast-iron strap hinges with spearhead shaped ends (Plate 42). There is visible water damage to the ceiling, wall and timber flooring at the southern extent of the room (Plate 40). A small, cast-iron Victorian fireplace with a stone fire surround is built in at the east elevation (Plate 41). To the north is a six over six timber sash window.

Plate 42: FF-6 door with strap hinges with spearhead shaped ends

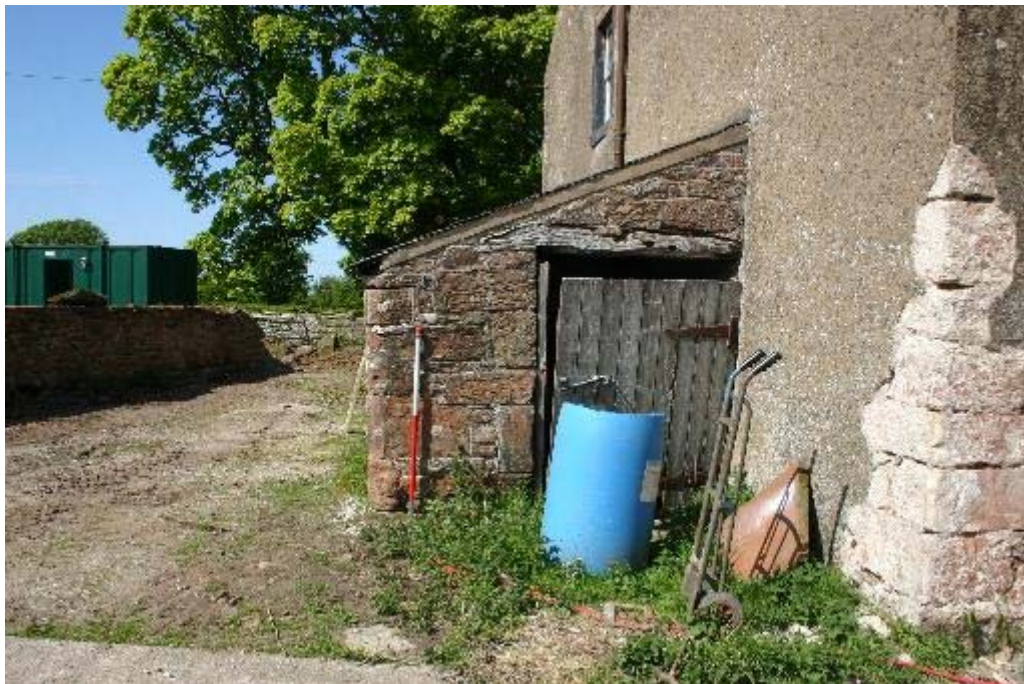
- 4.4.3 The slate roof of the sandstone lean-tos appears to have been renewed in the 20th century as a uniform structure and slightly raised. Quoin stones on each side of the central building indicate that this was the first lean-to structure to be built. This was then followed by the smaller lean-to to the south (Plate 43), and the 20th century red brick lean-to to the north.

Plate 43: Southern lean-to

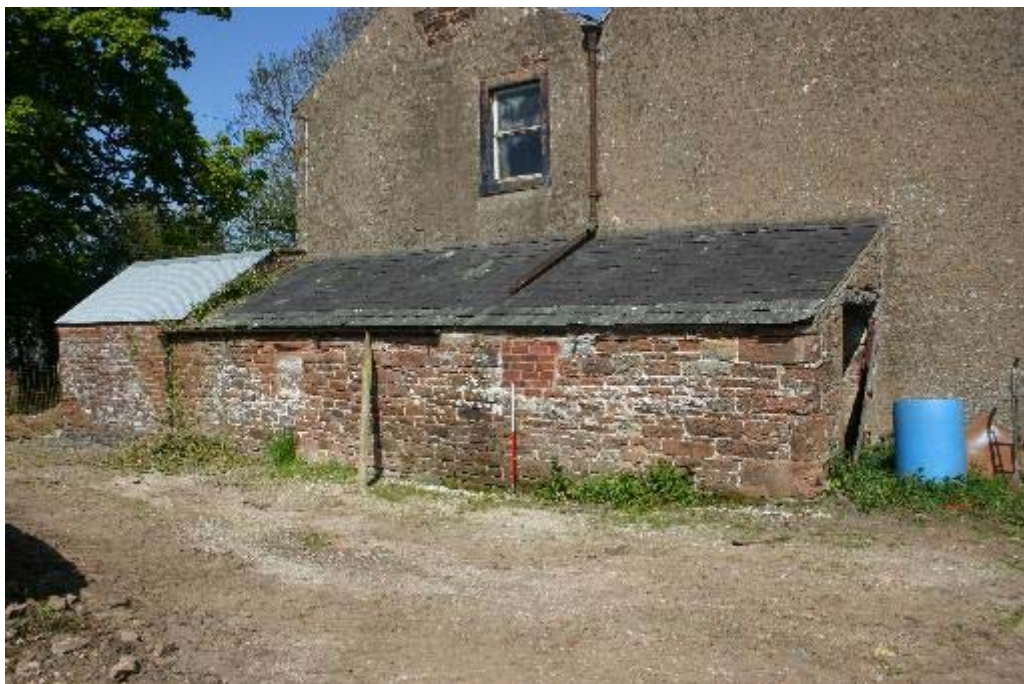
- 4.4.1 The lean-to abutting the building to the west comprises three sections (Plate 44). The two southernmost sections are built of roughly ashlar sandstone, and are of at least 19th century date. Abutting these to the north is a modern red brick extension (Plate 46).

Plate 44: Two sandstone lean-tos with modern red brick extension

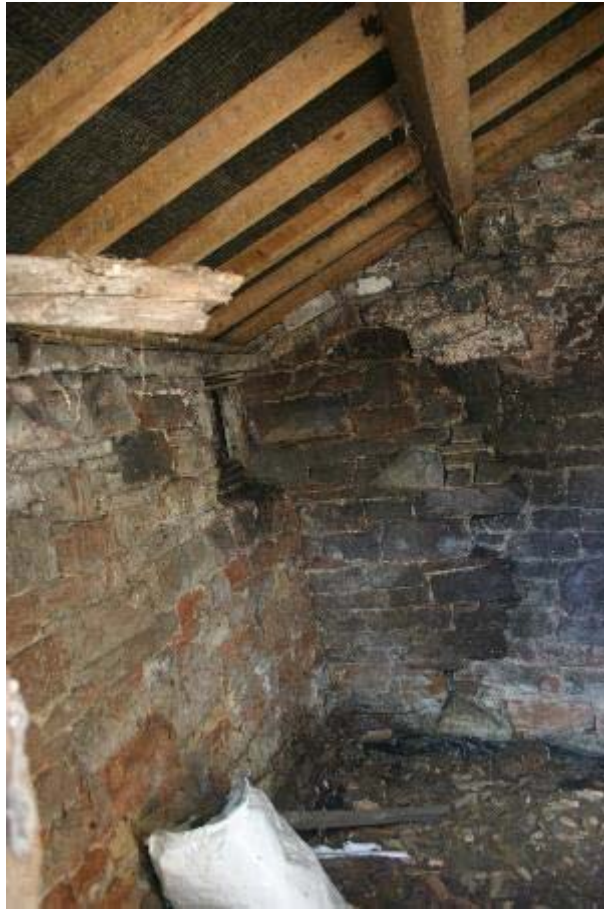
Plate 47: Southern lean-to with bricked up window at corner

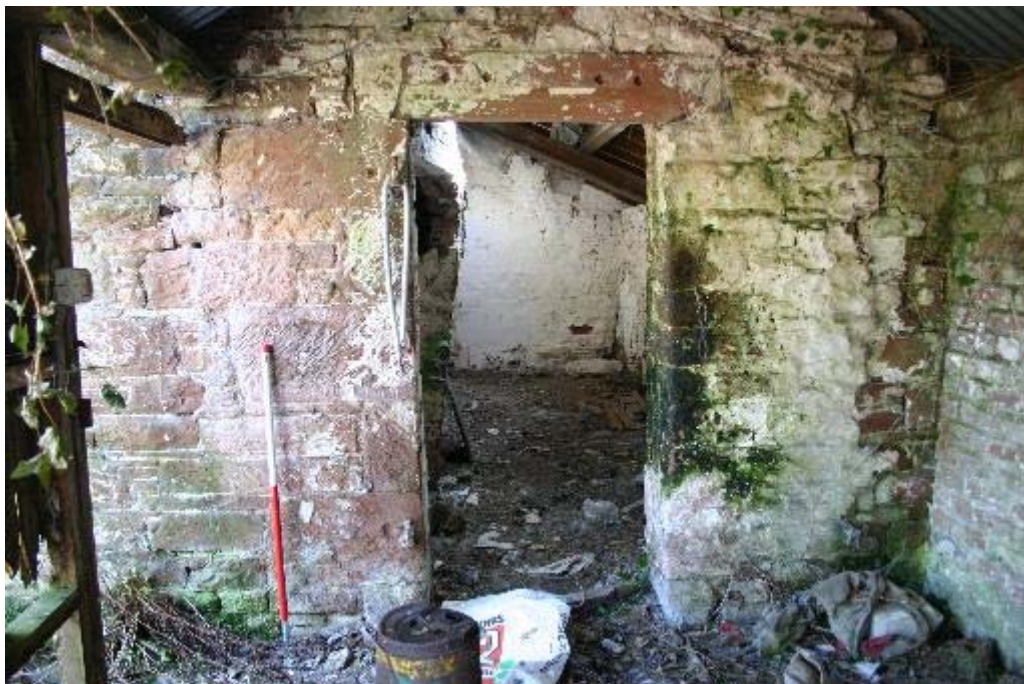
Plate 48: Doorway to the central lean-to from the red brick extension

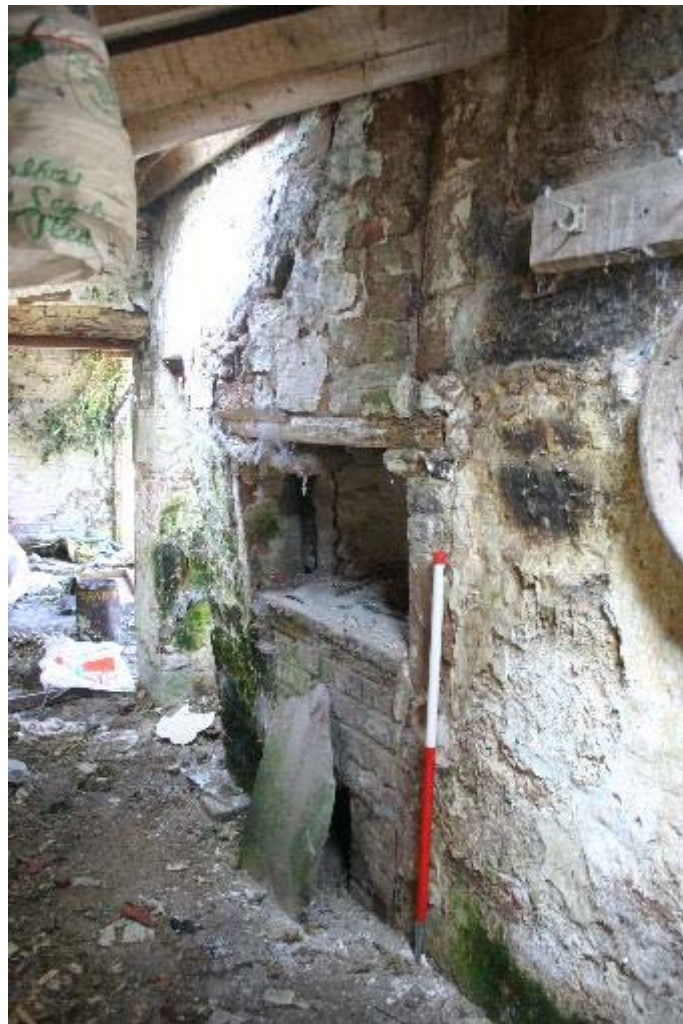
- 4.4.2 The central section of the lean-to is interlocked with the farmhouse at the northern end, with an oven built into a niche within the west facing farmhouse elevation. The masonry of the oven is clearly separating from the main structure and is bowing out into the room, thus making this a structurally unsafe area (Plates 48 to 51). A small window at the western elevation of the lean-to has been blocked off. The southern structure only contains a small empty room, which can be accessed via the doorway at the south elevation. A window at the south-western corner has been bricked off (Plate 47). The south-western corner of the structure is curved. There is some red brick repair works where the southernmost structure abuts the central structure (Plate 45).

Plate 51: Oven in central lean-to
