Hamsterley Hall  
Hamsterley  
County Durham

Emergency Archaeological Building Recording  
and Watching Brief

*Report 064-13-HS | July 2013*

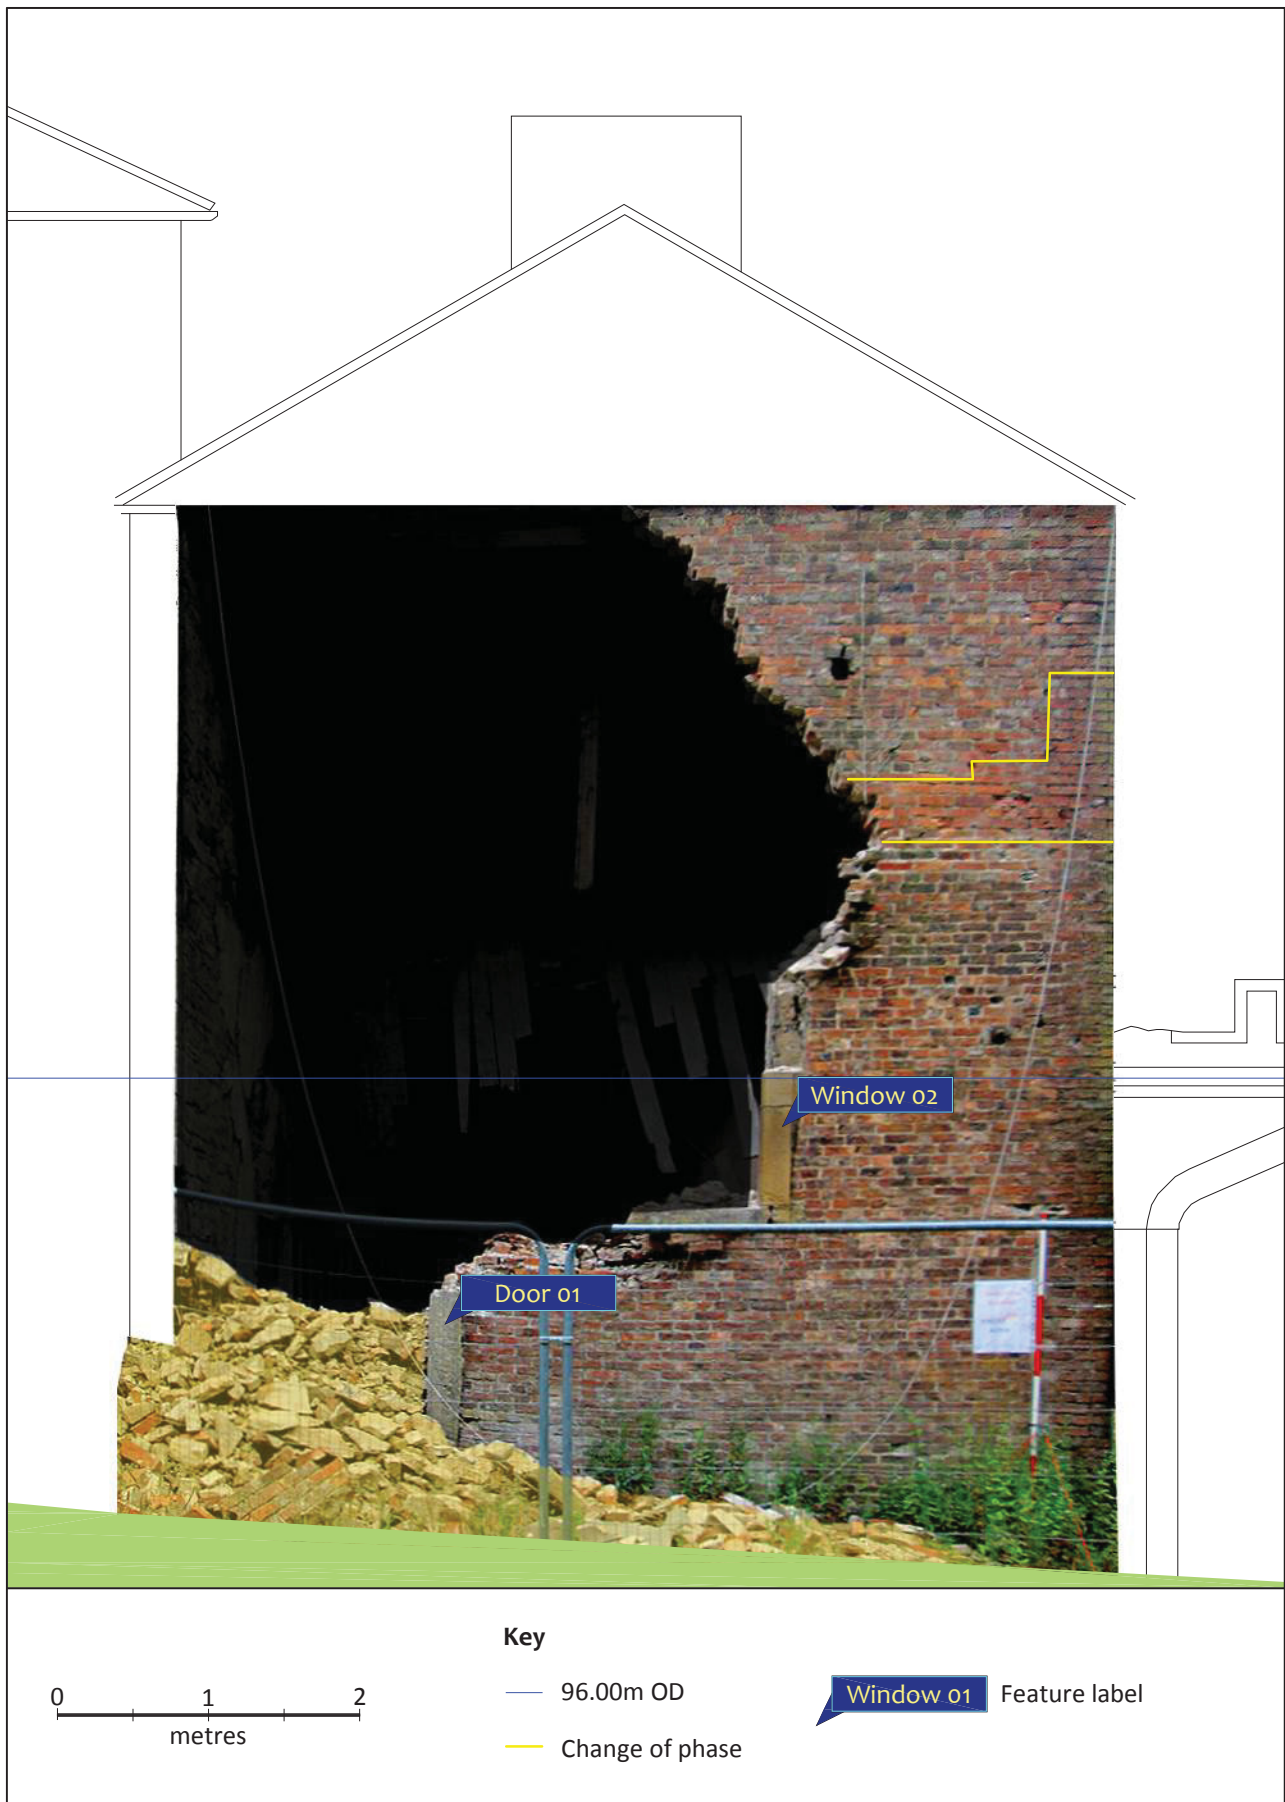
Figure 3. Northern elevation, showing rectified photograph of elevation

3.1.1 The northern elevation suffered the greatest loss of fabric through collapse of all four elevations, in terms of area lost. The area lost was 51.5% of the elevation fabric, including the majority of the architectural features including the door and windows. A fraction of the stone jamb of the ground floor door was still *in-situ*, as was a section of the ground floor window sill. However, both architectural elements were broken. The elevation measured at 6.2m wide and 6.78m tall from floor height to the eaves.

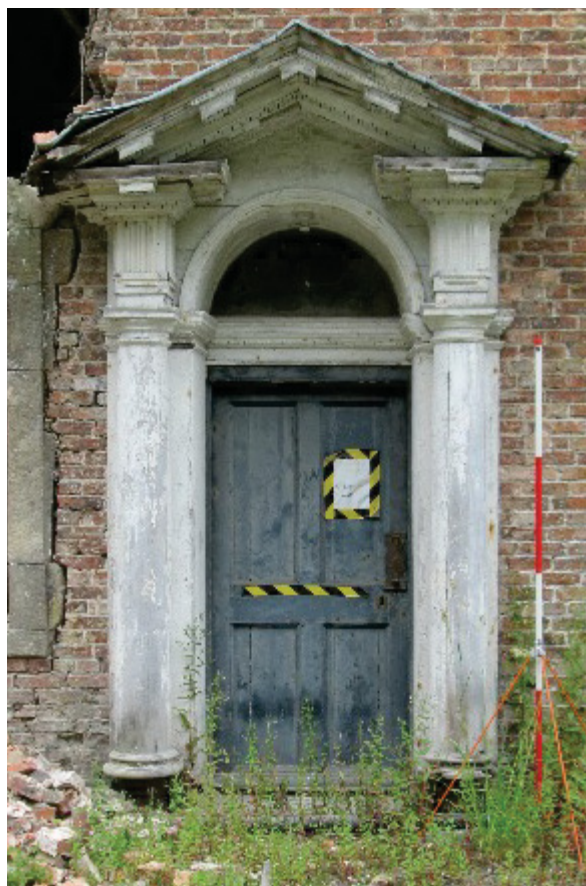
**Plate 7.** Western elevation of brick wing, showing detail of Door 02 (photo reference HHH13J023).

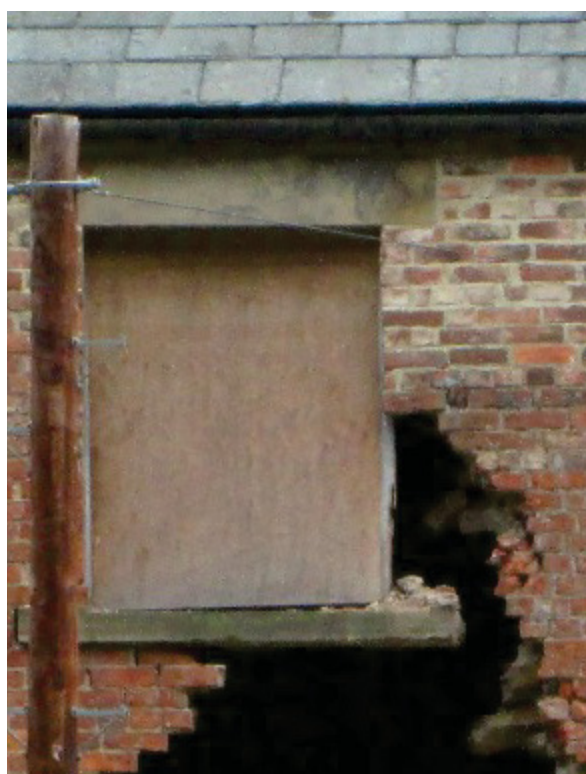
- 3.2.6 Window 04 (Plate 8): Duplicate of Window 03. Collapse in brickwork on southern base. Boarded up.
- 3.2.7 Window 05: Duplicate of Window 03, boarded up.

**Plate 8.** Western elevation of brick wing, showing detail of Window 04 (photo reference HHH13J020).

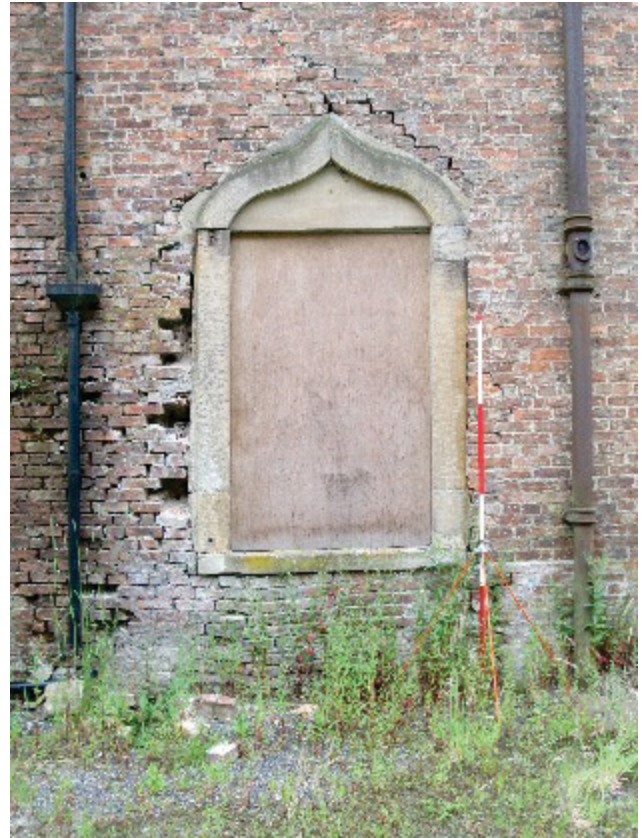
**Plate 10.** Western elevation of brick wing, showing detail of Window 08 (photo reference HHH13J027).

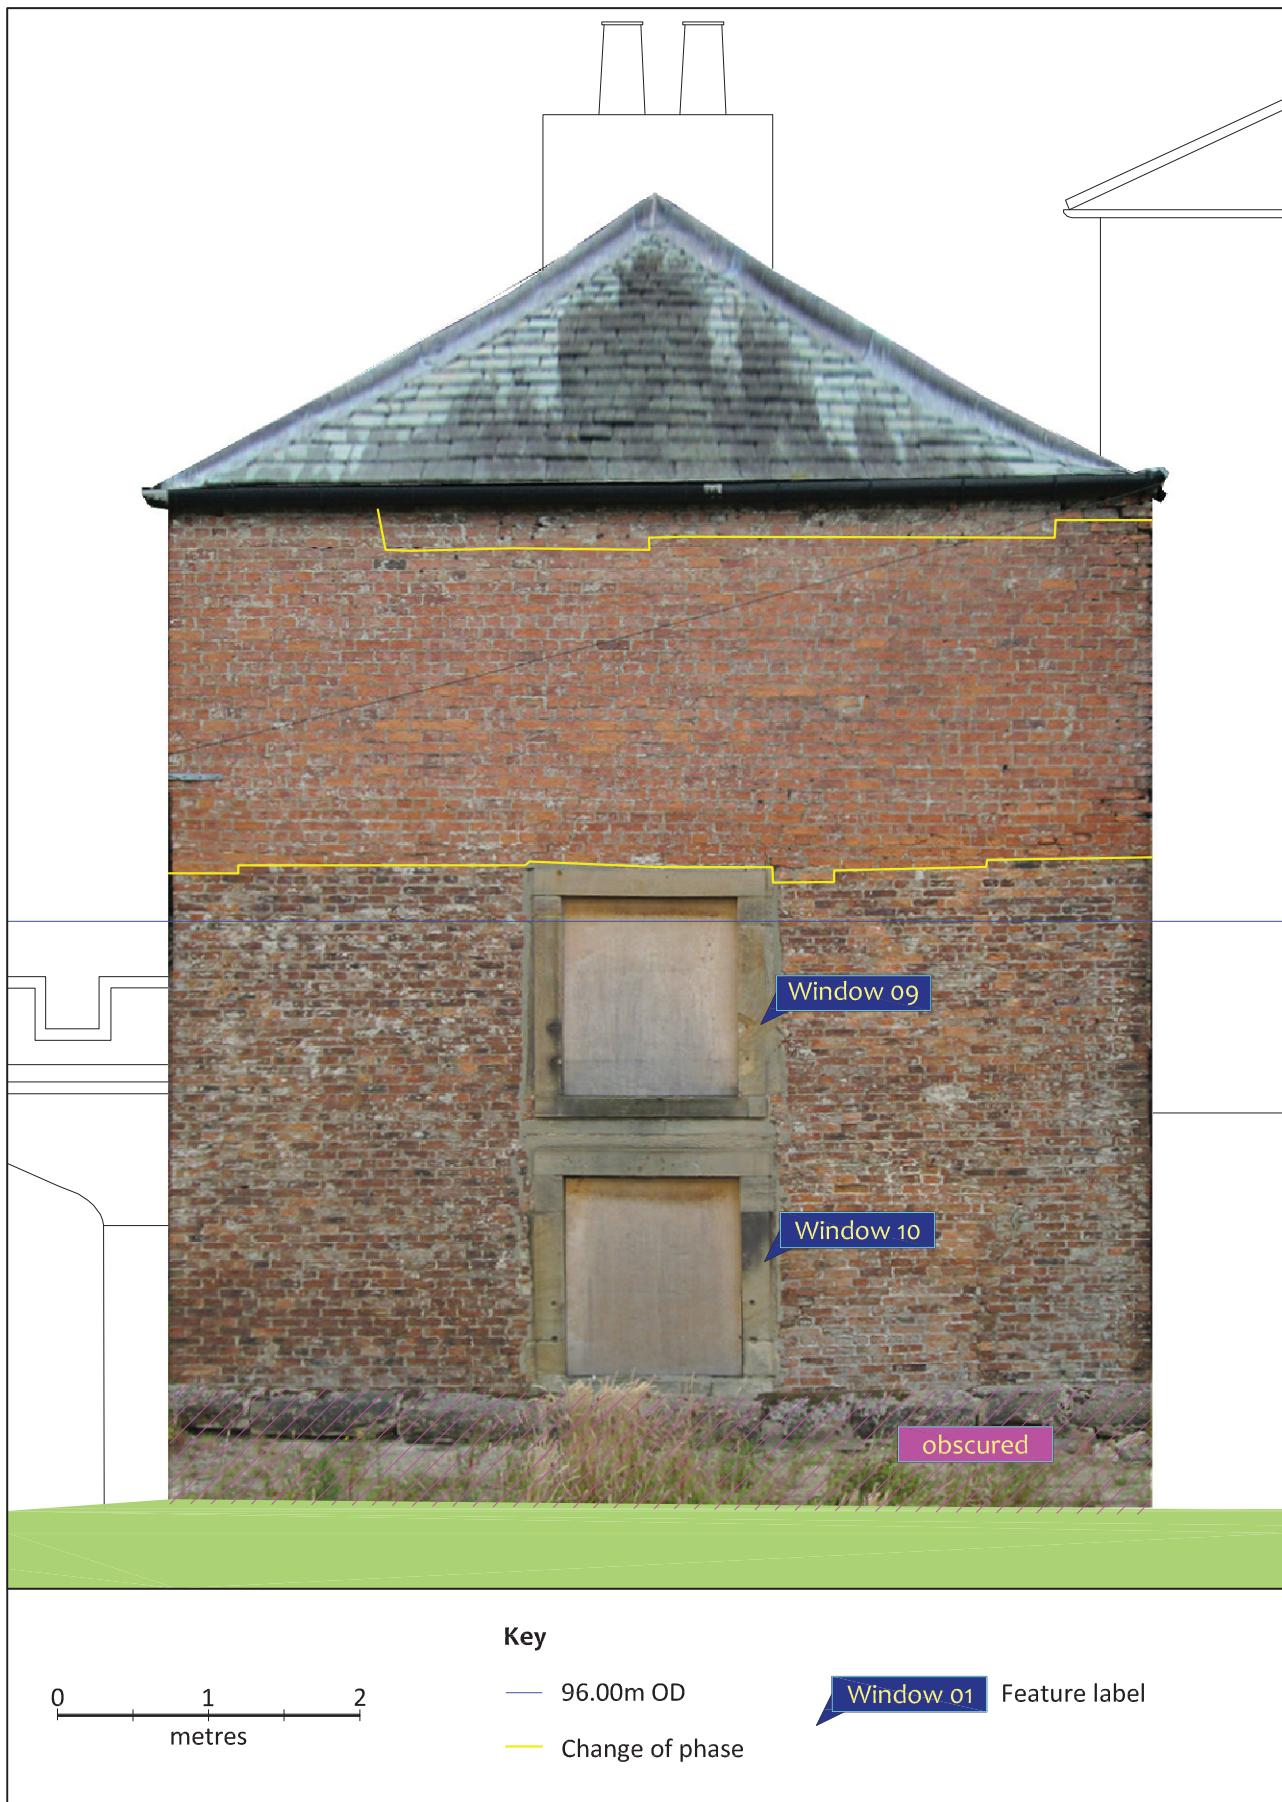
Figure 5. Southern elevation, showing rectified photograph of elevation

3.3.7 Structural sinking (Plate 12): Stress cracking was especially notable on the southeastern base corner.

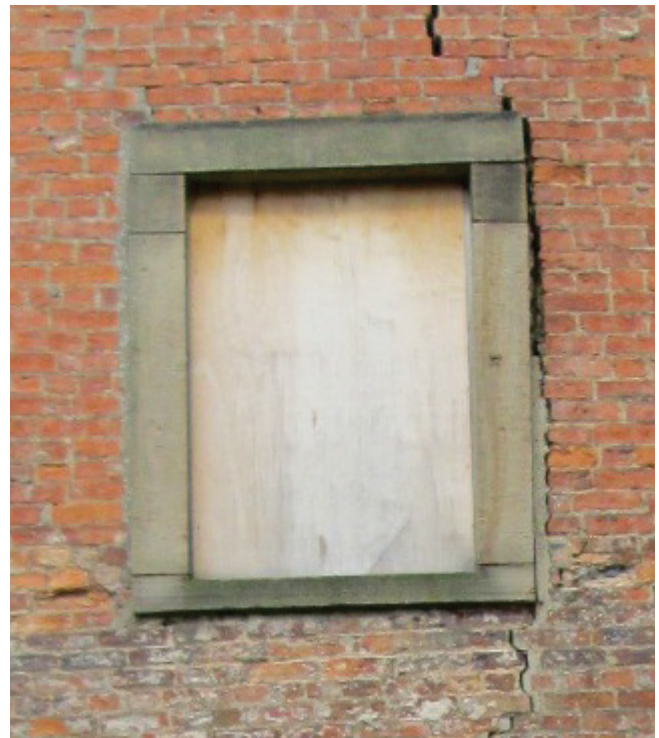
**Plate 13.** Eastern elevation of brick wing, showing detail of Window 11 (photo reference HHH13J003).

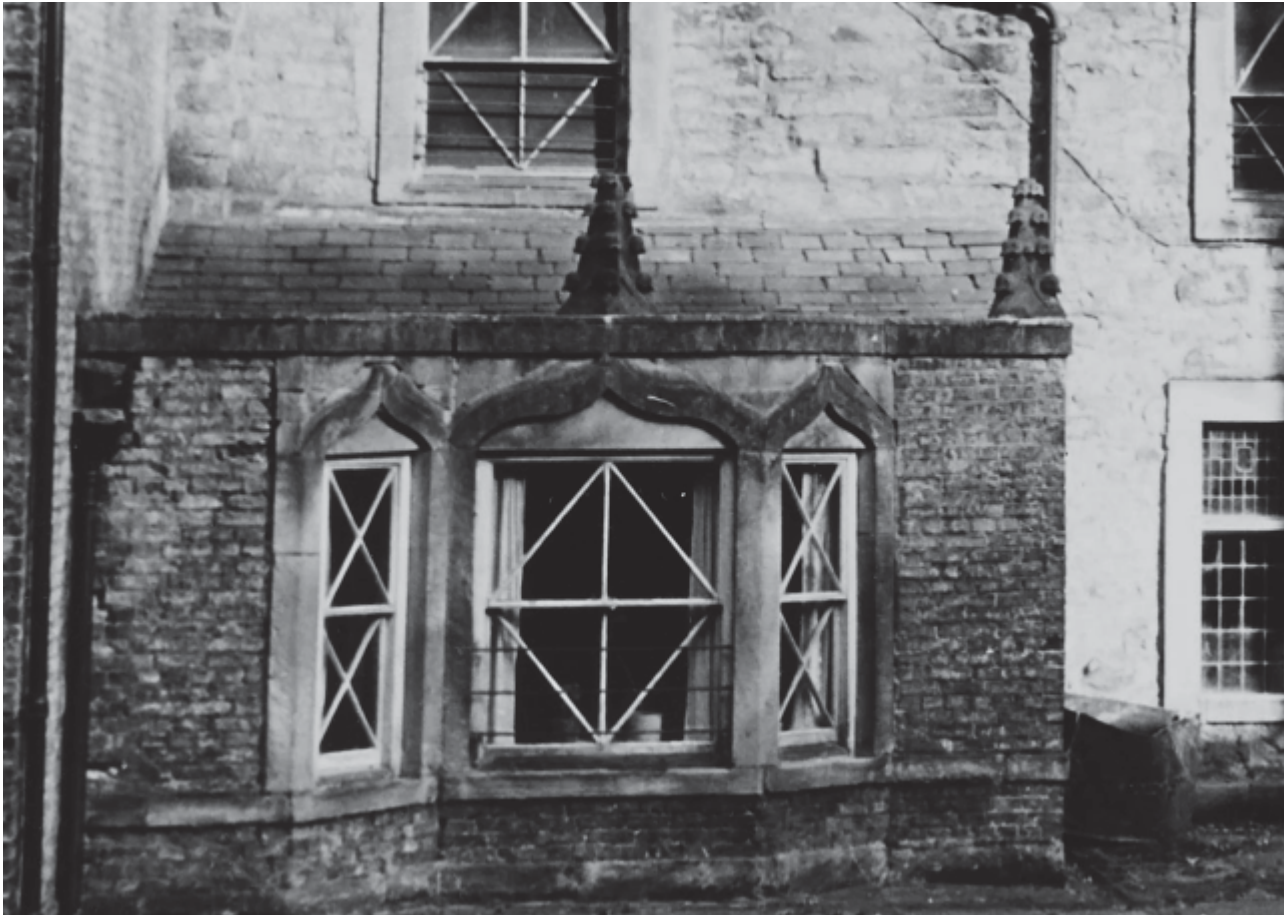
**Plate 15.** Photograph from 1970, courtesy of Durham County Council Planning Department.

was built and also when it was demolished, but the photograph of 1970 (Plate 15) suggests its construction of brick Type 01 (Section 5.1), 30 courses high of English Garden Wall bond, complete with the Westmorland gabled slate roof. The wall face also contained 3 recessed ogee arched windows, gutter cornice, brick course and Gothic finials. The scar is set at 19° and apart from the blocked door and opening in the south elevation of the main central range is all that remains of the joining extension.

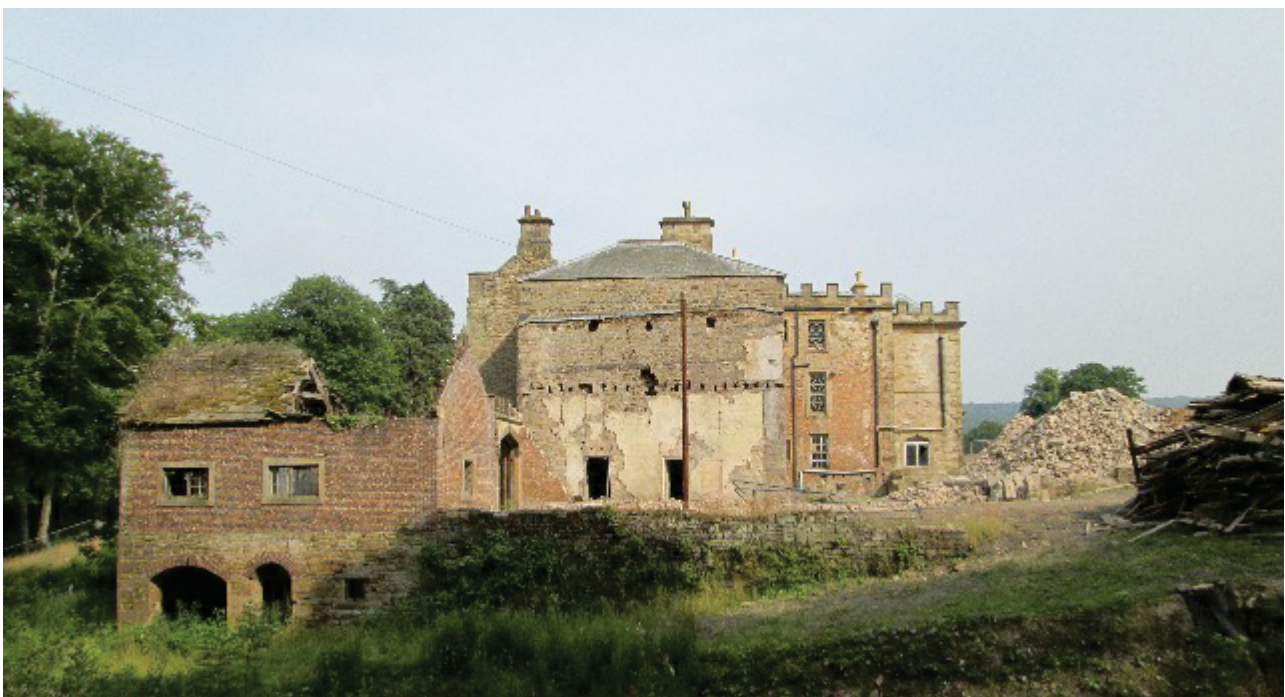
**Plate 18.** The end of Day #4 of the watching brief, showing the western elevation of the central range exposed.

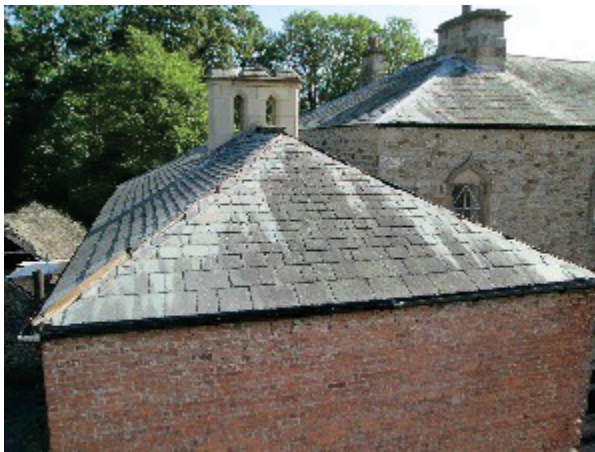
**Plate 19.** Southern face of the hipped roof, before demolition (photo reference HHH13J050).

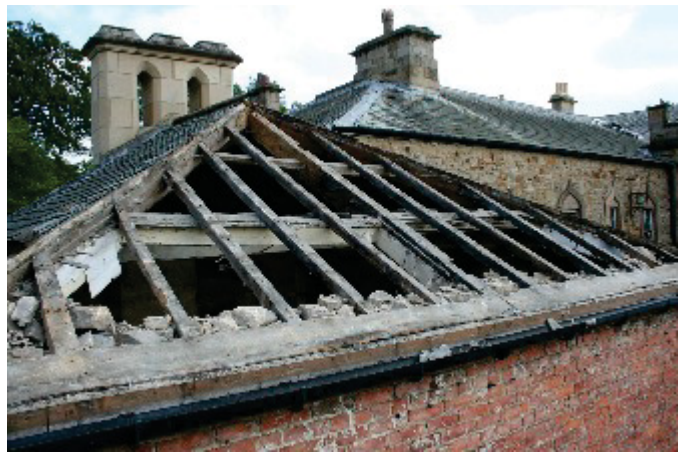
**Plate 20.** Southern face of the hipped roof, during demolition (photo reference HHH13J068).

- 4.2.3 From what was visible during the demolition works, nearly 50% of the common timber rafters had been replaced (potentially when the structure was re-roofed, as discussed in 4.2.2), though the ridge board and hip rafters may have been original. The timber was Douglas Fir and riddled with woodworm and rot. Examples observed post-demolition can be seen in Section 5.7. Internal ceiling joists appeared to have been painted white.
- 4.2.4 The extant chimney stack was of modern sandstone construction, presumably replaced at the same time as the roof. Unfortunately, due to the weight of the stonework, the blocks had to be removed via the mechanical plant rather than by hand.

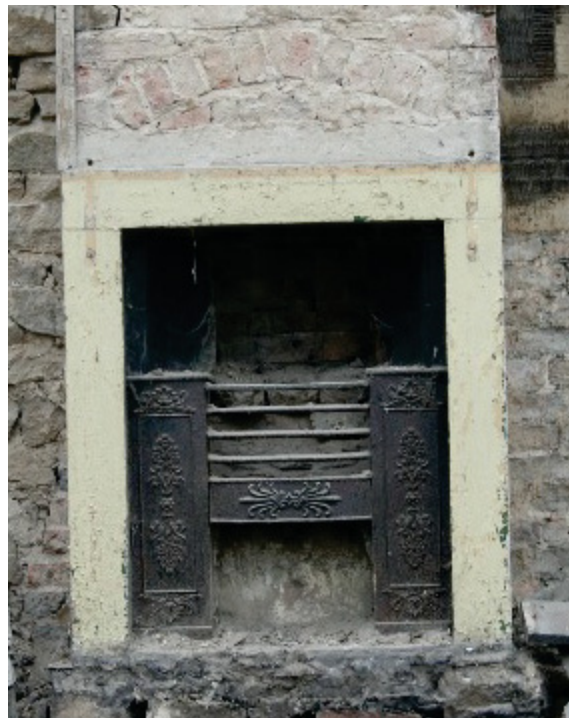
**Plate 24.** Fireplace 02 (photo reference HHH13J098).

4.4.4 **Fireplace 02 (Plate 24):** This fire surround was constructed of plain stone, topped with a rounded

brick arch. This fireplace was a nice example of a late 18<sup>th</sup> century hob grate, cast in iron, which again ties into the 2<sup>nd</sup> floor of the building being constructed 1769 onwards.

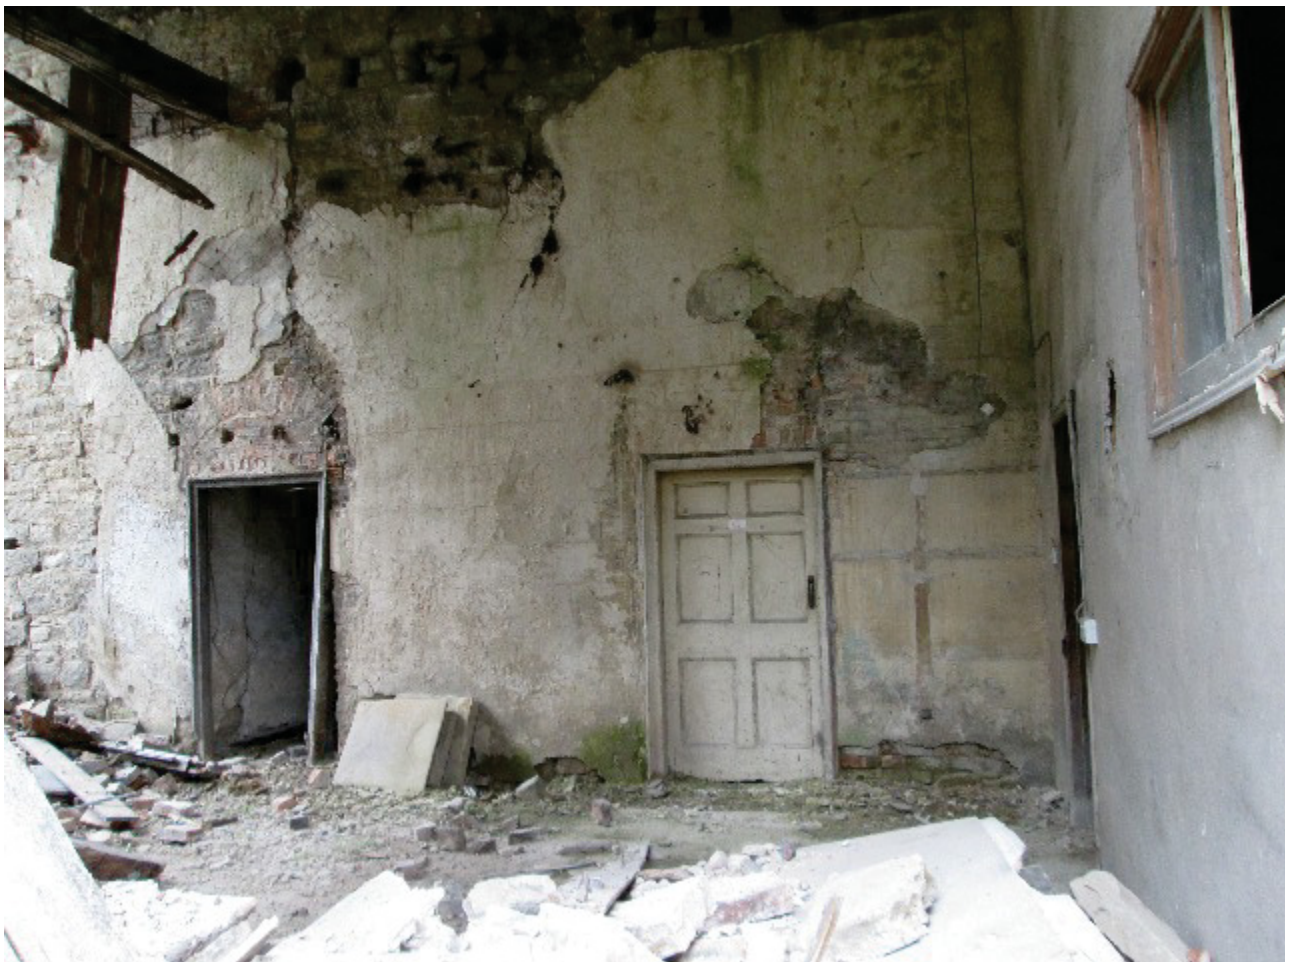
*Plate 26. Doors 05 and 06, with the stud wall on the right along with Window 15 (photo reference HHH13J038).*

- 4.6.5 Stud Wall and Window 15: A photograph of the plastered stud wall and window frame can be seen on the right of Plate 26. They appear to be modern built.

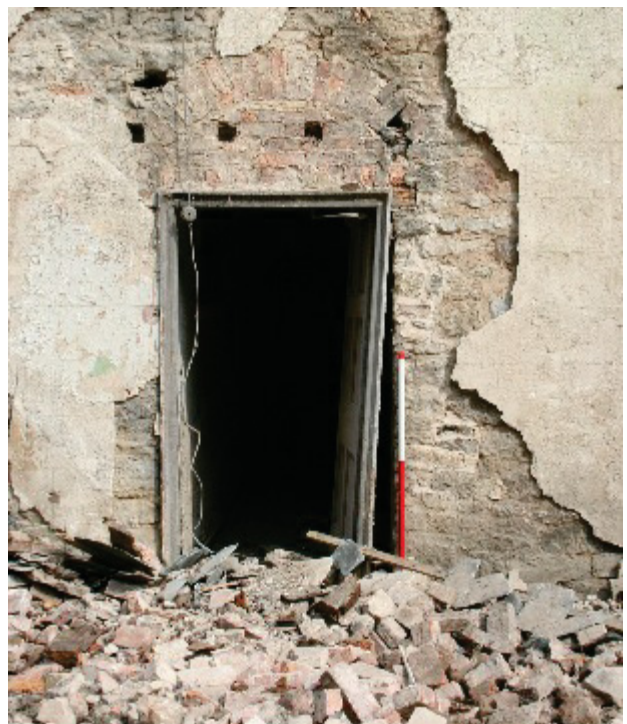
- 4.6.6 Door 05: Door 05 (Plate 28) was potentially originally an external door to the western elevation of the central range of the Hall. As the door surround has been inset with hand-made brick into the wall, it is likely to have been in use just prior to the brick wing being built in the early-mid 18<sup>th</sup> century. Evidence of this being an external door rests with the four baton holes in the brick, suggesting that the door once had a hood (unlikely on an internal door). Above the doorway is a brick-built semi-circular brick arch, and the door itself is a six-panelled door of late Georgian/early Regency design.

**Plate 28.** Door 05 (photo reference HHH13J161).

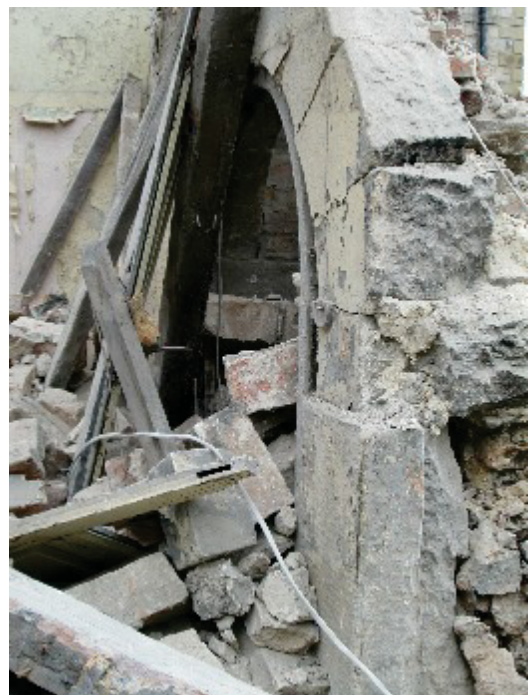
4.6.10 **Door 08:** Door 08 was an ornate painted stone arch, set in the southern wall. This arch formed a passageway (the rest of the passageway was brick)

**Plate 30.** Door 08 (photo reference HHH13J133).

1.68m long through into Room 6 to the south. The door on the arch would have been held on an arched wooden frame, but the door was no longer present.

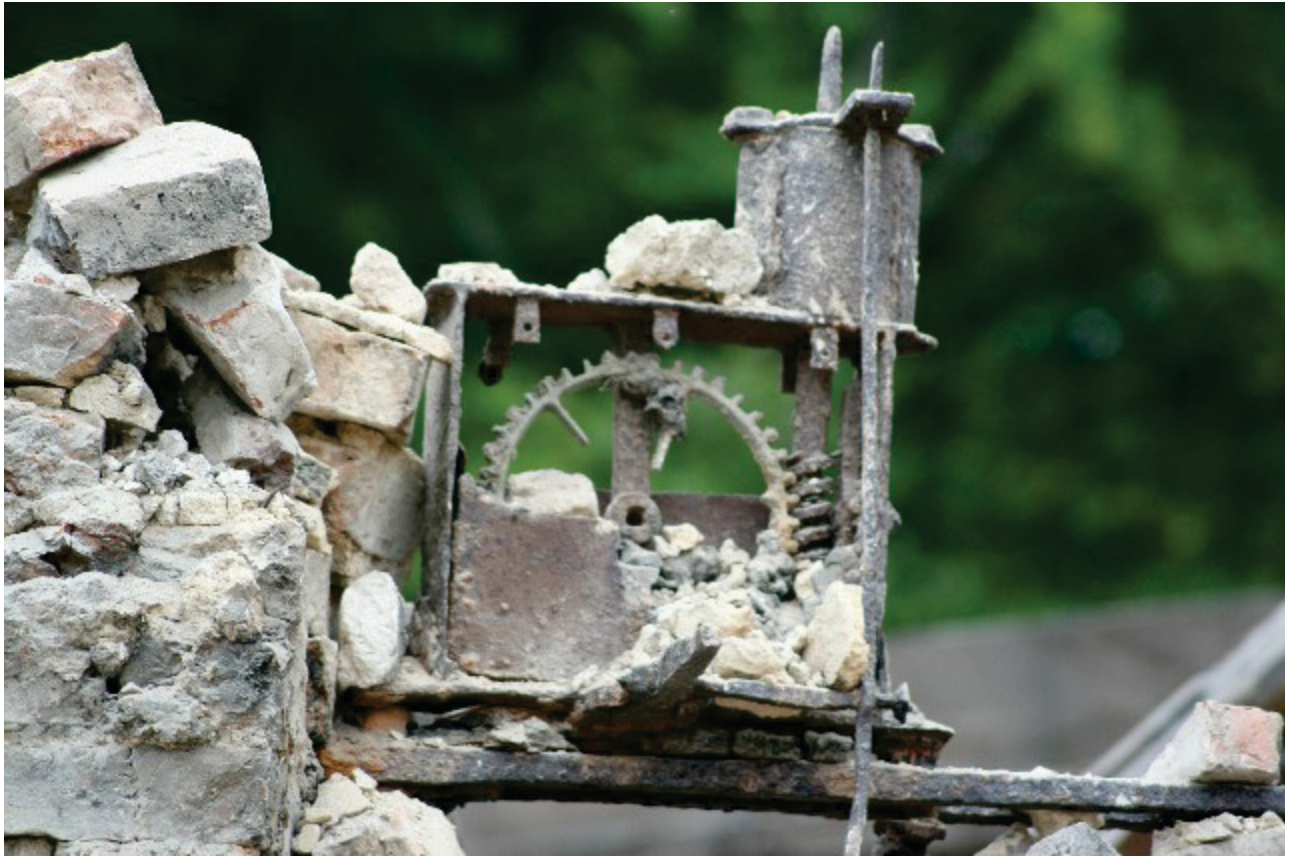
**Plate 31.** Mechanism above the back boiler (photo reference HHH13J143).

- 4.6.11 Back boiler (See Section 5.10): During the demolition of the chimney stack, it became apparent that a fireplace may once have been set in the southern wall but it had been removed and replaced with a back boiler. This back boiler held no maker's marks or stamps, making it awkward to date. The back boiler was still attached to a winding mechanism (presumably to move plates). However, two forms of brick were noted in the construction of the wall around the boiler, Type 4 and Type 5 (Section 5.4 and 5.5). These two brick types suggest a potential mid 1940s build, supporting the argument for addition and repair of the brick wing during this period.

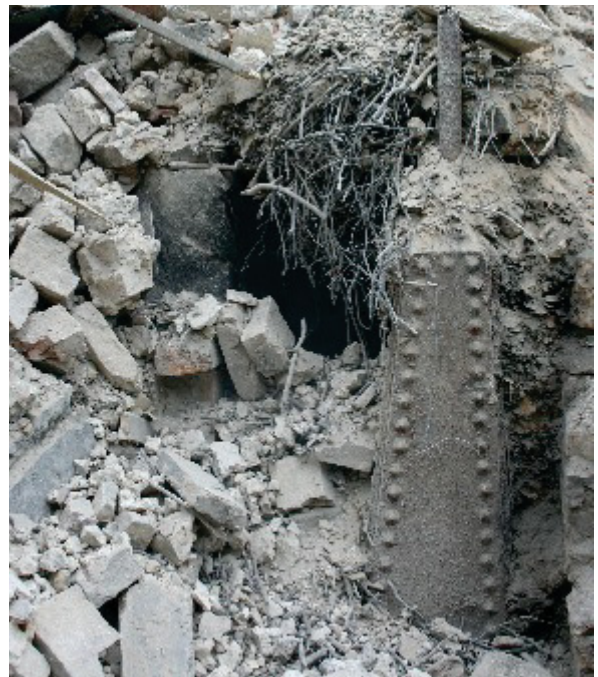
**Plate 32.** The back boiler set in the wall (photo reference HHH13J145).

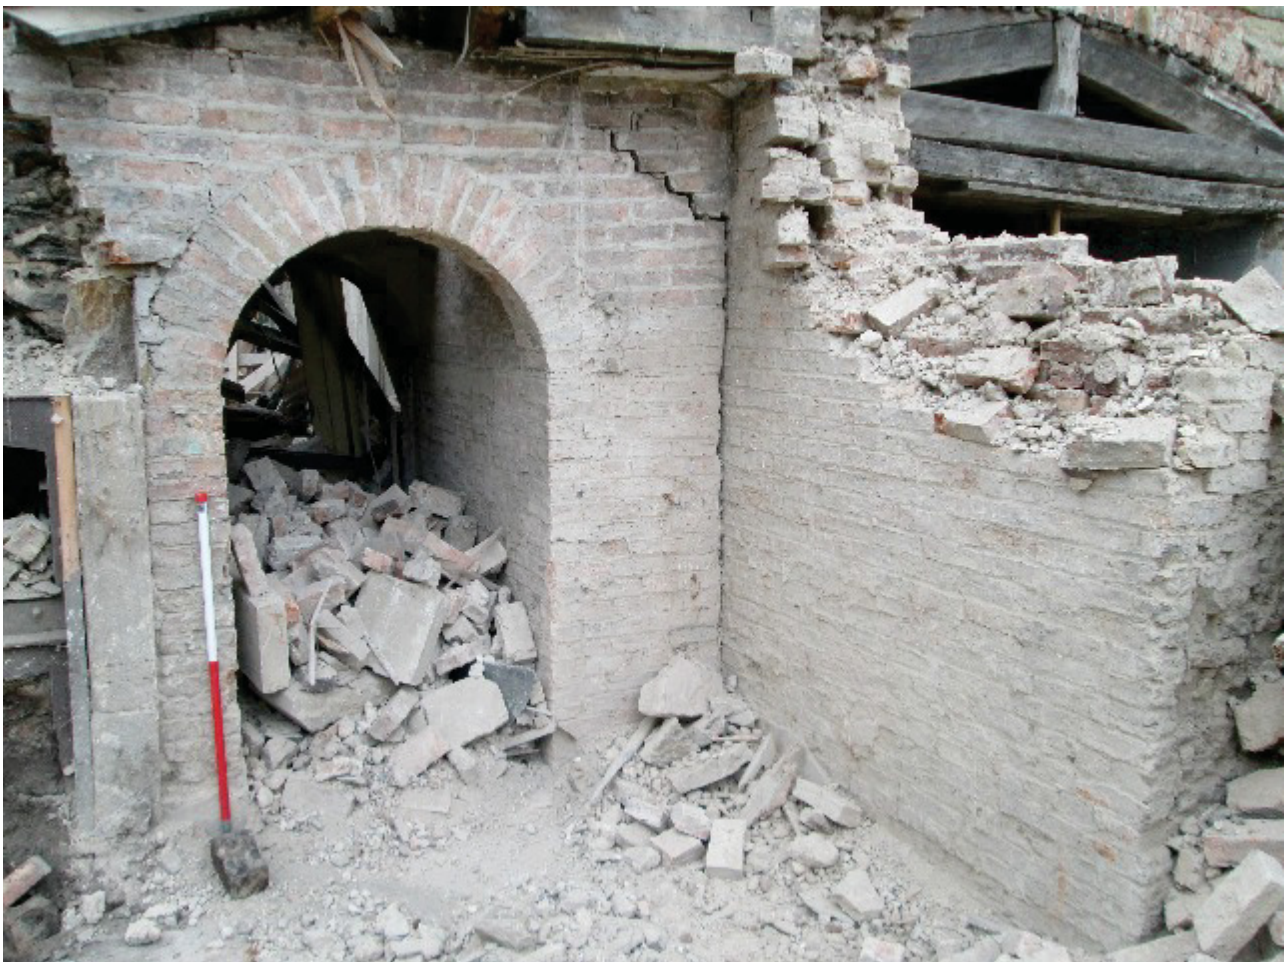
*Plate 33. Brick arched Door 08 (photo reference HHH13J132).*

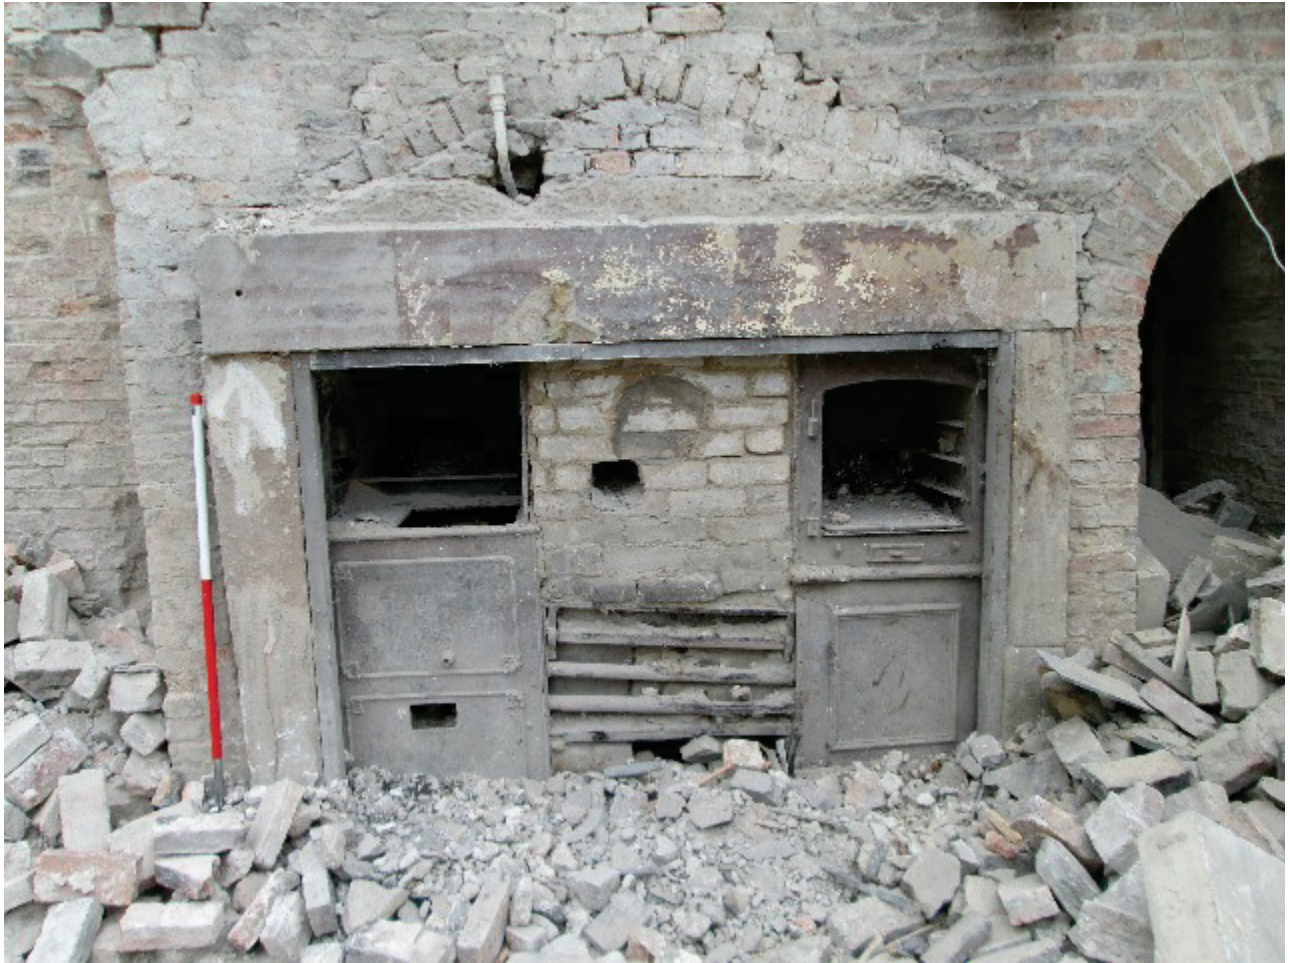
- 4.6.17 Fireplace 03: Fireplace 03 was set in the northern wall and was used to heat the back boiler set in the wall behind it. This was a twin-oven Georgian range, though it was noted that the fire grate had been bricked up and the (presumably) decorated iron doors previously removed.

**Plate 34.** Fireplace 03 (photo reference HHH13J130).

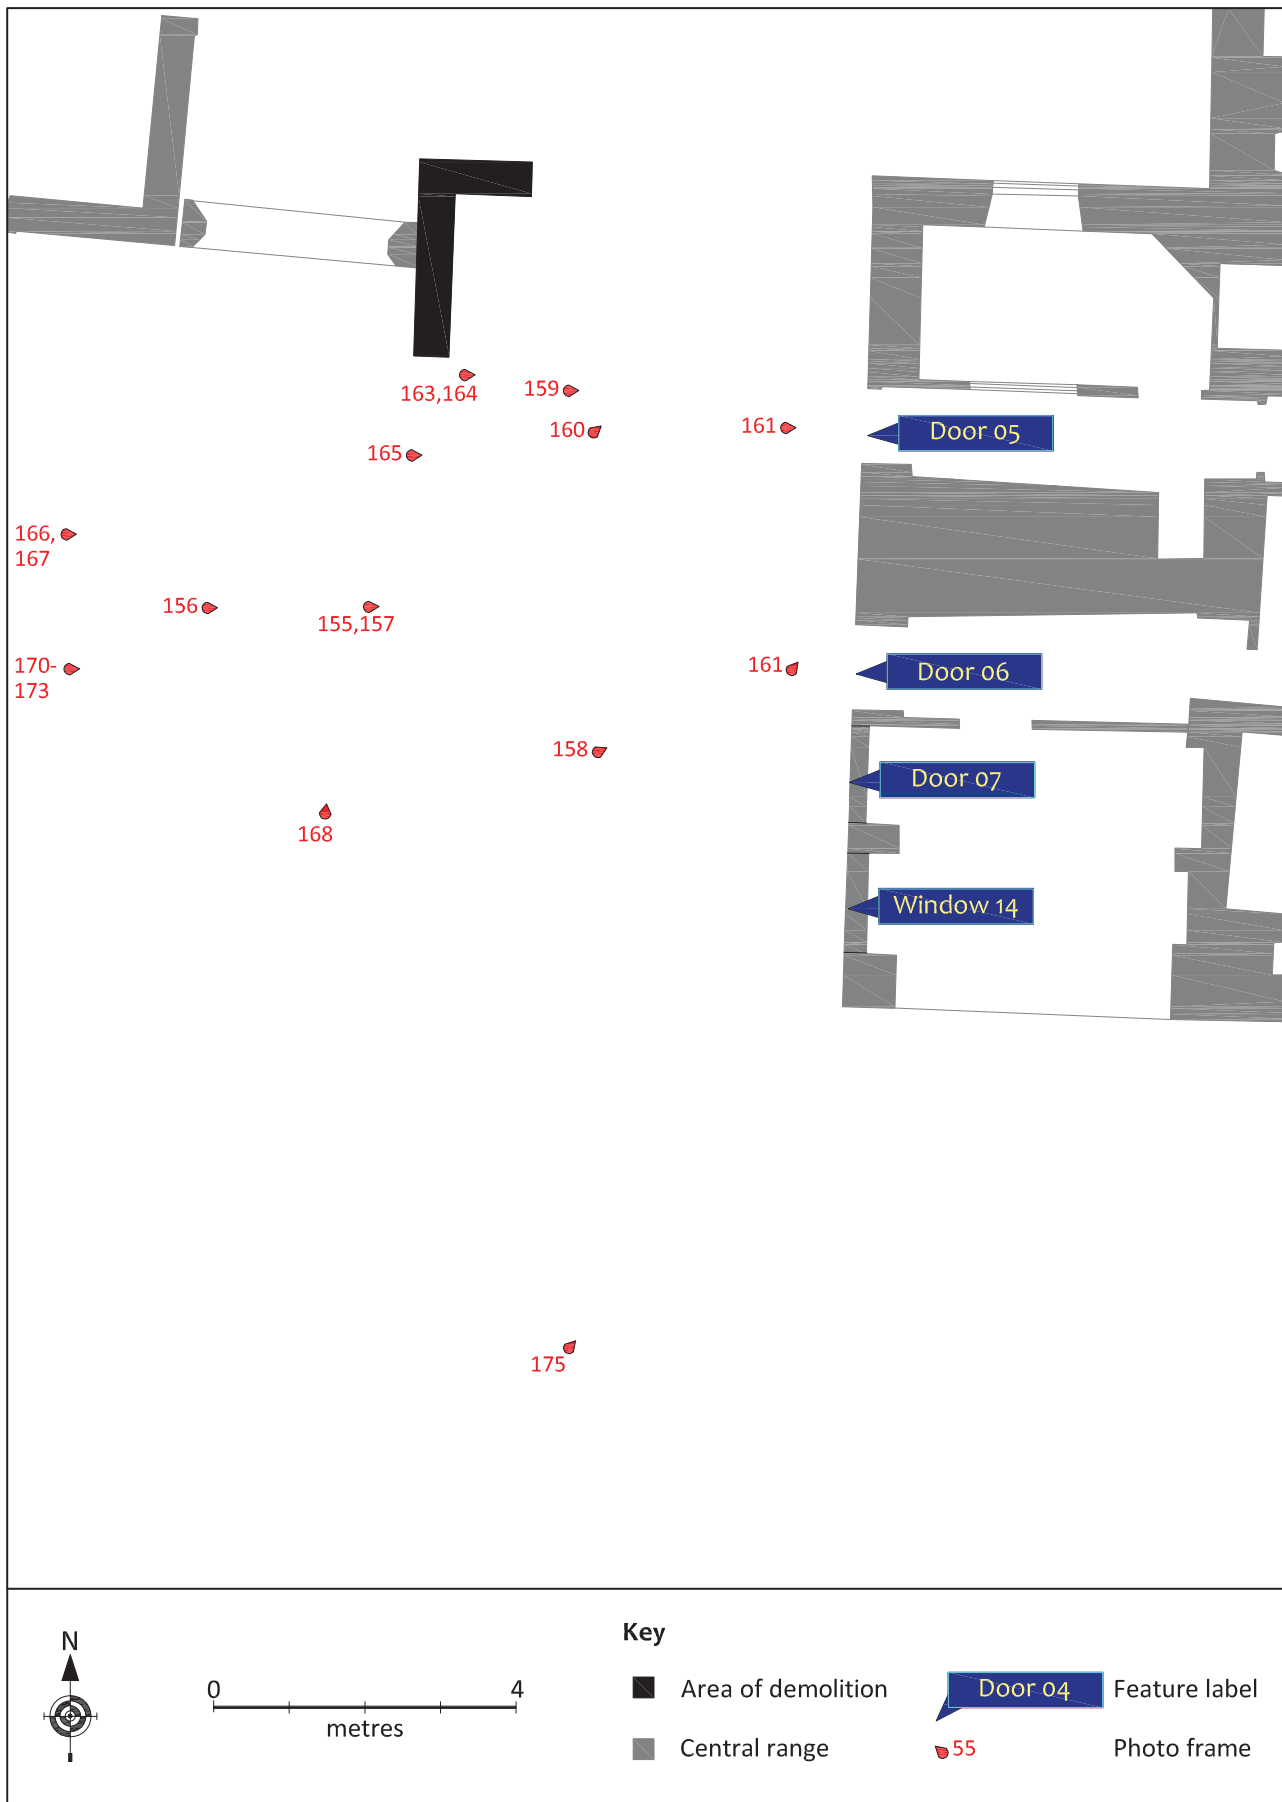
Figure 11. Ground floor plan, post-demolition

- 4.7.1 With the removal of the brick wing, a number of architectural features came to light within the western elevation of the stone central range that had been previously hidden by the later wing. Figure 11 records the features in plan, and Figure 12 shows a rectified image of the now exposed elevation.

- 4.7.3 Window 14: Window 14 was blocked with stone and more noticable from inside the opposing room within the the main stone range. The window opening measured approximately 1.5m by 1m, and had been covered with plaster on the ground floor.

- 4.7.4 Door 07: Door 7 was blocked with brick and almost completely covered by plaster on what would have been the inside of the brick wing. The door opening was more noticeable from inside the stone range. Of interest was the horizontal timber lintel that marked where the door had been, suggesting that this could have been an original door out of the western elevation of the central range. Of further interest is this door's positioning in comparison to Door 05. Unlike Door 06, this older door would have been equidistant with Door 05 from their respective wall returns, with the

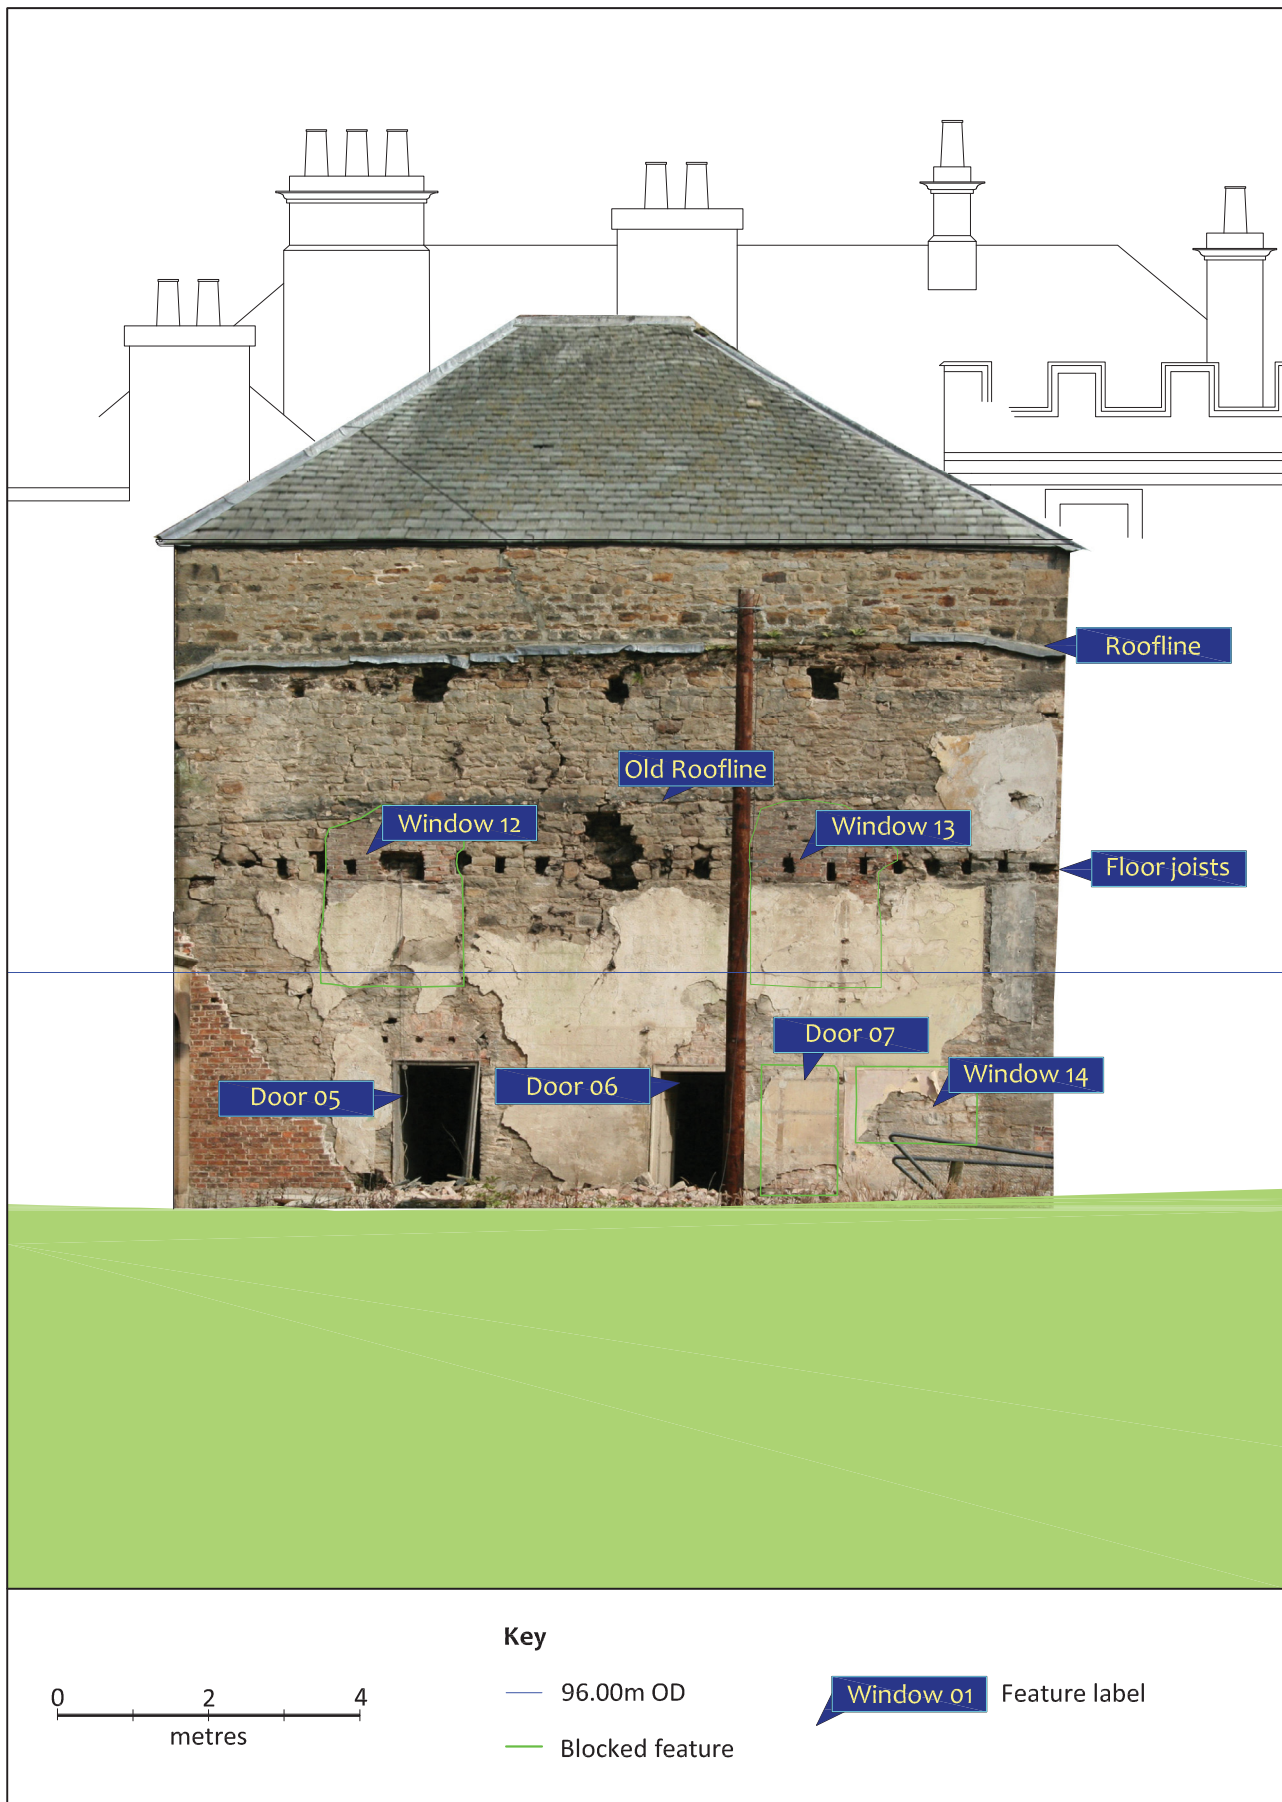
Figure 12. Western elevation, showing rectified photograph of elevation

- 4.7.2 Windows 12 and 13: These windows could be seen in the exposed elevation, roughly in line with the 1<sup>st</sup> floor as seen in Room 3, now blocked by brick (their location can be seen on Figure 9 and 12). The brick structure has also been broken by the insertion of the floor joists for the second story. From the shape of the blocked areas, these windows are likely to have been the same in size and shape as Windows 06-08 on the western elevation of the brick building - ogee headed Georgian Gothic in style.

- 4.7.5 Roofline: The roofline of the brick wing's 2 storey block is marked on the new western elevation by roof joist sockets in the stonework and by lead flashing and wooden blocks that joined the old brick wing roof to the western structure.
- 4.7.6 Old roofline: The old roofline (for when the structure was a single storey) can potentially be seen 5.35m from the ground as a stain on the side of the elevation. If this is indeed the line of the old roof, then it means that the ogee windows would have been removed from the main western elevation of the stone range when the brick wing was originally built.
