Hamsterley Hall  
Hamsterley  
County Durham

Emergency Archaeological Building Recording  
and Watching Brief

*Report 064-13-HS | July 2013*

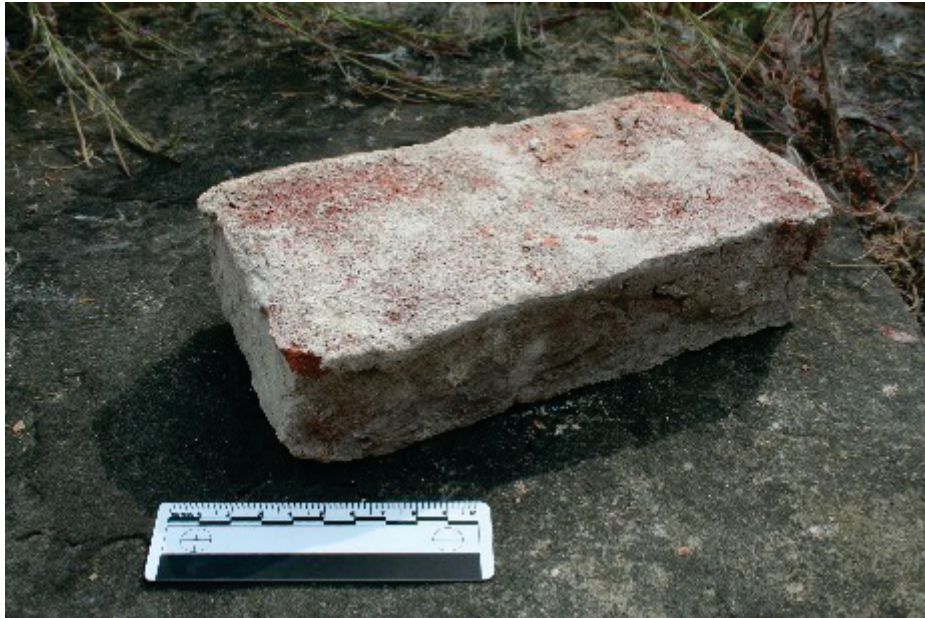
- 5.1.1 Hand-made brick, some narrower than others. Mottled red/black with multiple air pockets. Dimensions 0.215m x 0.10m x 0.05-0.07m. Likely dating from 1762 or pre-1762 construction.

*Plate 36. Brick type 01 (photo reference HHH13J182).*

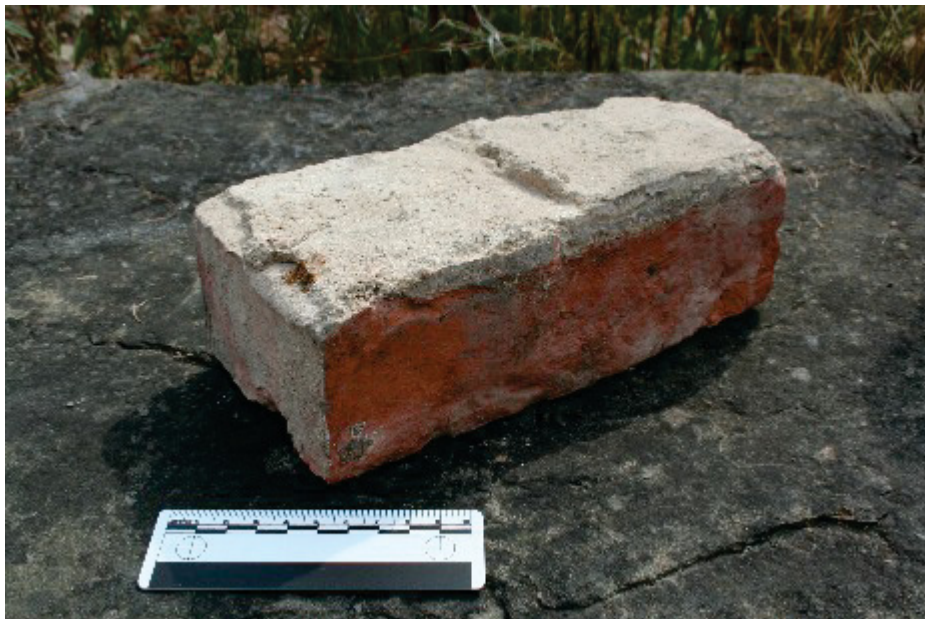
- 5.2.1 Hand-made brick, red, some narrower than others. Dimensions 0.215m x 0.10m x 0.055-0.065m. Likely dating from 1769 or post-1769 construction.

*Plate 37. Brick type 02 (photo reference HHH13J183).*

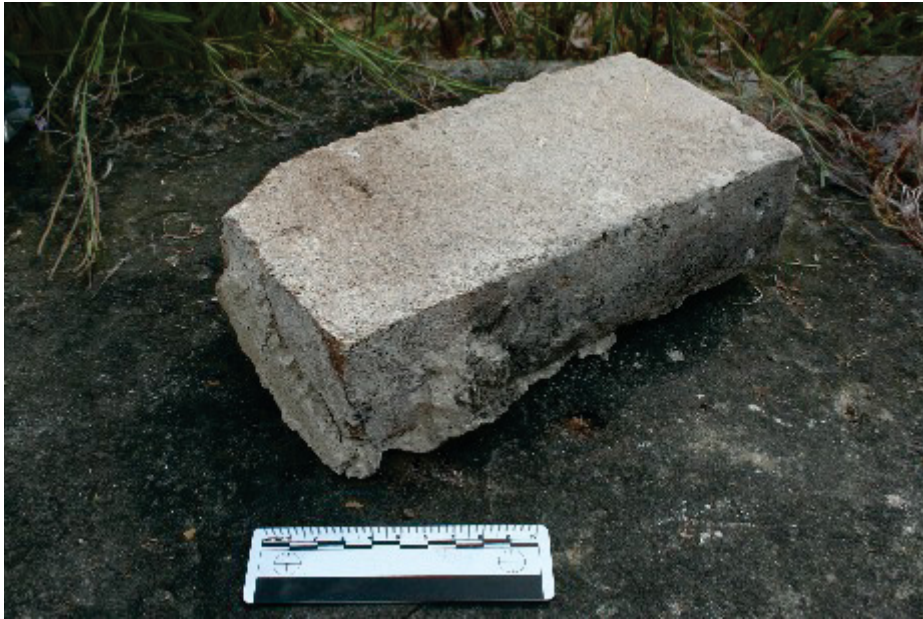
- 5.3.1 Firebrick, fine grained, pale brown. Dimensions 0.235m x 0.115m x 0.06m. Found in base for potential Regency period 'hob' range in Room 4.

**Plate 38.** Brick type 03 (photo reference HHH13J180).

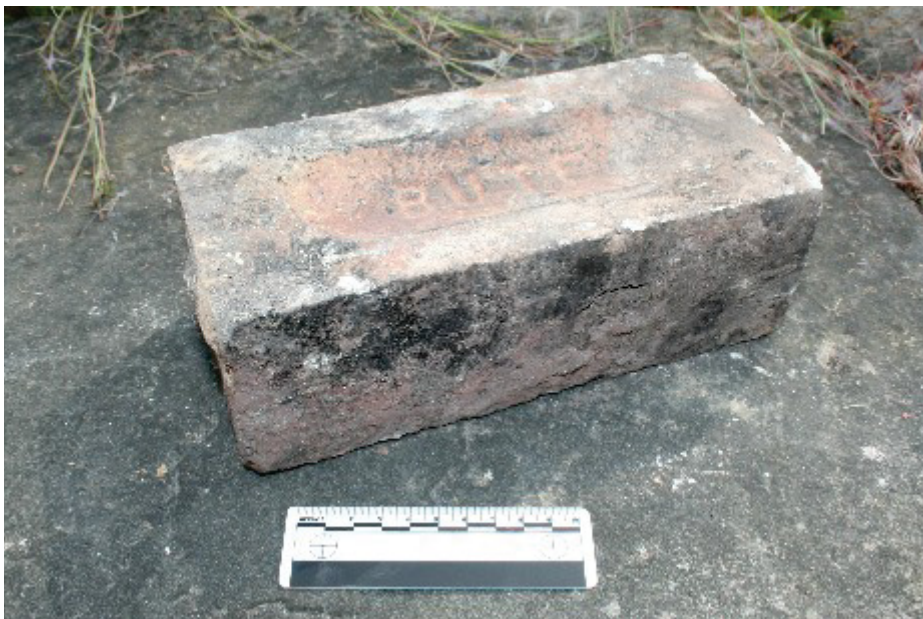
- 5.4.1 Machine-made brick stamped with 'BUTE'. The Bute Brickworks was based at High Spen, and produced the same bricks for Chopwell Colliery in 1947. Dimensions 0.23m x 0.11m x 0.08m. Found in the later walls surrounding the back boiler in Room 5.

**Plate 39.** Brick type 04 (photo reference HHH13J181).

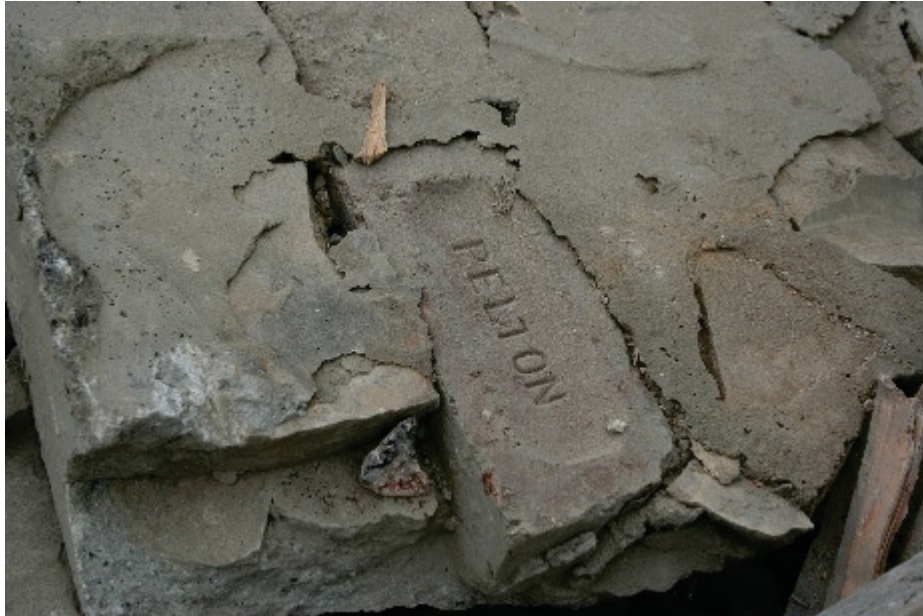
- 5.5.1 Machine-made brick stamped with 'PELTON'. This brick type may originate from Pelton Fell brickworks (closed in 1975) but this is uncertain. Found in the later walls surrounding the back boiler in Room 5.

**Plate 40.** Brick type 05 (photo reference HHH13J189).

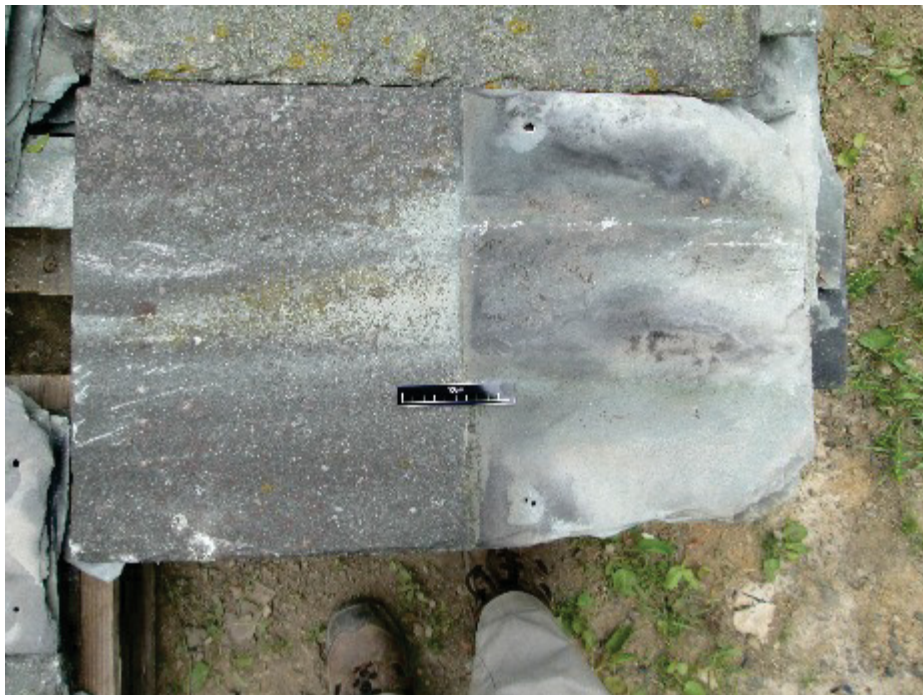
- 5.6.1 Westmorland slate roofing material, ranging in size and shape. Maximum size observed 0.70m x 0.60m x 0.08m).

**Plate 41.** Westmorland slate example (photo reference HHH13J190).

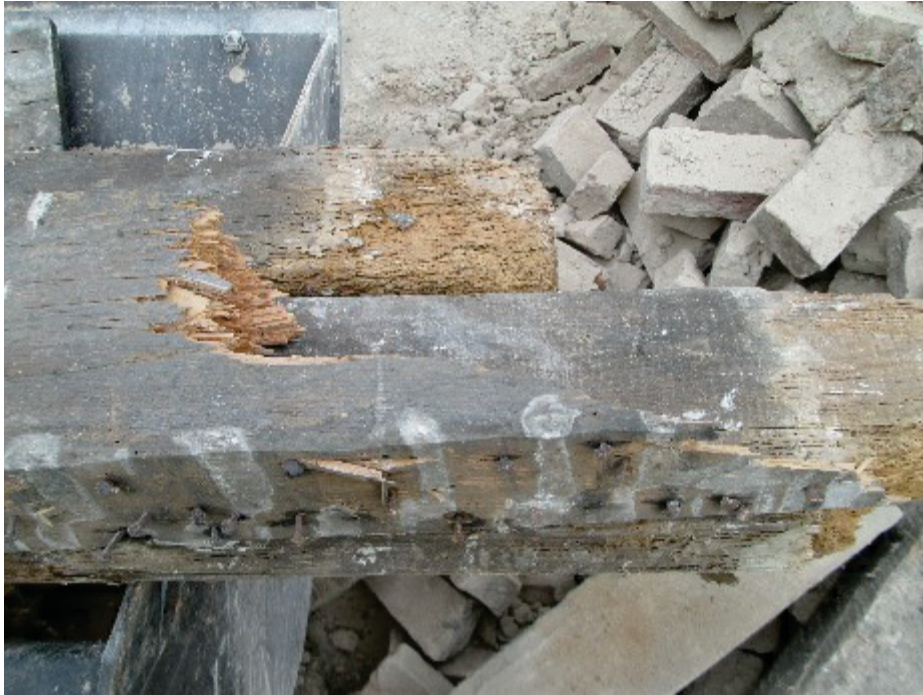
- 5.7.1 The remains of the original roofing materials were constructed of Douglas Fir, but were riddled with rot and woodworm.

**Plate 42.** Timber example (photo reference HHH13J187).

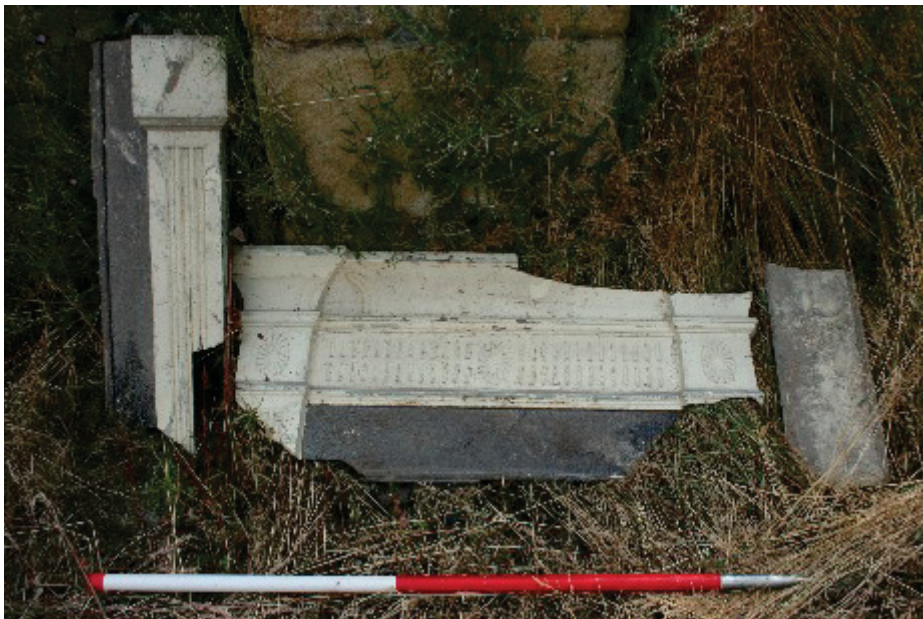
- 5.8.1 The remains of the cast iron fire surround from Room 1. The fire surround was of classical design with fluted jambs and oval medallions in the corners, suggesting a Regency or early Victorian date.

**Plate 43.** Fireplace 01 (photo reference HHH13J177).

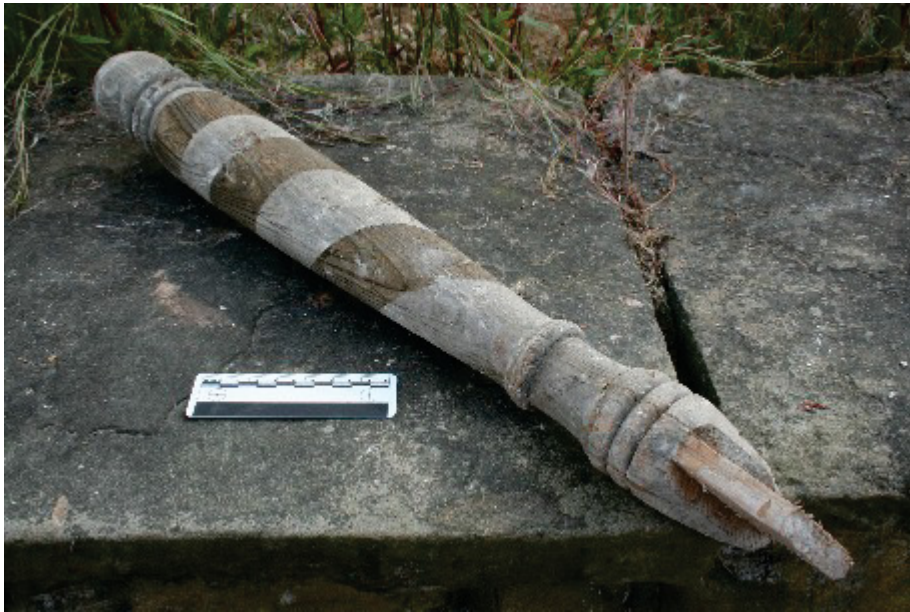
- 5.9.1 An example of one of the staircase's ballustrades. The striped effect is from hazard tape being wound around the shaft.

*Plate 44. Ballustrade example (photo reference HHH13J179).*

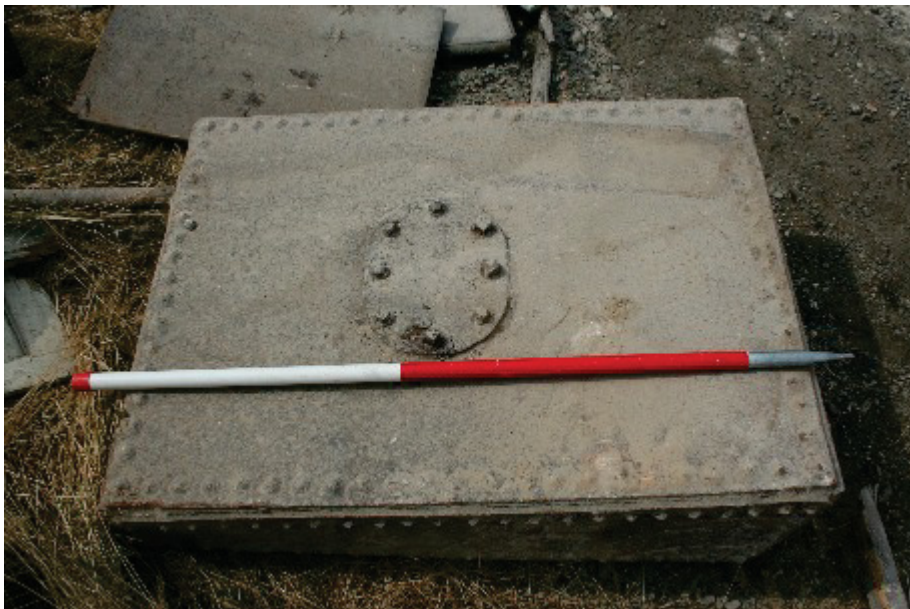
- 5.10.1 The back boiler was possibly installed in the 1940s, replacing the fireplace that had once been set on the southern wall of Room 5.

*Plate 45. The back boiler (photo reference HHH13J178).*
