GRETA VIEW BARN

Low Road, Bowes
County Durham

Historic Building Recording

Project 250-19-HBR | August 2019

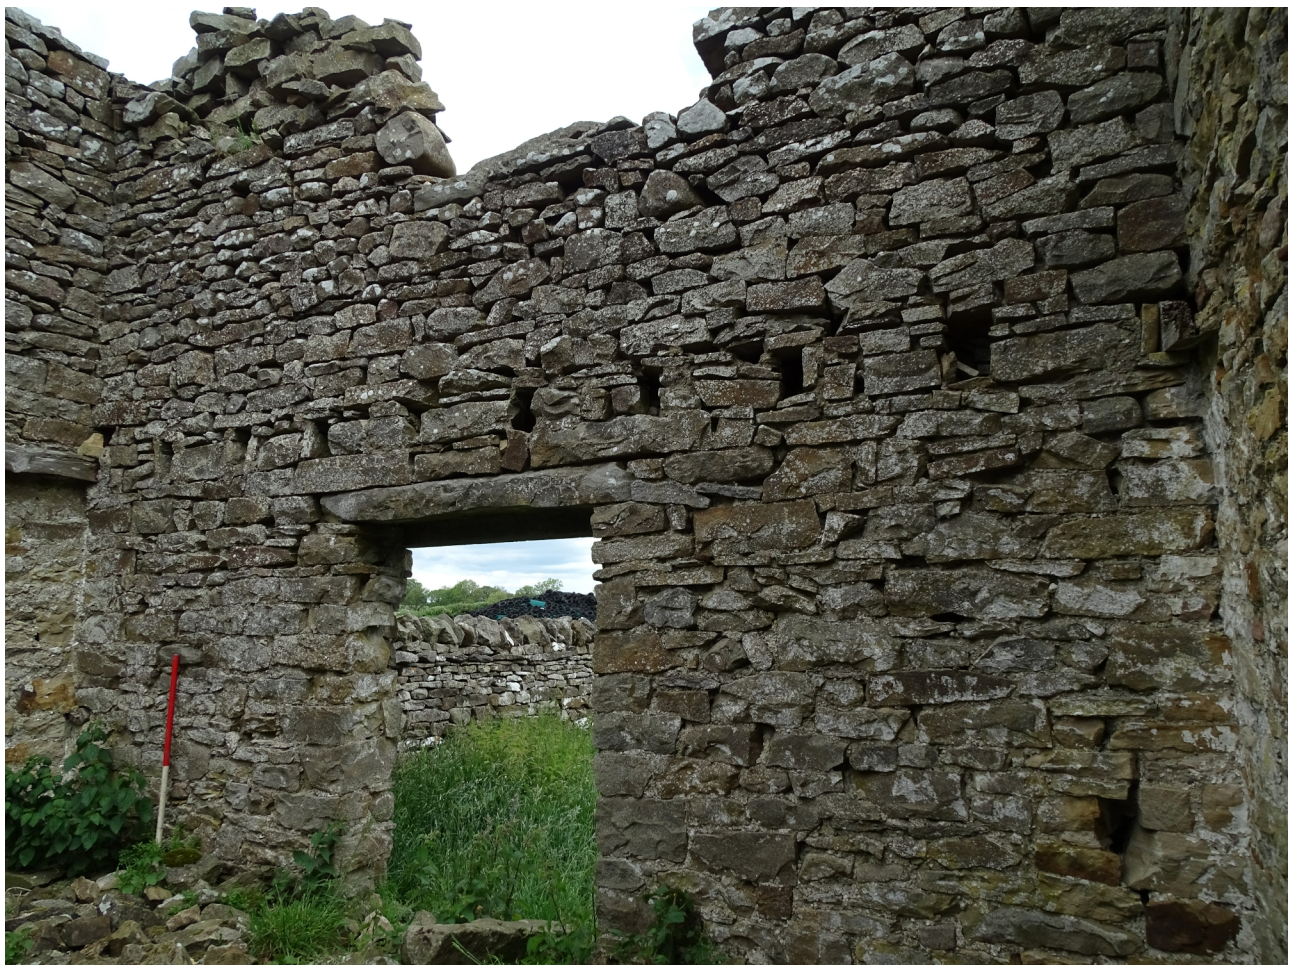
Plate 21. The east wall of Area B, showing detail of upper floor joist sockets (frame GVB19043)

northern elevation is located directly above the internal west partition wall and is generally in a poor condition, with the sill missing allowing a partial collapse of the window's lower courses. There is no frame but the window's lintel is still *in situ*. There is one lower arrow loop within the elevation, with an upper lintel and lower sill intact and its description conforming to the other arrow loops. The block work associated with the northern elevation is of roughly hewn, partially dressed un-coursed sandstone and limestone

- 3.3.8 The internal eastern elevation of the room is constructed of partially dressed sandstone and limestone, squared and randomly coursed. The lower portion has been mortared and pointed in places although this is sporadic. There are eight recessed joist sockets visible within the elevation located midway within the elevation immediately above the access door to **Area A**. These recessed joist sockets are integral supports for the missing/collapsed roof associated internally with the room. The external access doorway within the elevation has an impressive single limestone lintel but has no frame; the sides of the doorway have been pointed. The central portion of the elevation has collapsed above and around the centrally located single window aperture within the wall, leaving only remnants visible. There are no frame, sill or lintel remaining. The internal eastern elevation is generally in a very poor condition.
