**BUILDING SOUTH OF
WHINFIELD COTTAGE**
Windy Bank Road, South Bedburn
Woodland, County Durham
NGR 406578 527310

Historic Building Recording

Project 284-19-HBR | November 2019

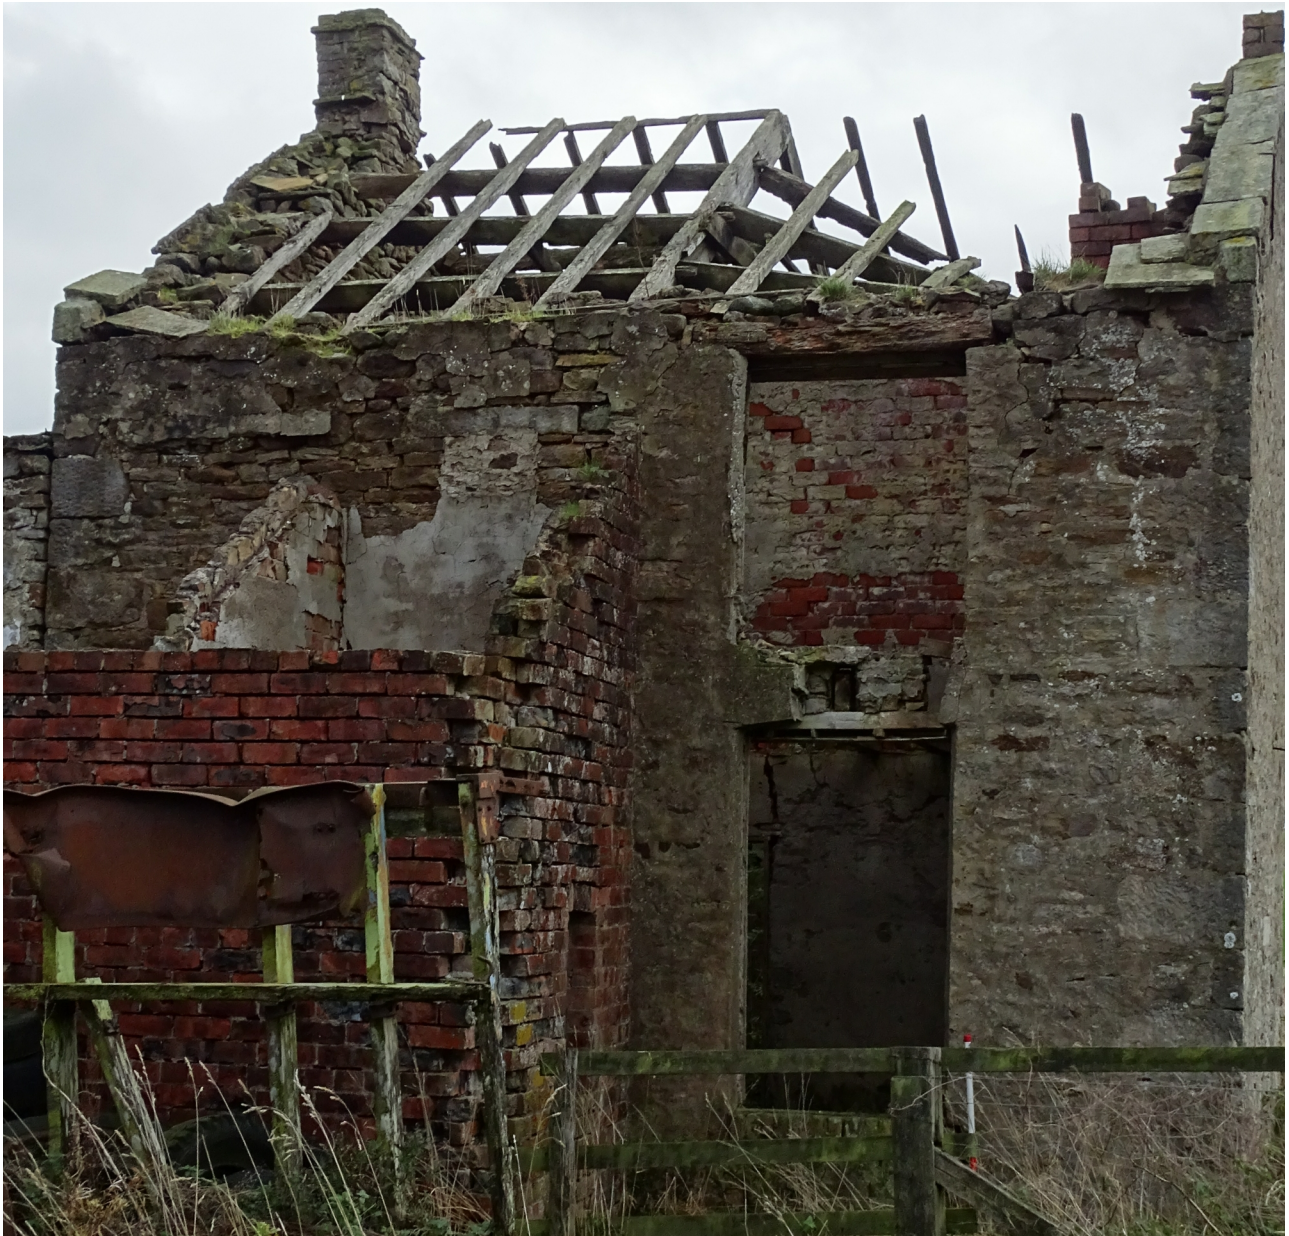
Plate 12. The north-west elevation of the main house (frame WCW010).

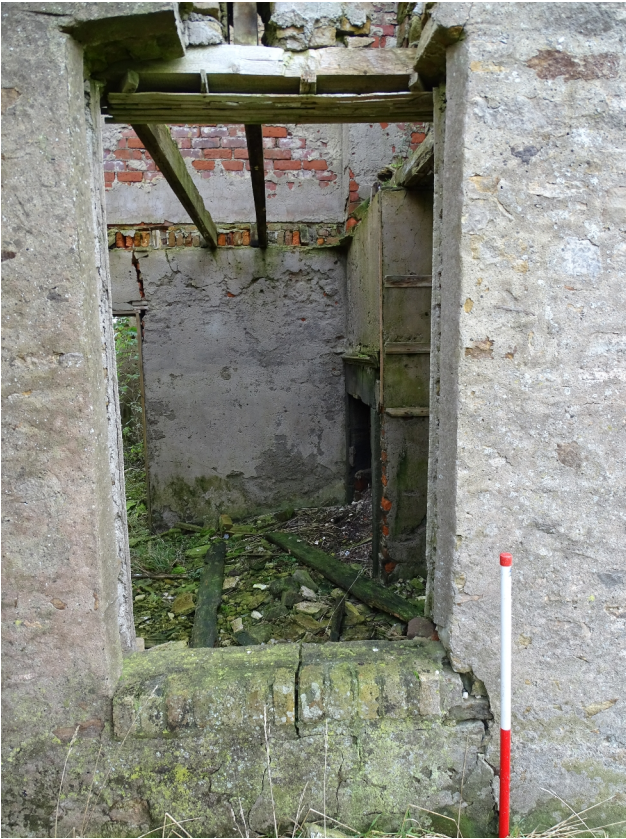
Plate 13. The north-west elevation ground floor window (frame WCW011).

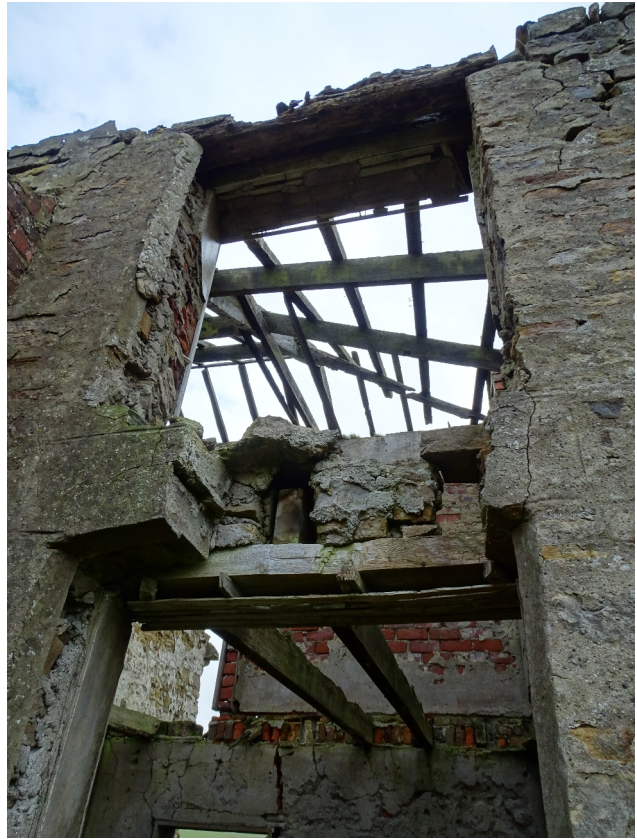
Plate 14. The north-west elevation first floor window (frame WCW011).

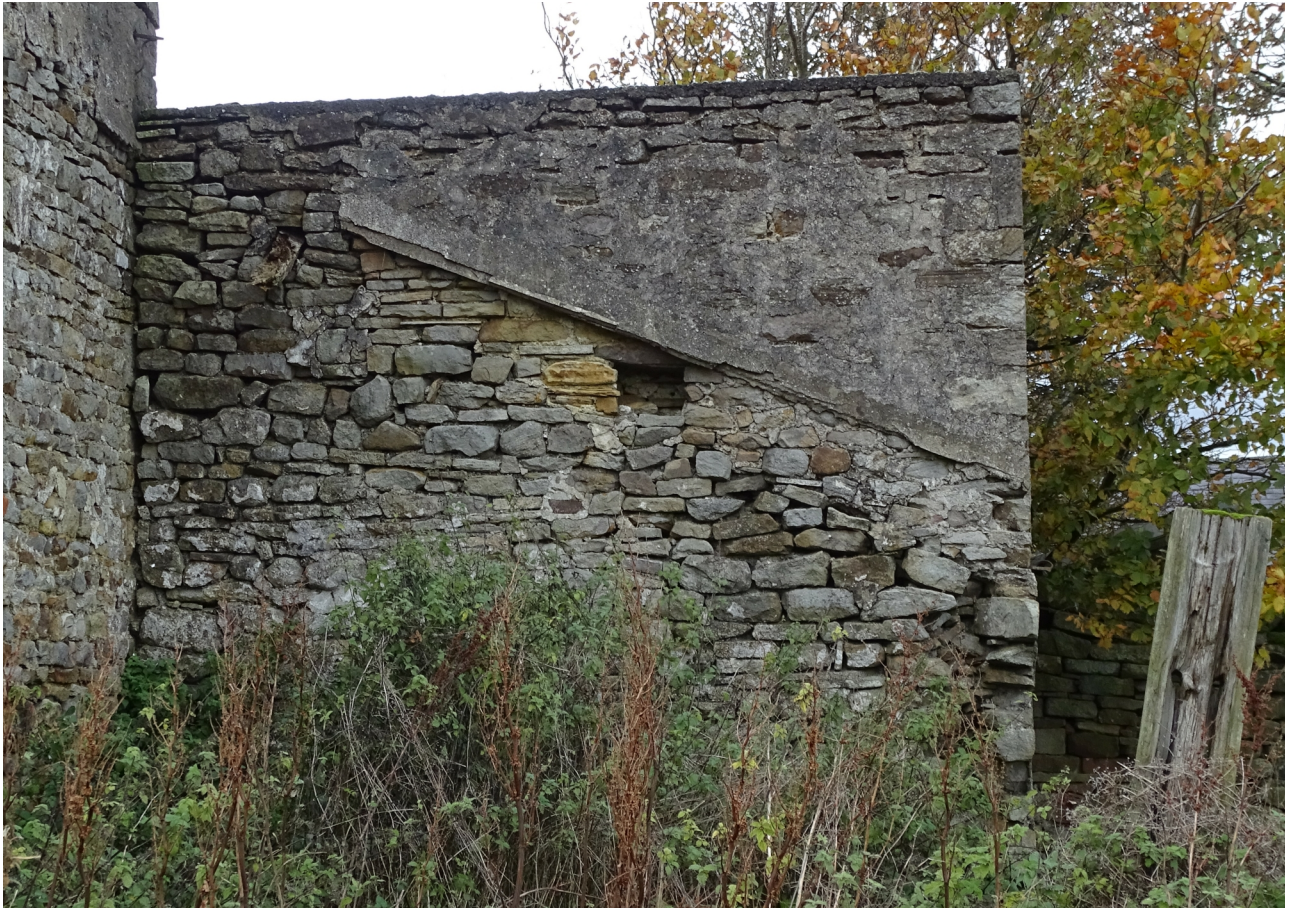
Plate 16. The internal south-facing wall of the lean-to (frame WCW017).

3.2.11 **North-west facing elevation:** The main north-eastern elevation of the main house was rendered (see Plate 15) above the roof line for the lean-to 'barn'. Historic mapping shows that the barn was derelict by at least 1978. Where the north-western elevation would have been within the 'barn' it can be seen to be constructed of rubble and slabbed stone, roughly coursed and repaired in a number of places. Voids relating to the timber structure of the lean-to can be seen within the wall, and Plate 17 shows the internal south-east facing wall of the structure, which can be seen to butt the main house and was not keyed in.

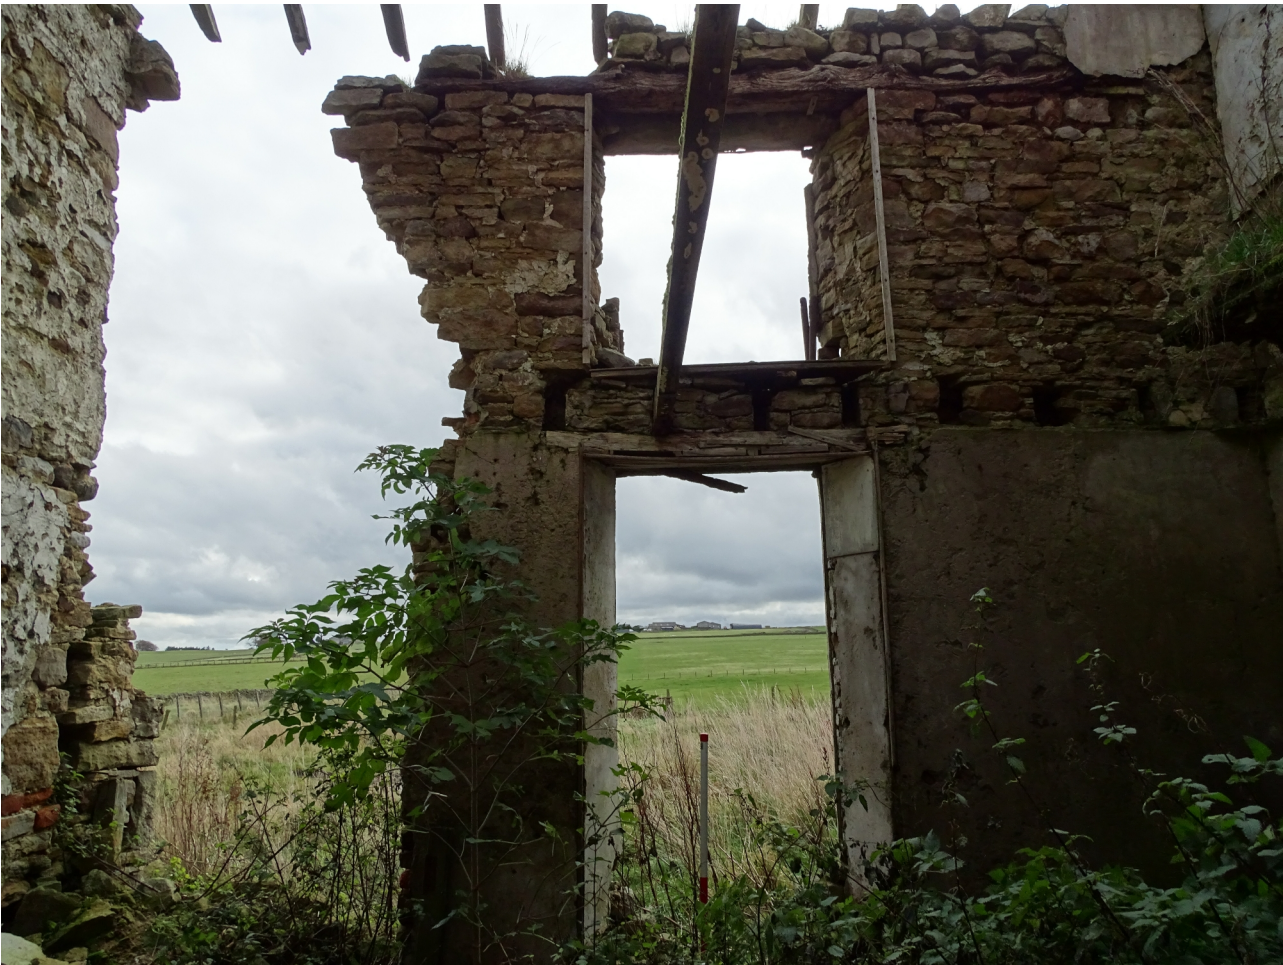
Plate 18. The internal north-west facing wall of Room A (frame WCW025).

3.3.2 **Room A:** This area would have been the primary living area for the house on the ground floor, with a large window in the southeast wall as well as the main entrance (see Plate 18). Internally, the walls on both floors were rendered, though most of the render had fallen from the upper floor walls. The joist holes for the ceiling/floor were visible in the southeast and northwest walls.

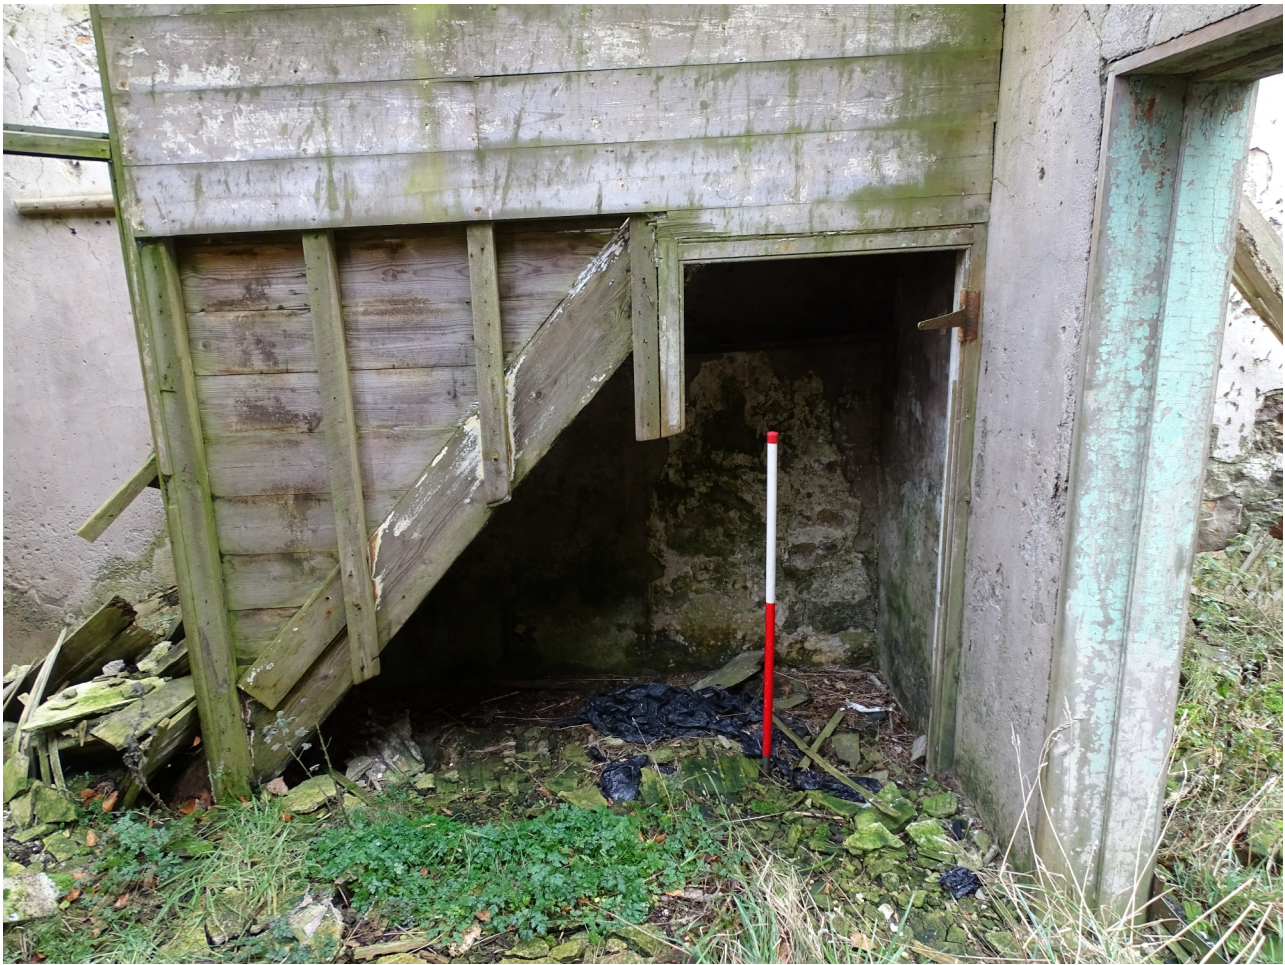
Plate 24 (above). The timber framed staircase in Room B (frame WCW033).

- 3.3.7 **Room B:** The northeast wall of this room was taken up by the remains of a timber staircase up to the first floor, with an under-stair cupboard below (see Plate 24). The staircase was in a dangerous condition as can be seen in Plate 25. The timber panelling for the staircase had also formed a ground floor wall, with a doorway from the main room lying to the north of the staircase. The first floor appeared to be partly rendered, with no features of interest visible.
- 3.3.8 The southeast wall of the room as noted in Room A was a later brick construction and remained partially rendered on the upper floor (see Plate 26) and fully

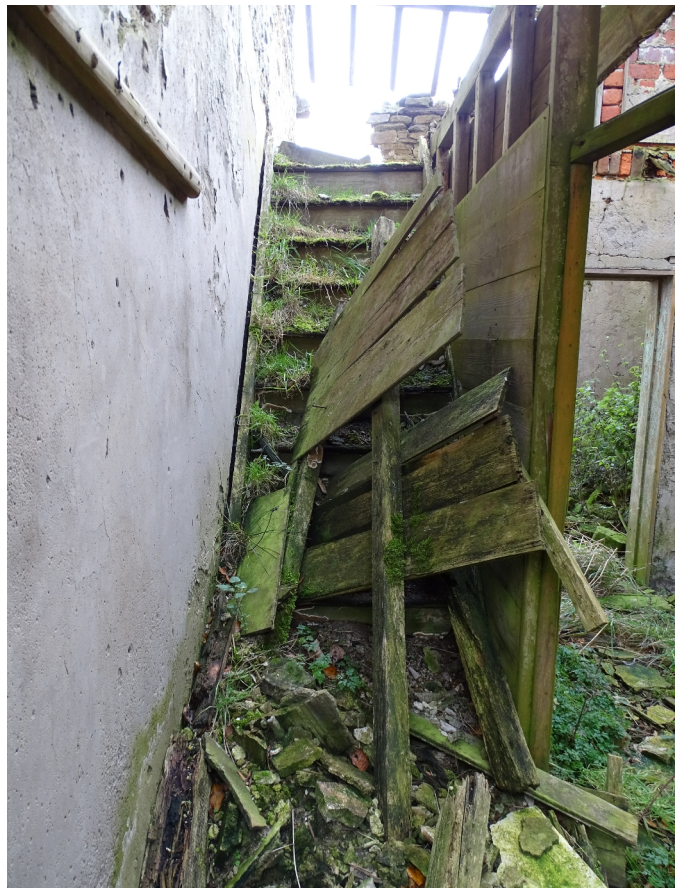
Plate 25 (right). The timber framed staircase in Room B (frame WCW035).

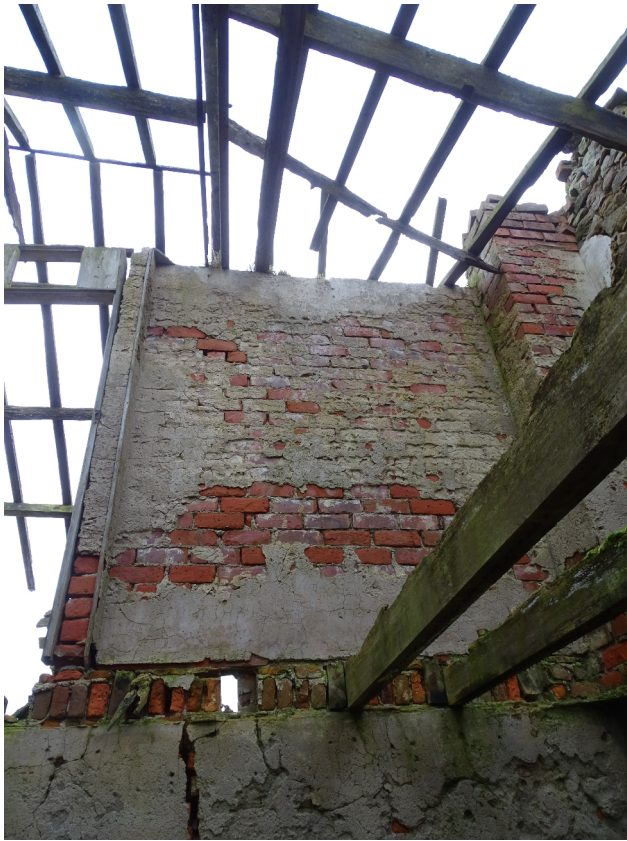
Plate 26. The first floor southeast wall of Room B (frame WCW030).

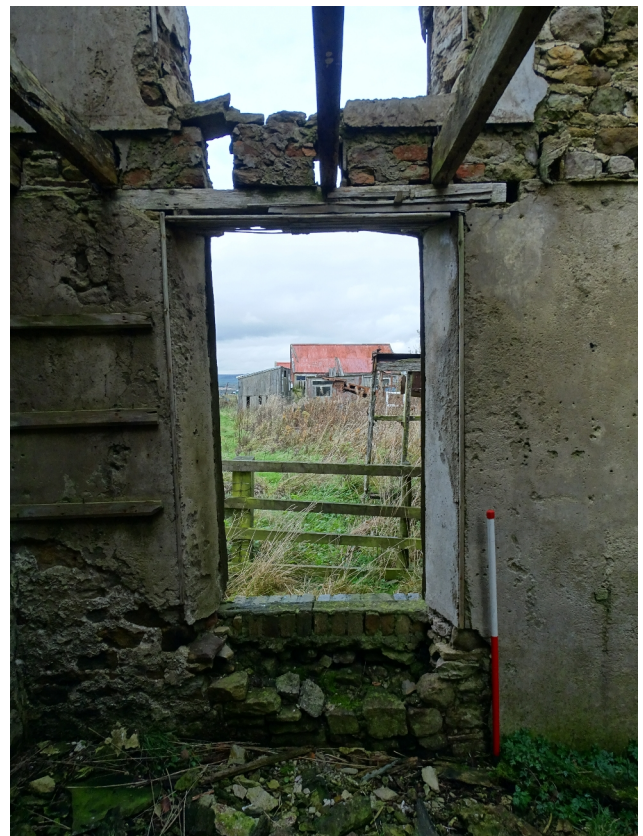
3.3.10 The northwest wall is partially rendered and holds timber framed windows on the ground and upper floor, along with the precarious remains of the ceiling/floor

Plate 28. The ground floor window in Room B (frame WCW031).

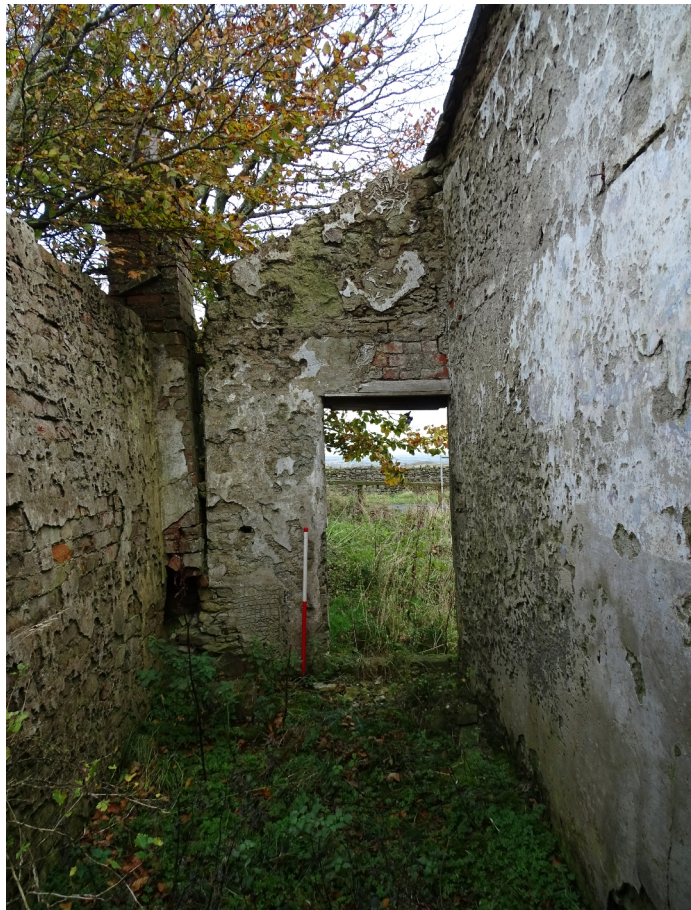
Plate 30. The late 19th century extension looking northeast (frame WCW039).

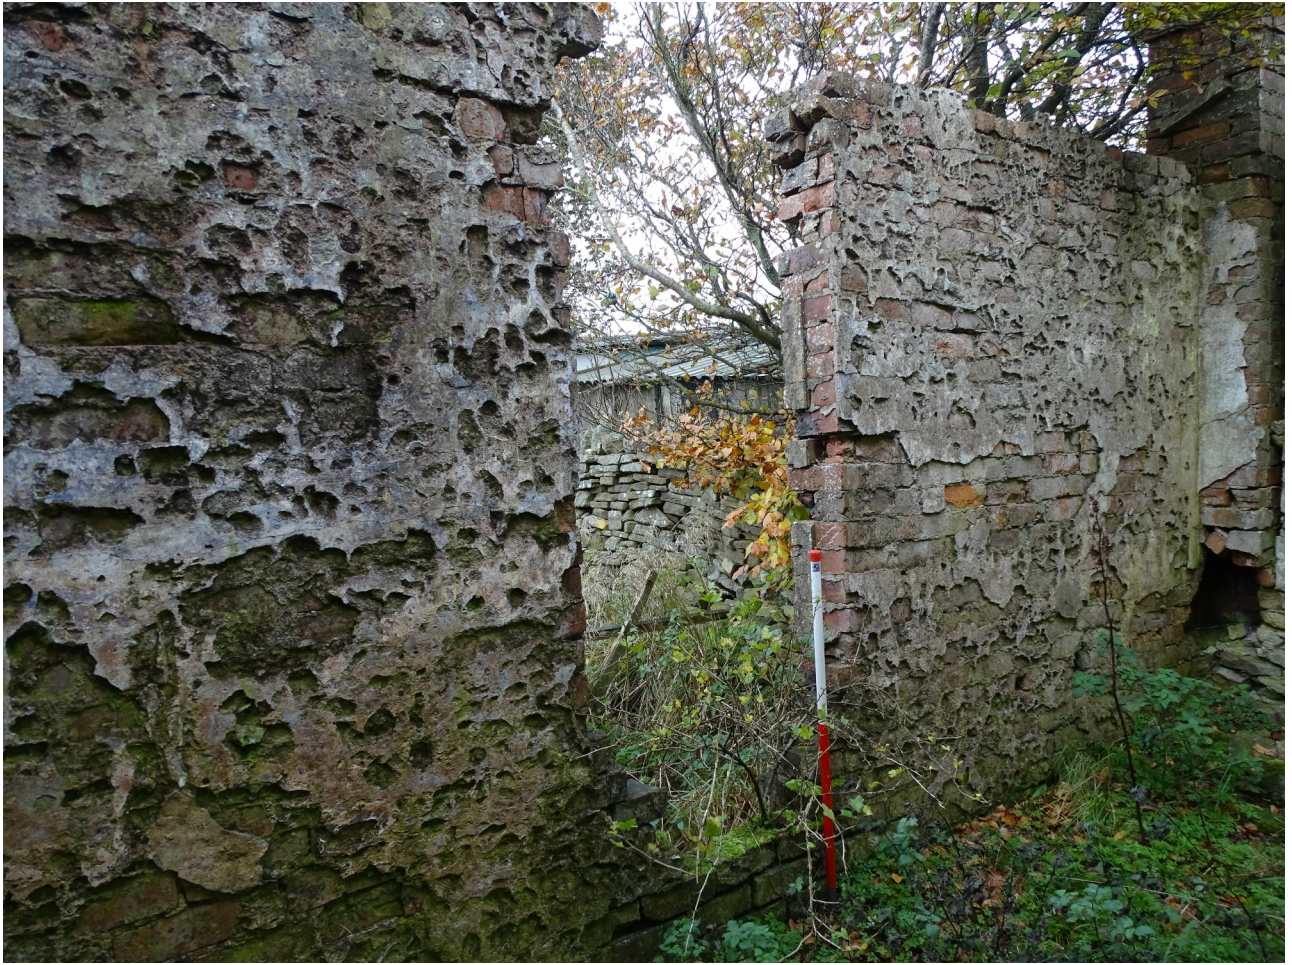
3.3.11 **Room C:** This area forms the main space within the northern brick extension. The structure was a single storey lean-to, with the inner southeastern wall formed by the stone northwestern wall of the main house and attached barn. The northeastern wall was also constructed of stone, with a single door set with a timber lintel and three courses of brick fill above (see Plate 30). The northwestern wall was of brick with degraded render over, with a large window set within it (see Plate 31).

Plate 31. The window within the northwestern wall of the extension (frame WCW042).

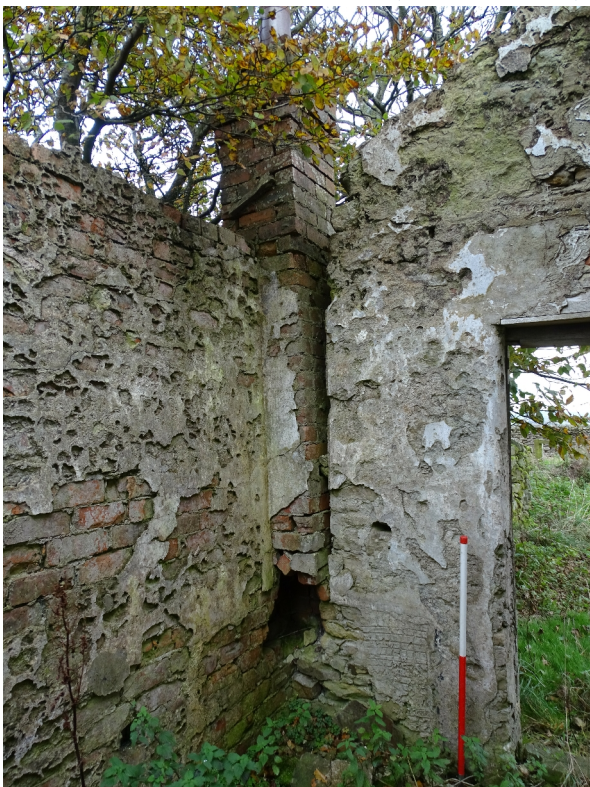
Plate 33. The late 19th century extension looking southwest into Room D (frame WCW038).

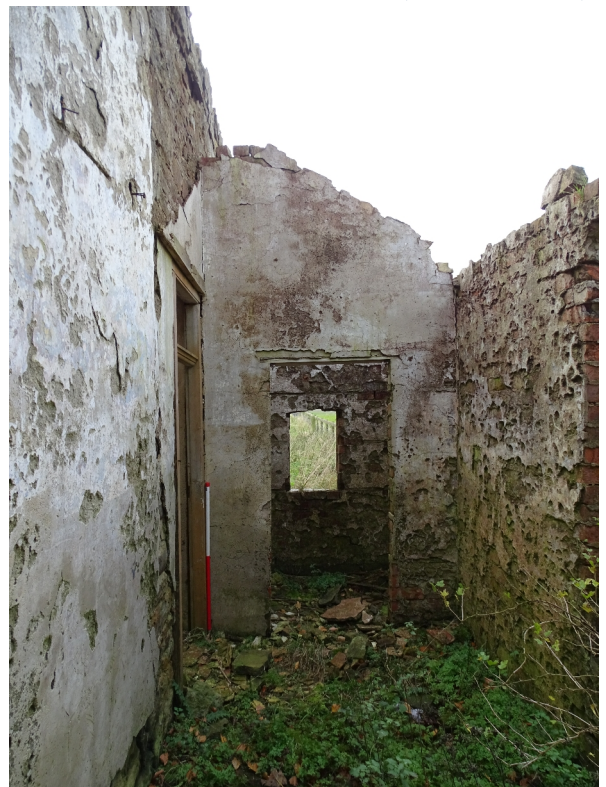
Plate 34. The southern corner of Room C, granting access to Room B (left door) and Room D (right door) (frame WCW036).

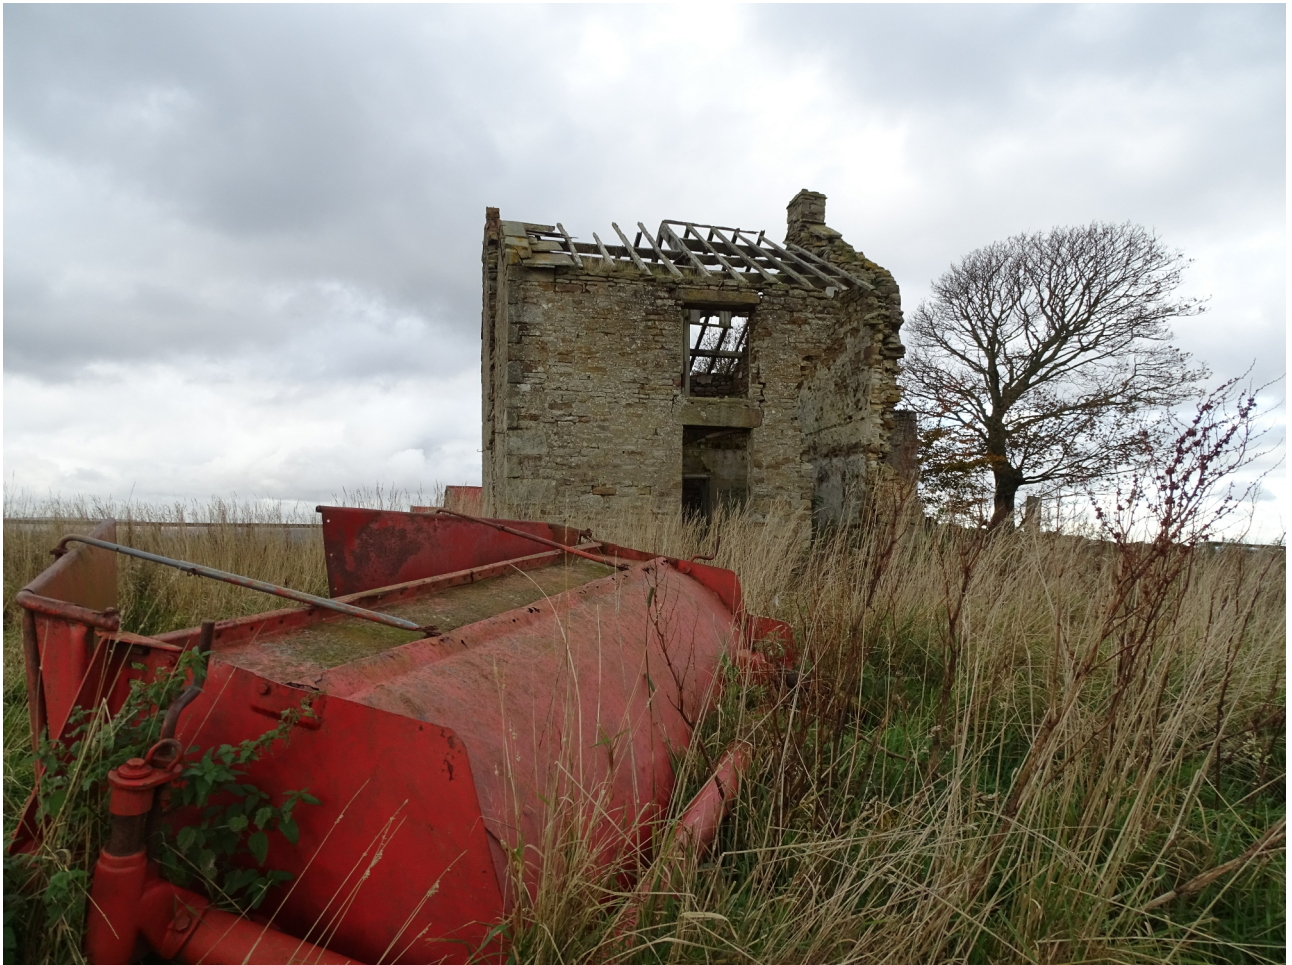
Plate 36. The house from the southeast (frame WCW001).

- 4.1.2 *The structure is a standard example of an early 19th century agricultural workers' accommodation building but it is in very poor condition and subject to collapse. No features remain within the structure that would require preservation.*
