December 2012

Archaeological Assessment of the moat at Lower Brockhampton, Bromyard, Herefordshire

Herefordshire Archaeology Report No. 314

**NGR: SO 6874 5590
EHE 2061
HAR 314**

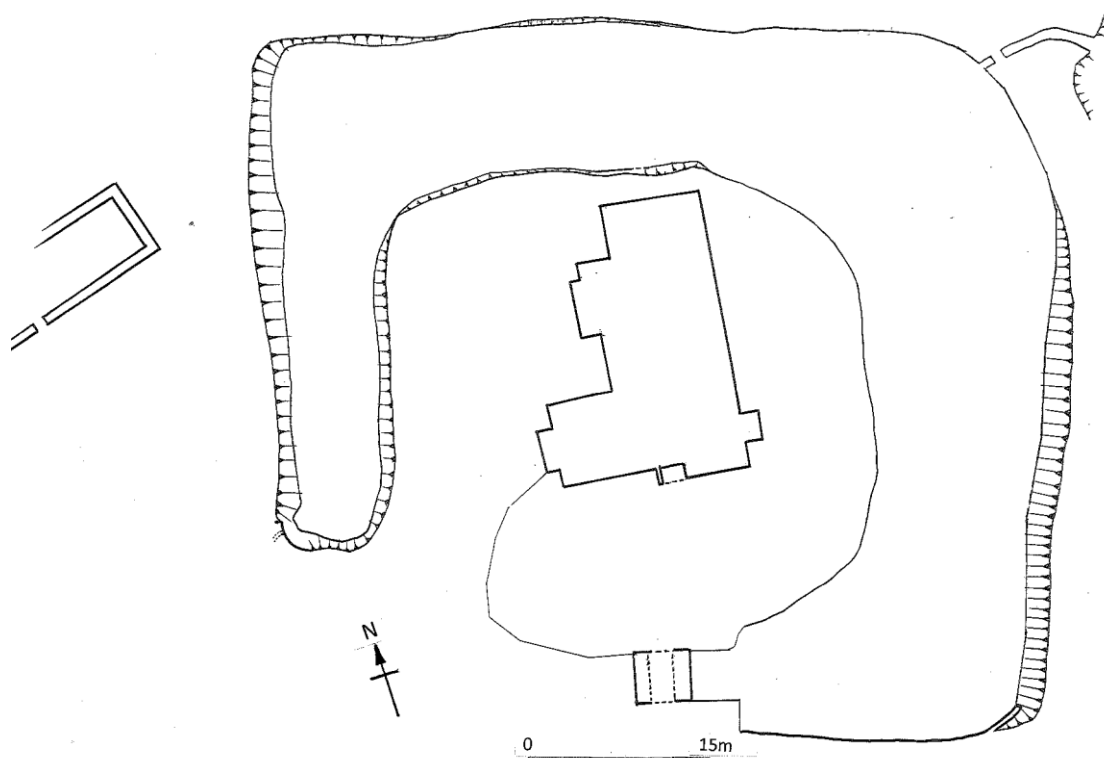
Figure 9: Measured survey plan produced in order to locate the buildings accurately in relation to the present edges of the moat.

A new accurate measured survey plan was produced using a Total Station survey instrument. This new survey plotted the top and bottom of the moated area bank, together with the footprint of the house, gatehouse and chapel. This was then used as a base plan onto which features relating to changes associated with the moat could be mapped (figure 9).

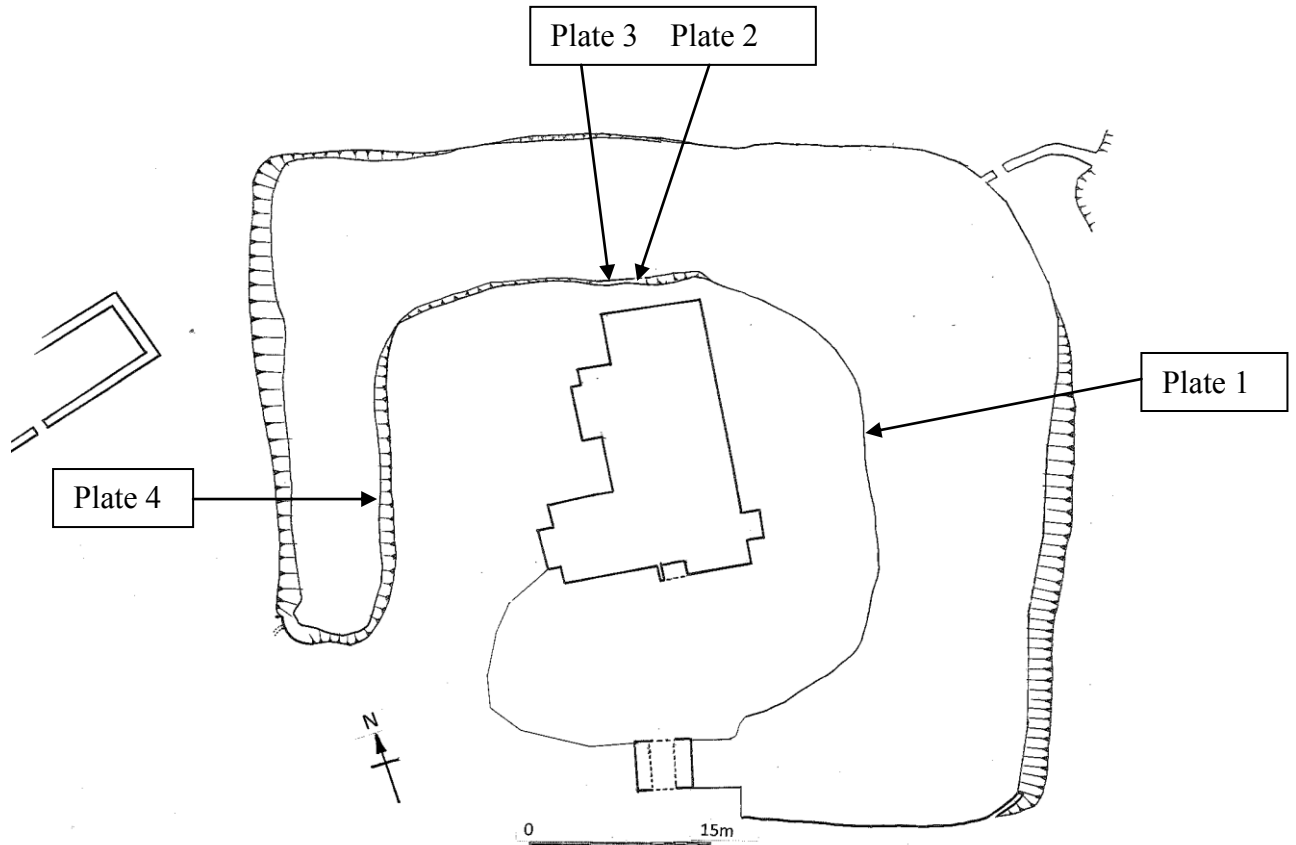
Figure 10: Location of features photographed on the inner bank of the moated area

The inner bank of the northern arm of the moat is higher and steeper than the bank along the western inner edge of the eastern arm of the moat. It appears that much of this stretch was revetted in the past by a masonry wall (Plate 2). The surviving extent of the walling is not known, but displaced masonry lies within the moat along most of the northern side (a distance of around 25 metres).

The collapsed masonry is particularly dense along the line of the north gable end of the most northerly part of the east wing of the house, and the rubble continues around the inner bank-edge of the western arm of the moat. This suggests that this bank, also, was once revetted by a stone wall (Plate 4). In places, large stone blocks appear still to be attached to the bank. However, not enough survives to indicate the original scale of the revetment.

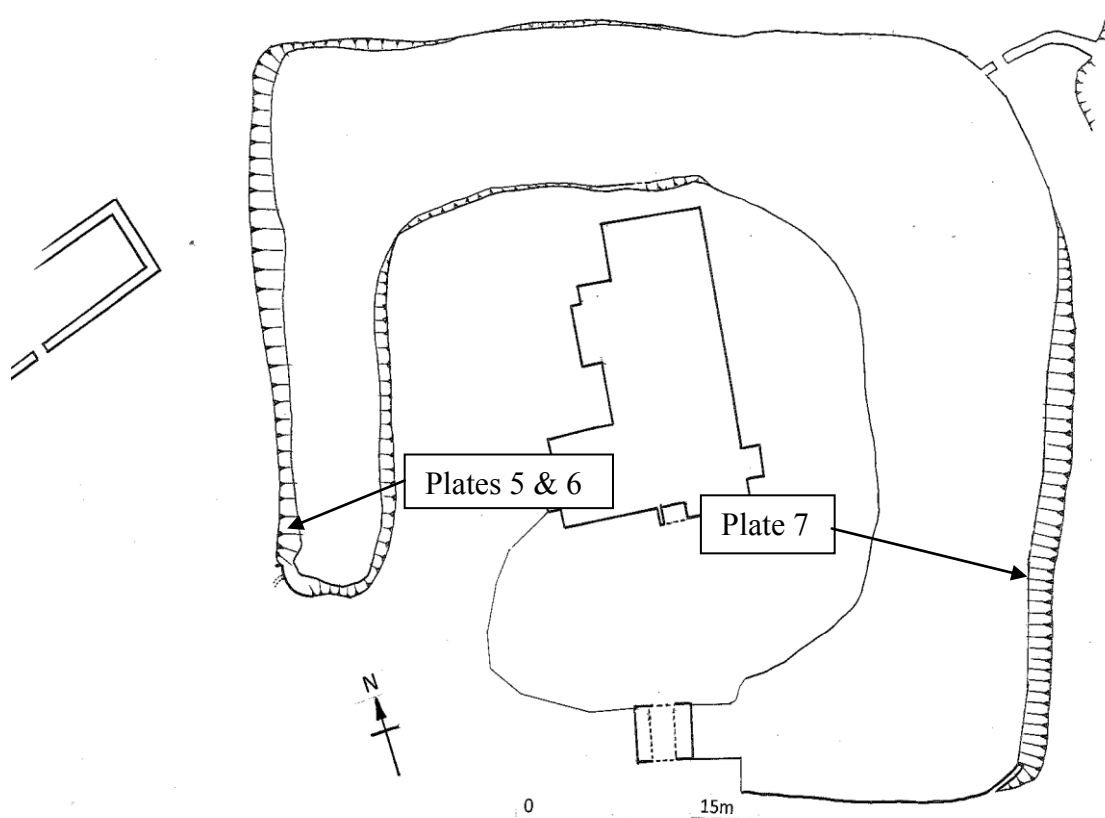
Figure 11: Location of features photographed on outer bank of moat

This system of timber revetment was presumably an attempt to halt both erosion through water action and more localised decay caused by water-fowl. This system of bank stabilisation appears to have had only limited success as the water has penetrated behind the planking and has undercut the bank (in some cases substantially). Further scars are being produced by water-fowl using localised areas to enter and exit the moat, (see plate 7).
