HEREFORDSHIRE ARCHAEOLOGY

A Programme of Archaeological Observation and Recording Snodhill Castle, Peterchurch, Herefordshire

March 2018

> Herefordshire Archaeology Report No. 374 Event No. EHE 80341

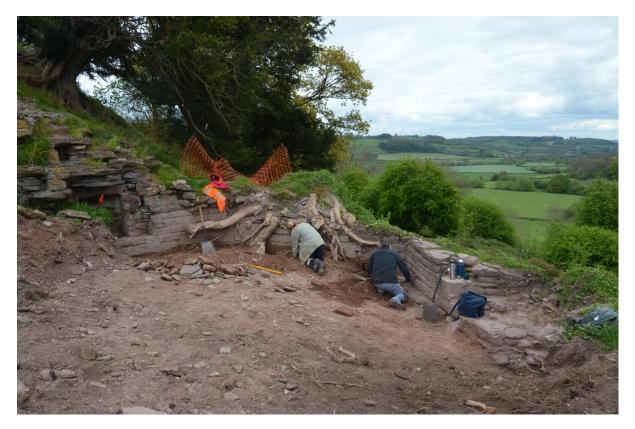
The internal area of the bastion was pulled back and graded in order to form a gentle slope to assist with drainage and to ensure a safe approach to the surviving wall. No deposits of archaeological significance were encountered and no worked stone was encountered during these works.

Plate 1: Cleaning and recording after machine grading of the internal area of the South Eastern bastion.

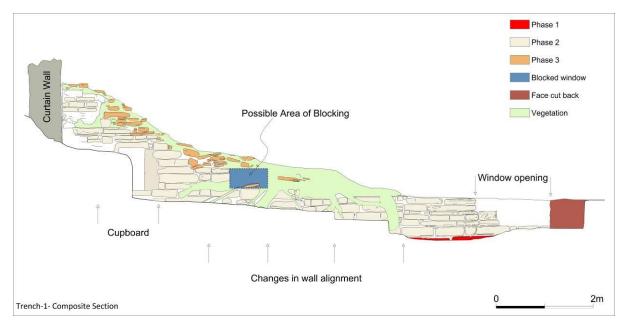
Figure 3: Composite section, Trench 1.

The external appearance of the south bastion shows that the south bastion is rounded however the internal elevation reveals that the south bastion is formed from a series of straight walls with angled junctions (See figure 3).

Prior to the consolidation works it was noted that a series of unbonded flat stones forming a rectangle had been laid upon the top of the south bastion wall, it was speculated that they may represent civil war fortification of the structure (See figure 3).

Located towards the south of the south bastion evidence was observed for a large splayed window with later blocking, the window had had the cill/floor removed, examination of the wall face indicated that the east splay had been cut back (see plate 2, figure 3). Within the west a single stone jamb remained illustration the style of decoration applied to the window jambs, this comprising of a chamfered jamb with lozenge stop end (See plate 3 figure 3).

Located within the junction between the south and east wall of the south bastion at approximately 0.75m below existing wall level an angle line of masonry was recorded (See plate 4, figure 3), the exact nature of this feature was uncertain, however it may reflect a change in the construction of the south bastion wall, a shelf or structural bracing.

During the original excavation (HAR 367) it was a speculated that a blocked window opening existed on the east wall, a series of straight line construction breaks were observed (see figure 3), however during the process of consolidation and tree root removal no indication of the blocked window was detected.

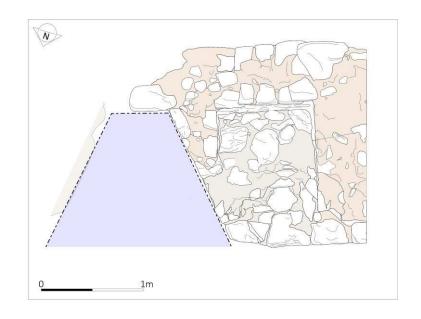
Figure 6: Trench 6, plan showing phase 1 window opening.

Originally a splayed window opening had been formed in the south wall of the keep. (See figure 6) it is interesting to note that the splayed opening is not cut through the full width of the wall and reflects the same depth as the later cupboard or niche. Within the blocking of the window it was observed that the original splayed opening was finished with a thick (approximately 0.015m) plaster finish, however no decoration or surface finish was detected on the surviving plaster.

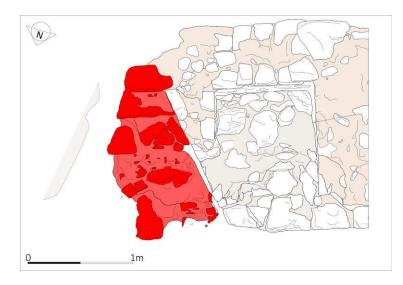
Figure 7: Trench 6, plan showing phase 2 window blocking.

The window opening was blocked (See figure 7) using flat rubble blocks bonded with a creamy yellow mortar, similar to that seen in the main wall construction.

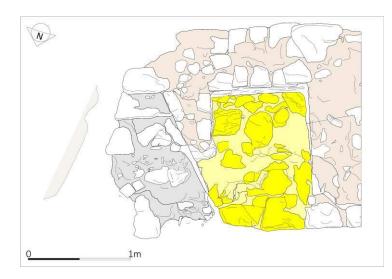
Figure 8: Trench 6, plan showing phase 3, construction of cupboard or niche in wall structure.

Following the blocking of the original window opening a rectangular niche or cupboard is cut into the core work of the wall, the west splay of the original window opening, and subsequent blocking material being cut to form the east return wall of the niche or cupboard. Evidence

existed to indicate that the cupboard was finished with a plaster render, comparable to that observed within the original splayed window, however not as thick (0.003m). (See figure 8)

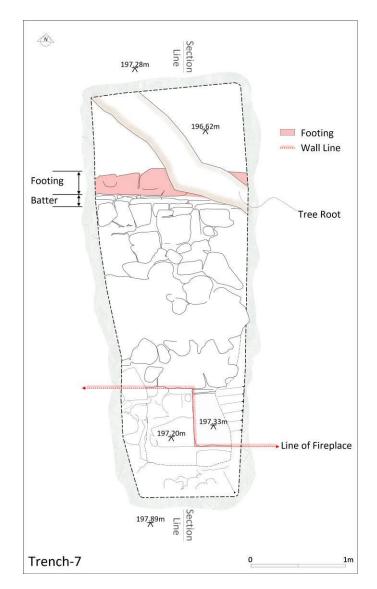
Figure 9: Trench 7, plan showing change in wall line indicating location of the fireplace and splayed footing in Trench 7

Within the trench 7, a right-angle turn, aligned north south, in the internal wall alignment was observed and at approximately 0.70m below the present ground level a solid stone surface was encountered. An extension to trench 7, aligned east west and measuring approximately 2.5m by 1.00m was excavated to identify the purpose of the right-angled turn in the wall line.

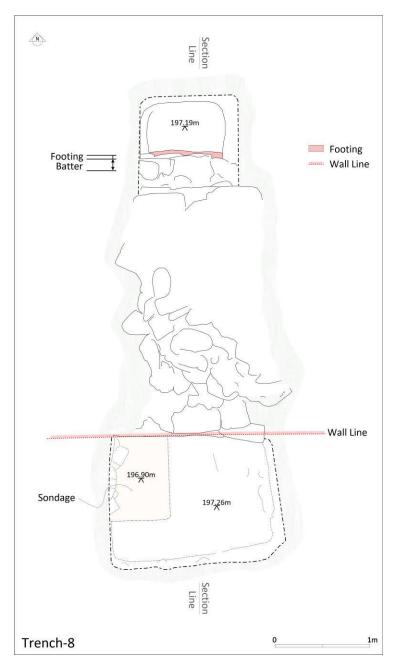
Figure 11: Trench 8, plan showing excavated sondage.

Within the trench 8, a small sondage was excavated to a depth of approximately 1.00m below present ground level, no change in stratigraphy was observed.

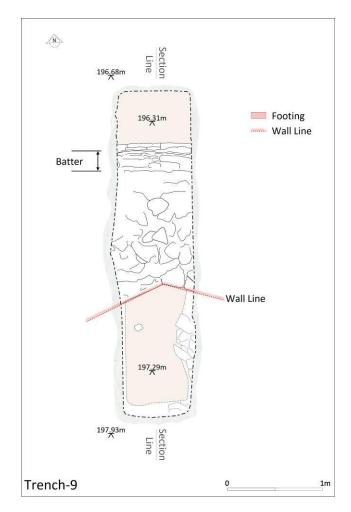
Figure 13: Trench 9, plan showing change in wall line.

Within the trench 9, an angled change in the internal wall line was recorded reflecting the changes in the south wall of the keep. (See plate 13)

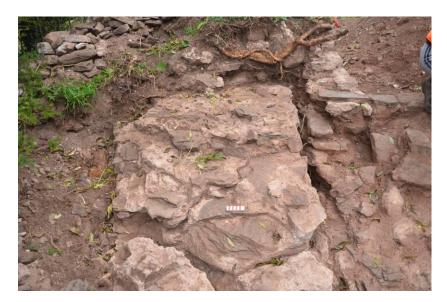
Plate 15: Trench 10, showing (1008) and (1007)

The excavation identified a sequence of evens within the construction of the keep wall and fireplace structure identified in trench 7. (1008) formed the north wall of the keep the structure was bonded with a creamy yellow mortar, however the section that would have formed the return to the gatehouse tower had collapsed leaving only loose rubble present (1009) in the south end of the trench.

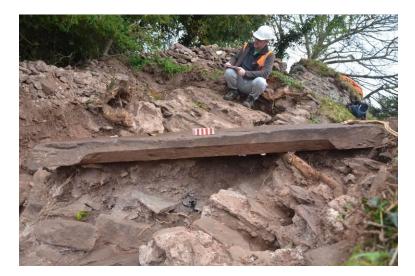
Plate 17: Trench 10, showing possible fireplace mantle stone.

Within the loose rubble a large architectural carved stone was observed (See plate 17, figure 15) possibly relating to the fireplace or a large window cill or lintel. The detail on the stone comprise of a chamfered edge with angled stops although one of the angled stops appeared to be unfinished. A further carved stone architectural object was observed within the north section comprising of a column fragment. Both architectural stone objects were left in situation.

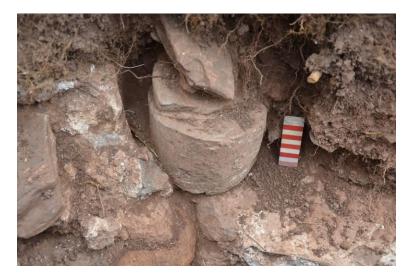
Plate 18: Trench 10, showing carved column fragment within north facing section.

The fireplace structure previously observed within trench 7 was fully exposed within trench 10 where it was noted that the fireplace structure was not bonded to the external wall of the keep, (See figure 15, plate 16) a gap of approximately 0.15m separated both (1008) and (1009) possibly indicating the presence of a beam slot or construction timber. A second possible beam slot or construction timber void was also noted within the fabric of the fireplace construction (See plate 18).

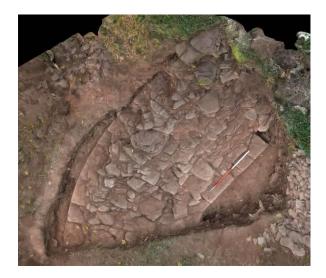
Plate 20: Trench 11, top down.

The excavation identified that dressed face stones on both internal and external elevations survived (1205, 1206 & 1207). the bastion tower wall at this level had an approximate thickness of 3.00m and illustrated that the internal arrangement of the tower consists of straight walls with angled joints set in a circular tower, this is a stylistic characteristic seen elsewhere at Snodhill castle for example the south bastion and the keep. (See, plate 20 figure 16)
