Cow Tag 17 Type possible structural post

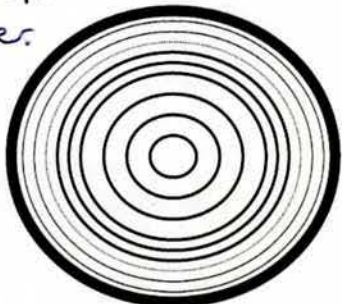
Description 70cm in length. Tapers to a point at 'end A'. Badly damaged at 'end B'. 8cm wide x 8cm thick (varies). No fasteners. It is in a dried out and extremely brittle state. Surfaces are cracked and covered in a orange/yellow staining or growth. May have been part of a riverfront structure however it can not be said for certain.
