Oak radial, disc 11/5/10, org 258a

Cow Tag 19	Type Timber fragment.	DB 19/5/2010
----------------------	---------------------------------	--------------

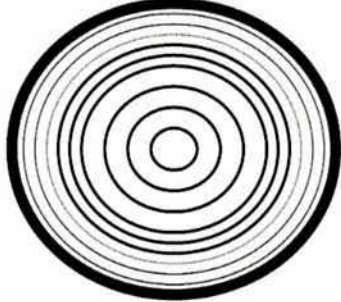
Description
length 24.5cm width 7cm depth 6cm
The surfaces of the timber is very cracked with damage at both ends.
Side B appears to have more damage than side A.
Side A has patches of rust colour. Also some sections of the timber has started peeling back.

Wood Science: Surface is too bad condition to see tree rings.
