DB 19/2/8

Cow Tag 238 Function Code 52.1

This plank have two fragments 238 52.1a and 238 52.1b

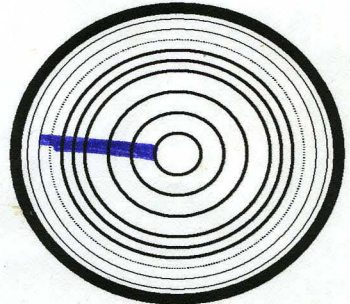
Brief Description: [timber element, p/s, condition, fragments]  
DAMAGED GENERALLY GOOD CONDITION, HOWEVER BADLY DAMAGED BY CONCRETE POST (?) ON THE AFT END. END OF THE PLANK - BOW SITE - IS CURVED \* MANY CRACKS WHICH HAVE BEEN FILLED WITH COULMING MATERIAL (ANIMAL HAIR & PLANT MATERIAL) OUTBOARD FACE →

c 1204 + c95 (forward end)  
radial. Very straight grained. Clear age trend with sapwood on upper edge.

DENDRO BUT prime sample location in sensitive area close to hood end.
