Cow Tag 38	Type Timber fragment
----------------------	-----------------------------

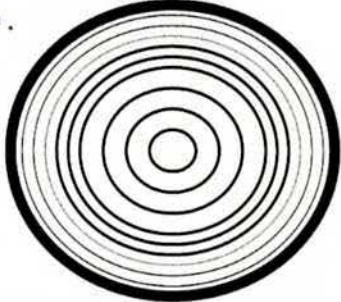
Description
length 34cm width 7cm depth 4cm
The surface of this timber is very dry and cracked and damaged.
Side A is very cracked with no features.
Side B is very cracked with one large crack. Also contains some modern damage on one end.

Wood Science:	Surface very damaged and cracked - hard to see grain.
