Cow Tag

48

ship component - plank

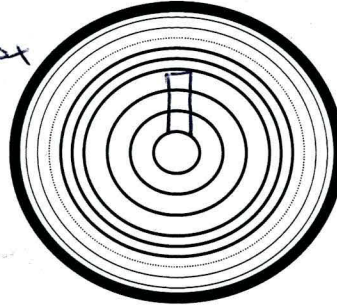
Description One metre long plank fragment, 14cm wide, 3cm thick. Three iron nail fasteners → Two holes and one nail shaft remain. Nail has been driven into the edge of the plank. Other two driven through the thickness of the plank. One treenail hole, oval in shape (possibly due to dried out wood) 3cm in diameter. One surface has covering of what appears to be animal hair. This may be the area of overlap - inboard, bottom edge. Approx 5cm wide. does appear to taper in thickness towards the bottom edge from 3.5cm to 1.5cm. No visible tool marks. Nail holes 1cm x 1cm. Nail driven into edge is small, measuring 0.6cm x 0.6cm. SURFACES are extremely dry and cracked

radially split
35 tree rings approx

sample of animal hair has been taken SH
