DB 13/3/8

Cow Tag	571	Function Code	52-5
---------	-----	---------------	------

Brief Description: [timber element, p/s, condition, fragments]
 Very good condition, however aft end damaged

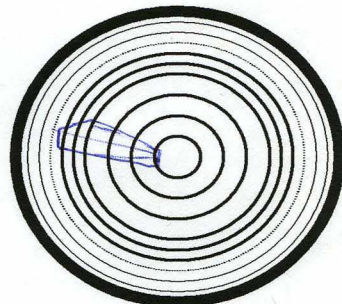
Inboard Land Strongly beveled, towards aft end there is a concreted rove with nail end. Very small additional nail close to aft end of plank.

Smaller than normal treenail on aft end of plank. - Also on outboard face

Outboard: scribed lines near the middle of the plank.

Radial, c75H, ARW = 170/75.
 Pith beyond upper edge? Straight around except at forward end where grain curves away

Photo of in situ rove
