DB 13/3/9

598 S3_4 Monika Maleszka-Ritchie 20.02.2006

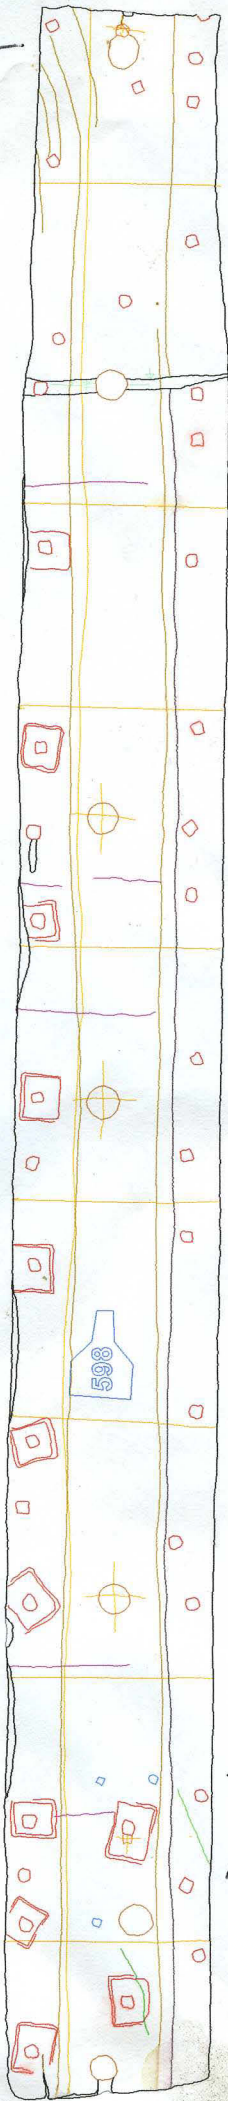
Cow Tag 598		Function Code 53.4
Brief Description: [timber element, p/s, condition, fragments] VERY WELL PRESERVED PLANK		
Notable Features: [tool marks, scribed lines, decoration, repairs] POINTS TO LOOK OUT FOR WHEN RECORDING ufos TREENAIL (THE 1 FURTHEST TO THE AFT) HAS A WOODEN PLUG RIGHT NEXT TO IT SET OF INSCRIBED LINE + 3 ^{2 or more (?)} LONG NOTCHES AT AFT END, OUTBD. 1 MORE LINE TOWARDS THE FRONT, OUTBD. 1 TREENAIL TOP WITH CUT MARKS + 1 WITH DIMPLE, OUTBD. BEVELLED LAND, INBD. 3 ADD. NAILS AT SCARF (FORW. END) - NONE HAD FE-CORR-PROD., ALL WERE FILLED WITH TAR/PITCH		
Wood Science: [rings, ARW, knots, sapwood, conversion] Radial c. 80% ARW = 210/80 P.H. beyond upper edge? No major knots but wavy grain at aft end.

<p>Temporary? Conduct?</p>
Recommended action: [samples, additional photos, moulding, queries and problems] <u>Photos</u> : wooden peg/spike? aft end additional nails inboard face forward + outboard. treenail heads outboard as indicated.
