Cow Tag 005 Type possible beam.

Cow TAG 005 EMC 22/4/10

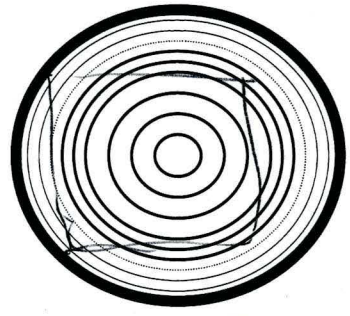
Description 1.86m in length, Approx 37cm wide x 21cm thick. Extremely damaged, possibly by a pile. End 'B' is cut, possibly done on site. Some evidence of fasteners, however all is extremely distorted. One toenail hole, 3.3cm in diameter. One iron bolt partial hole Approx 4cm wide x 22cm in length. Second partial metal fastener 3.3cm in diameter

Another beam element damaged by piling within the ship. End is joint to beam self.

Checked: [corrections needed]  
NN Selective faro-cam record of fastenings & relatives.
