Cow Tag

631

Function Code

F 62-0

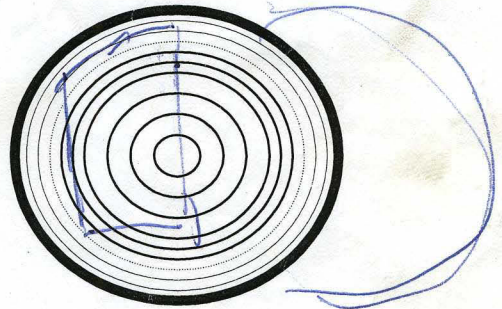
v. damaged floor element 'v' shaped, sliced in half by sheet piling

For - lots of see marks Pile damaged on port side  
I.B - see marks Hacked in antiquity on upper end of starboard arm.

Small round impression on 2nd Joggle outboard - starboard. - not sure what this is

>5, c70H + 10S + Be. on starboard side. Timber is from crown of tree

Photos: + 1B face

Core for deids after photos?
