Cow Tag 032 Function Code F2-0

Brief Description: [timber element, p/s, condition, fragments]
floor timber, slight damage to extremities
very soft.

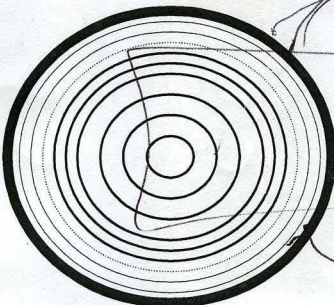
Notable Features: [tool marks, scribed lines, decoration, repairs] POINTS TO LOOK OUT FOR WHEN RECORDING
Starboard side - Scarf joint on O.B. sole,
∴ F2-2 was put in place first,
groin V. Swirly - 1.3 - Saddle - back edge almost
groin quite difficult to see
low top on aft
sole) Scarfed over F2.1? ☺

Wood Science: [rings, ARW, knots, sapwood, conversion]
External bark edge on wood face
Arises from two branches in crown.

Recommended action: [samples, additional photos, moulding, queries and problems]
Photos: angled 'feet' and timber hole showing from
floor is not coated. + Near horizontal Trunnel on aft
face
