Cow Tag 636 Function Code F 50-0

Brief Description: [timber element, p/s, condition, fragments]  
floor timber, slight damage to ends

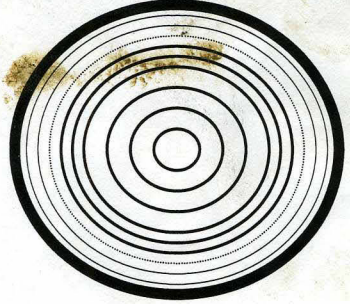
NUMEROUS T4, some double + triple marks. It is possible that some of these mark RFR's as well as joggle portions  
Rebated Fe nails (1 each) on both sides, saw marks - 1B.  
Deep Axe marks on outboard face in the timber hole.  
Nail Angles + Depth on outboard: Suspect - not cleaned out well.

Starboard arm = bole of tree, port arm = branch

Reclean nail? Had 2nd clean 12/11/7 but could be more to do on this timber.
