Cow Tag 63 Type function- unknown

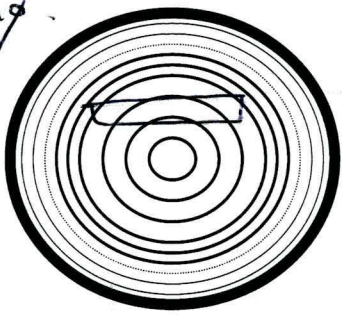
Description 20cm x 20cm x 3cm. One treenail - 2.7cm in diameter, still in situ. Second treenail hole (partial) appears to have diameter of 2.7cm also but is damaged. Some metal staining on outboard surface. However no metal fasteners. Inboard surface is in poor condition. No landmarks remain. original wood number 230.

Possibly elm ✓<sup>10/19</sup>  
Tangentially faced ✓✓

Recommended action: [samples, additional photos, moulding, queries and problems]  
Discarded ✓
