Cow Tag 9	Type function unknown
--------------	-----------------------

Description

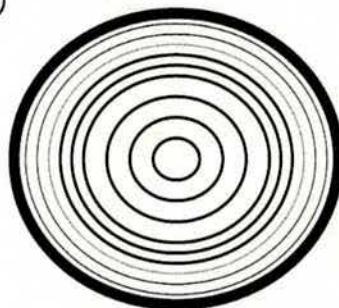
The outboard side has two treenail holes and two metal nail holes. One treenail hole is intact and is 3cm in diameter. The second is a partial treenail and is 3cm in diameter. The metal nail head impression is 3cm in diameter while the shaft is 1cm in diameter. The second is slightly spur and is the head impression is 3cm in diameter while the shaft is 1cm in diameter. Next to the intact metal nail hole are two cut marks. At one end there is modern damage, there is one large crack and a few smaller cracks. There is also one knot.

The inboard side has two treenail holes and two metal nail holes. The intact treenail hole is slightly oval and is 3cm long and 2.3cm wide. The partial treenail hole is 3cm in diameter. The intact metal nail hole is 1.2cm in diameter and the partial metal nail hole is 1.5cm in diameter. The damage is longer on the inboard side at 17.5cm long. A large knot is visible and 7cm long. The surface has one large crack.

The outboard side has patchy white covering which may possibly be sealing or covering.

Wood Science: Slow grown, not straight grain

Recommended action: [samples, additional photos, moulding, queries and problems]

Discarded.
