WALTON FARM, WALTON POOL,  
CLENT, WORCESTERSHIRE –  
HISTORIC BUILDING RECORDING AND  
HERITAGE ASSESSMENT

# **Walton Farm, Walton Pool, Clent – Historic building recording and heritage assessment**

## **WSM 77849**

**25<sup>th</sup> November, 2021**

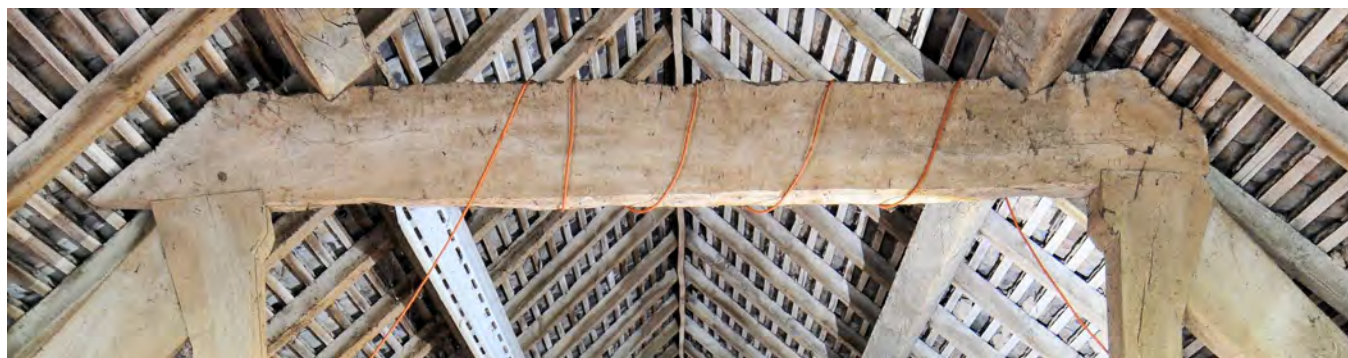
5.3.2 The framing of the two trusses is noticeable for the very small diameter pegging (circa 10mm) and the small size of the carpenter's assembly marks (vertical strokes of around 15mm). Some of the subsidiary timbers (eg horizontal braces to the wall plate) are spiked to the frame, and it would appear that the common rafters are spiked to the purlins. These are all features compatible with late-period framing.

*Enlarged detail of queen-post/collar joint showing small diameter pegging*

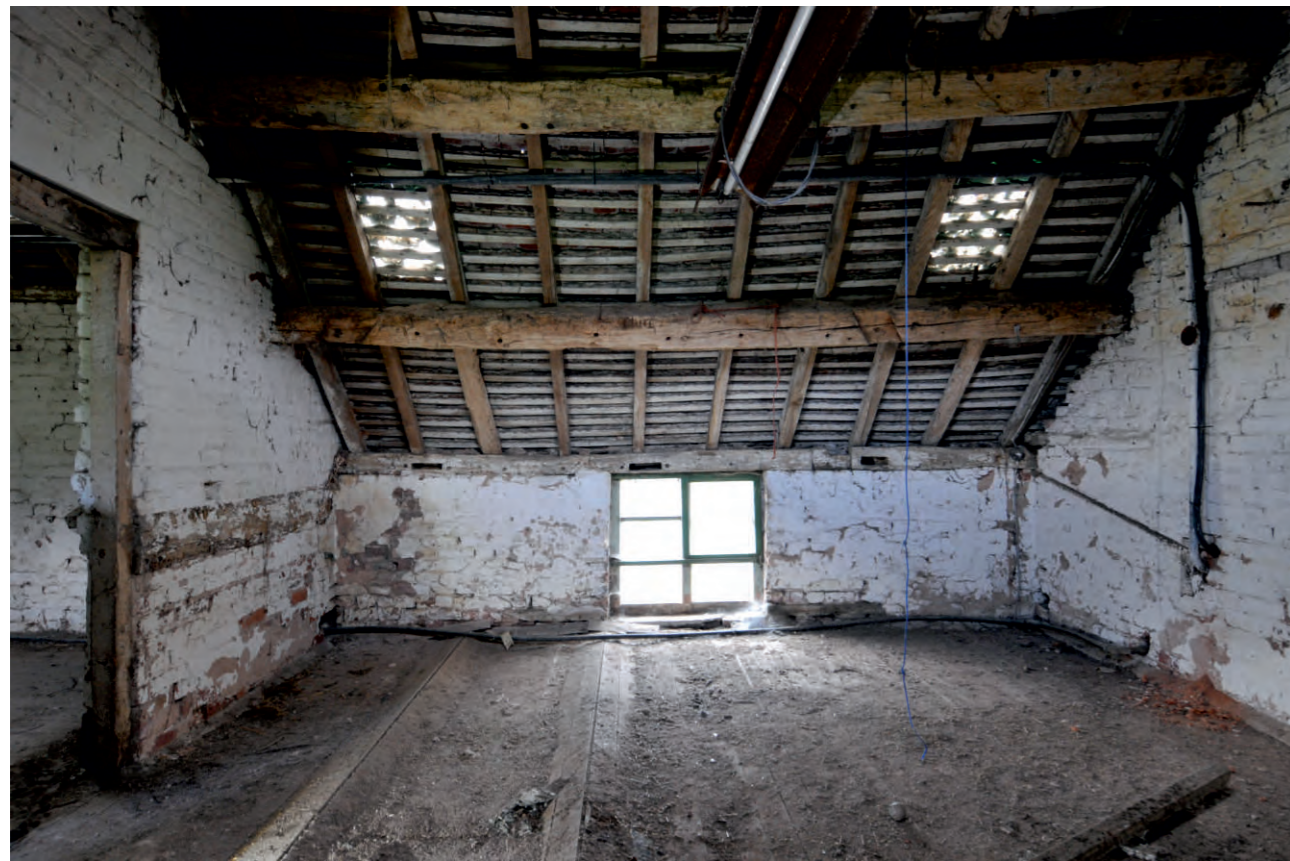
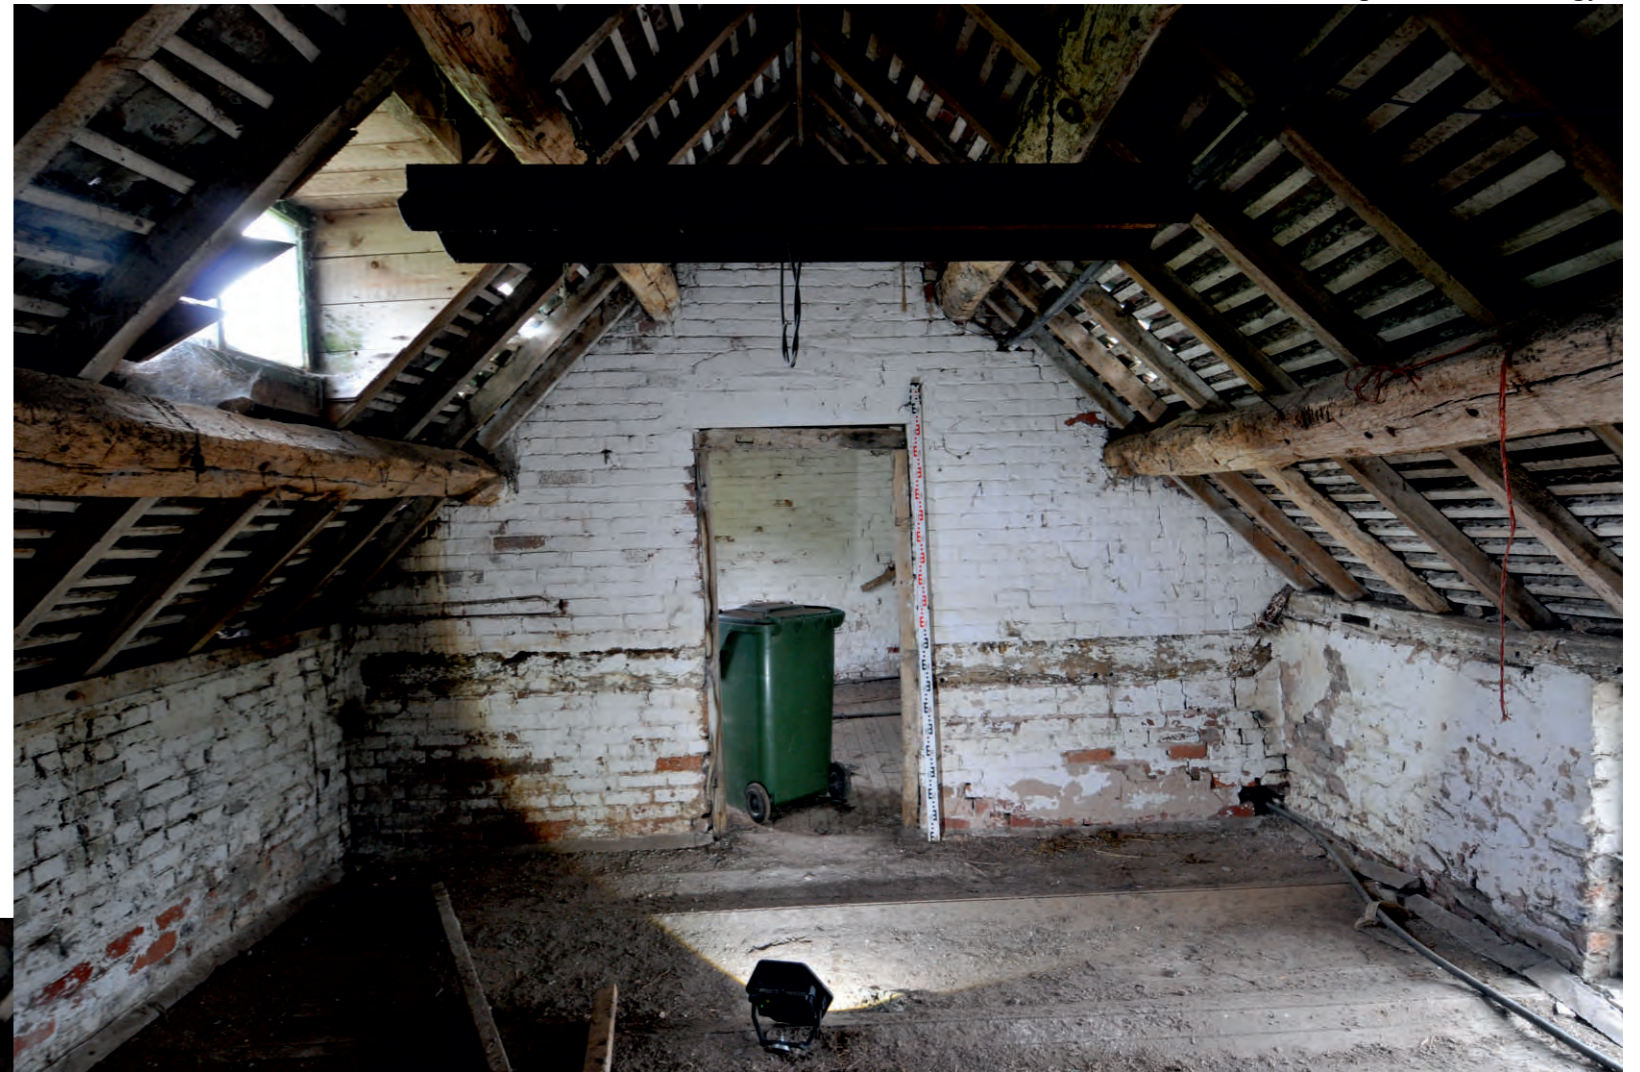
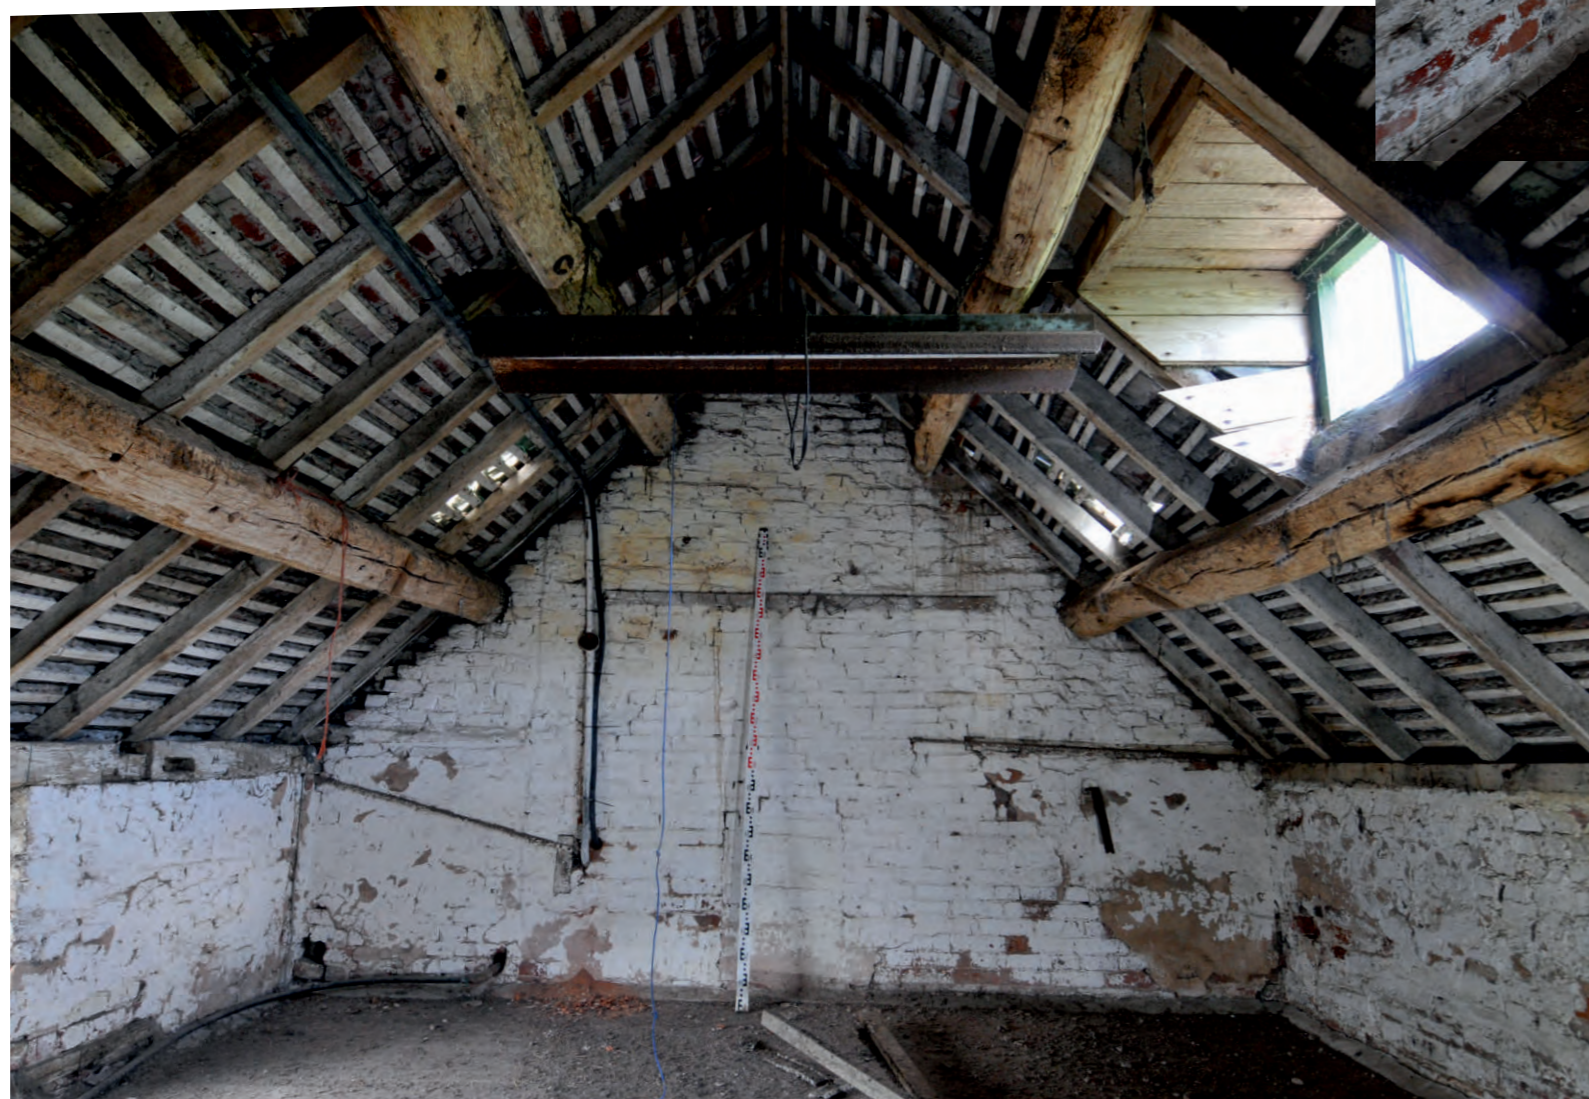
Figure 7: Upper (hayloft) level of former stable block - floor replaced in tongue and groove boarding

5.1.5 The northern-most bay (which is the bay through which the passage passes at ground floor level) has a lower eaves and ridge line than the remainder of the former stable range, and the brickwork appears to be earlier (circa 1760s-1770s) than the main elevations. The roof (Fig 7) has re-used timbers from a traditionally framed agricultural building as purlins, the floor structure is of substantial oak joists and bridging beam and also appears to be mid-late 18<sup>th</sup> Century. There is no indication of access between the levels. As the ground floor front wall has been largely removed it is not possible to determine the precise function, but the position (closest to the house) would usually be occupied by a tack room or stabling for the most valuable horse. The room above, which is the only upper level room with a window, may well have served as accomodation for farm servants, though there are no signs of domestic use. The floorboarding appears to have been replaced in the mid 20<sup>th</sup> Century.

Northern-most room

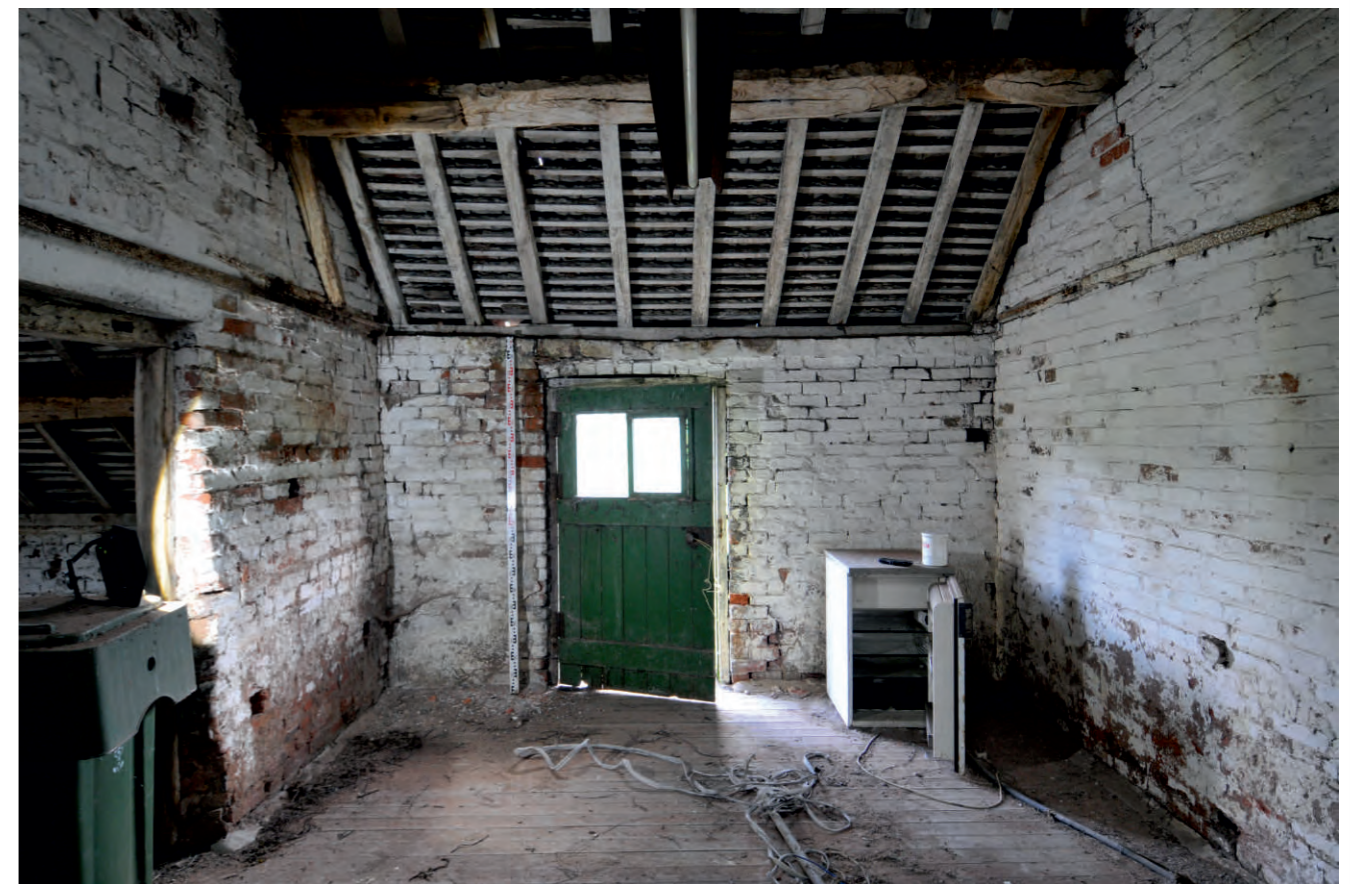
5.1.6 The middle section of the upper level (Fig 8) is rather featureless, lit primarily through glass tile panels in the roof, though two loading hatches have been boarded over and may have given some original natural light. The floor has been replaced with tongue and groove boarding, and the upper part of the wall facing the foldyard appears to have been re-built. The mid section truss is of oak and of later 18<sup>th</sup> Century character, traditional pegged construction with very slender queen struts.

Second room from north (facing NE)

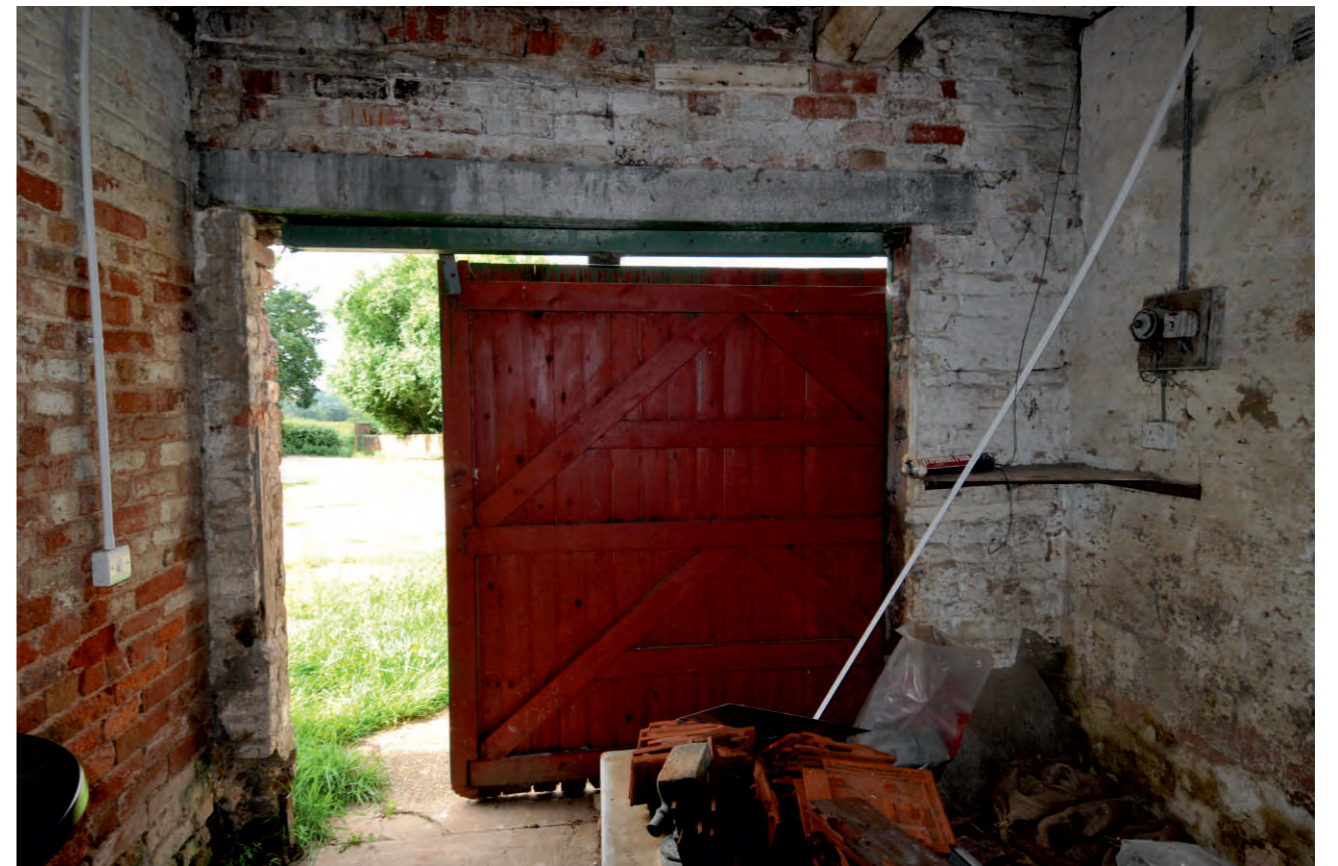
5.1.2 At the western end of the range a pedestrian passage leads through the block immediately adjacent to an outbuilding within the domestic curtailage. This block has had its frontage replaced with a sliding door, and the ground floor is now mainly

occupied by a recent washroom behind a stud partition. The first floor structure remains, however, and is of early 19<sup>th</sup> Century character, albeit the floor boarding has been replaced (mid 20<sup>th</sup> C). This bay of building appears to have been adapted, probably as a tractor shed, in the 1950s or 1960s – the doorway has a cast in situ concrete lintel and the top hung sliding door furniture is of 1950s-60s character. Remnants of an arched doorhead remain above the lintel – the height of this former opening is strongly suggestive of a stable-door. There is no access to the upper floor from the foldyard.

Westernmost room view facing foldyard

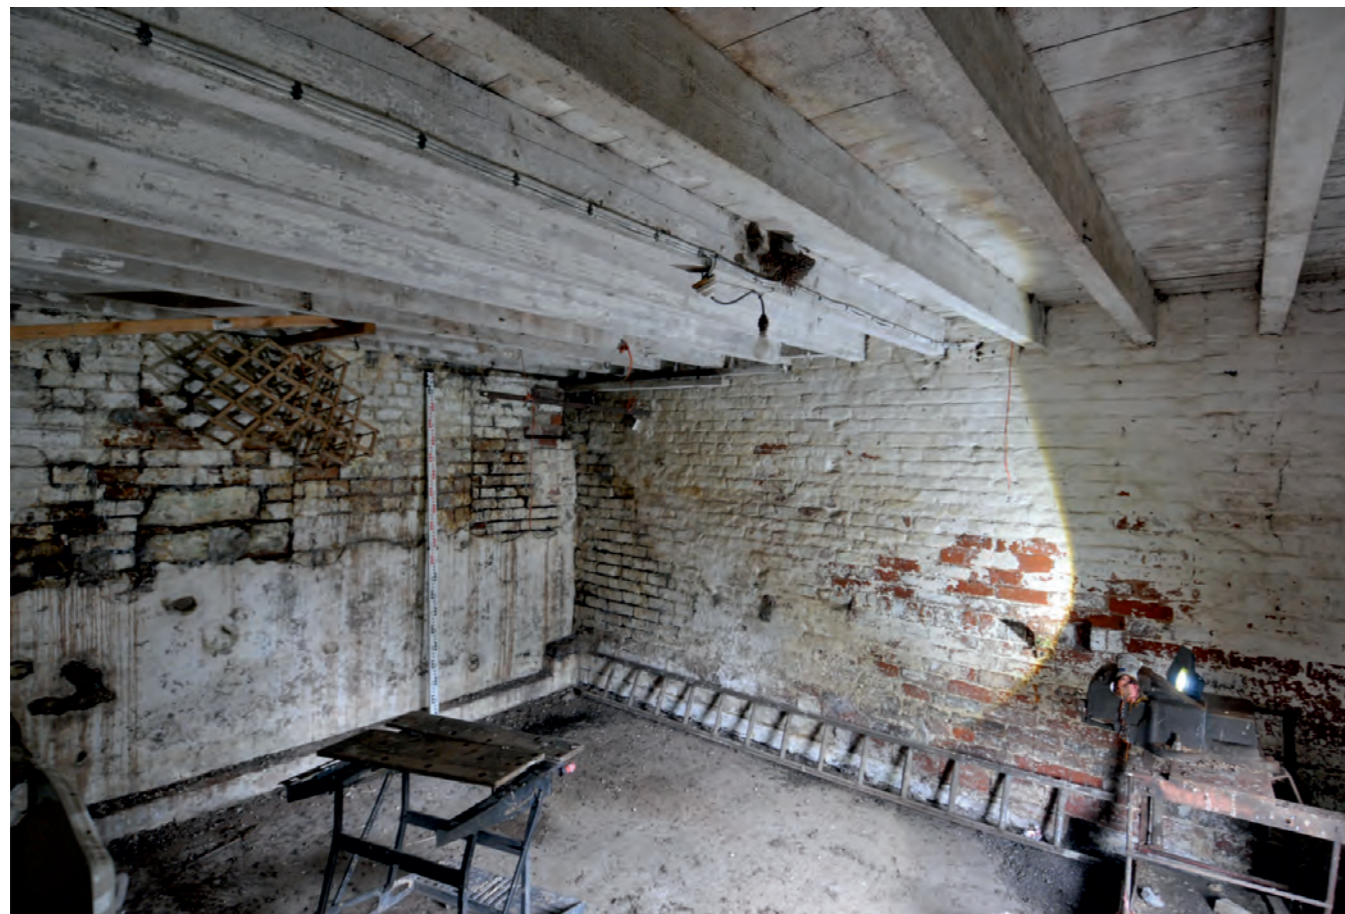
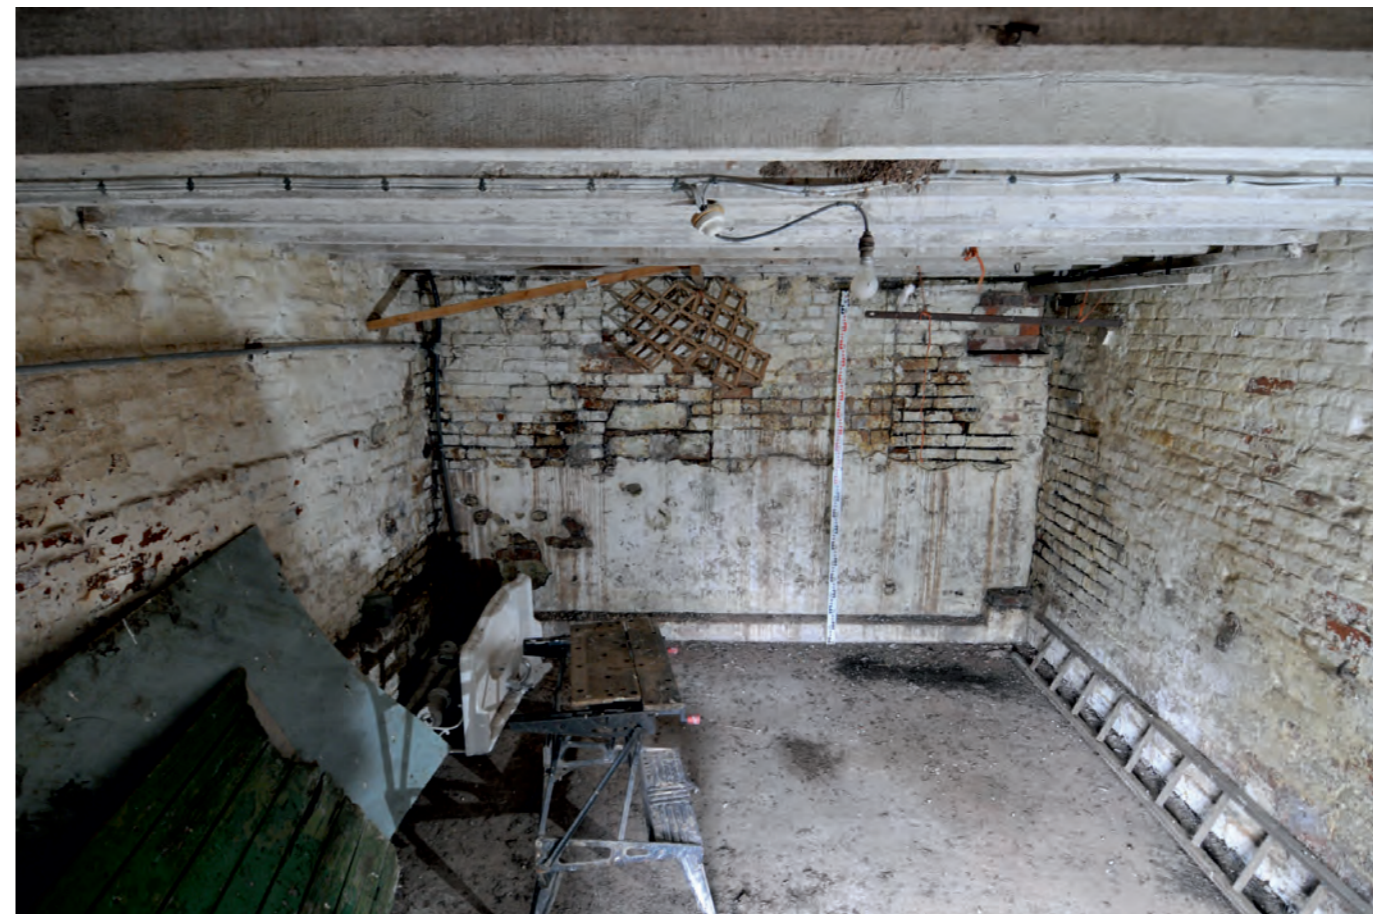
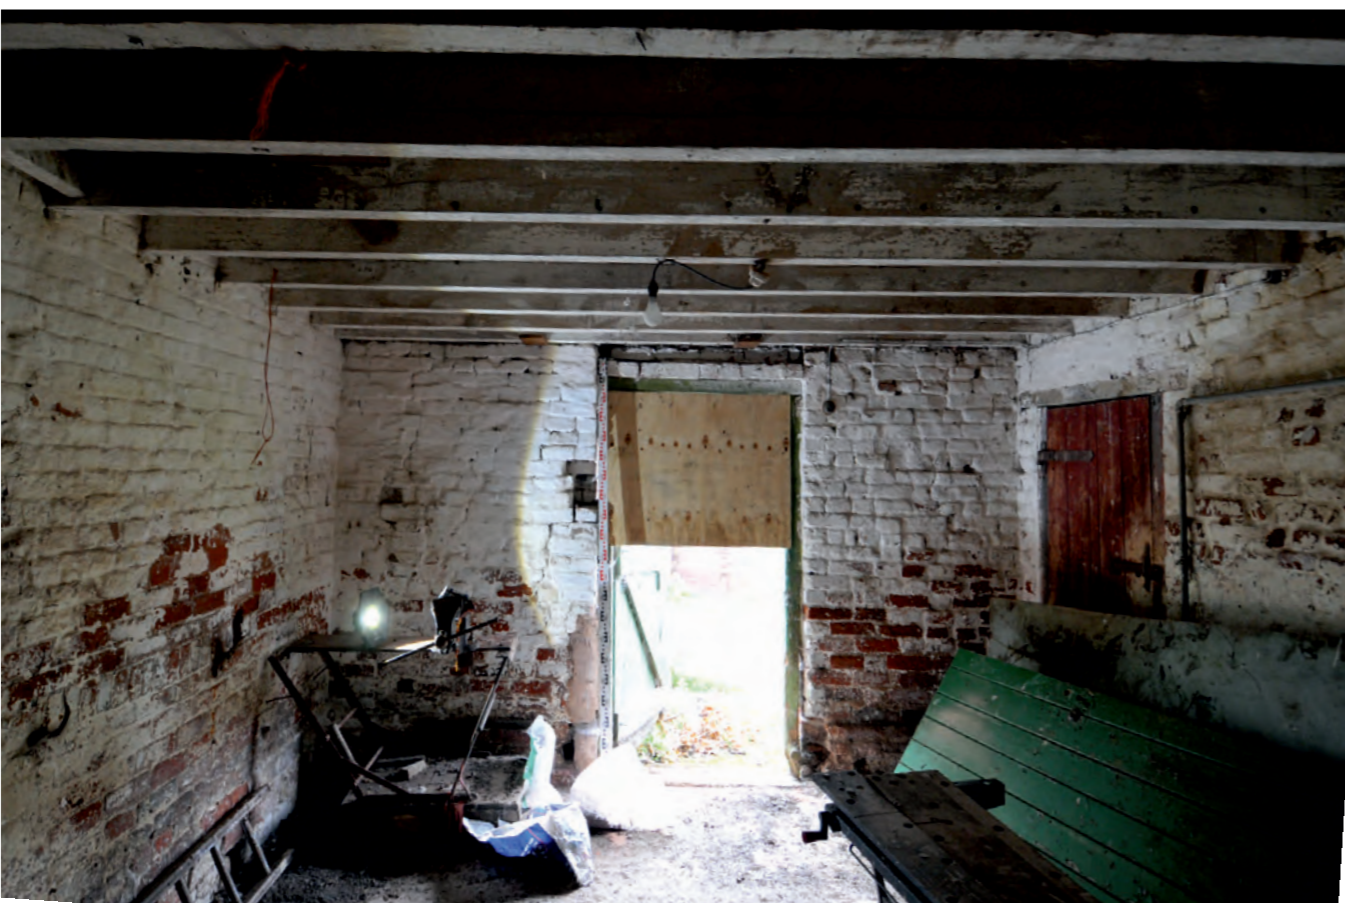
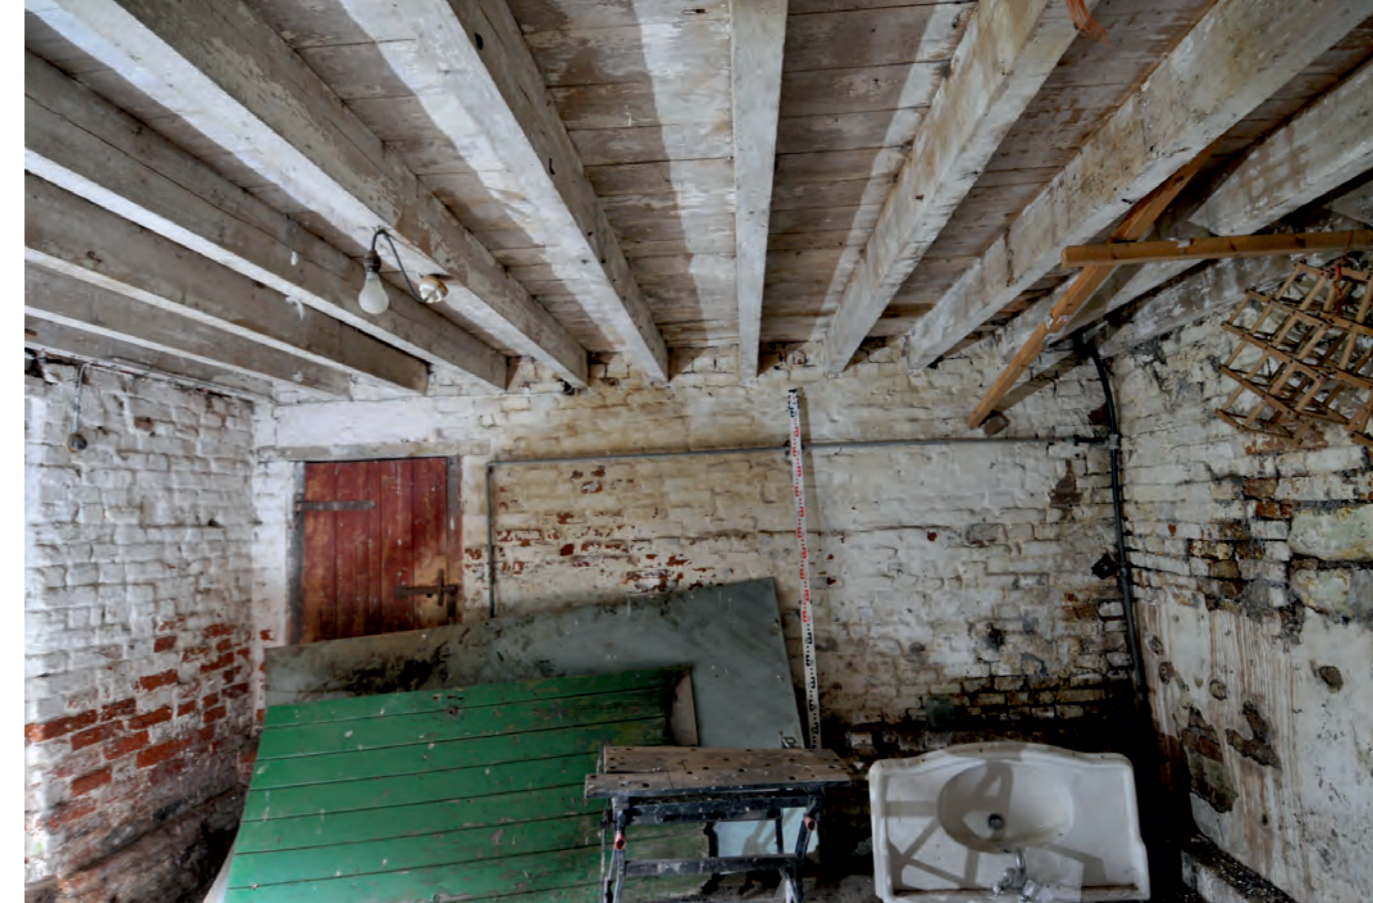
Figure 10: Former stable block range - eastern ground floor room

5.1.3 The stable adjoining the barn is less altered and retains some slight traces of its former use. The brickwork of this structure reveals that the rear wall formerly had some openings or recesses, patched in 19<sup>th</sup> C brick, and the southern wall is constructed of early 18<sup>th</sup> Century brick, representing the earliest fabric in this block. The first floor structure remains in relatively good condition, the upper floor has, however been re-boarded in tongue and grooved boarding (early 20<sup>th</sup> Century). There is an original doorway (now no longer functional) to the neighbouring meeting room.

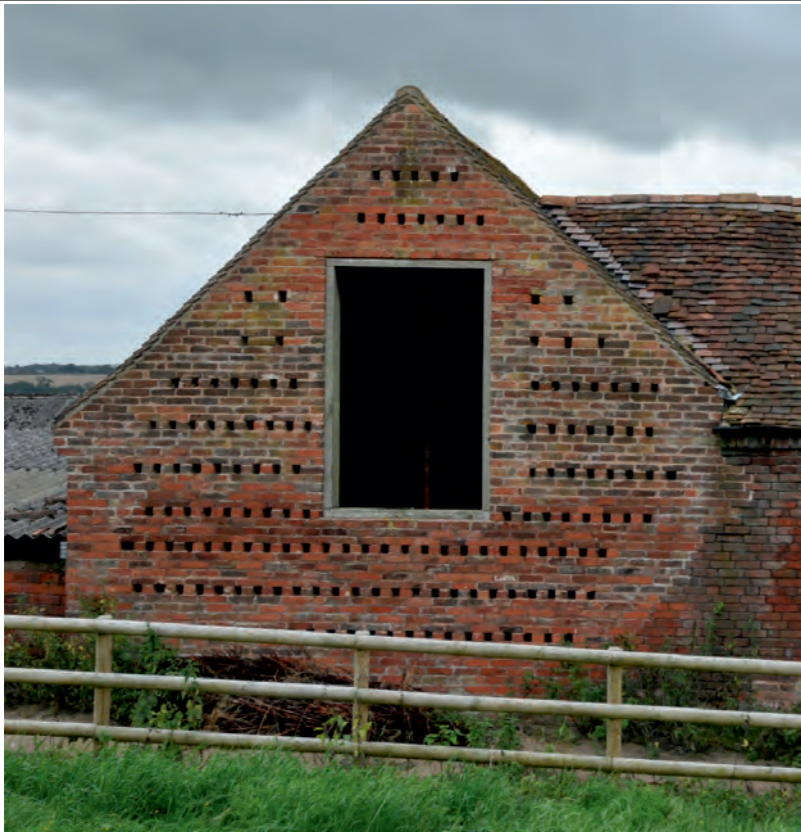
View of barn facing SW

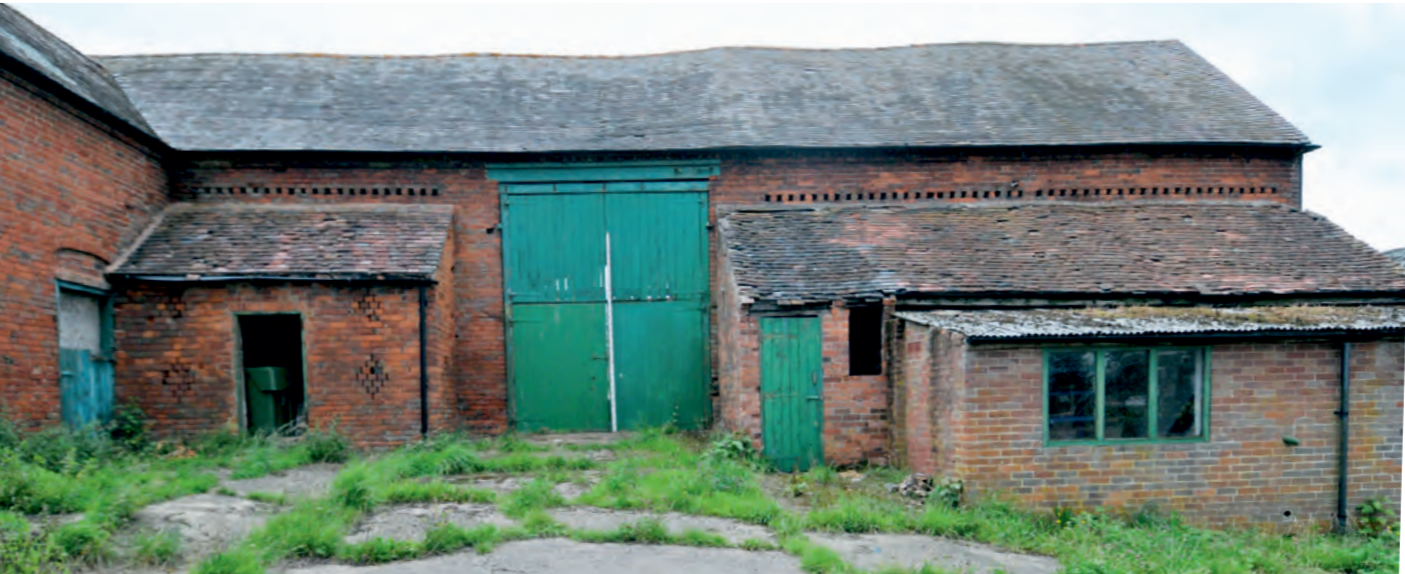
View of barn from foldyard facing NW

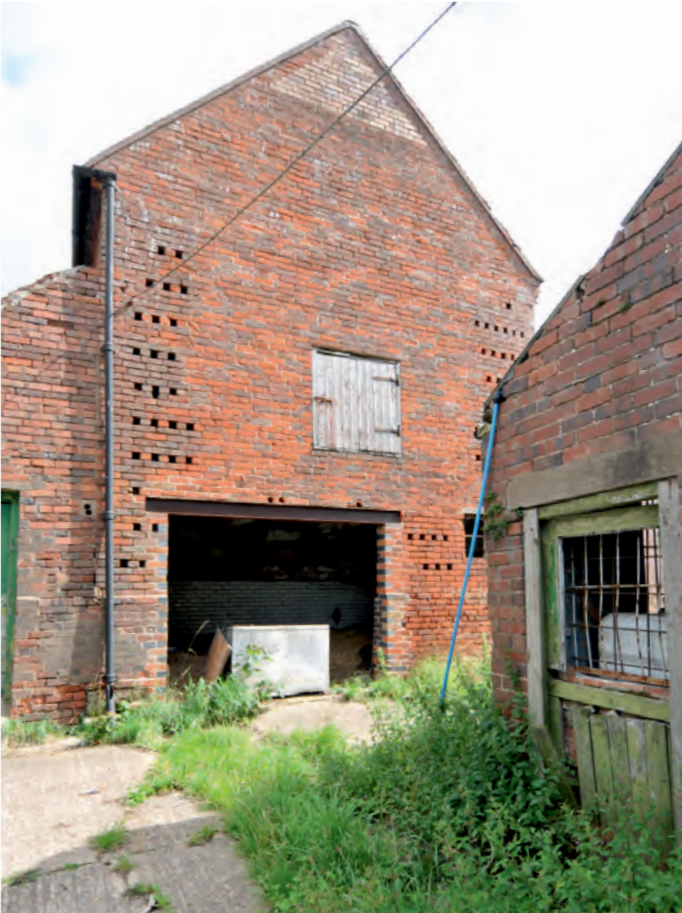
View of barn from outer foldyard facing NE

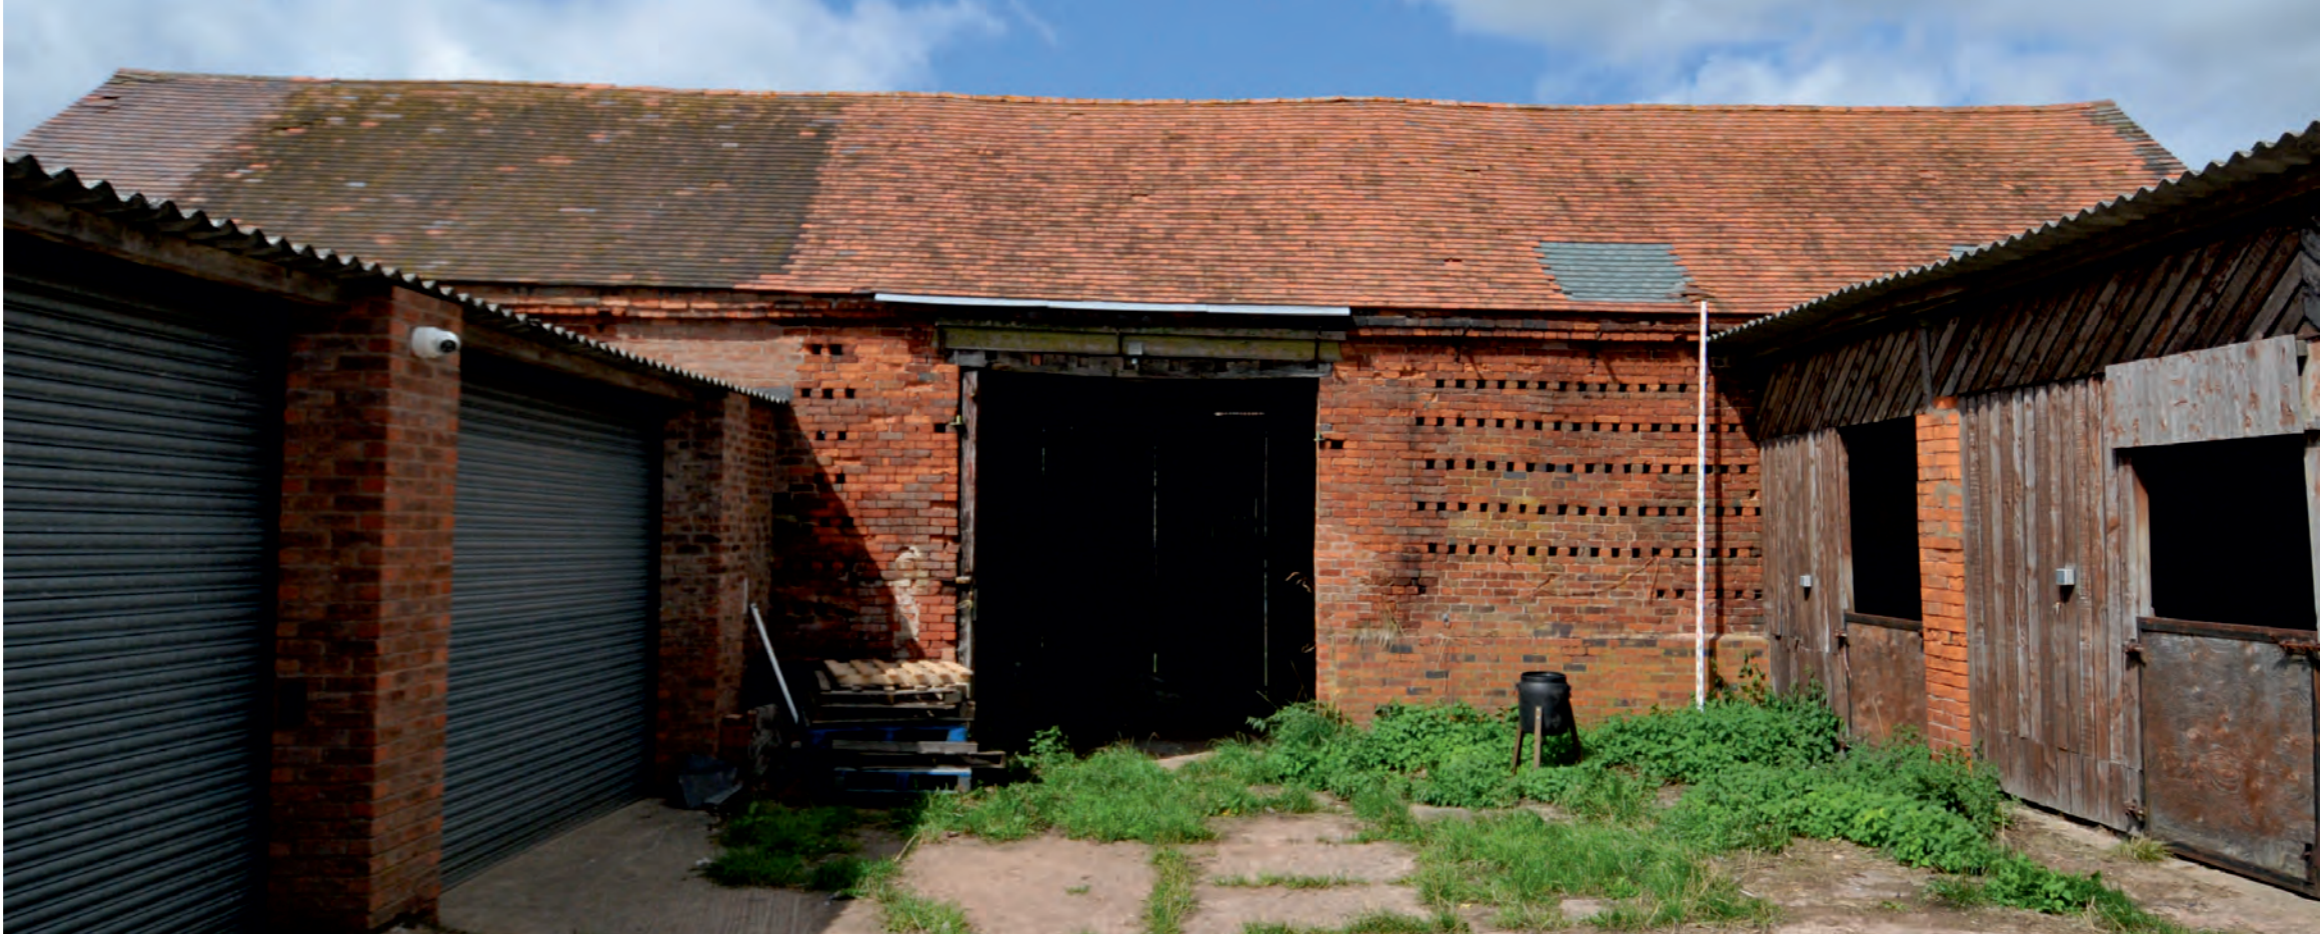
Figure 11: Threshing barn

5.2.1 The main body of the barn is aligned broadly north-south, with large wagon doors to both the east and west elevations. The central bay retains some stone slabs from a former threshing floor. The barn doors are 20<sup>th</sup> Century replacements hung on

new hinges – the original pintles were differently placed. The barn is almost entirely of mid-late 18<sup>th</sup> Century brick, but incorporates some reused earlier brick and a section of possibly re-used stonework internally beneath the hayloft staging. The floors are predominantly rough concrete.

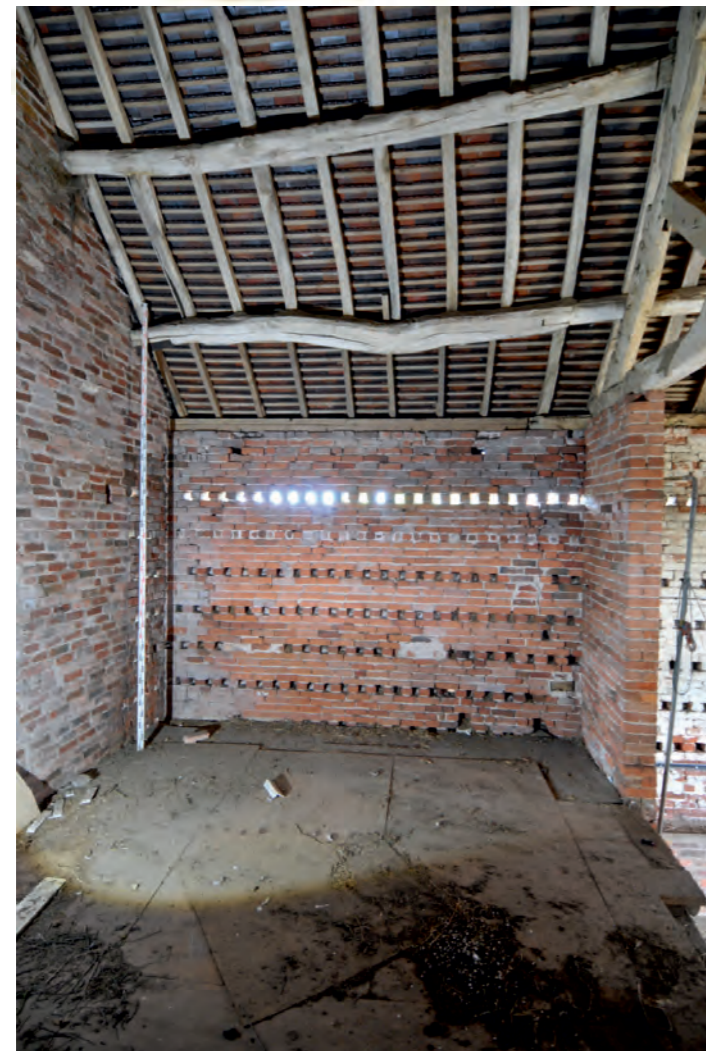
Western bay (north side)

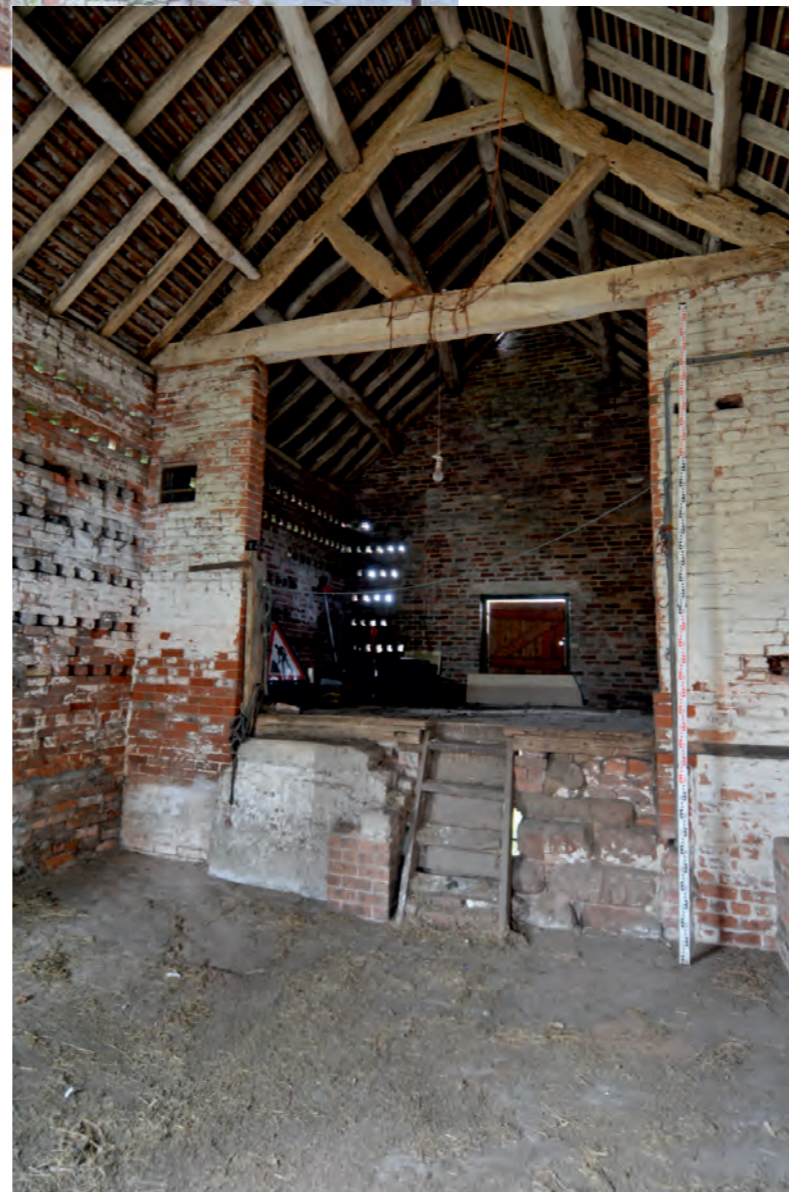
5.2.2 The barn is of four bays, the southernmost of which has a raised hayloft, over an area recently used as a loosebox and accessible only from the exterior. The wall between the loosebox and main barn is of sandstone, but appears to be a secondary insertion between the brick piers. The hayloft platform rests on substantial timber bridging beams and is likely to be of early-mid 19<sup>th</sup> Century origins. The walls had originally extensive through venting, however the central portion of the southern gable end has been rebuilt without venting. The rebuilding of the southern gable end and later insertion of a wider opening have removed any evidence of the original function of this area.

Raised platform in western bay

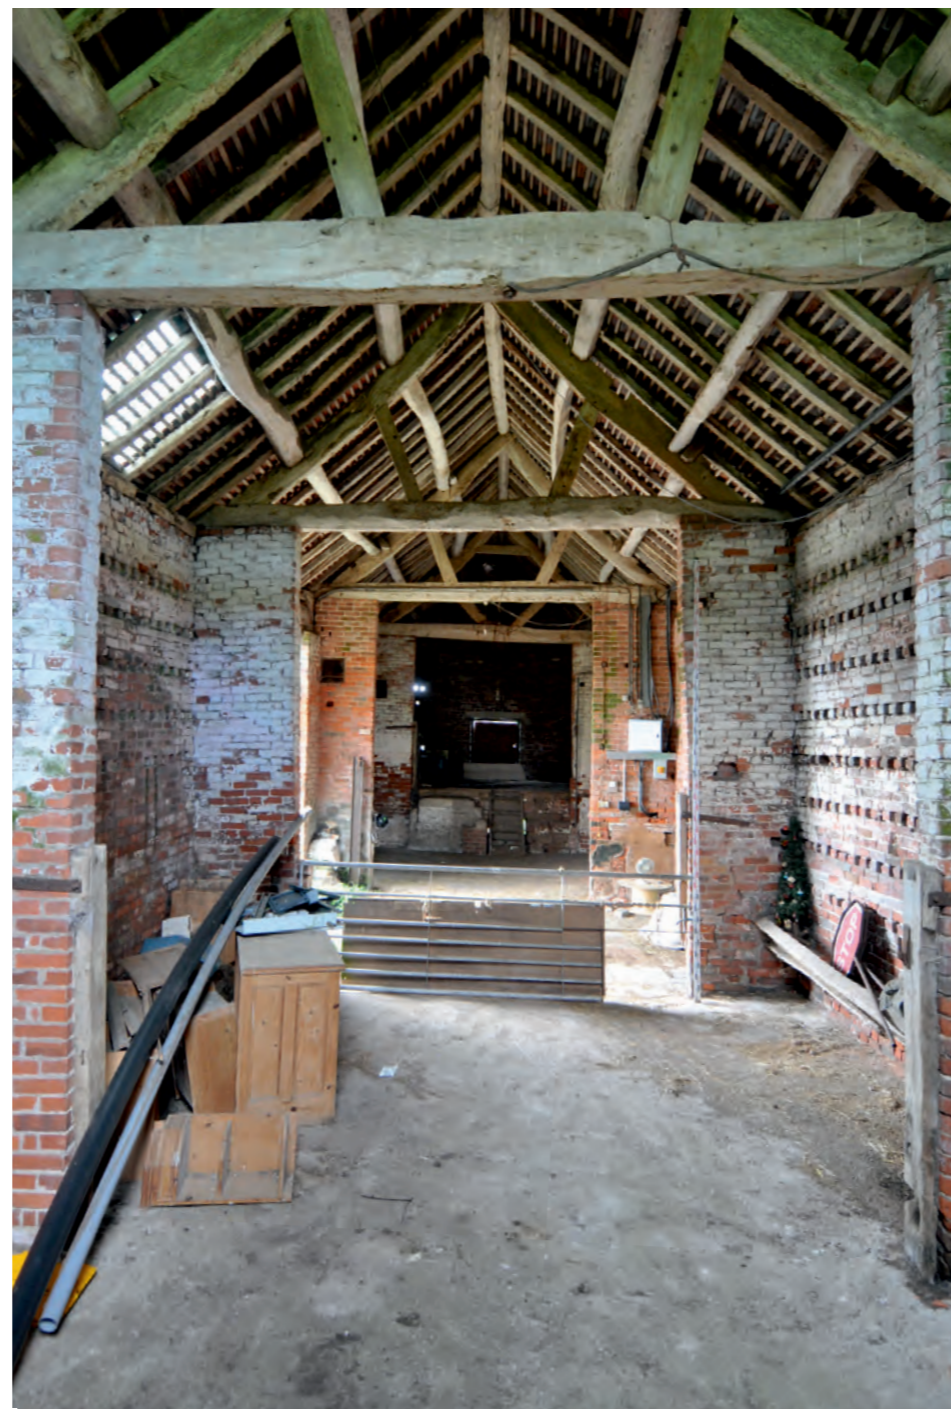
5.2.3 To either side of the through-bay the two remaining bays are of generous height, and retain substantial areas of through venting. As is usual in threshing barns the bays are devoid of original interior features. The brick and concrete built feed troughs are relatively recent (circa 1960s) and would indicate that the building has been used for stalling cattle.

View from easternmost bay towards west
