WALTON FARM, WALTON POOL,  
CLENT, WORCESTERSHIRE –  
HISTORIC BUILDING RECORDING AND  
HERITAGE ASSESSMENT

# **Walton Farm, Walton Pool, Clent – Historic building recording and heritage assessment**

## **WSM 77849**

**25<sup>th</sup> November, 2021**

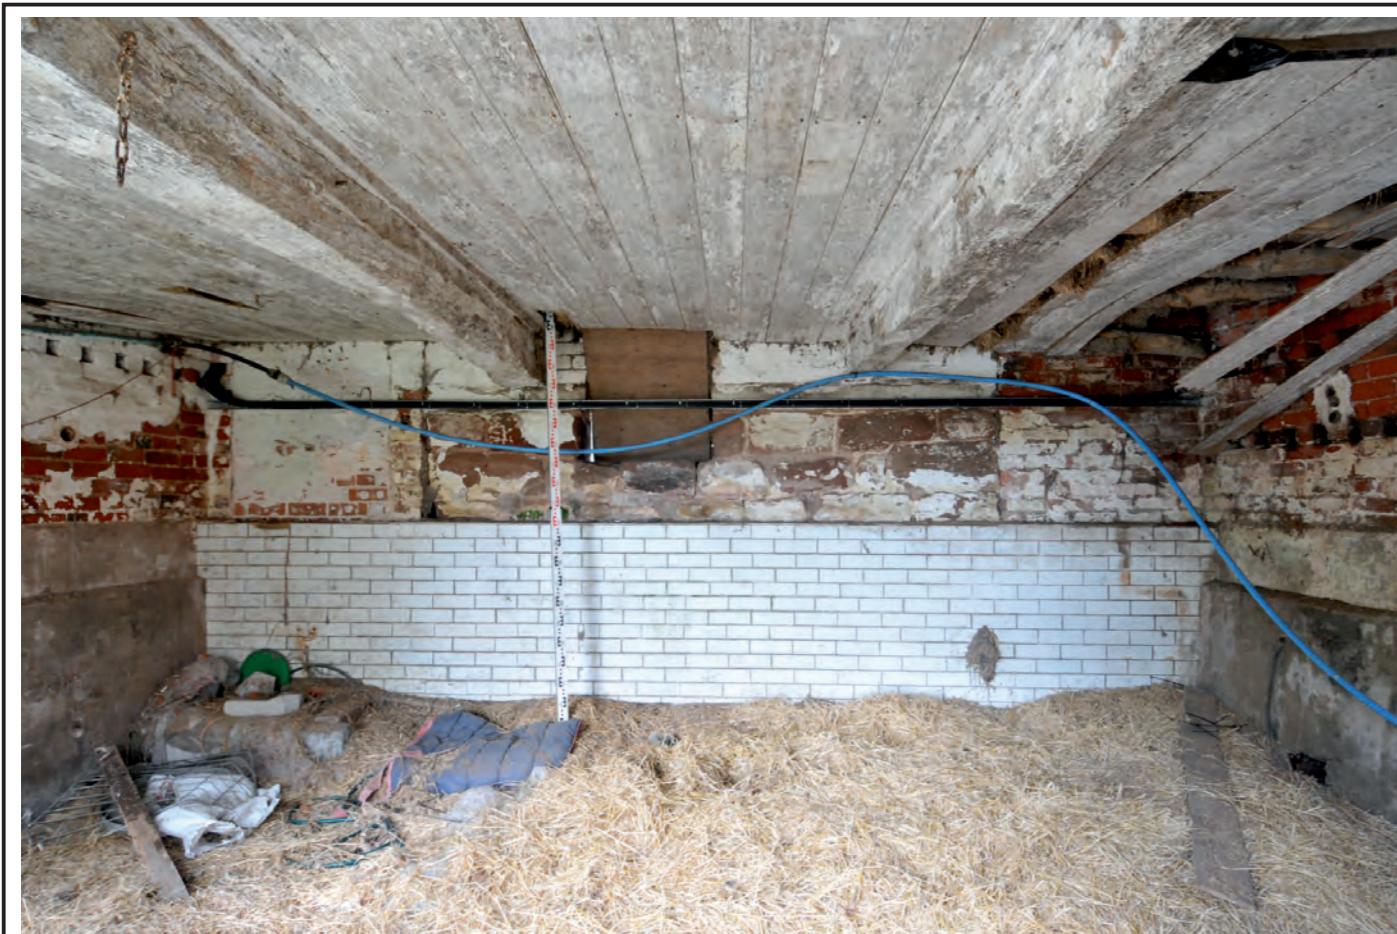
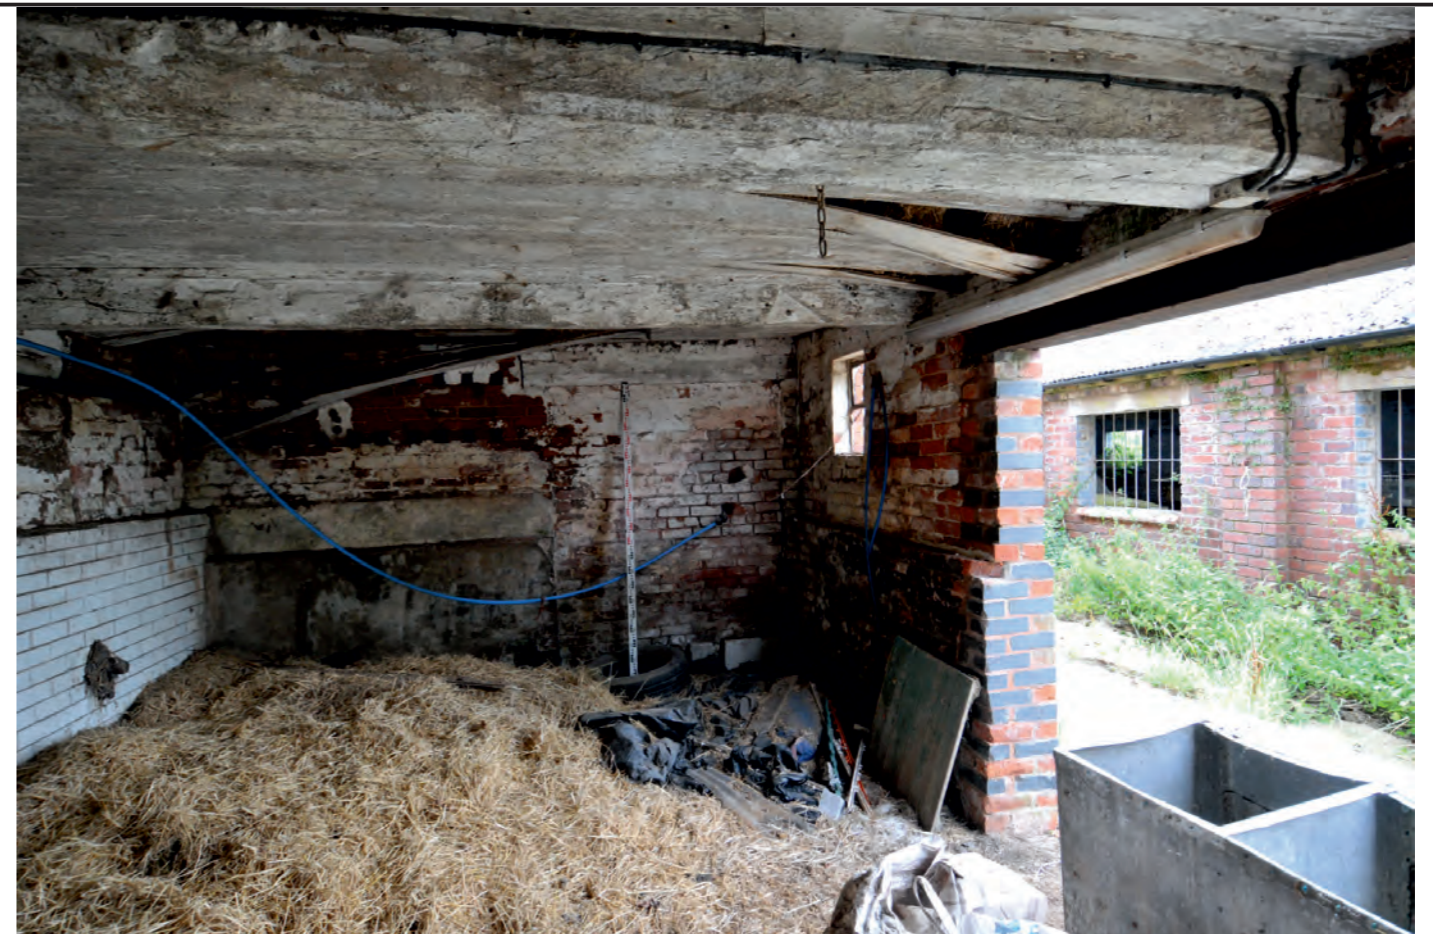
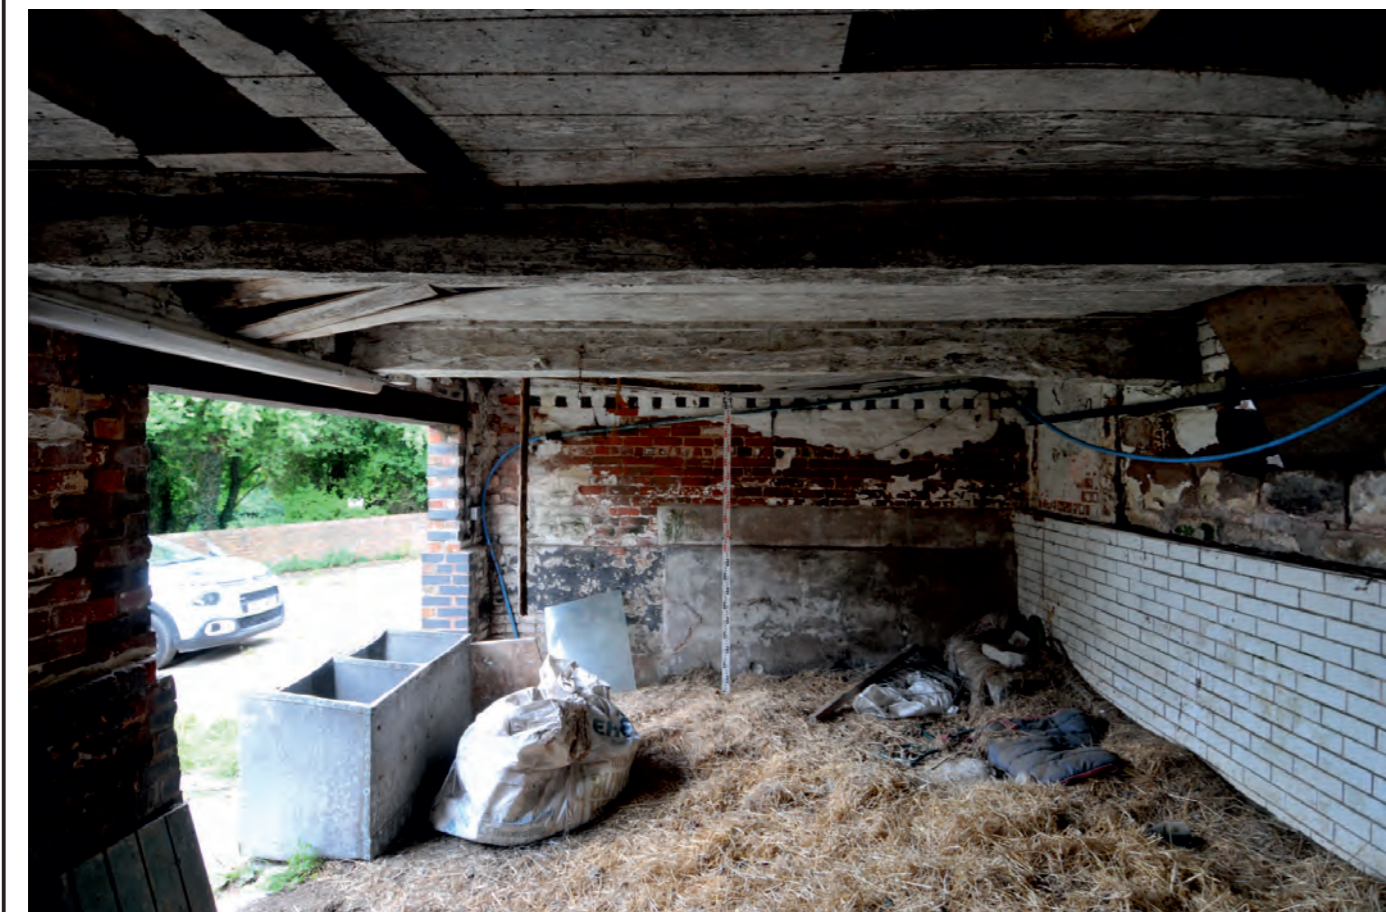
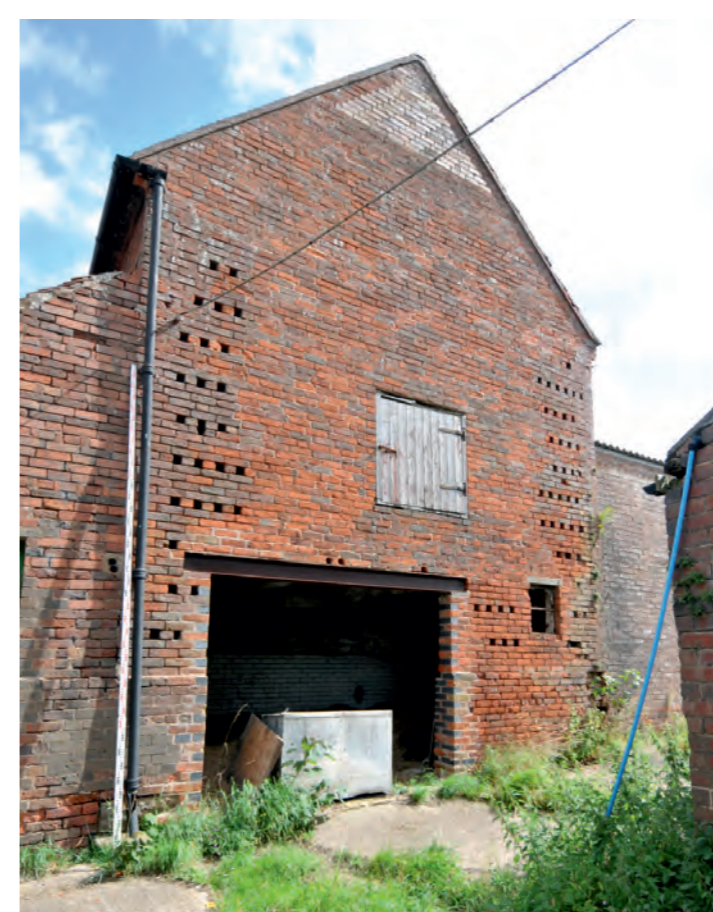
Figure 14: Former threshing barn - western bay beneath platform

5.2.2 The barn is of four bays, the southernmost of which has a raised hayloft, over an area recently used as a loosebox and accessible only from the exterior. The wall between the loosebox and main barn is of sandstone, but appears to be a secondary insertion between the brick piers. The hayloft platform rests on substantial timber bridging beams and is likely to be of early-mid 19<sup>th</sup> Century origins. The walls had originally extensive through venting, however the central portion of the southern gable end has been rebuilt without venting. The rebuilding of the southern gable end and later insertion of a wider opening have removed any evidence of the original function of this area.

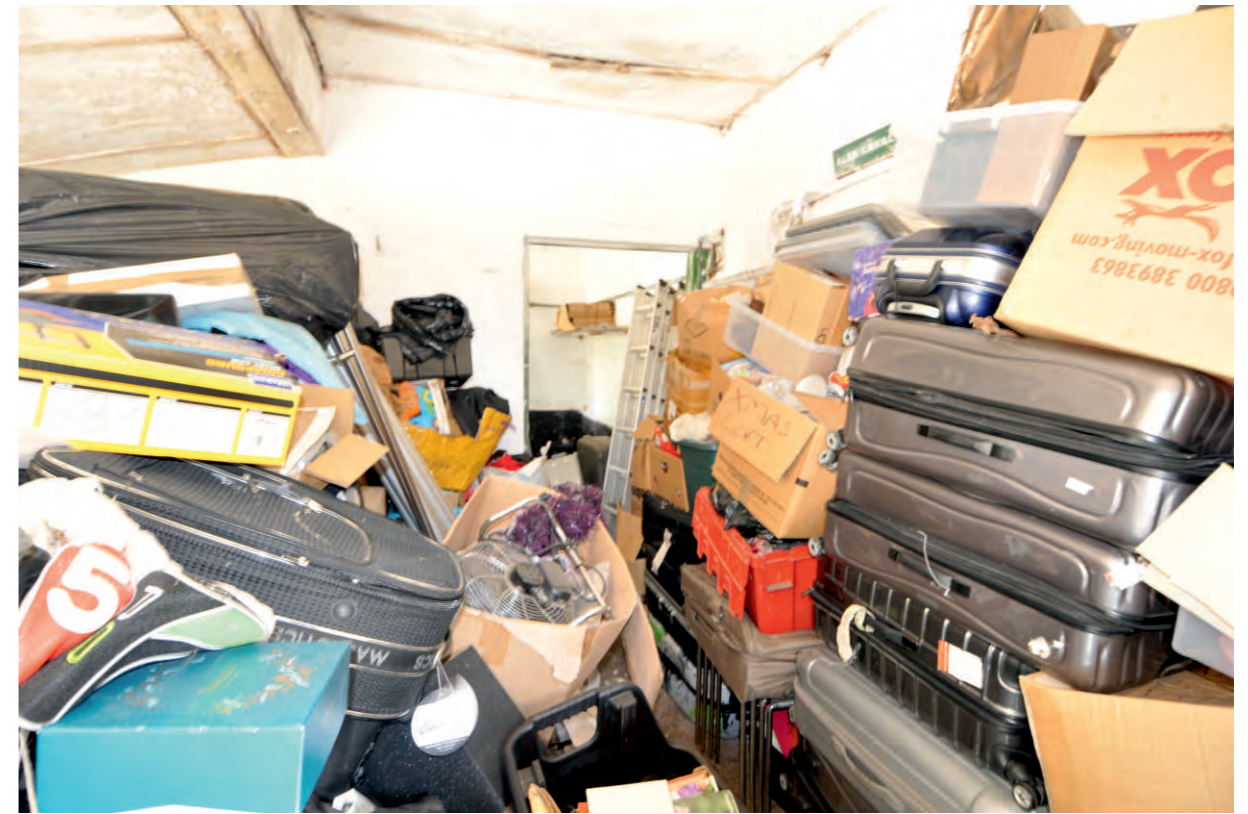
Interior of extended lean-to building (possibly former implement shed)

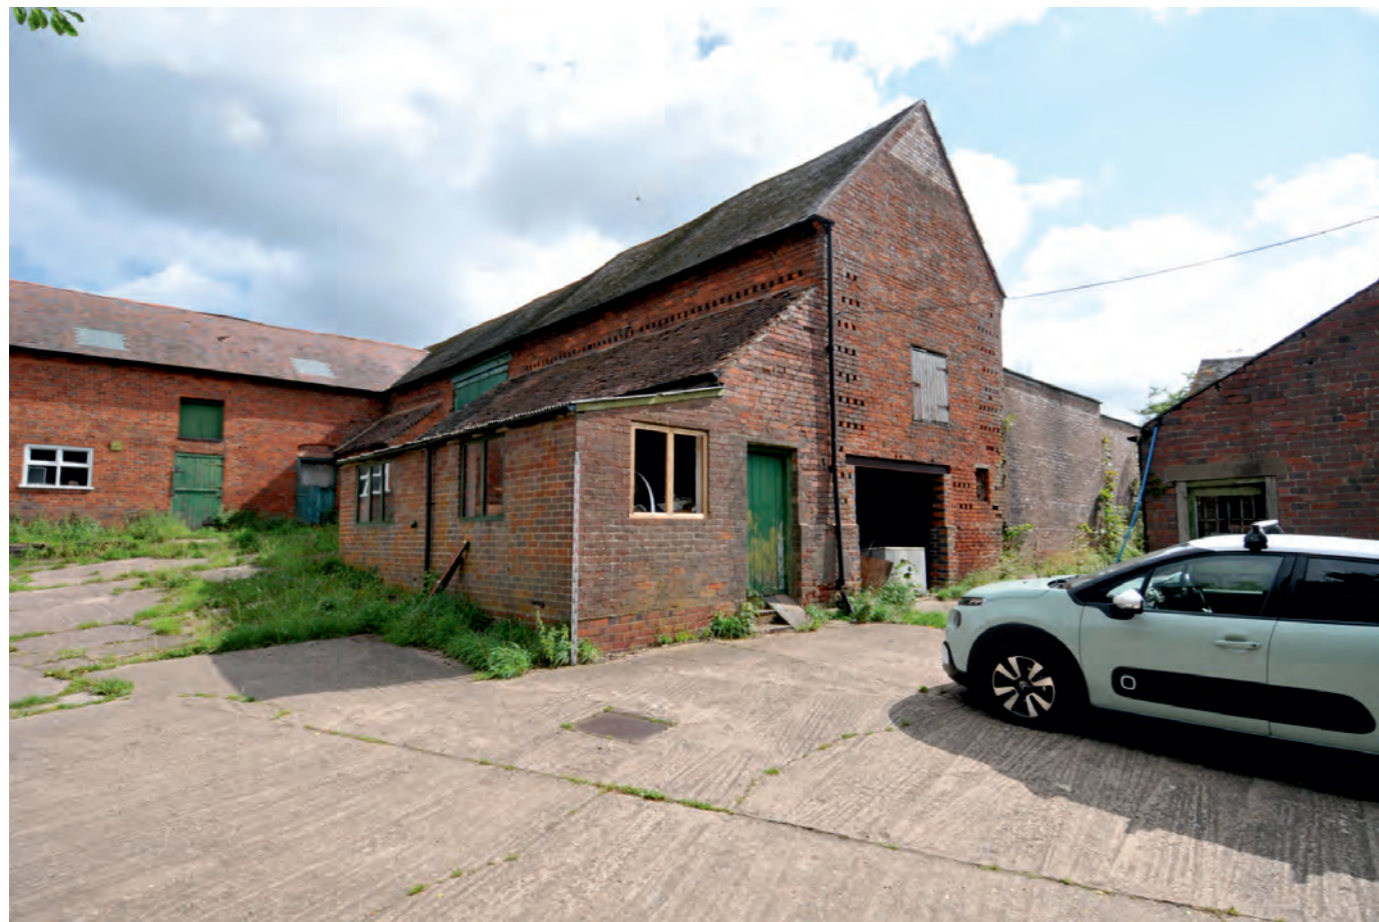
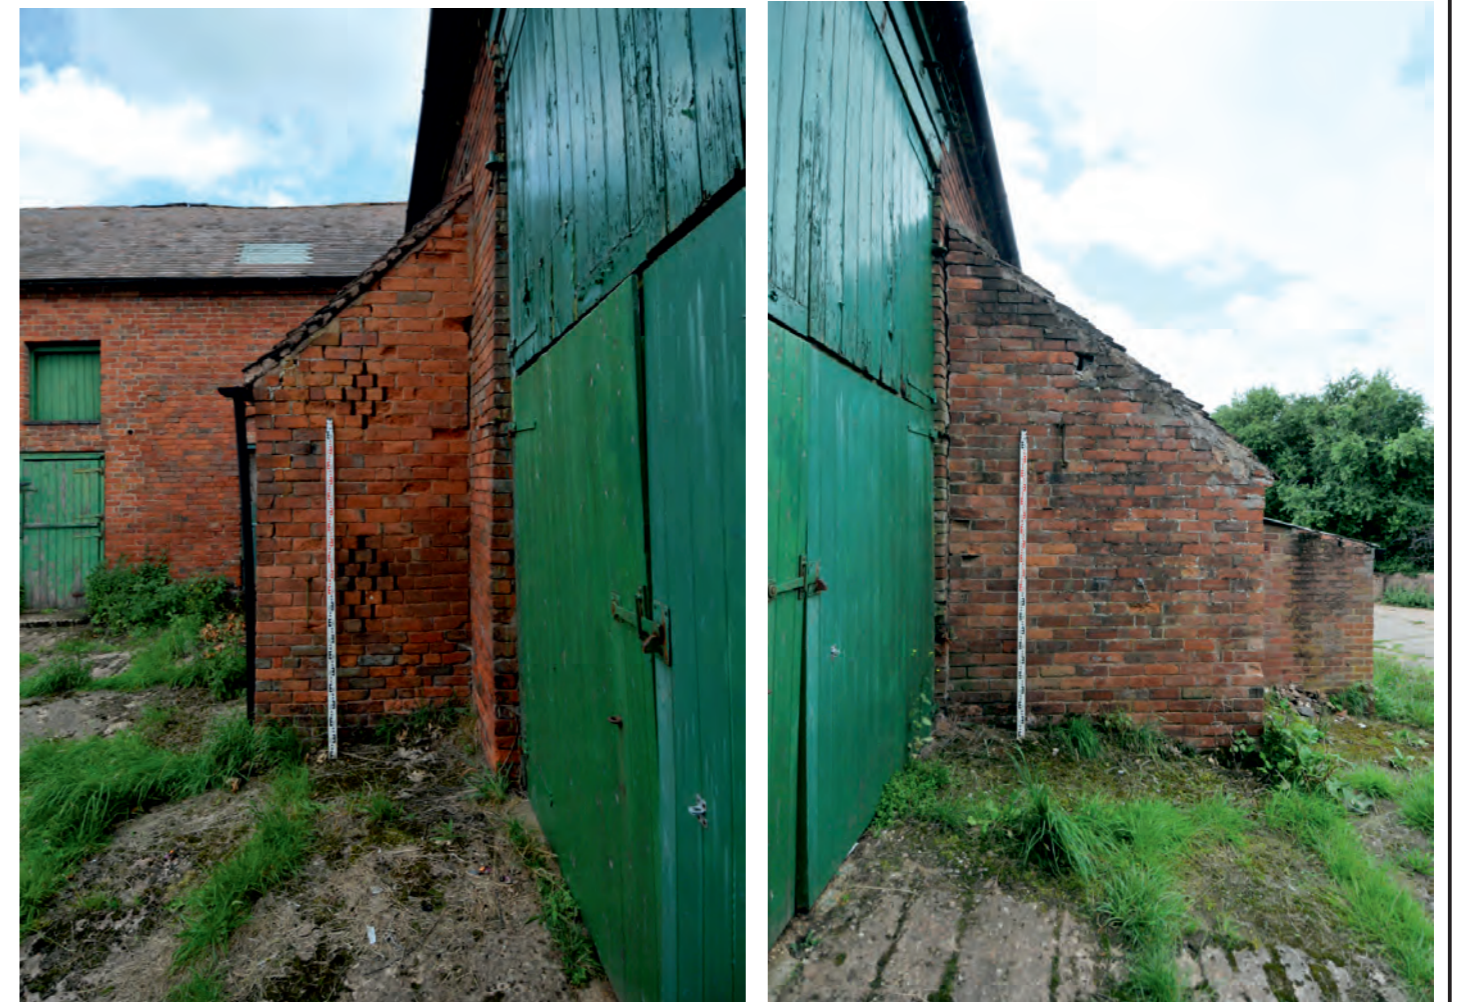
Figure 15: Former root house and possible implement shed abutting former threshing barn

5.2.5 Adjoining the barn, on the foldyard side facing the house are a small brick built lean-to structure in the angle of stable block and barn (almost certainly a root house) and a much converted and extended structure in recent times used as a tack room but converted from a row of three pig sties visible on the 1<sup>st</sup> edition Ordnance Survey. Both structures are likely to be of early 19<sup>th</sup> Century origins, but only the root-house survives in its original form. The presence of brick through vents indicates probable use for fodder storage, and the size is in keeping with a root house.

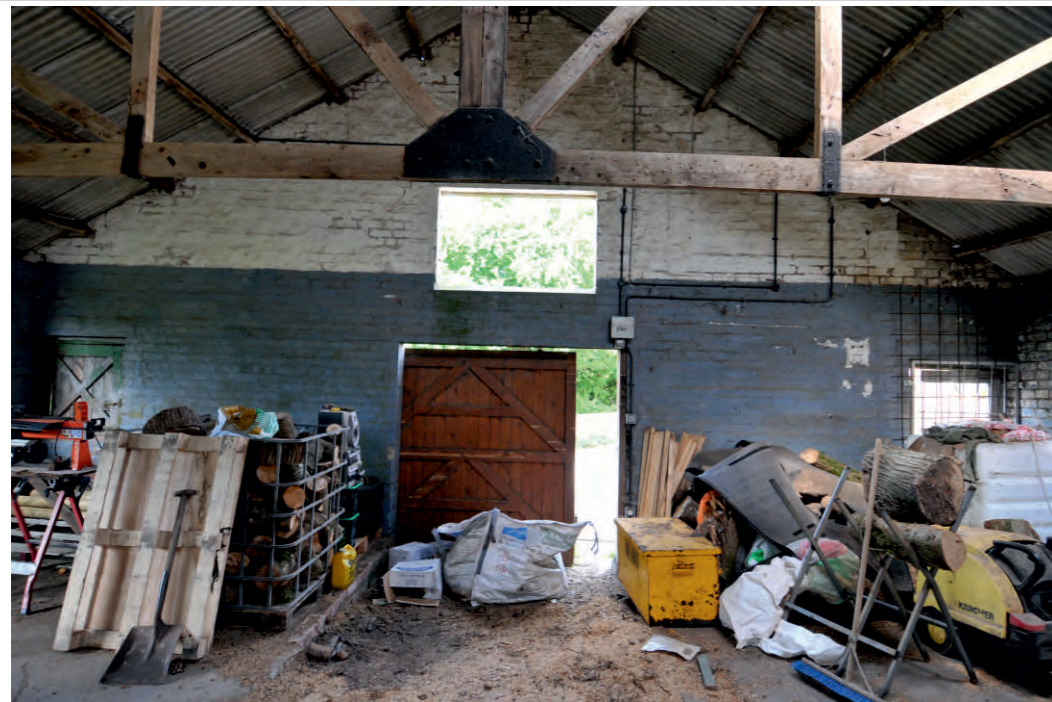
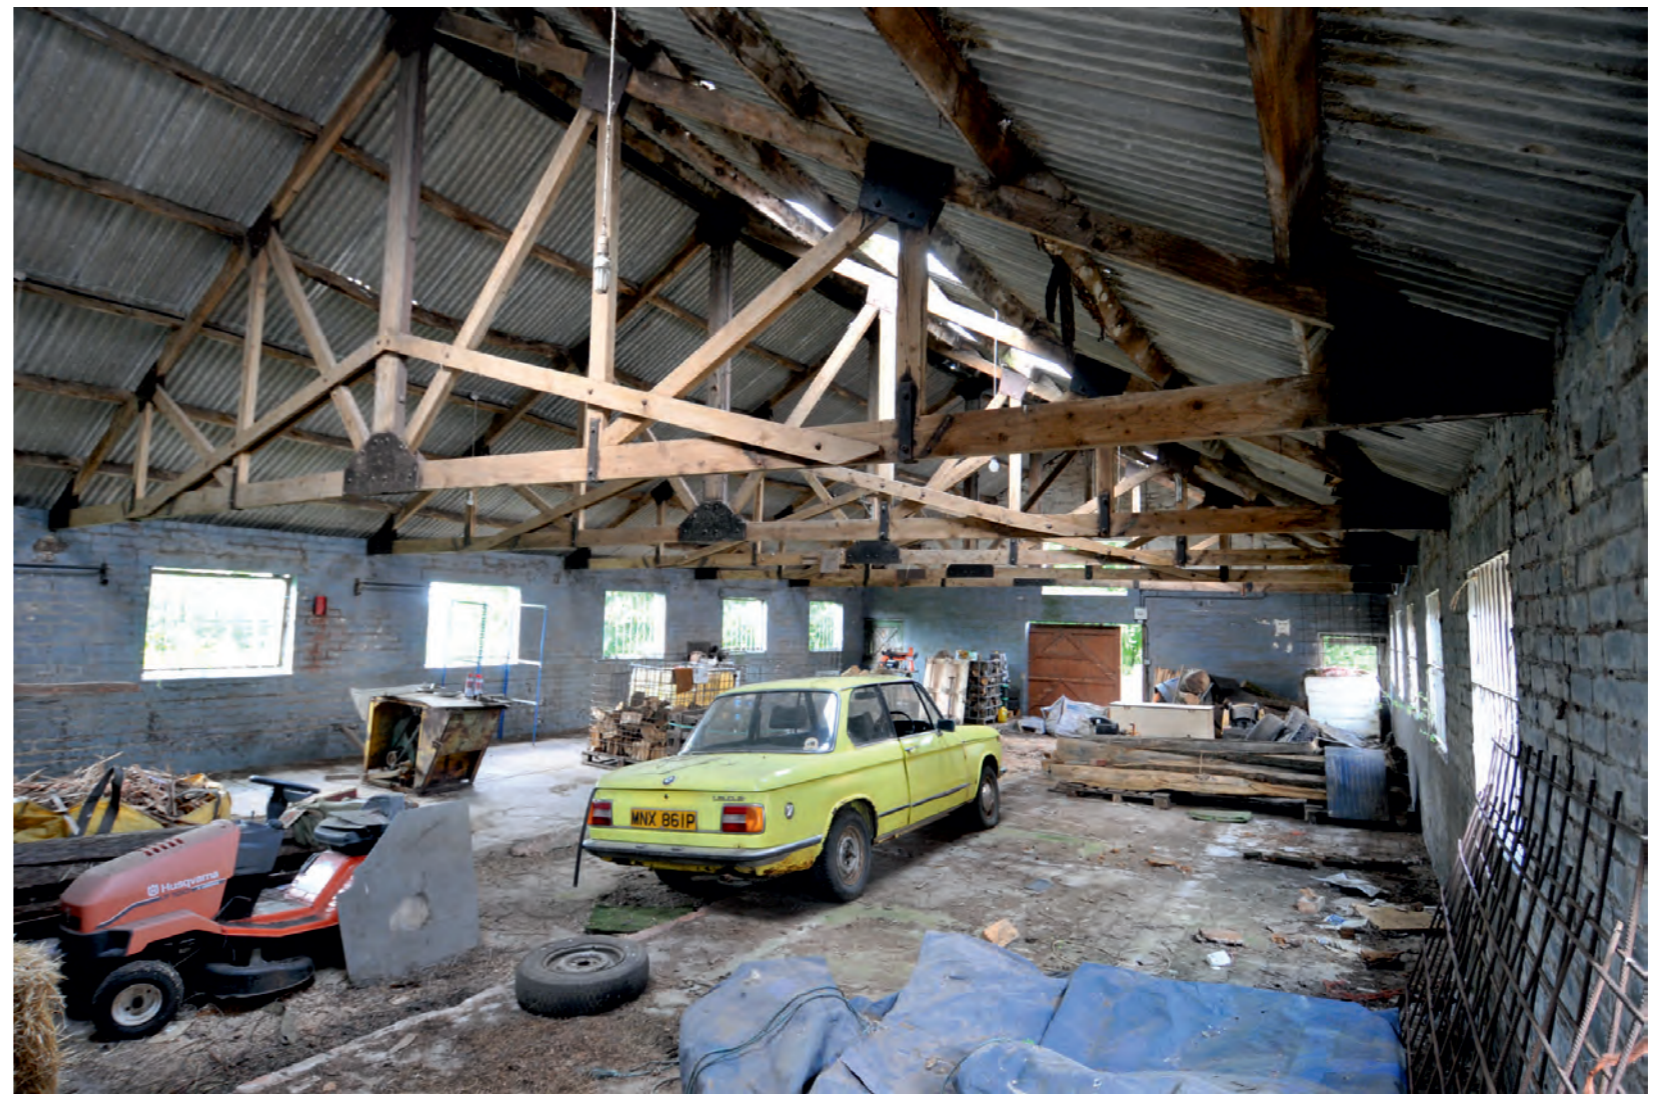
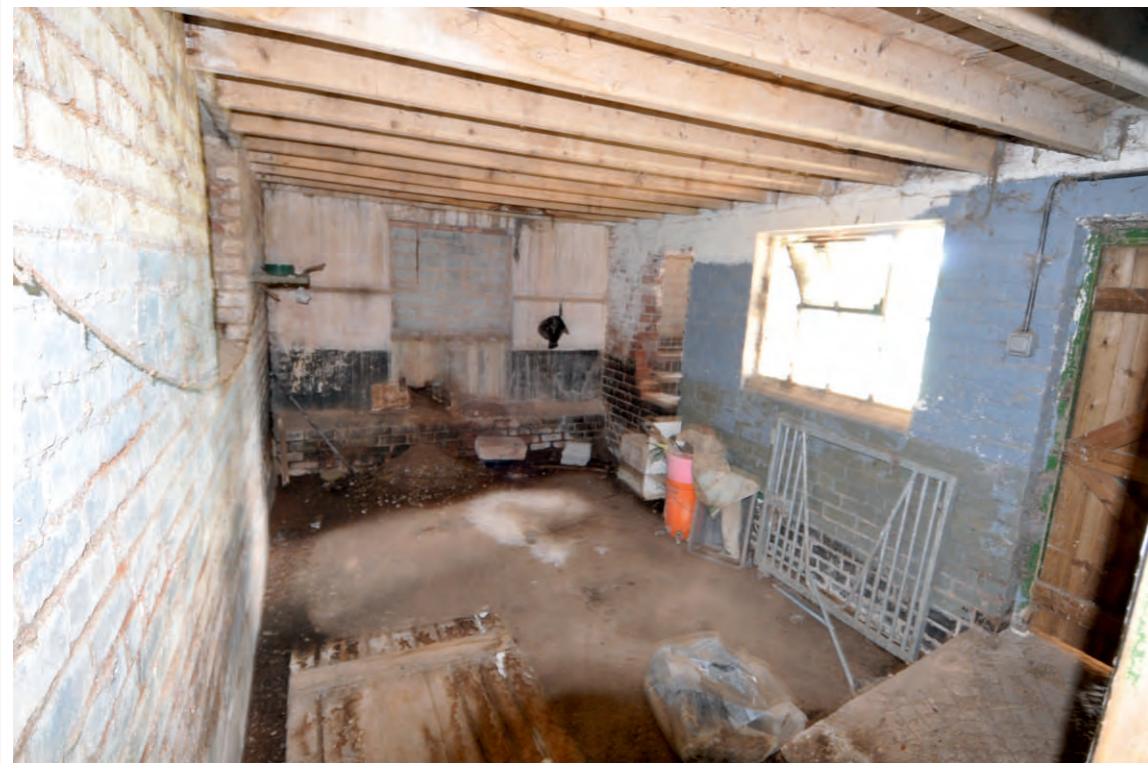
Figure 17: "Hogg barn" interior

Former loading bay

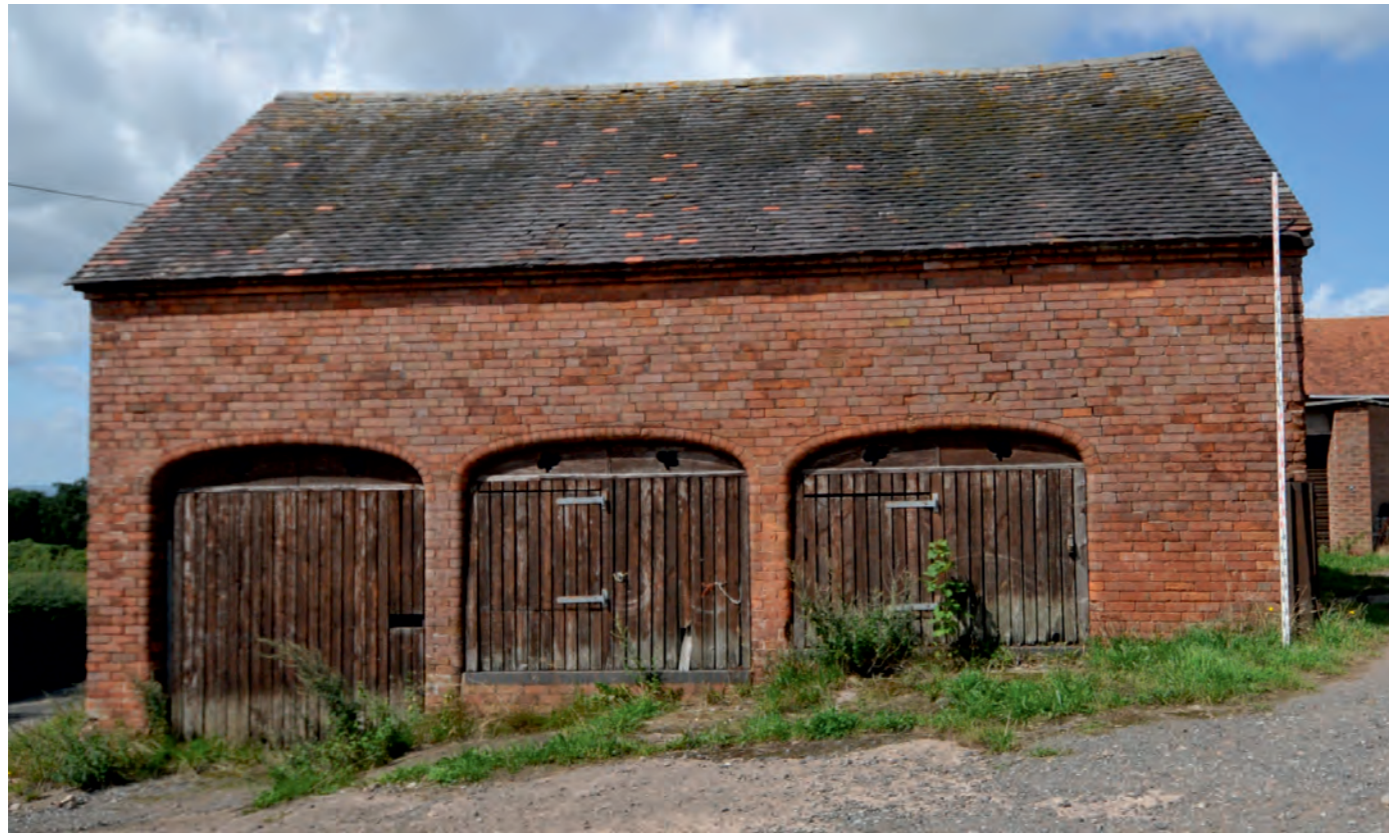
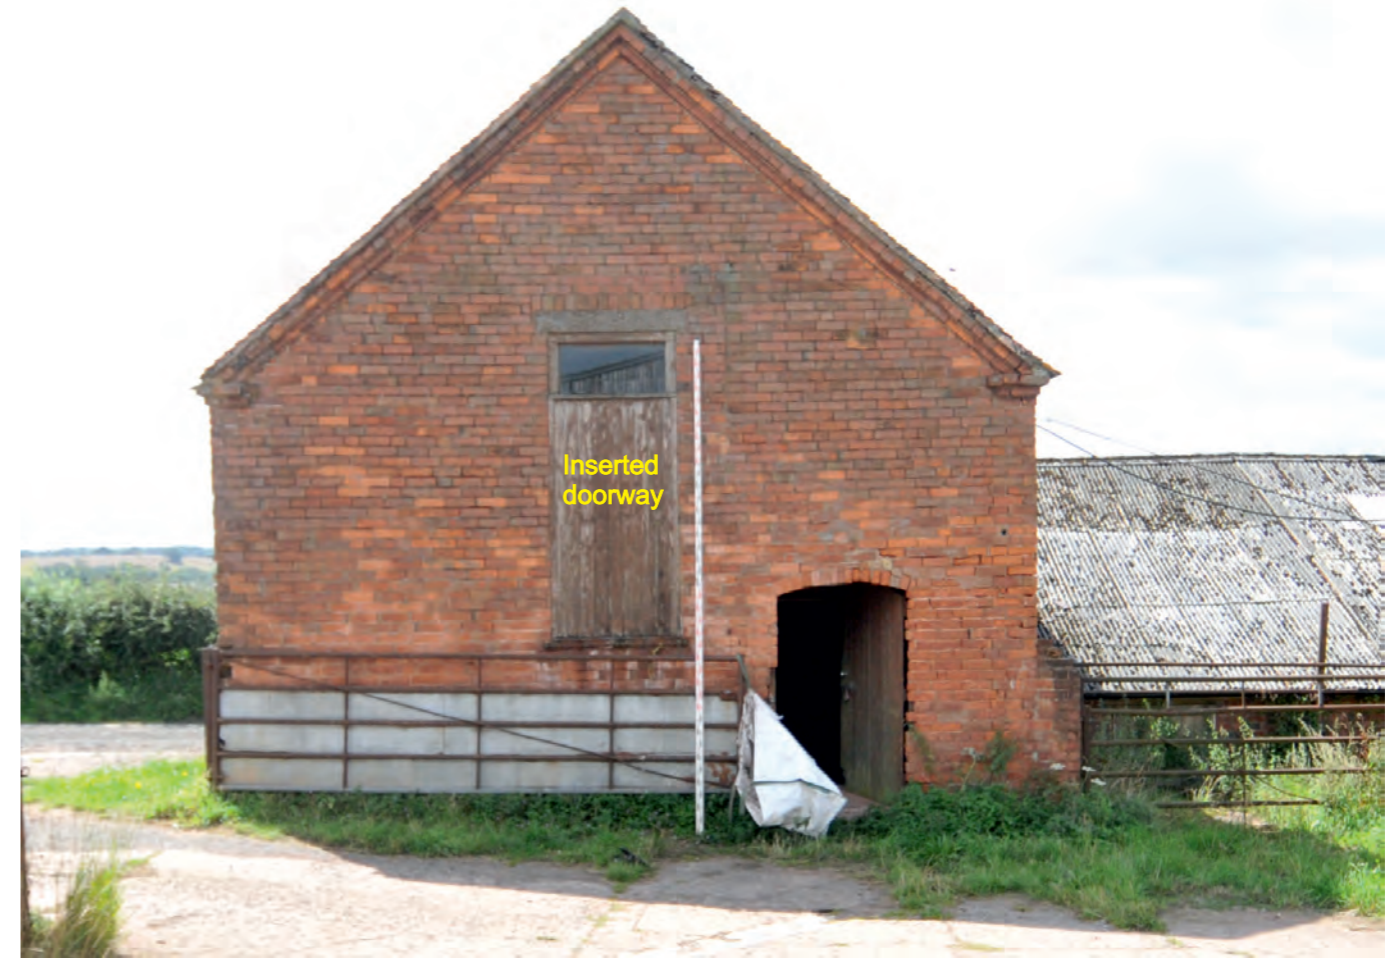
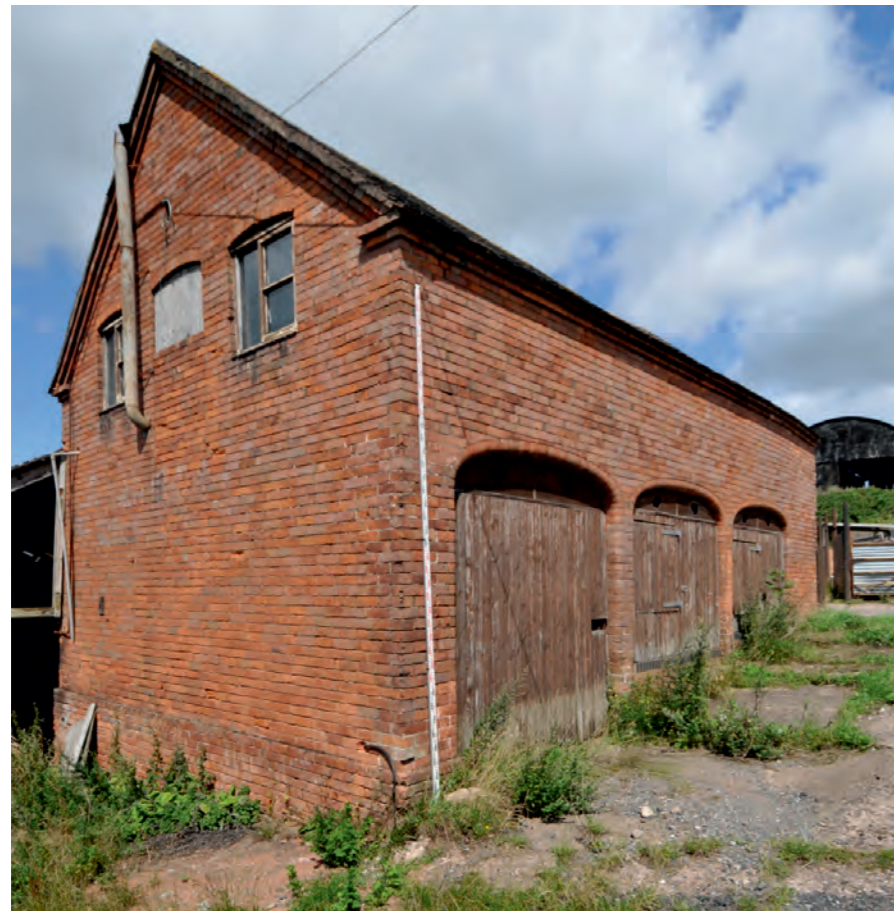
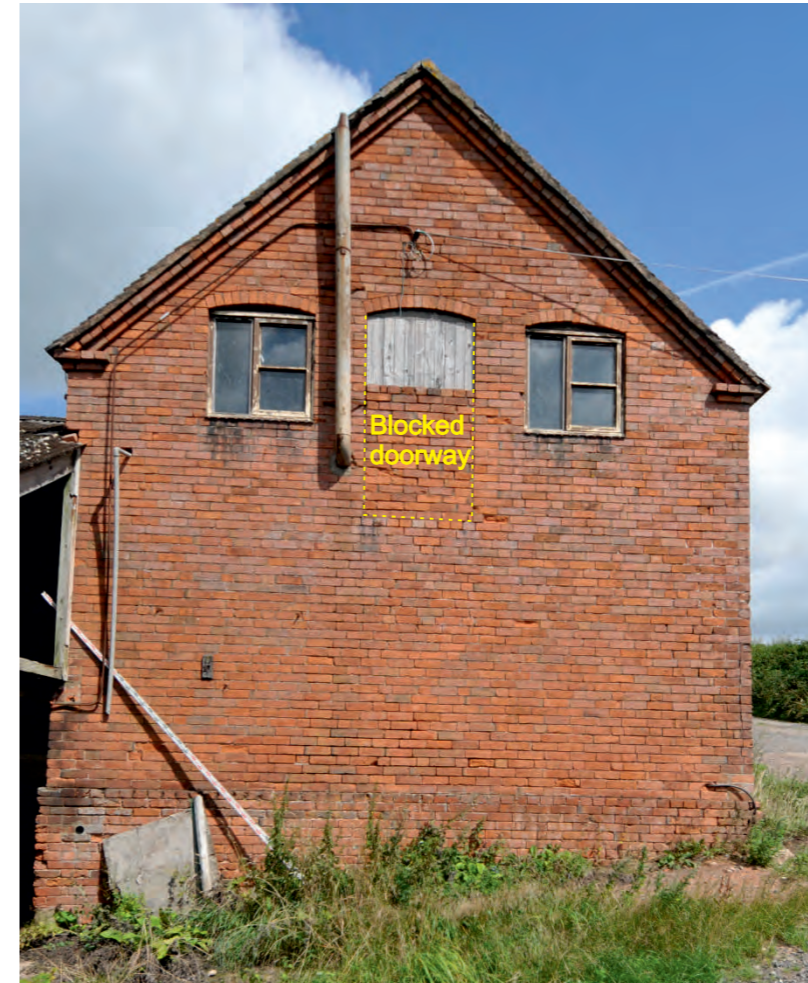
Figure 18: Former cart-house/granary latterly converted to stabling

5.3.2 There is an infilled loading door to the south western gable end and the opposing loading door has been modified to lower the threshold height and raise the head – the opening may originally have been a window (Fig 18).
