Peterborough Cathedral

Galilee Court Landscaping Project

A Report on a Programme of Archaeological Observation and Recording.

Planning Reference Number: 13/00505/FUL
HER Event Reference: 53791
Archaeological contractor's Site Code: PCGC

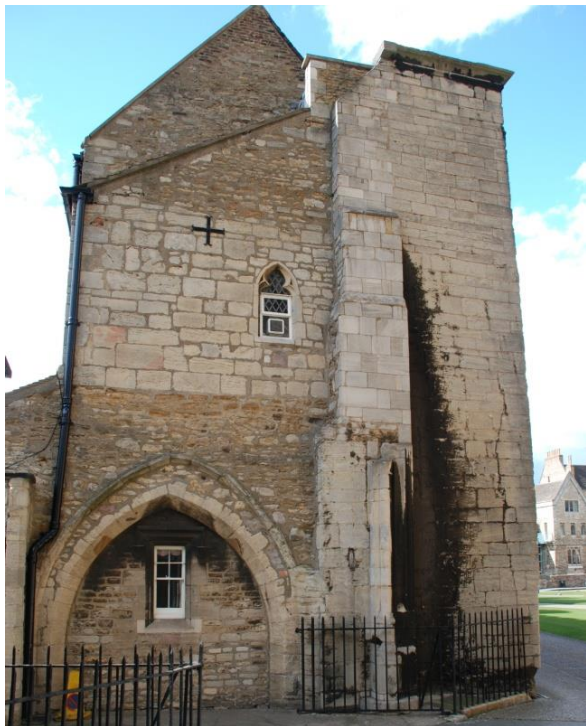
The remains of a former gateway can be seen adjoining the east side of no. 24 (PCCHER 80068) (Figure 2, area EG; Plate 3). It was still standing in 1791, when it was drawn by John Carter (Figure 6) but had been destroyed by 1795. The fenestration shows it to be contemporary with the adjoining range ie. early 14th-century.

Plate 3
The Eastern Gateway. Note the wall rib of the vaulted gate passage above the main arch connecting the gateway with No. 24. No. 24's NE tower is right of frame).
Photograph: Jackie Hall

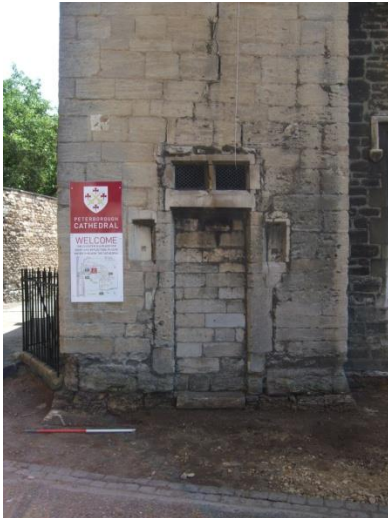
Plate 7

No. 24: NE tower, north elevation.

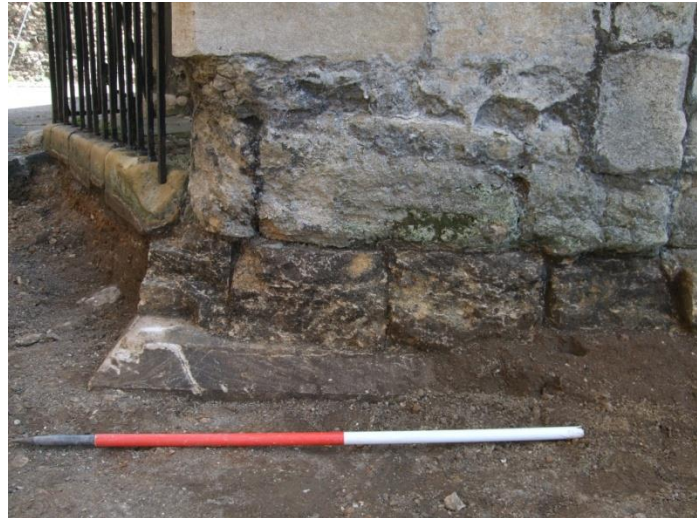
Plate 8

No. 24: NE tower, north elevation, east end, showing the previously buried chamfer. Photograph: Caroline Atkins

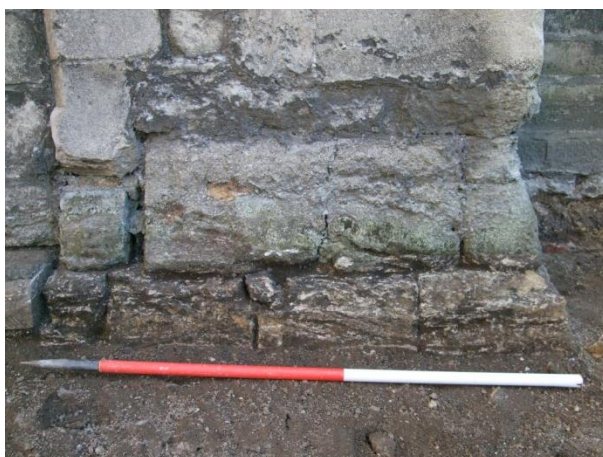
Plate 9

No. 24: NE tower, north elevation, west end, showing the west jamb of the doorway and the upper part of the plinth. Photograph: Caroline Atkins

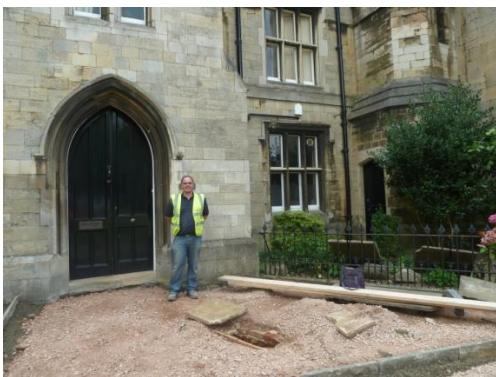
Plate 16

One feature of particular interest was found, beneath a stone slab, in front of the front door (Figure 2 and Plates 16 - 19), when levels were being adjusted to accommodate a temporary path surface across the works area. At its current base, 1.23m below the closing slab, the feature is a circular void, 1.12m in diameter, lined with roughly coursed small stones, and very like a well in appearance. Indeed, the true bottom of the feature was not found and it remains possible that it was a well when first excavated and lined. The nine courses of inwardly corbelled brickwork (bricks 230 x 108 x 60-65mm), which sit on top of the stone lining, appear to represent an alteration to an existing structure, fitting it for a second period of use.

No. 25: the location of the well/soak-away.

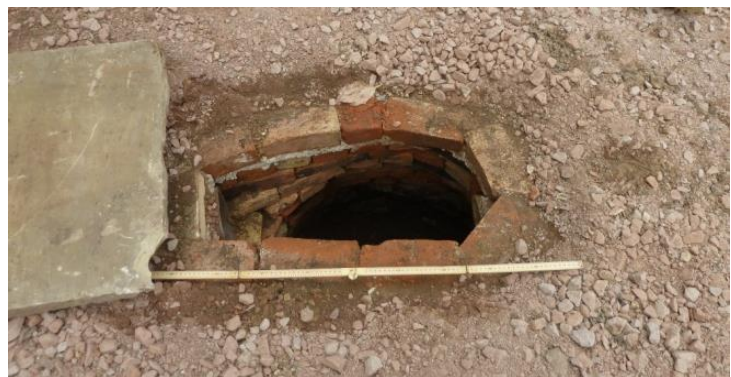
Plate 17

No. 25: brick top of the soak-away, from the E.

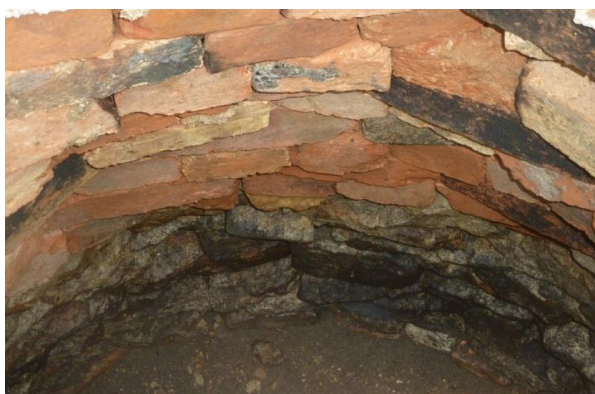
Plate 18

No. 25: the stone and brick courses lining the west side of the well/soak-away.

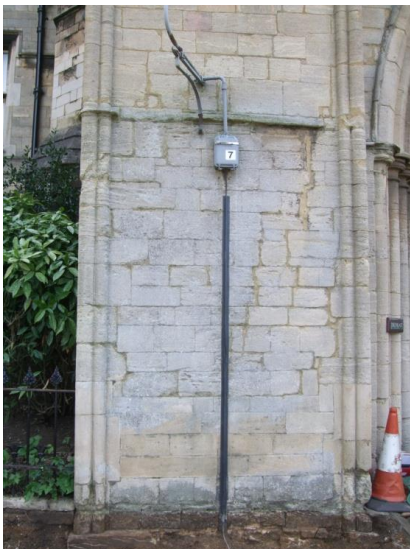
The reduction of levels adjacent to the north elevation of the Bishop's Gate exposed a 10cm offset beneath the previously masked bottom of the roll mouldings which decorate the corners of the elevation, and made it possible to discern the true lower limits of stone replacement on both sides of the gate arch. Much of both the offset course and the one above were shown to be Ketton stone replacements, a stone which appears to have been used elsewhere at Peterborough in the early 19th century (eg. on the west front). The lack of a base or moulded plinth, especially to the corner shafts, is probably indicative of inaccurate repair to an area that was no longer visible, just as with the documented repairs to the rear of the gateway (section 1.4.4).

Plate 20
(Archive image PCGC 145)
Bishop's Gate: east side,
north elevation.
Photograph: Caroline Atkins

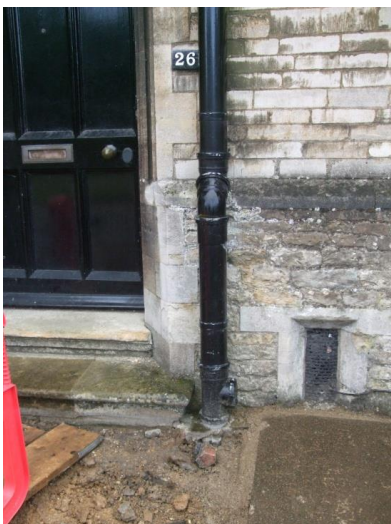
Plate 24

The reduction of levels outside Nos. 26 and 27 exposed very little additional detail other than a couple of previously buried courses of stonework, which are clearly part of the same (mid-19th century) build as the main elevation of the building, and two coal-holes, one for each of the current front doors (Plates 24 – 27). These pieces of evidence support the previously held belief that this building is unlikely to contain any remnants of earlier structures.

No. 26: north elevation, showing the location of the coal-hole.

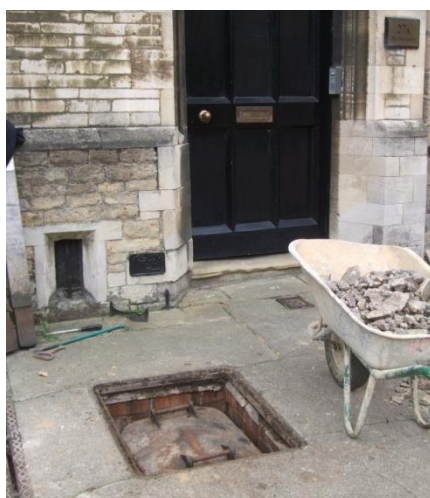
To the west of the Bishop's Gate in particular, numerous existing covers over service inspection chambers, water supply stop taps and meters required specialist contractors to adjust their height and tilt so that they conformed to the intended gentle slope of the new pavement. Three electricity supply installations formed a cluster outside the door which leads to No. 27A. The oldest and most easterly of these (Plates 28 - 30) is of particular interest. An electricity supply specialist confirmed that the installation was not only redundant but of a type which he had never seen before. Cast into the lid on the inspection chamber were the words 'CORPORATION ELECTRICITY SUPPLY', indicating that the transformer is likely to date from the period during which private companies and corporations were permitted to supply electricity, which in Peterborough was between 1900, when an electricity supply was first installed by Peterborough City Corporation, and 1947, when the new Electricity Act led to the merging of numerous private and corporation electricity suppliers in the area to form the Eastern Electricity Board.

Plate 28
(Archive image PCGC 008)
The electricity supply inspection chamber outside No. 27A
Photograph: Caroline Atkins

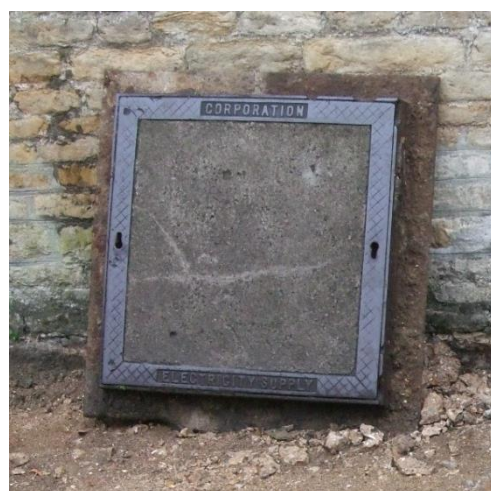
Plate 29
(Archive image PCGC 014)
The 'CORPORATION ELECTRICITY SUPPLY' inspection chamber lid.
Photograph: Caroline Atkins

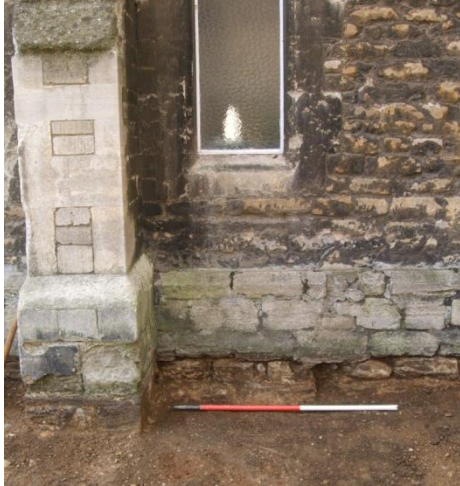
Further west, the exposed footings themselves appear to represent two separate periods of construction, at least one of which (and potentially both) predates the superimposed wall, at least on the exterior. The eastern footing in Plates 33 and 34 is offset from the plinth by an average of 17cm, while the western footing projects by only 8cm. The evidence which suggests that the footing(s) pre-date the superimposed wall is important because it confirms that there is the potential for medieval floors and construction deposits to exist inside the multi-period building known as No. 28. The evidence is of even greater importance because it reflects a piece-by-piece development of the medieval south range, with the western section perhaps contemporary with the Norman Gate, creating a stub ready for the next phase of building.

Plate 33
(Archive image PCGC 111)
No. 28: potential medieval footings
to the west of the buttress.
Photograph: Caroline Atkins

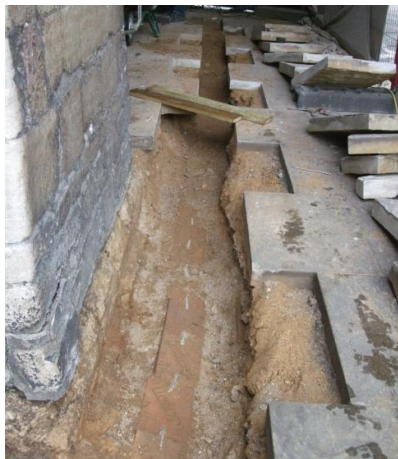
Plate 37

Norman Gate: the reopened service trench against the south side of the east gate arch.

The re-opening of an electricity supply trench on the south side of the gate passage exposed parts of the medieval footings for the east and west arches of the gateway (Plates 37 and 38 respectively). Unfortunately, the existing service trench was not bottomed and therefore it was not possible to see or record the full extent of the architectural and archaeological evidence exposed when the trench was first dug, and no such record was made at that unknown time.

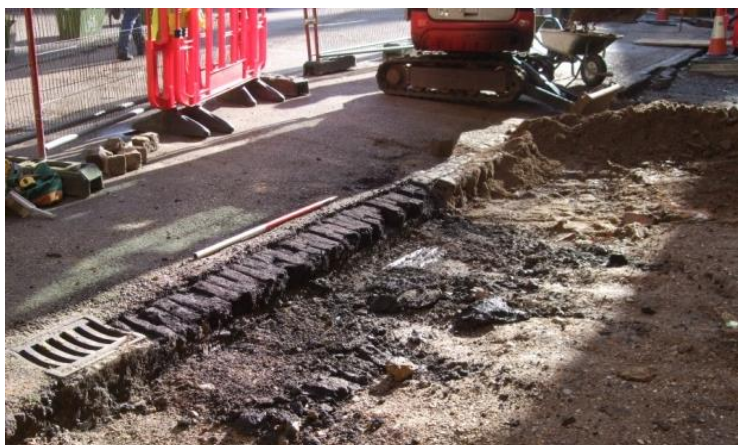
Plate 39

A relatively minor alteration to the extent of the groundworks, to the east of the Norman Gate, resulted in the exposure of a 2.60m by 0.23m strip of a tarred timber road surface, immediately beneath the current tarmac surface (Plates 39 and 40). The 228mm x 75mm x 75mm (9 x 3 x 3inch) blocks of tarred timber (807) had been laid on a very substantial concrete raft (808), 11cm thick (Plates 41 and 42). The concrete raft has cast, not cut, southern and eastern edges, the south edge running parallel to and 2.50m distant from the north elevation of No. 28 and the eastern edge lying 5.50m east of the Norman gateway (2.50m east of the cast iron gully grating shown in Plate 39).

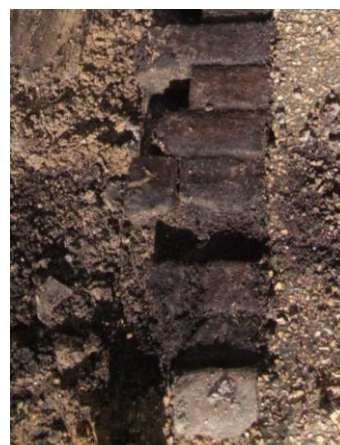
Plate 40

Norman Gate road surface: the east end of the tarred setts. Photograph: Caroline Atkins

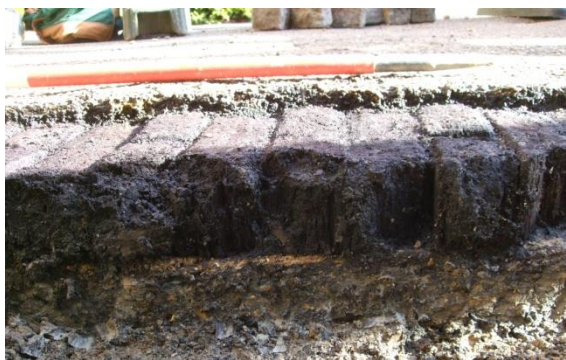
Plate 41

Norman Gate road surface: the tarred timber setts bedded on a raft of concrete.

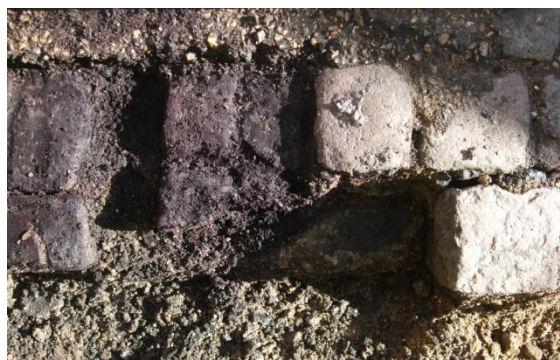
Plate 42

Norman Gate road surface: the eastern limit of the concrete raft with current stone setts overlapping it.

The current western limit of the concrete raft and timber setts lies approximately 0.50m east of the gateway's east elevation, where both have been cut away and replaced by a substantial raft of more recent concrete, presumably designed to strengthen the roadway surface beneath the gate arch and reduce damage to its structure.

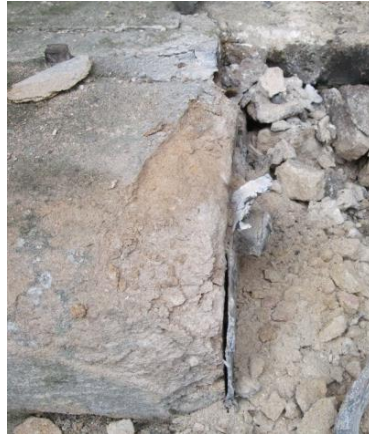
The first stones lifted were those at the northern end of the north portico's top step (Figure 2, area PN), where a total of three, Clipsham stones had survived the adjacent programme of stone replacement. Lead cramps were found between these three stones, as shown in Plates 43 to 45 below which record the joint between the 2nd & 3rd stones from the N end of the top step. No cramping was found between the later replacement stones, which were bedded on a strong, cement mortar.

Plate 44
(Archive image PCGC 198)
North Portico, top step:
the lead cramp exposed.
Photograph: Caroline Atkins

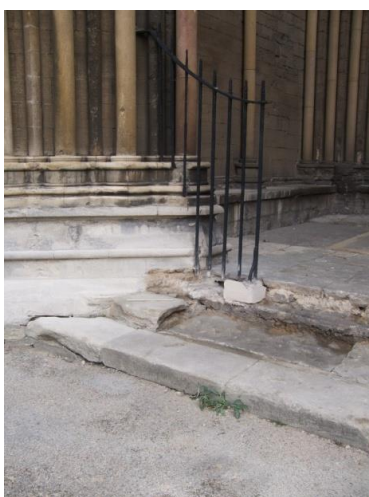
Several of the Clipsham stones at the north end of the steps (Plates 46 and 47) were not replaced in 2014 and therefore their relationship with the lower courses of the pier base remains as found. They pre-date the replacement plinth to the north-west tower.

Plate 46
(Archive image PCGC 233)
North Portico steps, north end:
after stone removal, showing the
location of Plate 44.

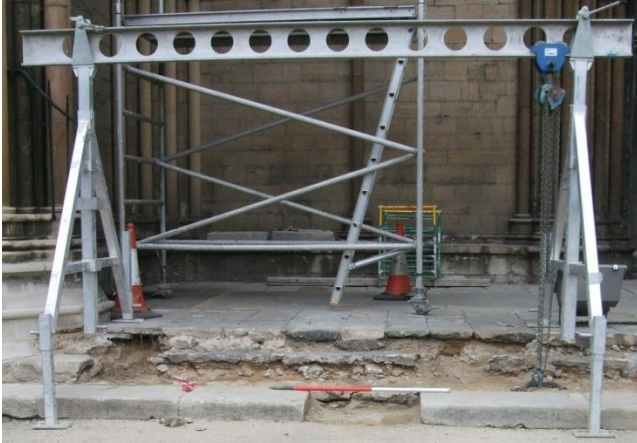
Lifting of the stones from the middle step exposed an alignment of small flat stones (Plates 48 and 49), which might be the capping on a duct or drain. The small flat stones did not need to be lifted, therefore the feature was not investigated, but it appears likely that it is a duct for cables serving new lights installed in the 1920s or 1930s and that the stones of the portico step were lifted and replaced for that purpose.

Plate 48
(Archive image PCGC 301)
North Portico steps, north of centre, showing
the location of Plate 49.
Photograph: Caroline Atkins

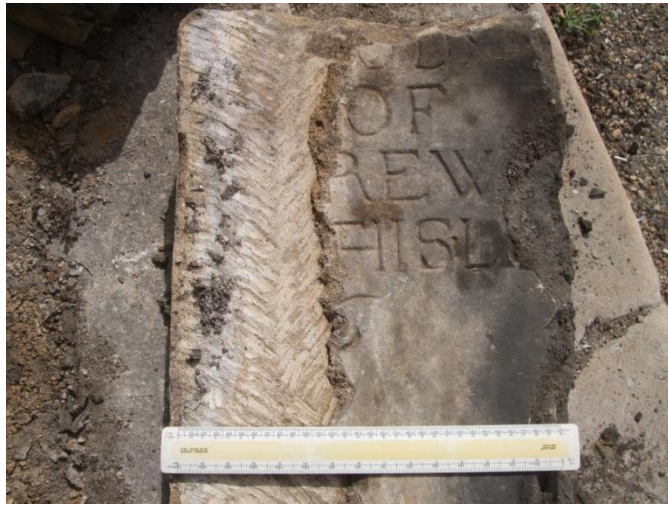
While the steps of the south portico (Figure 2, area PS) appeared to be very similar to those of the north portico, a significant difference was discovered when the stones designated for replacement were lifted. Several of those lifted were in fact reused memorial stones, cut into appropriately sized pieces (Plate 50). In some cases, the inscribed faces had been dressed to achieve a better fit, resulting in large parts of the inscriptions being lost, as can be seen in Plates 51 and 52 (stones SR 002 and SR 001 respectively), but in others, it was possible to reunite parts of a memorial, as shown in Plate 53 (stones SR 003 and SR 004).

Plate 51
 (Archive image PCGC 221)
 South Portico steps: stone SR 002
 Photograph: Caroline Atkins

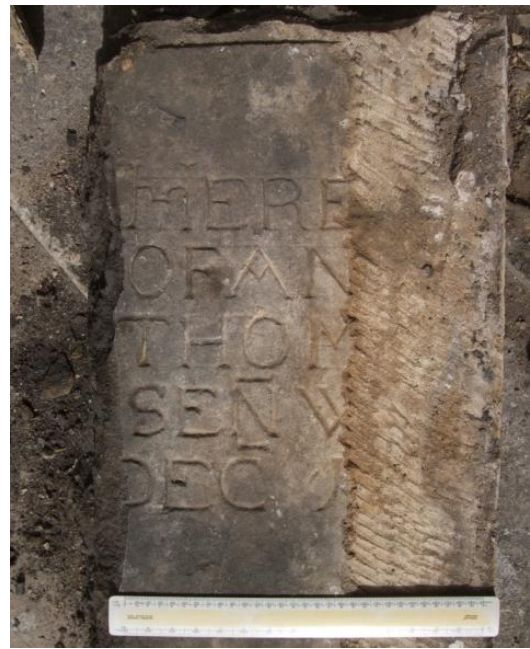
Plate 52
 (Archive image PCGC 219)
 South Portico steps: stone SR 001
 Photograph: Caroline Atkins

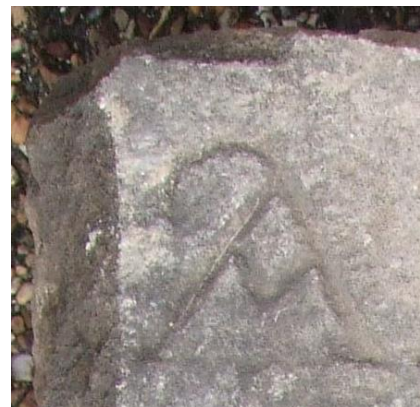
The inscriptions on the two stones shown in Plate 53 are as shown below, with grey shading on the decorative 'A's (Plate 54) which only appear in the upper inscription, dated 1699. Letters given in blue appear in the inscriptions in digraphic or otherwise abbreviated form. The letter in red is partially damaged and underscores show the location of illegible or missing characters.

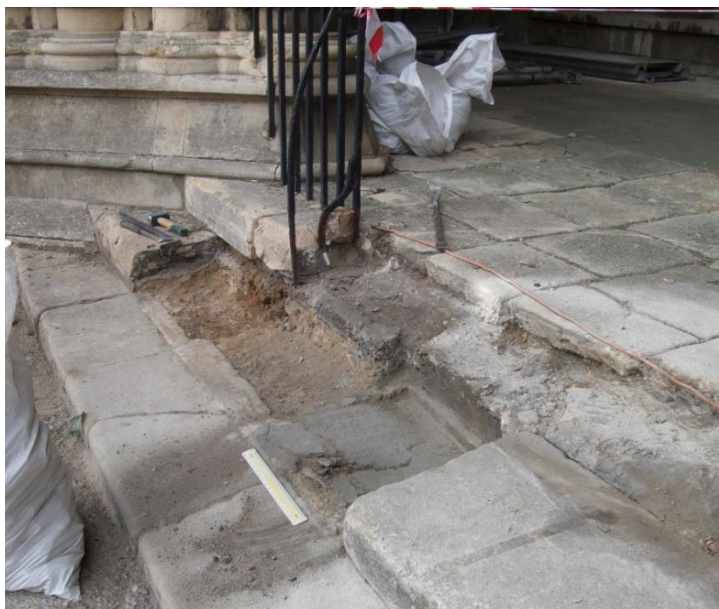
Plate 55

In contrast, two memorial stones were found towards the north end of the south portico steps (Plate 55) with parts of their edges and mouldings intact (Plates 56 and 57, stones SR 006 and SR 005 respectively).

South Portico steps: positions from which Stone SR 006
(centre bottom of frame) and Stone SR 005 were lifted.

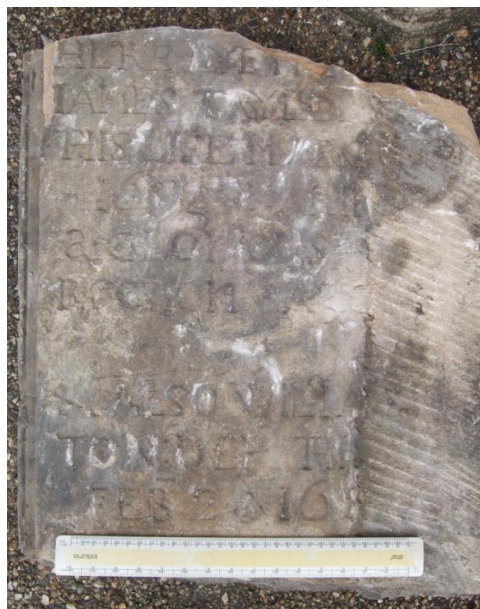
Plate 56

In addition to retaining a moulding along its side, which indicates that it was part of a table monument, stone SR 006 bears an inscription to James Taylor and gives a date in 168*. Unfortunately, stone SR 005 has only the moulding to offer, re-dressing and wear having removed any inscription there might have been.

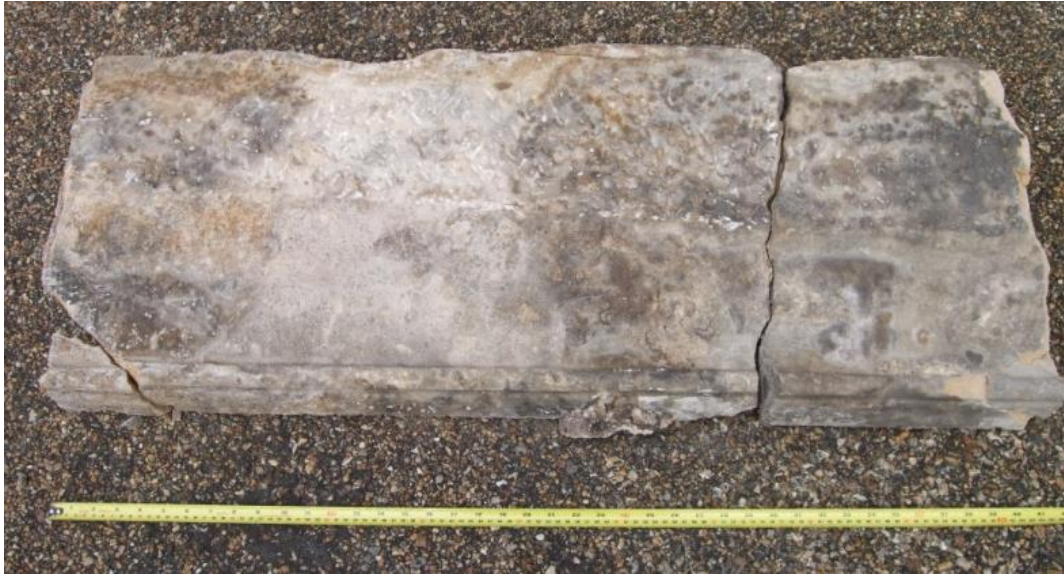
Plate 57

South Portico steps: Stone SR 005 after lifting from position of reuse as shown in Plate 55.

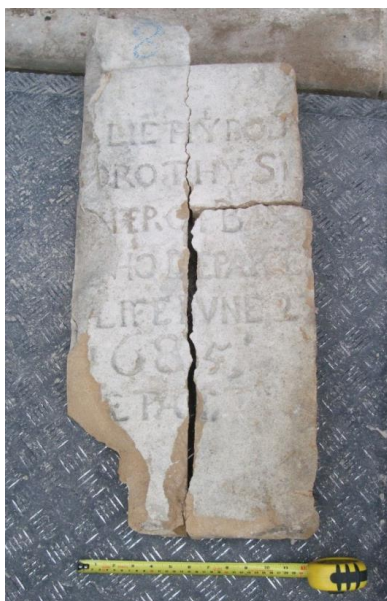
Plate 58

Relatively little work was required in the outer porch (Figure 2, area PO) and consequently little new information was collected. Part of one memorial stone (Plate 58, SR 007), dated 1685, was lifted from its position of reuse near the centre of the top step but otherwise, only recently laid slabs in the south-west (Plate 59) and north-west corners of the porch were lifted and these exposed only the modern backfill of the two floor light pits.

Outer Porch Steps: memorial stone SR 007 which was found in the top step.

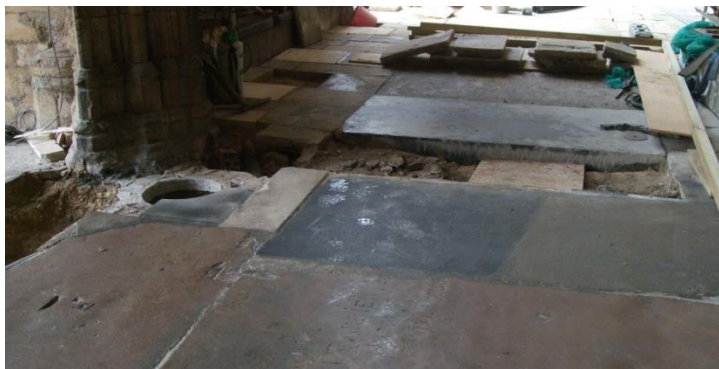
Works scheduled for the inner porch (Figure 2, area PI) were confined to its periphery, where small stone slabs were lifted and rebbed for the installation of electricity cable ducting, and larger stones, two of them memorial slabs (Plates 60, 61 and 62), were lifted and set slightly lower so that the new side screens could be installed.

Inner Porch, W & N sides showing a duct trench to the left and the vacant position of stone SR 008 centre right.

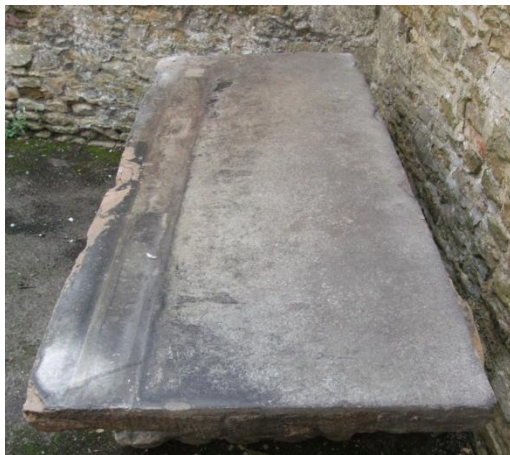
Inner Porch: memorial slab SR 008 while temporarily stored in the yard behind No. 24.

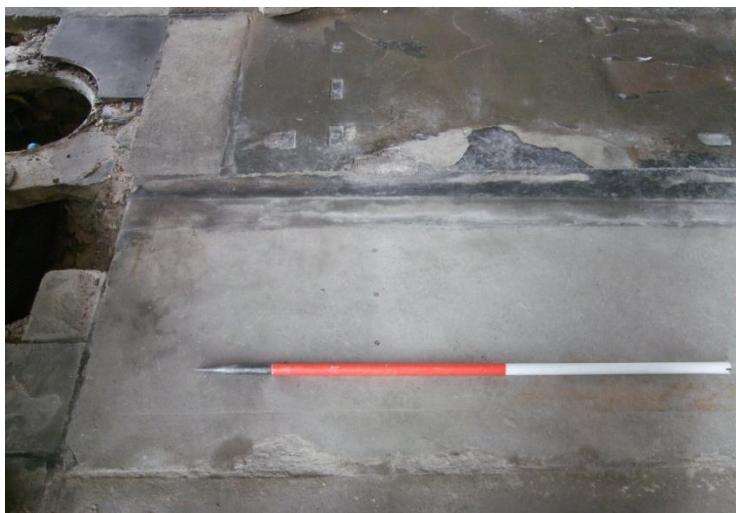
Inner Porch: memorial slab SR 009 *in situ* in the floor on the south side of the porch.

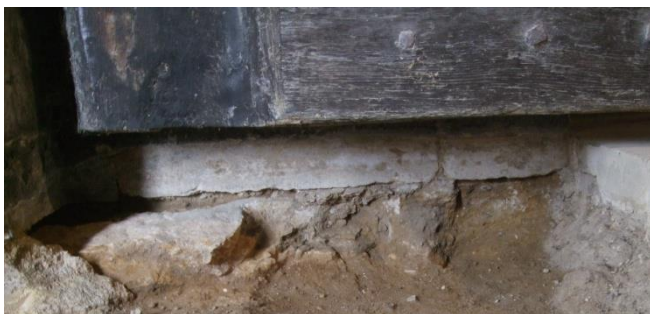
Archaeological supervision of the eastern half of the same trench enabled the recording of a previously buried offset footing or threshold (Plate 63) and patches of bedding material for an earlier paving scheme (Plate 64).

Plate 63
(Archive image PCGC 420)
Nave west doorway: north side viewed
from the south.
Photograph: Caroline Atkins

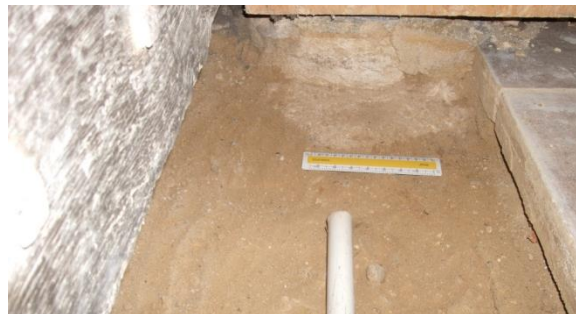
Plate 64
(Archive image PCGC 414)
Nave west doorway: west side viewed from the
north, showing the lower part of the central column.
Photograph: Caroline Atkins

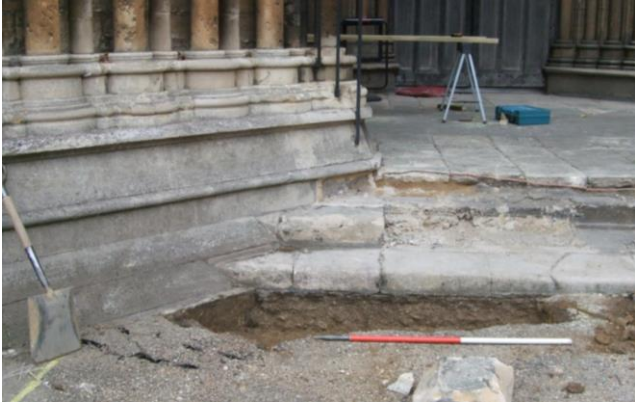
Plate 69

The east side of the test trench, abutting the bottom step, was 1.55m long by 0.70m at its widest point, and it was excavated, largely by hand, to a depth of 225mm, which was the maximum depth of excavation required at the perimeter of the mound where the new lengths of path would join the existing ones.

Ramp Test Trench: location abutting the south portico's bottom step.

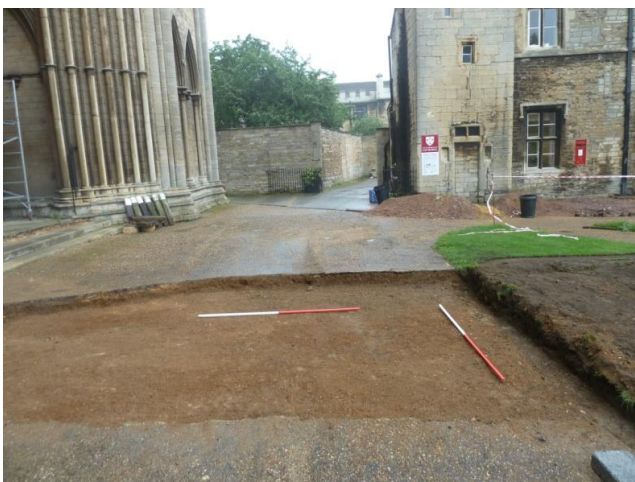
Plate 71

Trench RS: fully excavated, showing layer **824** centre-frame and the existing, undisturbed, tar-bonded gravel bottom of frame. Scale units = 1m

The deposits exposed in the bottom of Trench RS (Plates 71 and 72), were a ginger-brown coarse sand and gravel (context **824**), on which the existing tar-bonded gravel path surface had been bedded; a grey-brown clay mixed with sand and gravel (**825**), which lay beneath layer **824** and had a firm surface; and a patchy spread of mortar (**826**), which separated layers **824** and **825**. A dark loam (**827**) was exposed in the trench for the new kerb stones.

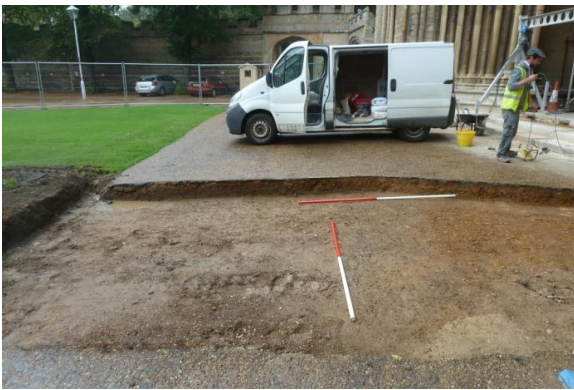
Plate 73

The deposits exposed in Trench RN (Plates 73 and 74) and Trench RW (Plates 75 and 76) were identical to those seen in Trench RS, but their relationships with each other, and the steps of the north portico in Trench RN, were more clearly defined.

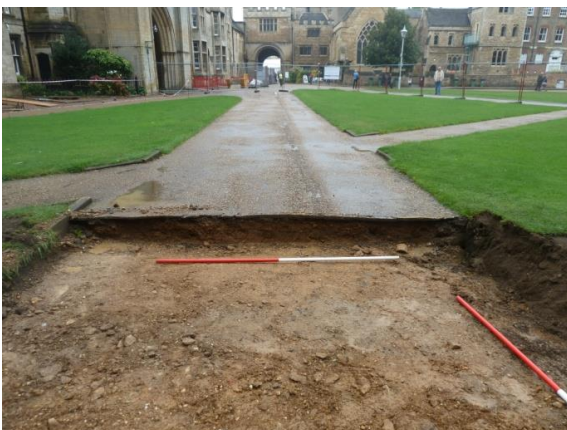
Plate 75

Trench RW: limit of excavation, viewed from the east. Scale units = 1m
