WEST LOGGIA ROOF

Hardwick Hall, Derbyshire

Historic Building Record

July 2021

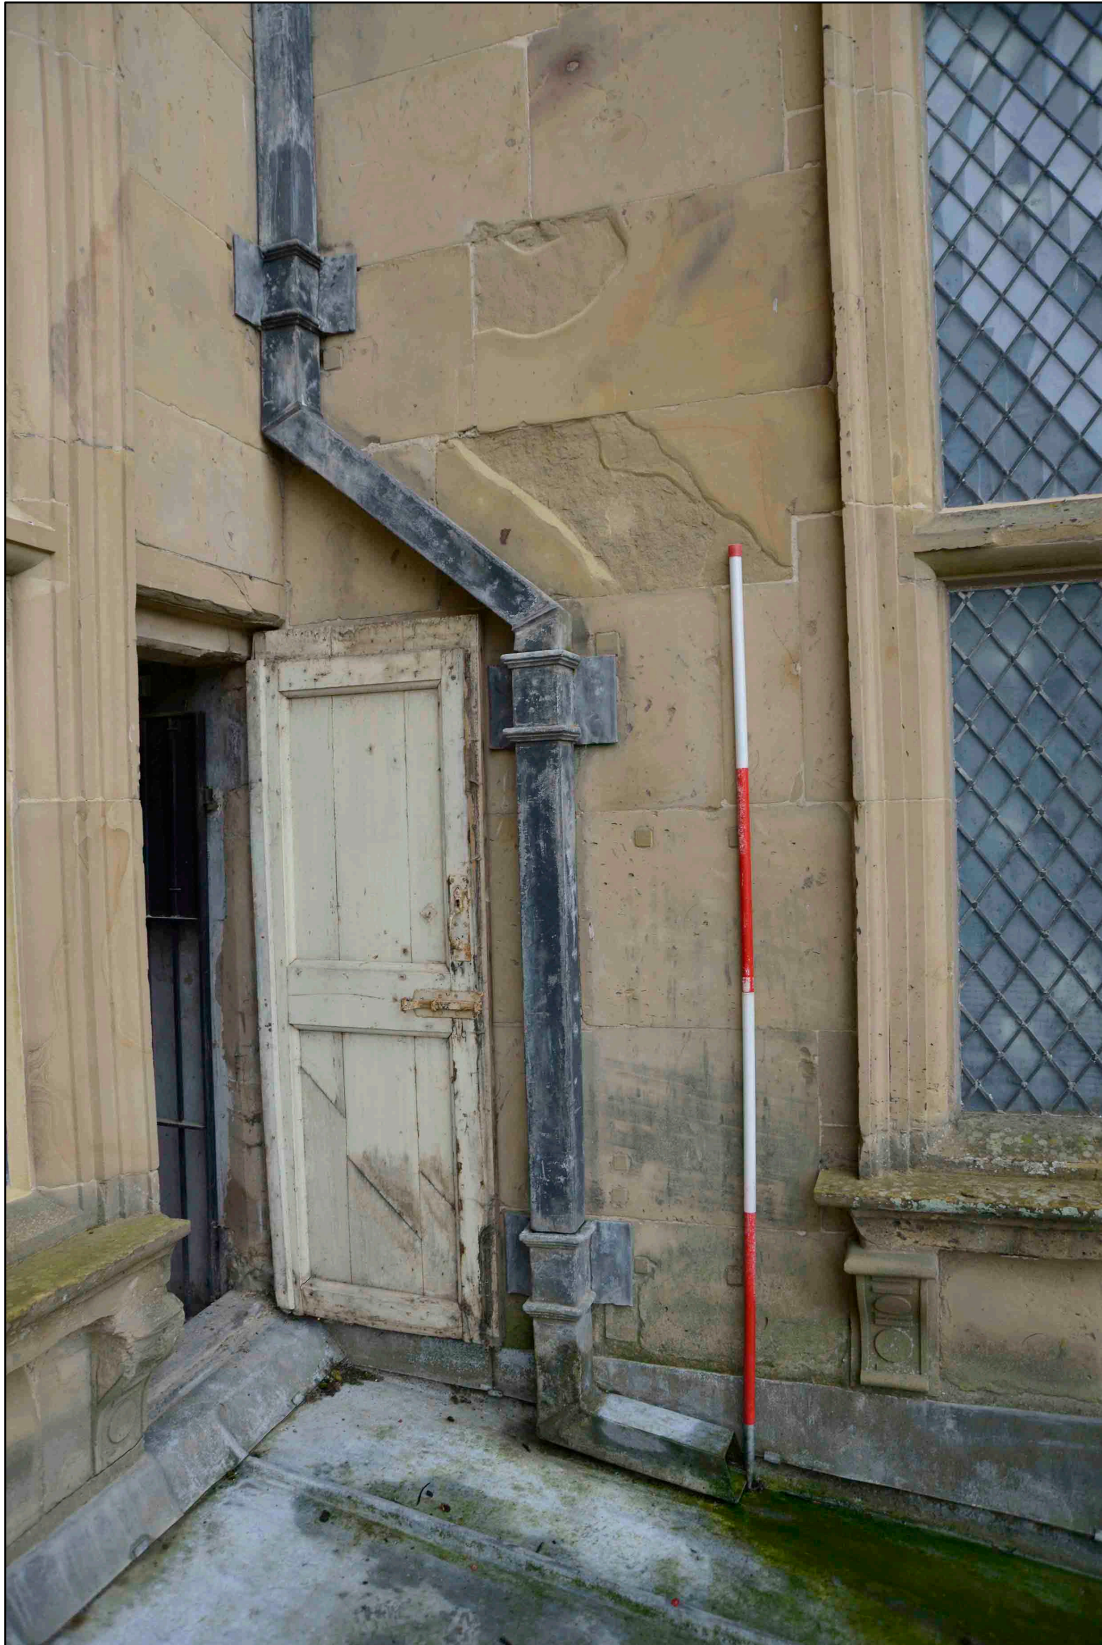
(Digital 10; 2m scale)

In the corners of each area of the roof, square sectioned lead gutters directed rainwater from the main roof of the house, down onto the roof of the West Loggia. The base of the downpipes are angled (**Appendices I.5, I.8, I.9**) and appear to have been remodelled in Phase 3.

Appendix I.5: View of south-east door onto West Loggia roof prior to repairs in October 2020.

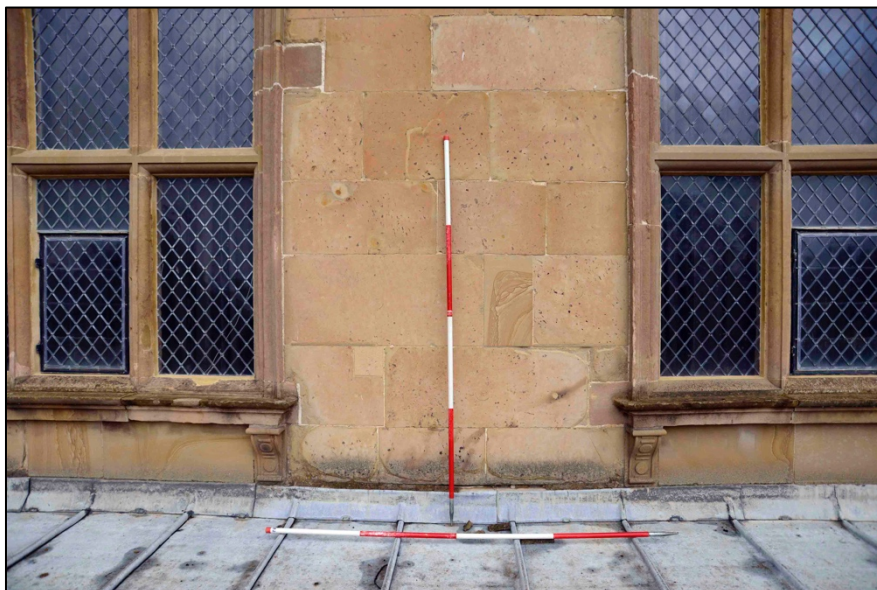
(Digital 22; 2m scale)

Appendix I.10: Detail of central section of west elevation (**Area B**), looking east.

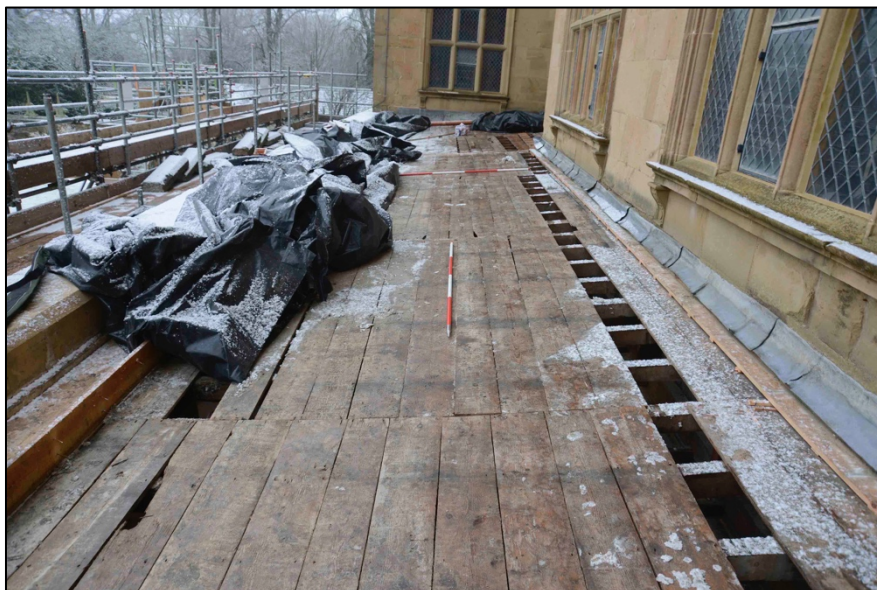
(Digital 110; 2m scale)

The roof of the West Loggia comprises of flat sheets of lead, with timber rolls that are laid over softwood boards. The timber boards were butt jointed and varied in length (**Appendices 1.16, 1.17**). All were softwood, most likely pine and either measuring 2.5cm x 17cm (Phase 3 - 1960s) up to 5.33m long, or slightly wider at 3cm x 28-29cm (Phase 1- 1590s) up to 5.52m in length. Approximately 40% of the boards were replaced, mainly along a 1-1.5m strip against the west elevation of the Hall and the south end of **Area A** (**Appendices 1.15-1.17**). Alterations had also occurred along the edge of the parapet where a new softwood box gutter had been inserted, presumably replacing an earlier one. Two forms of nails were noted, with those of the wider boards being handmade.

Appendix I.16: View of exposed 'original' boards in central section of roof (**Area B**), looking north.

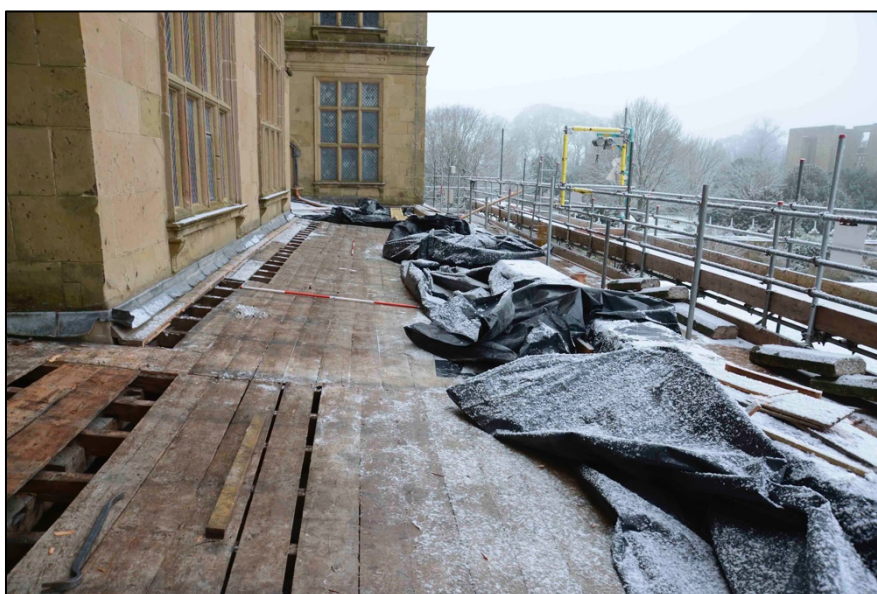
(Digital 112; 2m scale)

Appendix I.17: View looking south along exposed boards below leads.

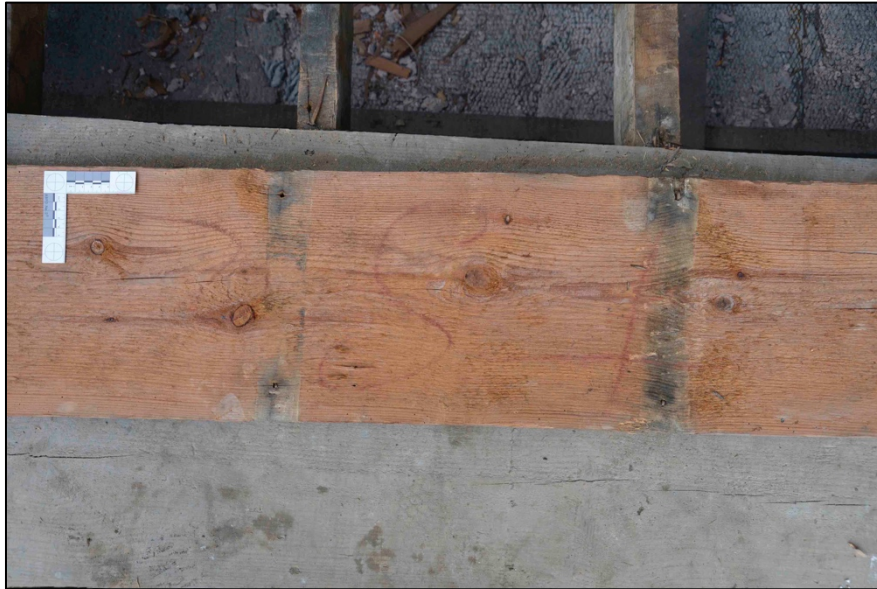
(Digital 49; 5cm scale)

On the underside of a number of the wider softwood boards lettering was noted applied in red paint, or with a red ink – **T S 2** (**Appendix 1.18**), **T S 14** (**Appendix 1.19**) and **T S 18**. Whether this denoted a particular craftsman, or related to the construction of the roof is however unclear but appears to be associated with phase 1 work.

Appendix I.18: Detail of underside of 'original' pine board; note red letters T S 2.

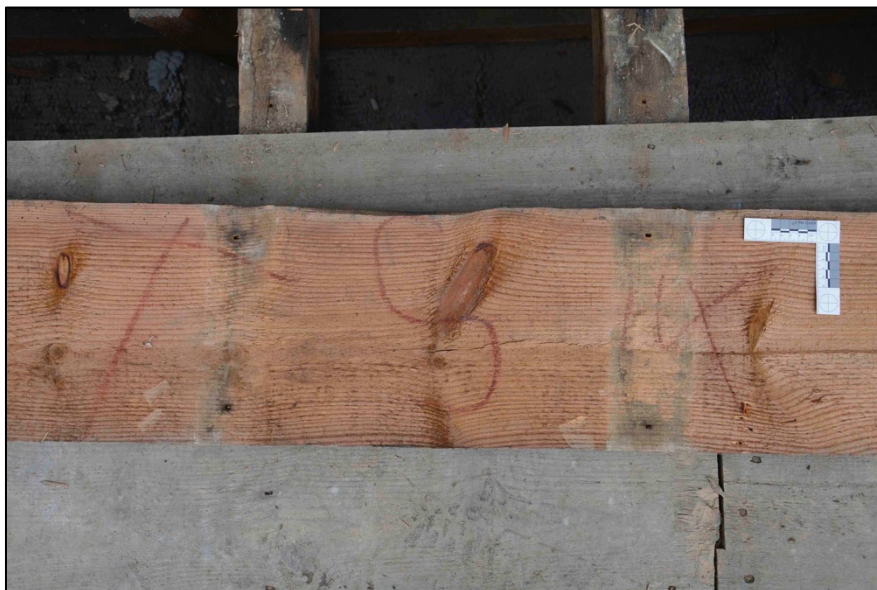
(Digital 50; 5cm scale)

Appendix I.19: Detail of underside of 'original' pine board; note red letters T S 14.

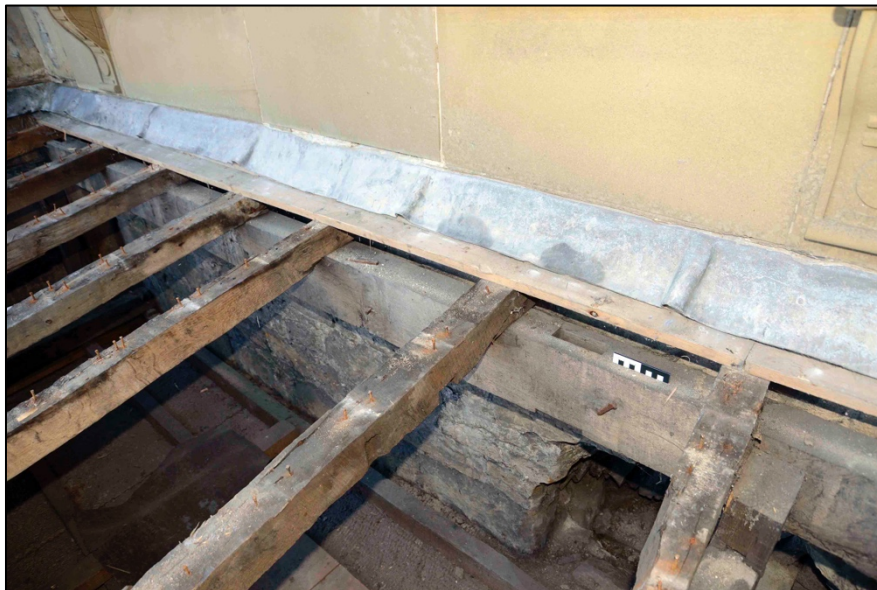
(Digital 44; 10cm scale)

Within the roof occasional timbers contain features such as redundant mortices (**Appendices I.24, I.29**), rows of nails, or pegs (**Appendix I.27**) which suggest that when the roof was built the carpenters were recycling structural timbers from elsewhere.

Appendix I.29: Detail of timber construction along the west wall of the Hall in **Area A**; note rafters notched over timber bearer.

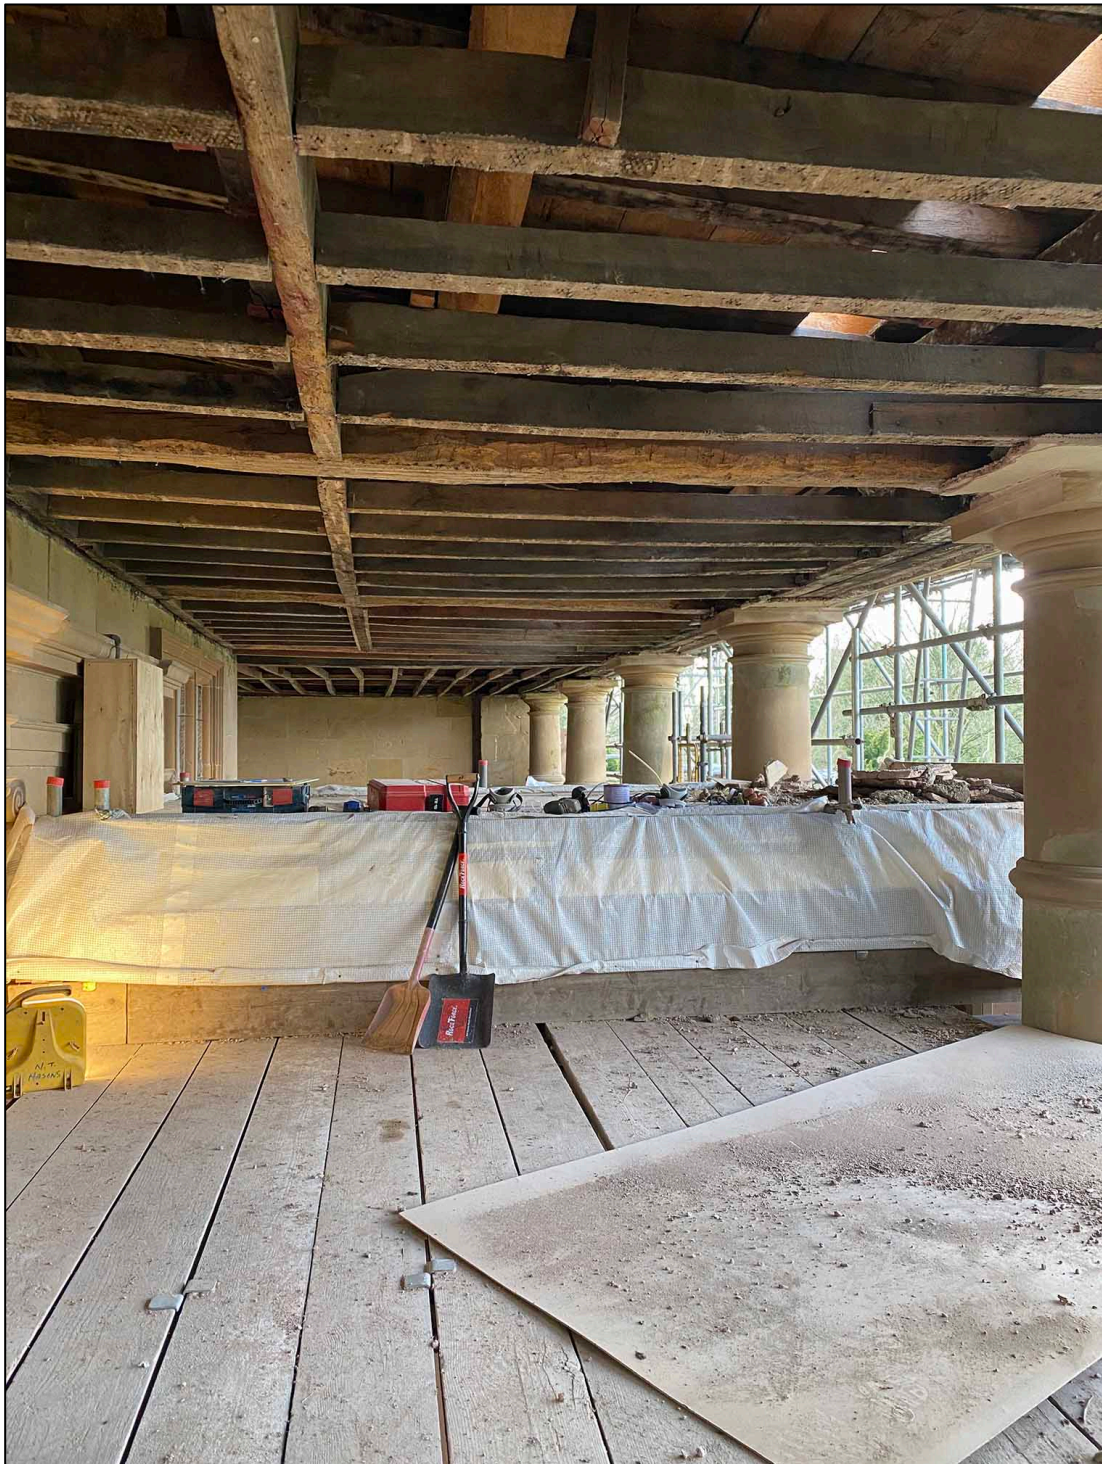
Both the rafters and ceiling joists are orientated west-east (**Appendix I.31**), although southern end of the ceiling joists has been replaced in 1950 with softwood timbers measuring 6cm x 8cm on a north-south alignment (**Appendix I.47**). The earlier ceiling joists measure 5.5cm x 7cm.

Appendix I.31: General view looking south of lower ceiling joists following removal of plaster

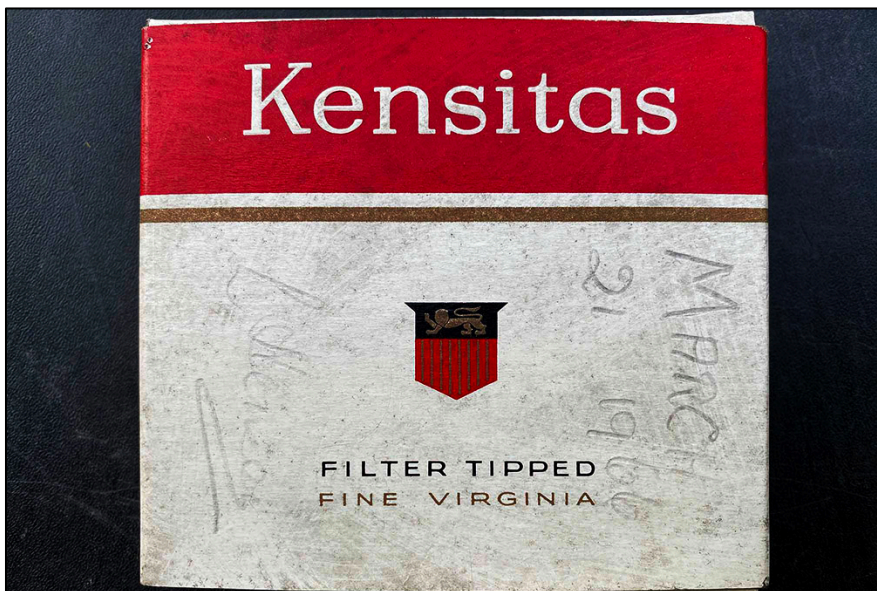
The watching brief has confirmed that since the initial period of construction of the Loggia roof in 1595, it has been repaired in three stages during the mid-late 20th Century. Evidence for this is in the form of written dates in pencil and chalk '1950' on at least four of the ceiling joists (**Appendix I.35**), all of which are softwood replacements that support an expanded wire mesh that forms the ceiling above the colonnade. Then a second phase of work occurred in 1966 which included replacing many of the ceiling boards and the leads as noted by a newspaper and a dated cigarette packet '21 March 1966' (**Appendix I.34**). The third phase of repairs comprised patching the lead.

Appendix I.34: Detail of cigarette packet in roof void in **Area A** with date – MARCH 21 1966.

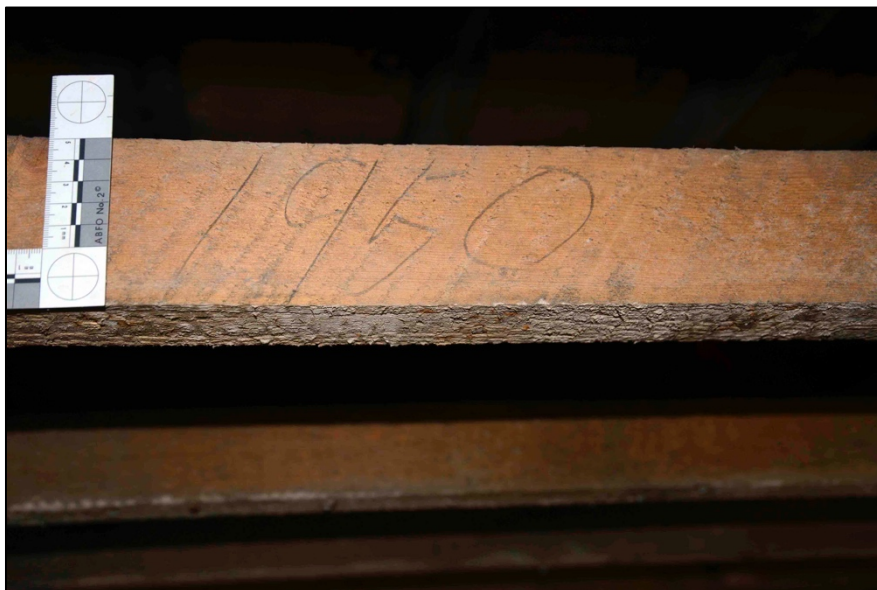
(Digital 106; 5cm scale)

Appendix I.36: Detail of pencil date on lower ceiling joists in **Area A** - 1950.

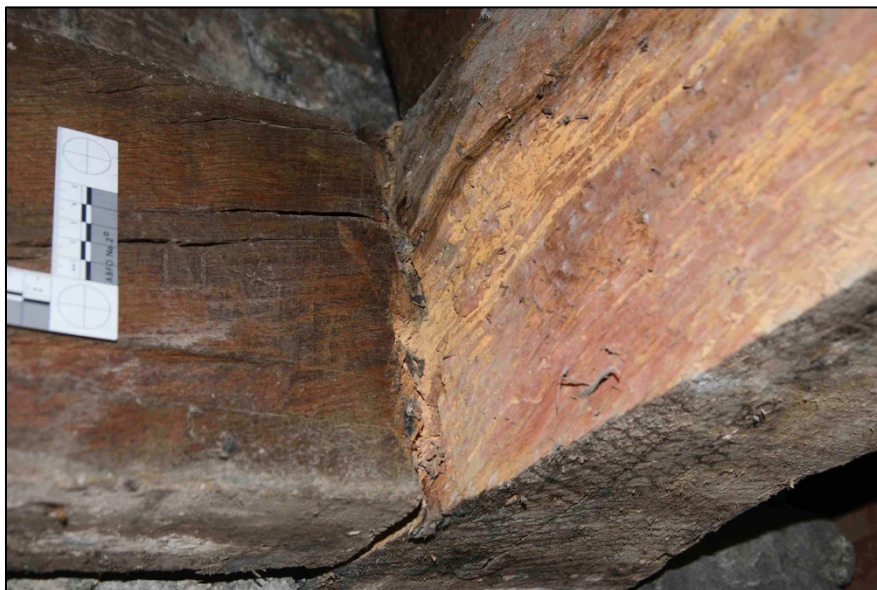
Appendix I.51: Detail of chisel cut assembly marks (VIII) on lower timber bearer against west wall of Hall in **Area C**.

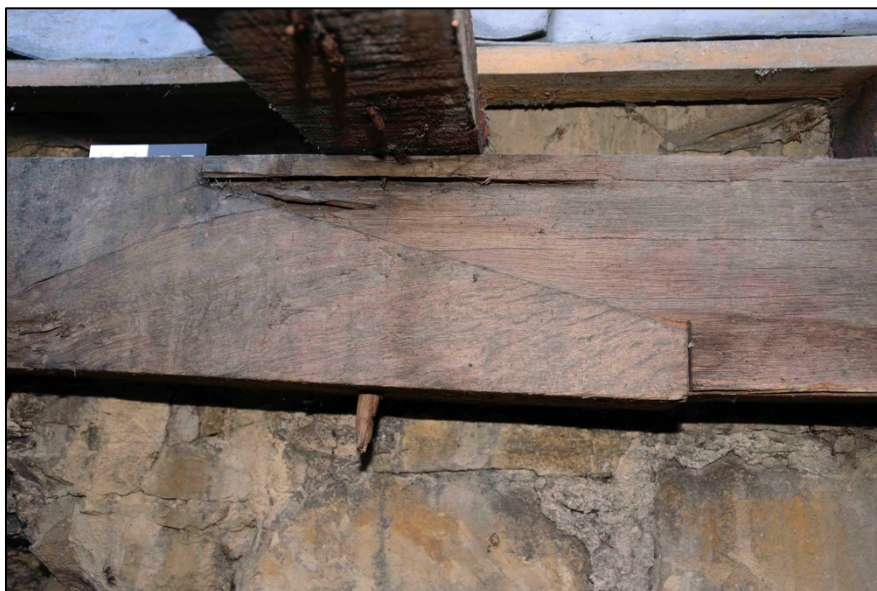
Appendix I.52: Detail of chisel cut assembly marks (IX) on lower timber bearer against west wall of Hall in **Area C**.

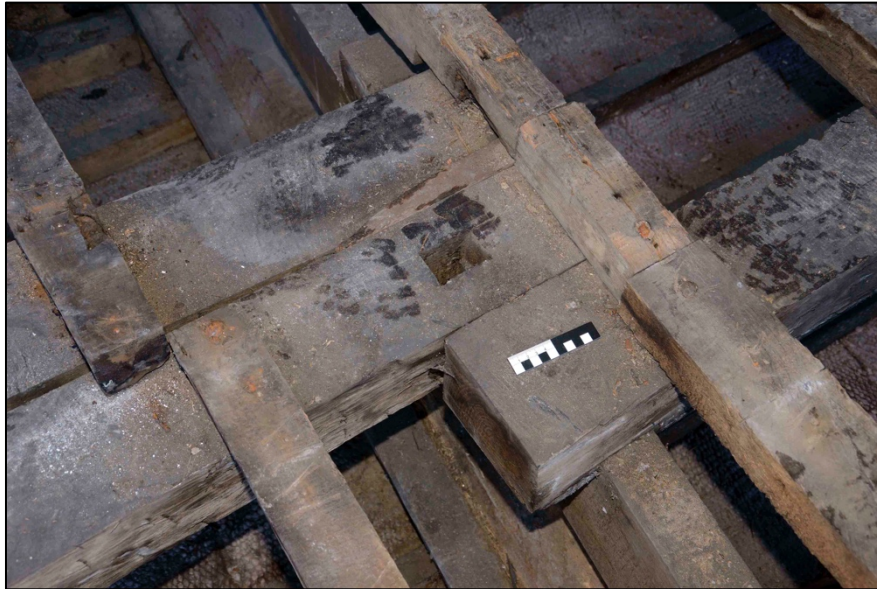
Appendix I.53: Detail of pegs and scarfed timber bearer beam against west wall of Hall in **Area A**.

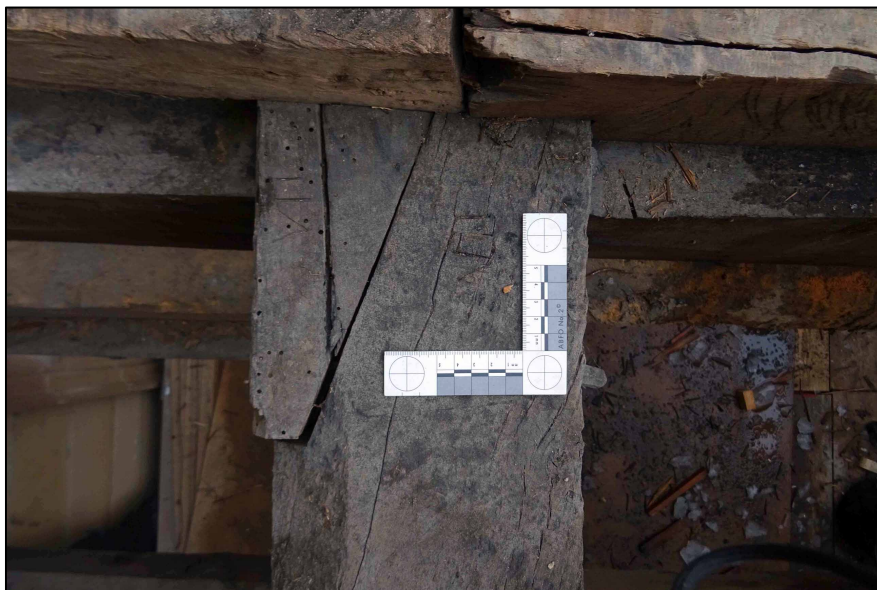
Appendix I.54: Detail of three parallel upper purlins in **Area A**; note reused timbers.

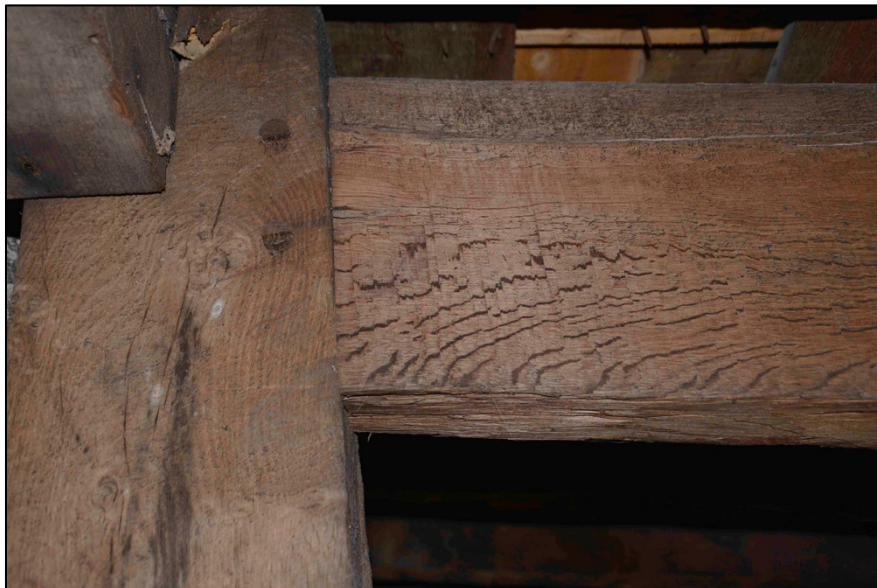
Appendix I.57: Detail of red painted letter 'B' on north face of post and principal joist of T2.

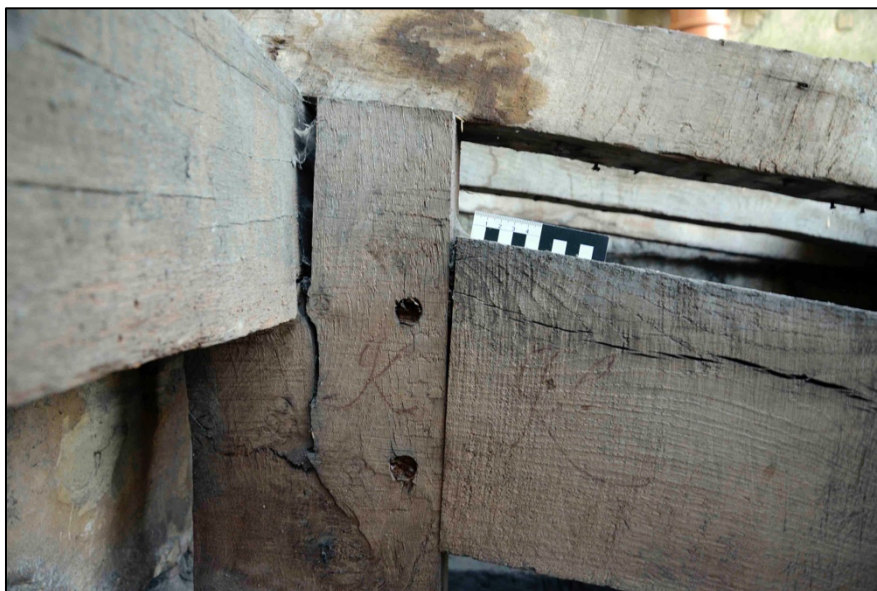
Appendix I.58: Detail of red painted letter 'D' on north face of post and principal joist of T4.
