# CANNON HALL PORCH, BARK HOUSE LANE, CAWTHORNE, BARNSLEY, SOUTH YORKSHIRE

## Archaeological Photographic Survey and results of a Watching Brief

February 2016

Document No: TJC2018.08

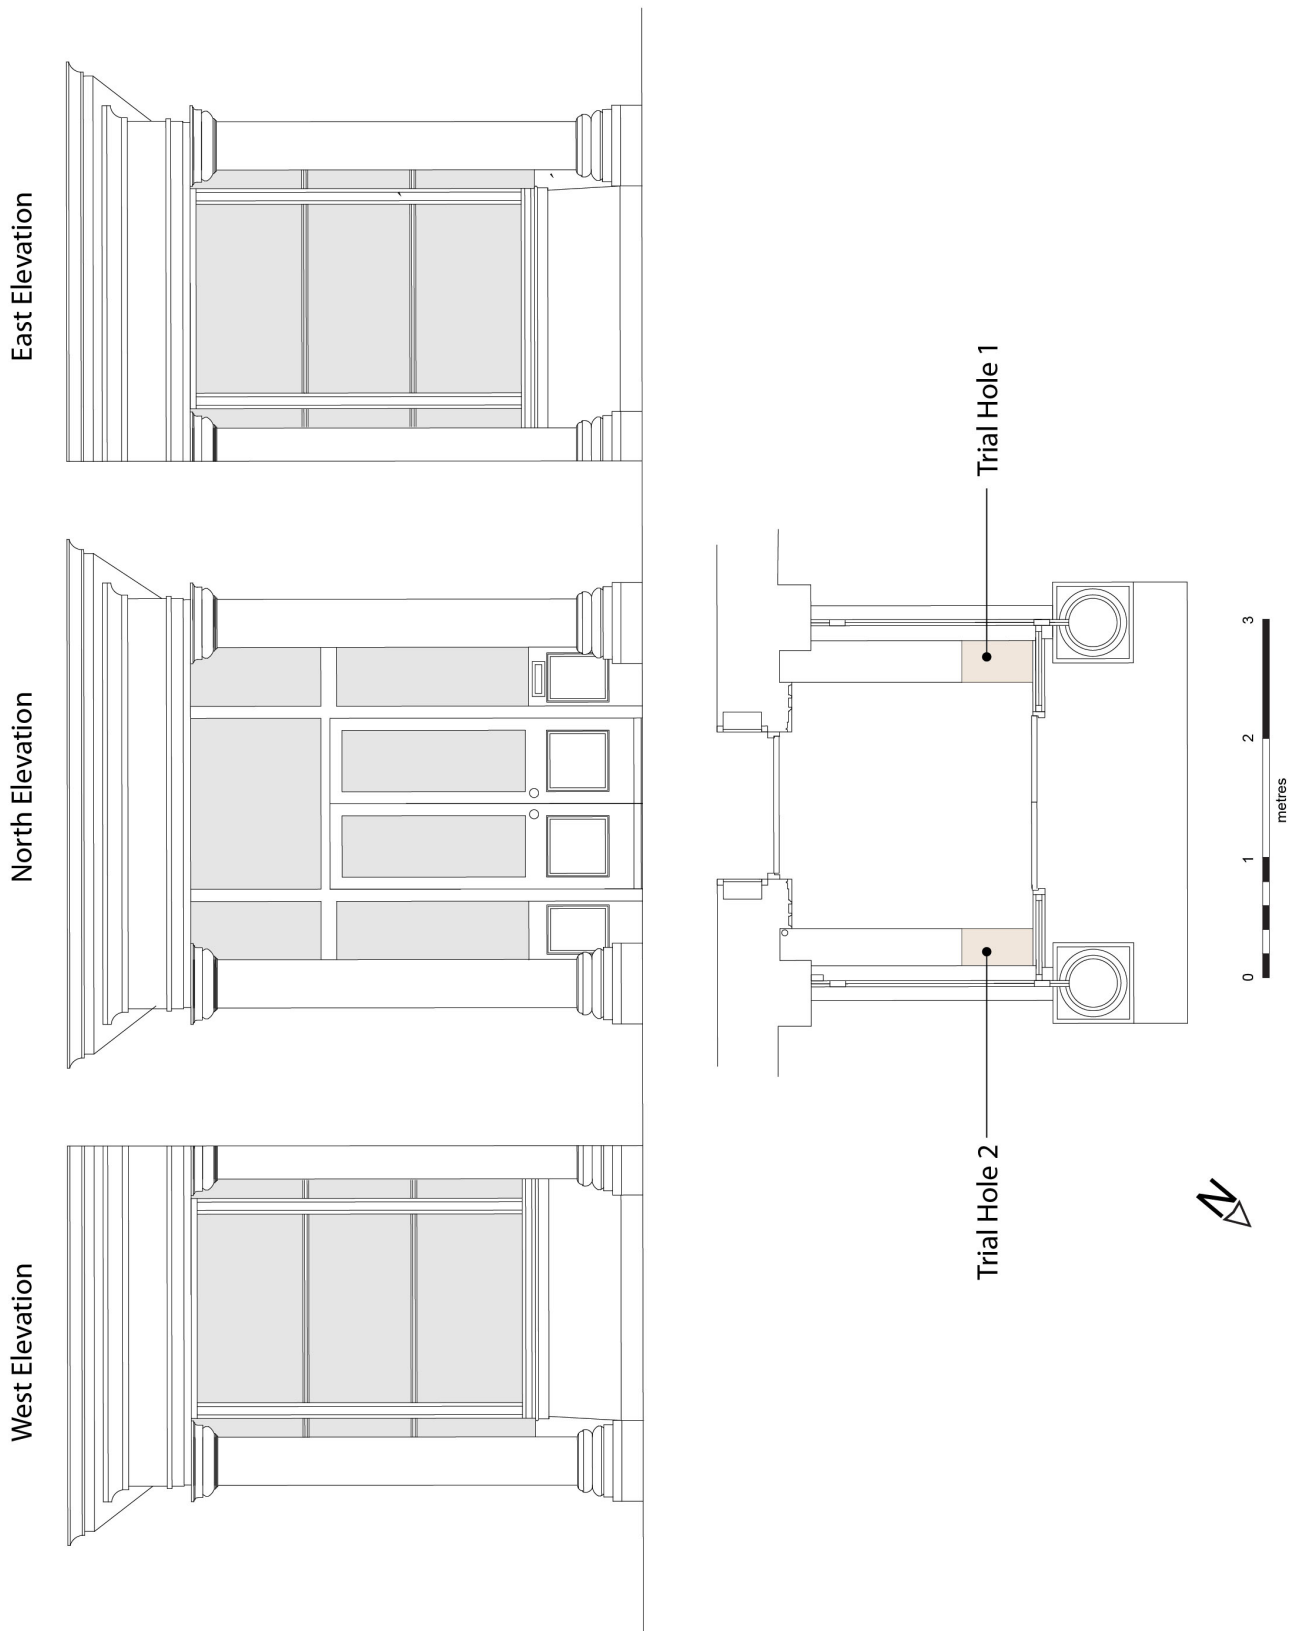
Figure 3: Plan and elevations of the entrance Porch

During the lifting of short sections of floor slabs in the northwest (**TP1**) and northeast (**TP2**) corners of the porch (see **Figure 3**) an archaeological watching brief was maintained. The joints between the stones were cut with a steel saw to widened them and enable their removal. No features of note were observed.

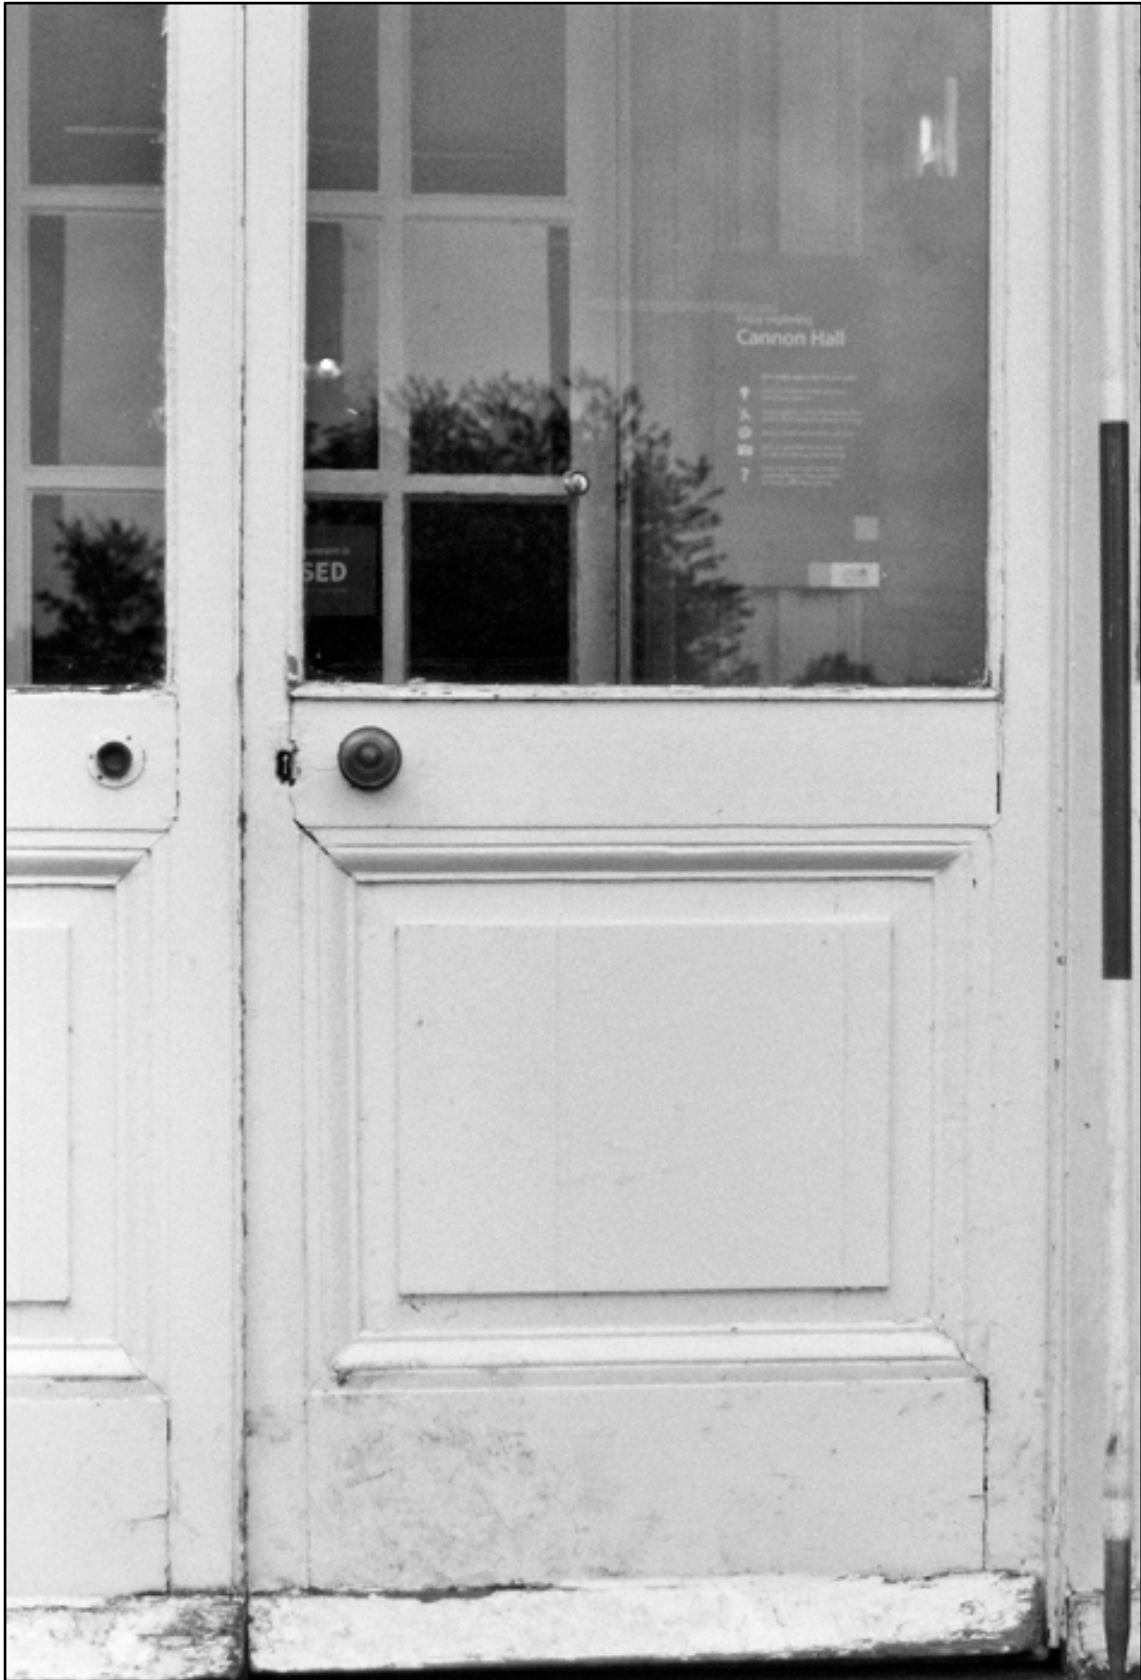
**Appendix I.7:** Detail of external doors (50cm scale divisions). **Film I.8.**

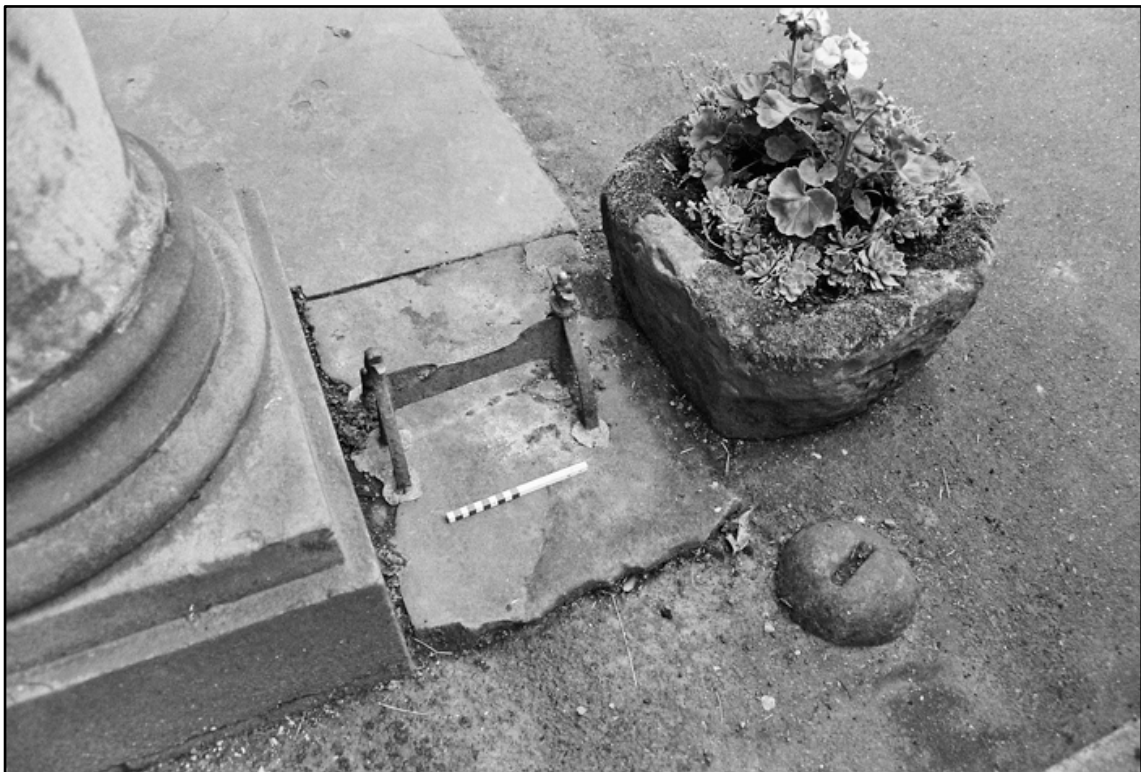
**Appendix I.10:** Detail of bootscraper on northeast side of Porch (20cm scale). **Film I.16.**

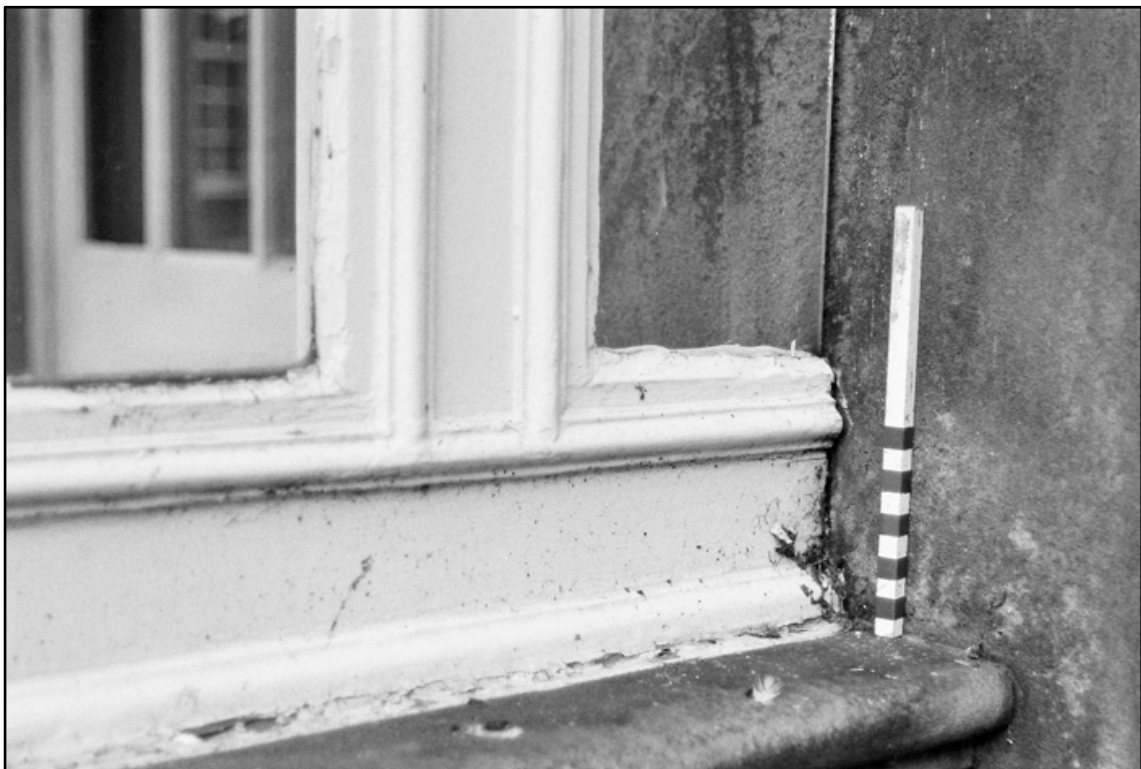
**Appendix I.12:** Detail of joinery and glazing on west elevation (20cm scale). **Film I.12.**

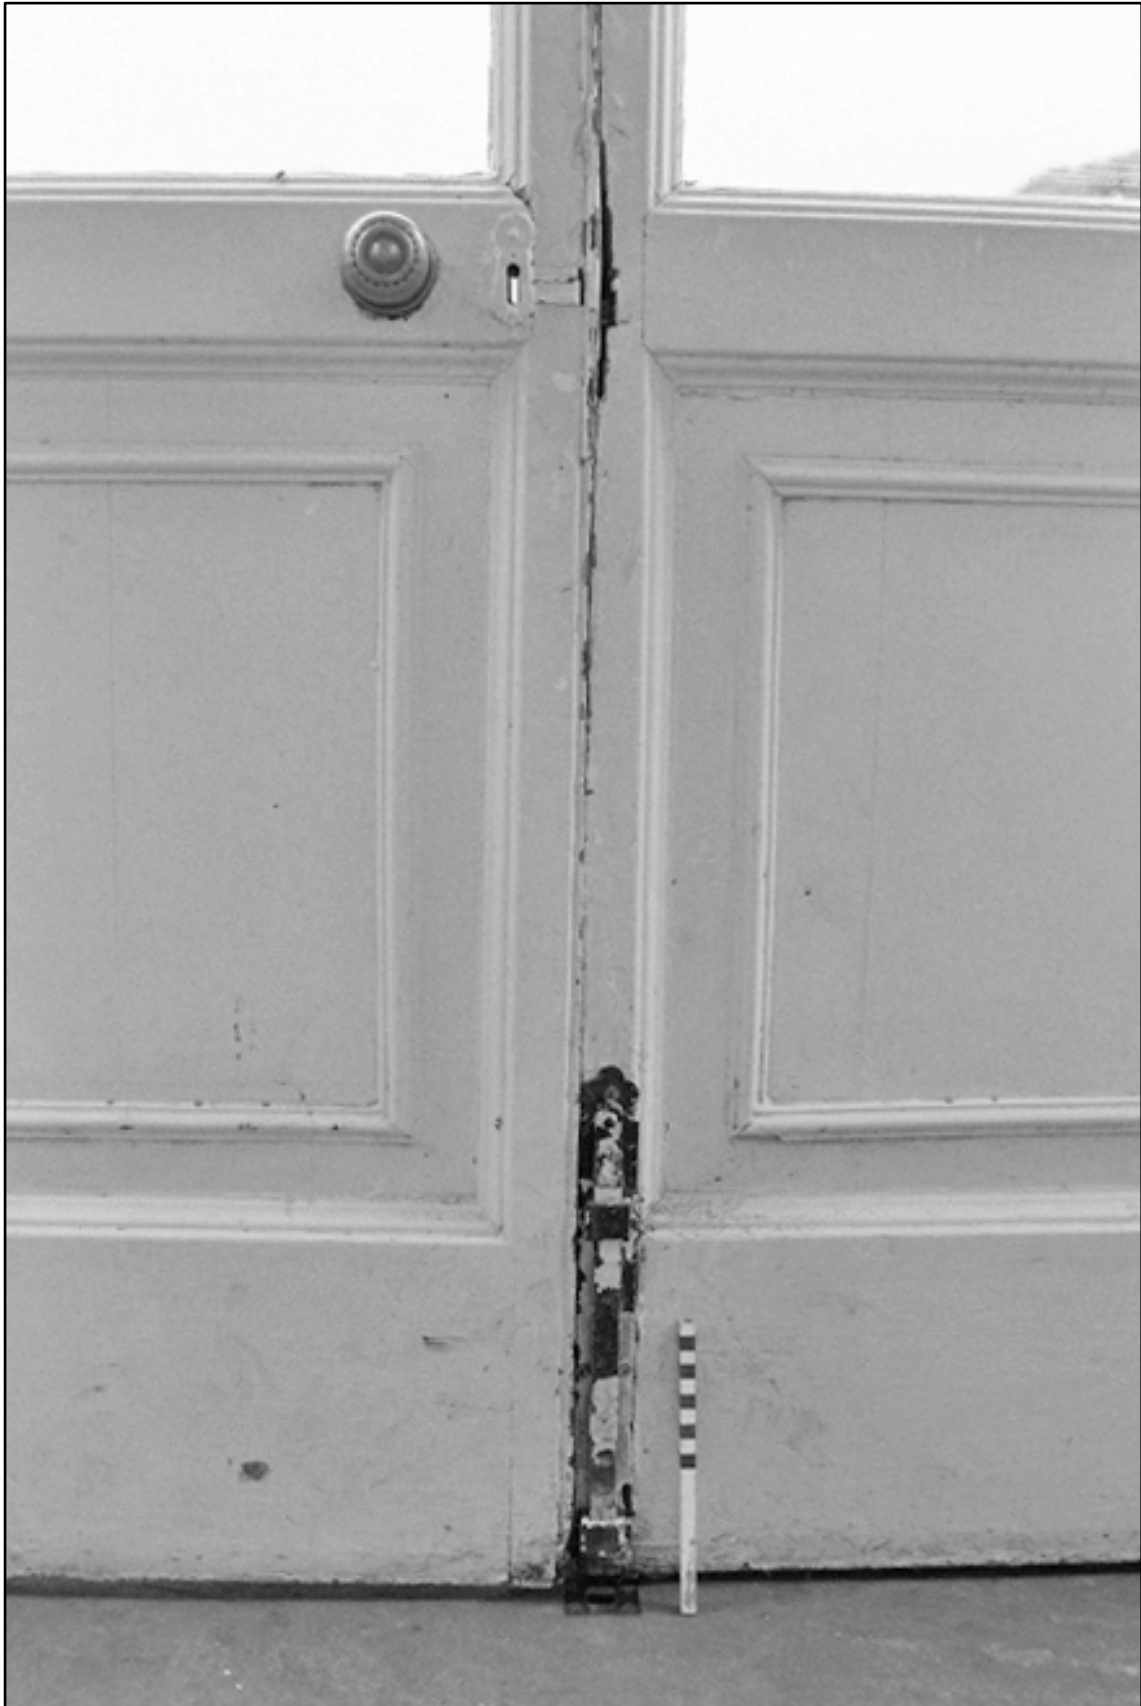
The doors opened inwards and each was supported on three large iron hinges (**Appendix I.15**). There was an internal security bolt (**Appendix I.13**) and a decorated brass handle (**Appendix I.14**) which was heavily worn.

**Appendix I.13:** Detail of door furniture on inner face of external doors to Porch (20cm scale). **Film I.19.**

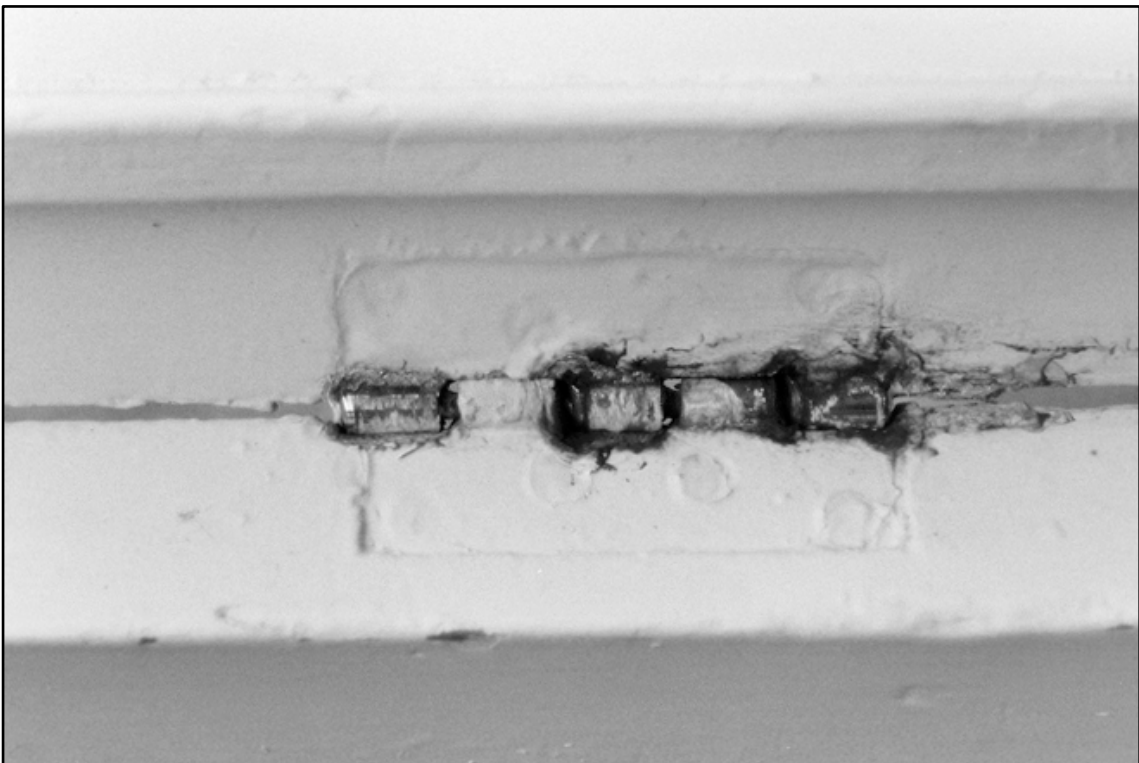
**Appendix I.15:** Detail of hinge to front doors. **Film I.33.**

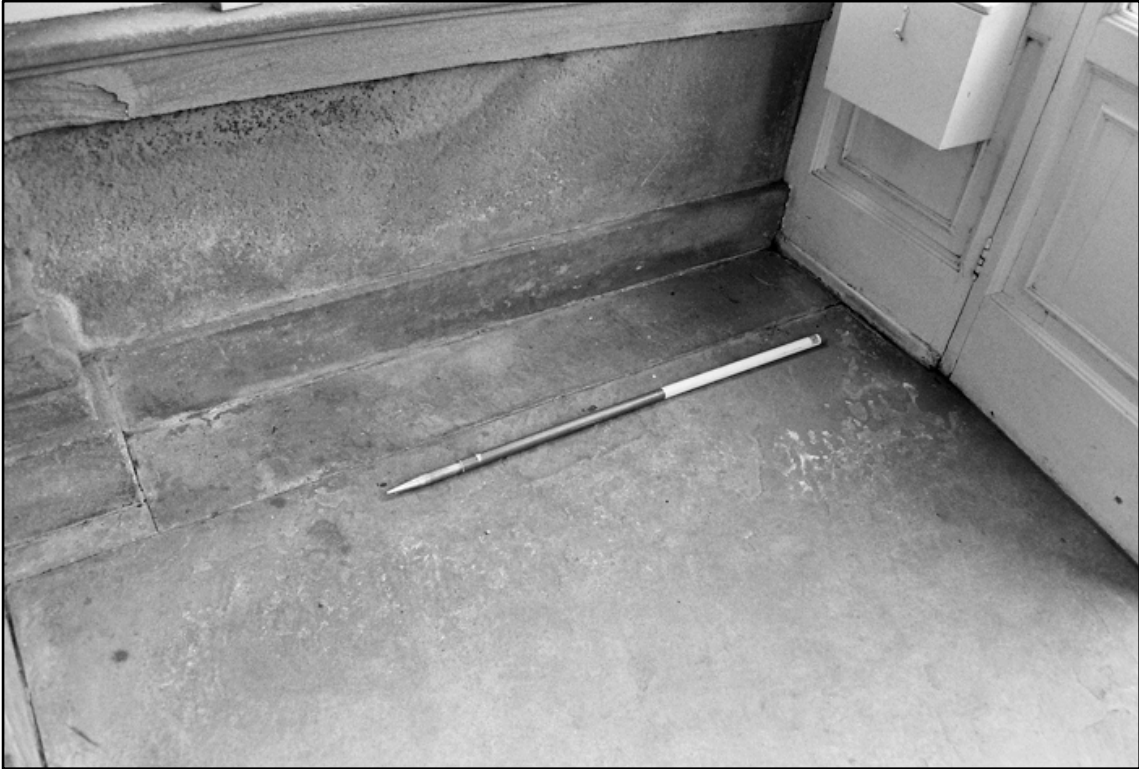
**TP1** – This hole measured 27cm x 49cm and located in the northwest corner of the Porch (**Appendix I.22**) and the York Stone slab that was removed was 11cm in thickness. The stone was found to be bedded on a deposit of yellow sand (**Appendix I.23**).

**Appendix I.22:** Detail of southwest floor of Porch (1m scale). **Film I.28**

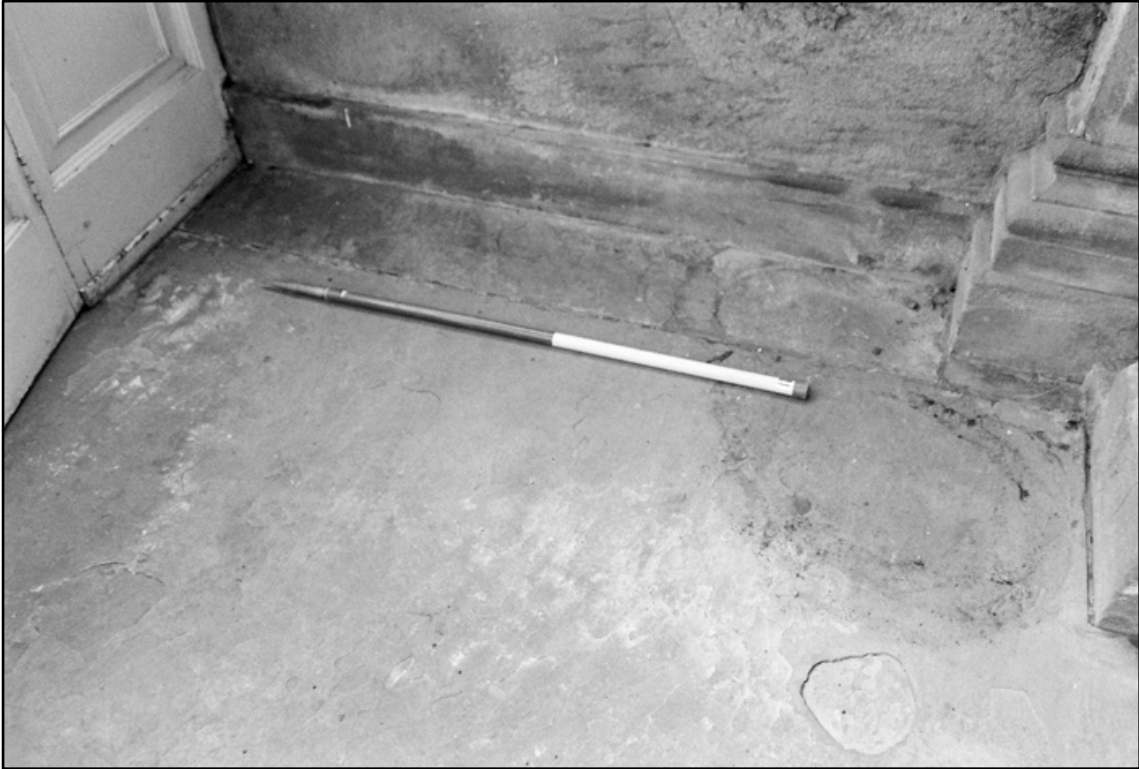
**TP2** – This hole measured 28cm x 48cm and located in the northeast corner of the Porch (**Appendix I.24**) and the York Stone slab that was removed was 11cm in thickness. The stone was found to be bedded on a deposit of yellow sand (**Appendix I.25**).

**Appendix I.24:** Detail of southwest floor of Porch (1m scale). **Film I.29**
