MODEL FARM, THE GREEN, UPPER POPPLETON,
YORK.

REPORT ON A HISTORIC BUILDING RECORDING SURVEY
OSA REPORT NO: OSA19BR04

April 2019.

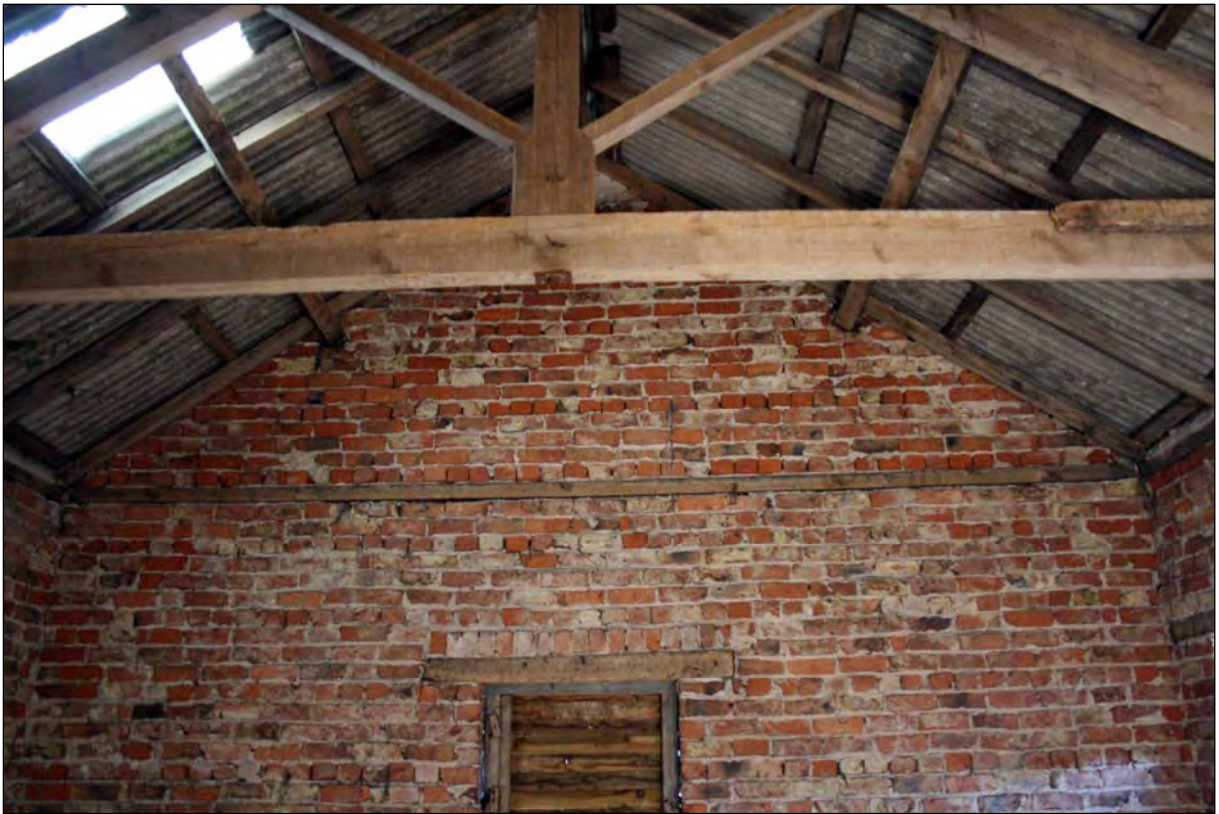
Plate 7. B1 interior looking NE (image no. 008).

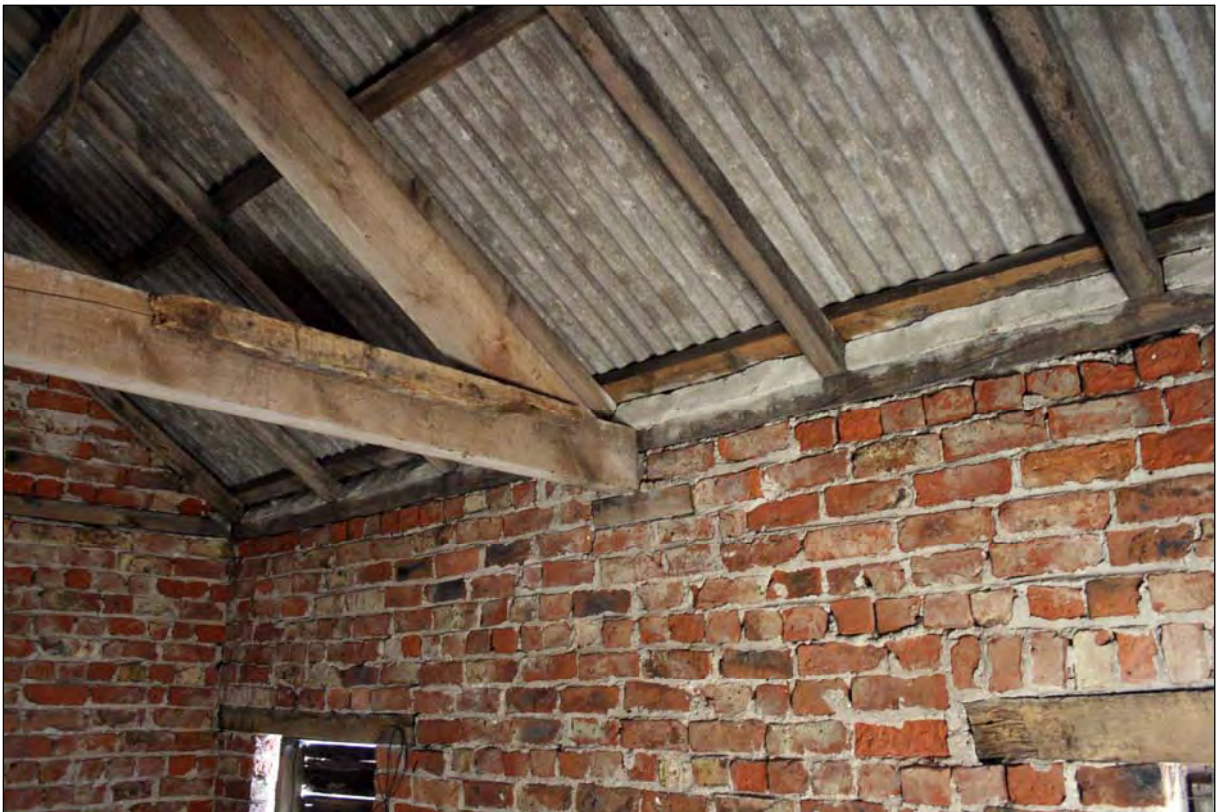
Plate 8. B1 interior looking east (image no. 023).

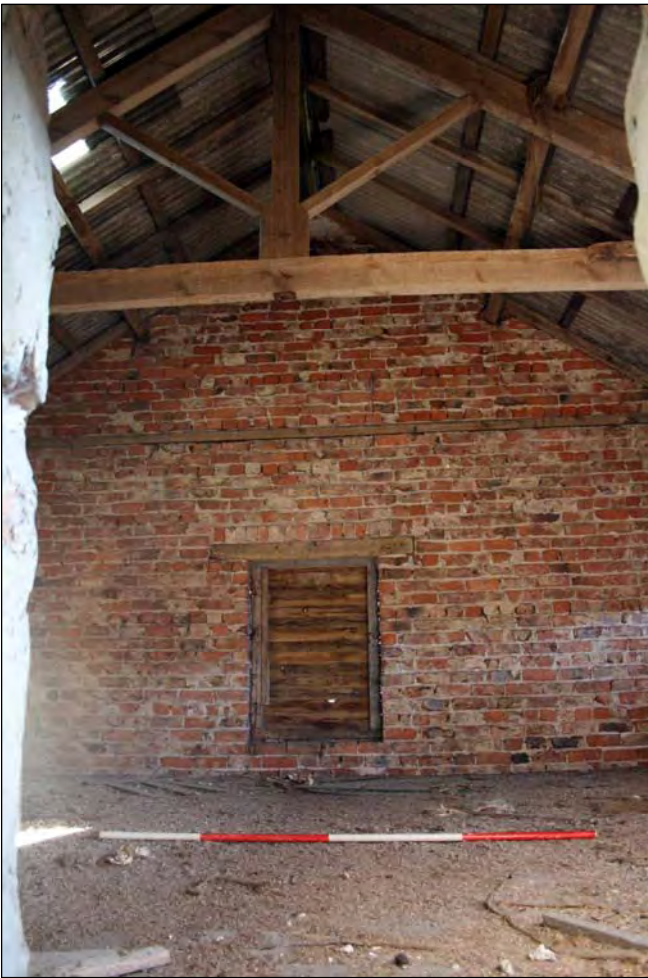
Plate 9. B1 interior looking NE (image no. 002).

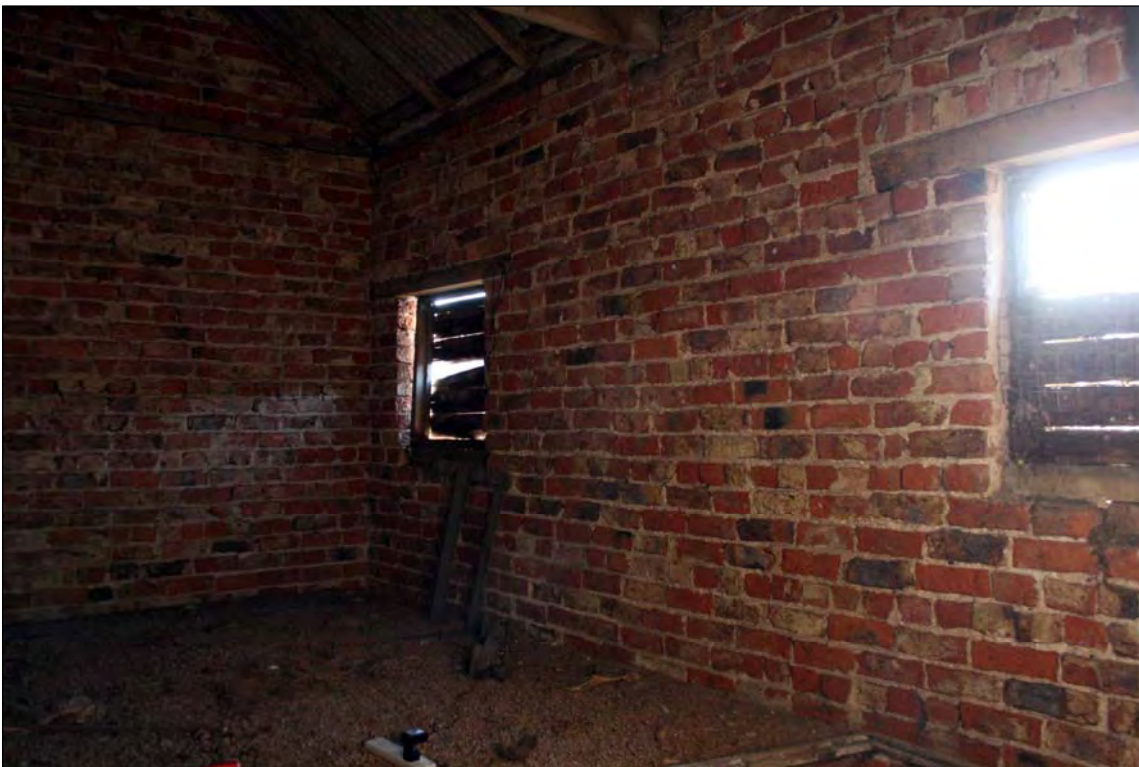
Plate 10. B1 interior looking east (image no. 014).

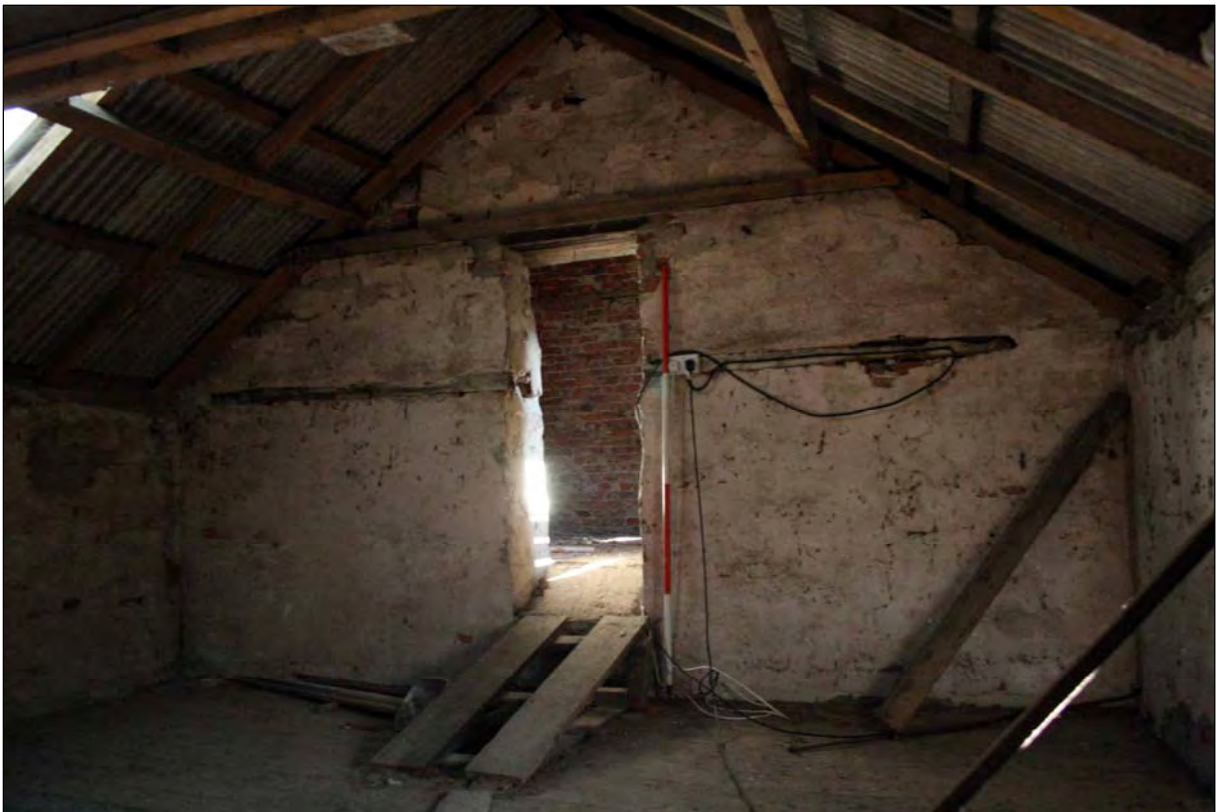
Plate 12. B1 interior doorway looking SE (image no. 058).

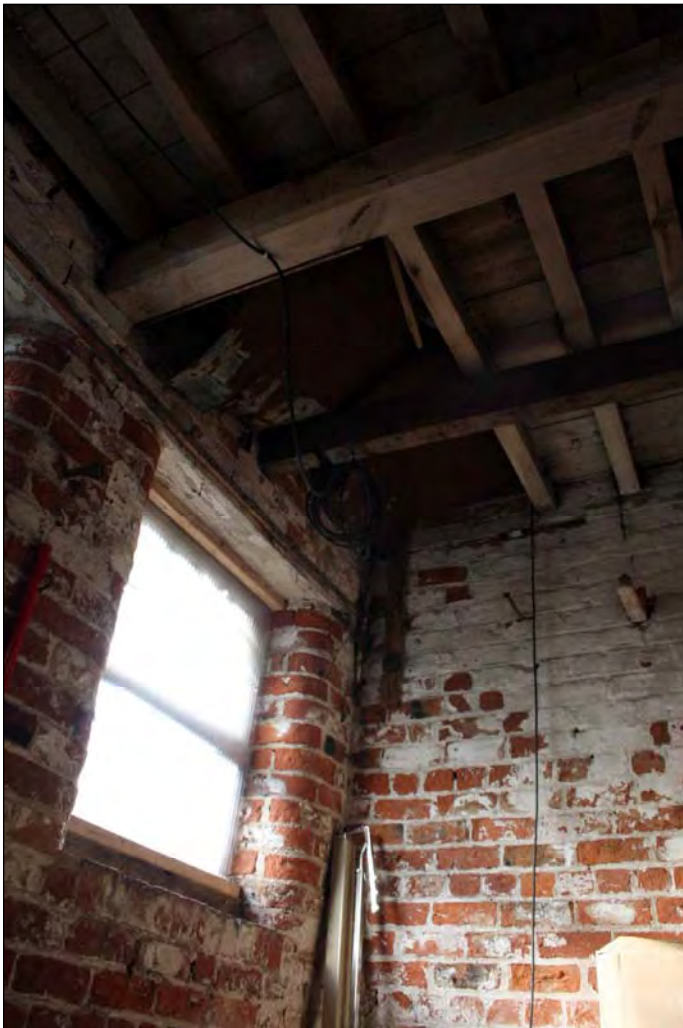
Plate 17. B1 interior ground floor opening in ceiling looking south (image no. 157).

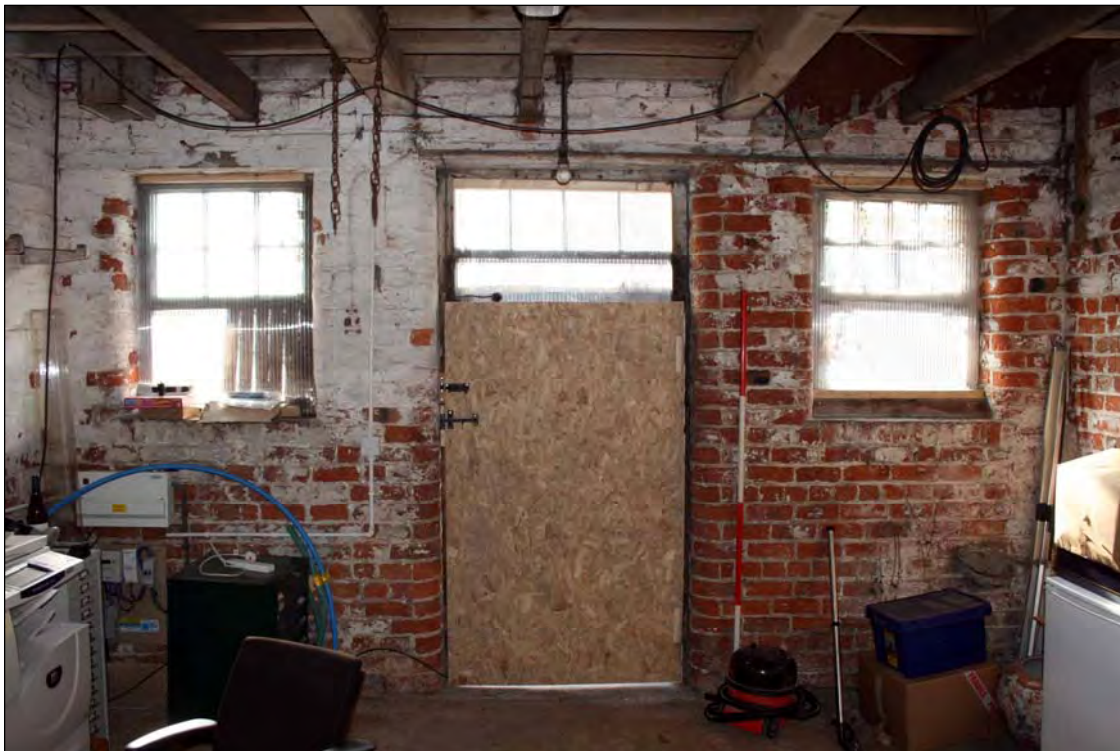
Plate 18. B1 interior ground floor looking NW (image no. 153).

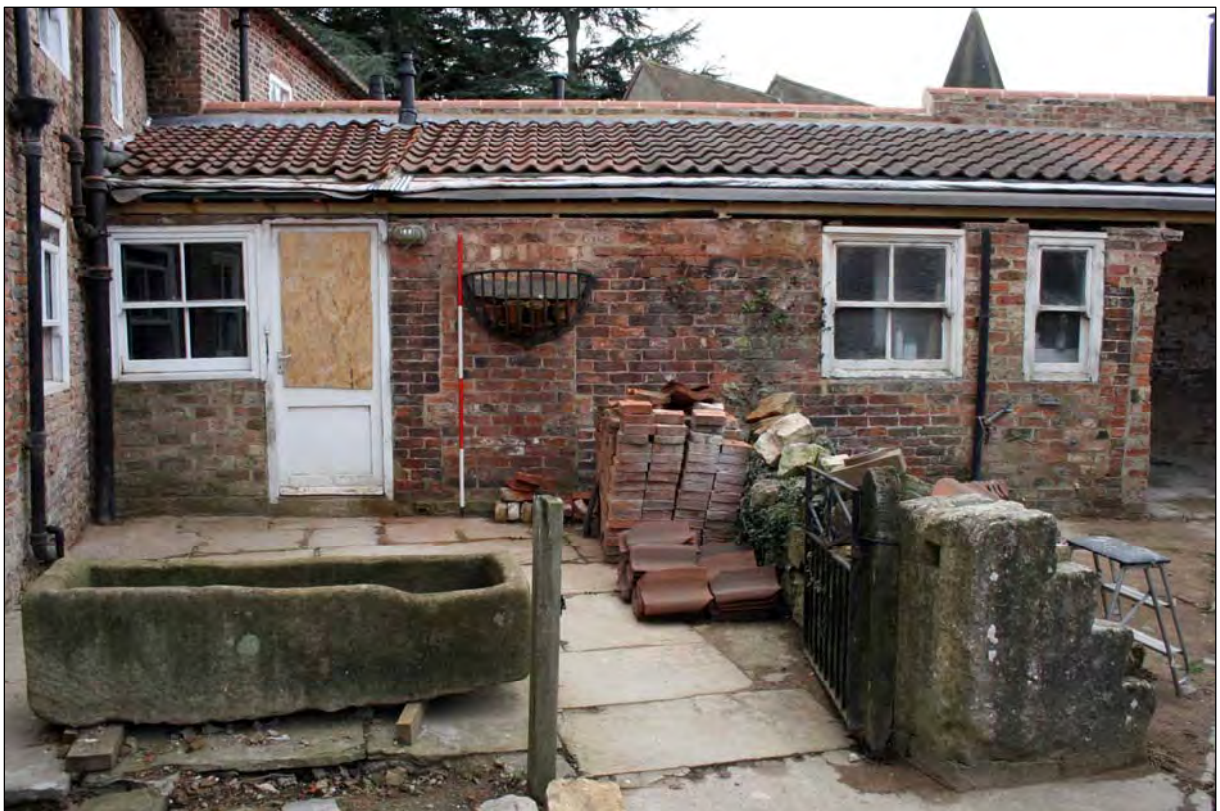
Plate 24. B2 exterior looking west (image no. 387).

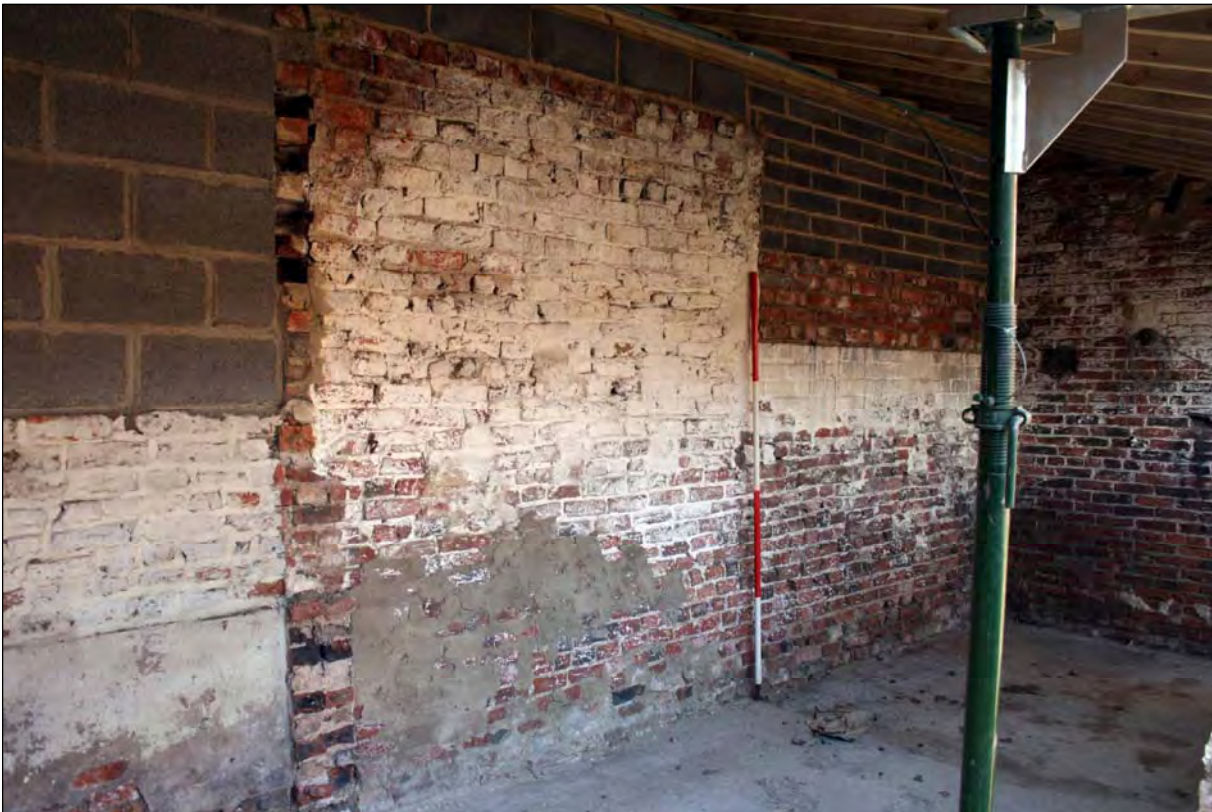
The northwestern half of B2 interior was bare with different patchwork of brick. Within the southwest elevation was the shadow of an internal wall and two bricked up window openings (Plates 25). The southeast elevation had a small bricked up opening and a possible former doorway opening (Plate 26). The northeast elevation was a reflection of the external elevation with a patchwork of brick with a small feeding hatch (Plate 27). The northwest elevation was

Plate 25. B2 interior NW looking west (image no. 253).

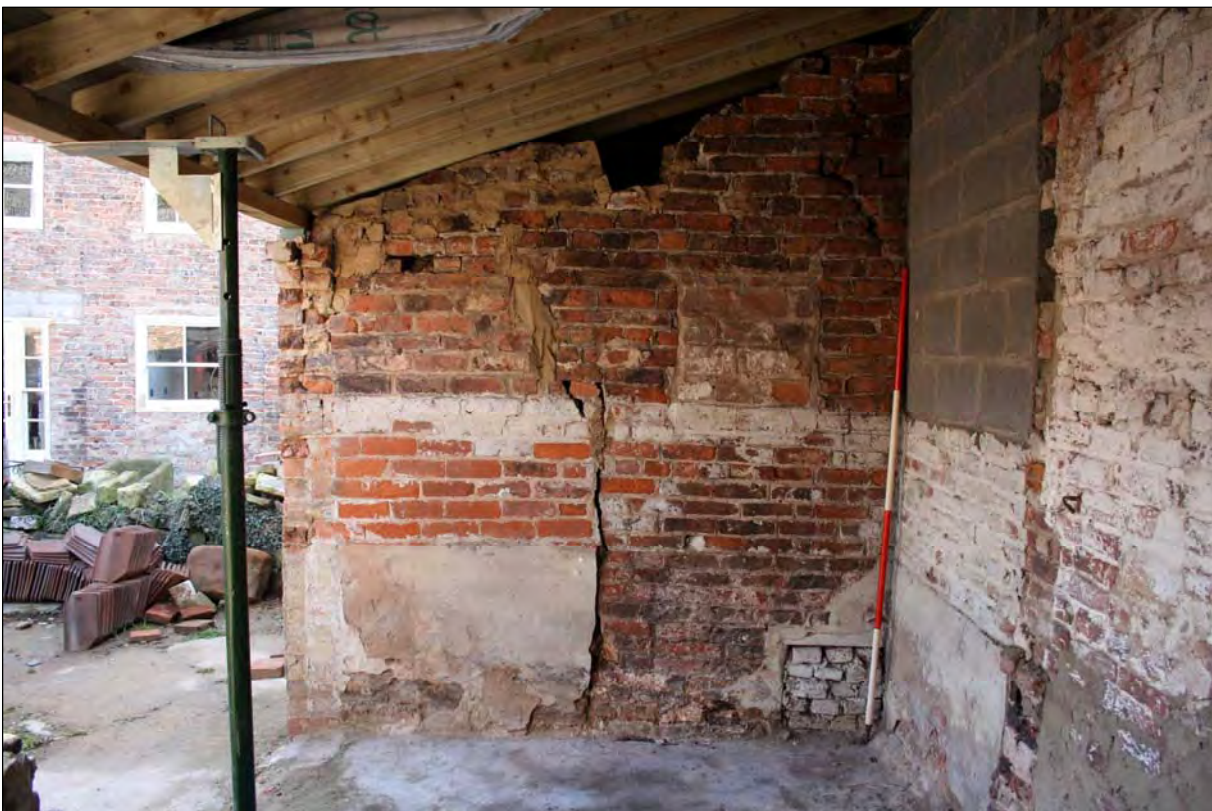
Plate 26. B2 interior NW looking southeast (image no. 240).

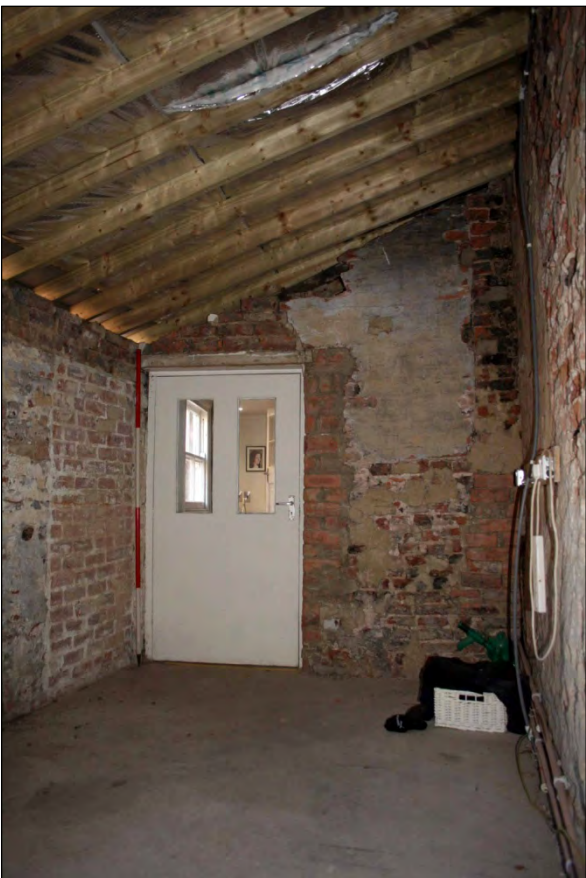
Plate 30. B2 interior SE bricked up doorways looking southeast (image no. 217).

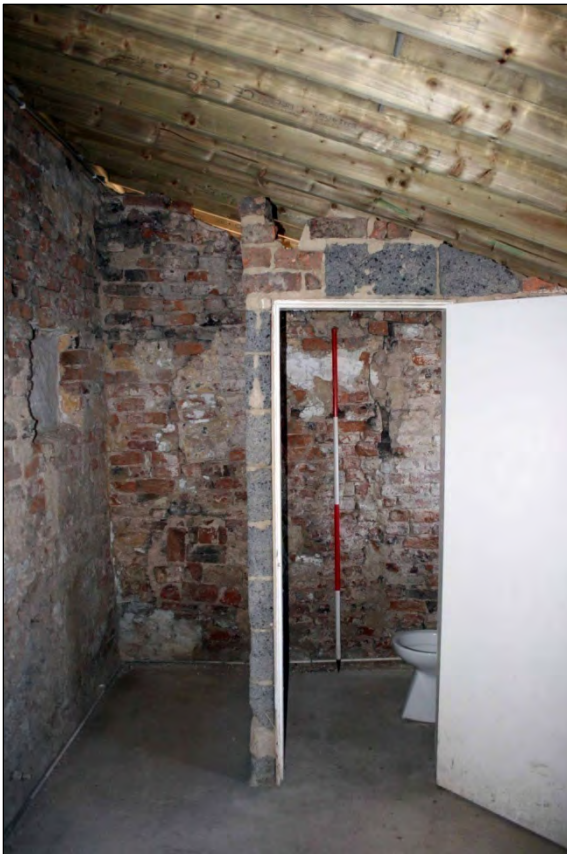
Plate 31. B2 interior SE bricked up doorway/window looking NW (image no. 223).

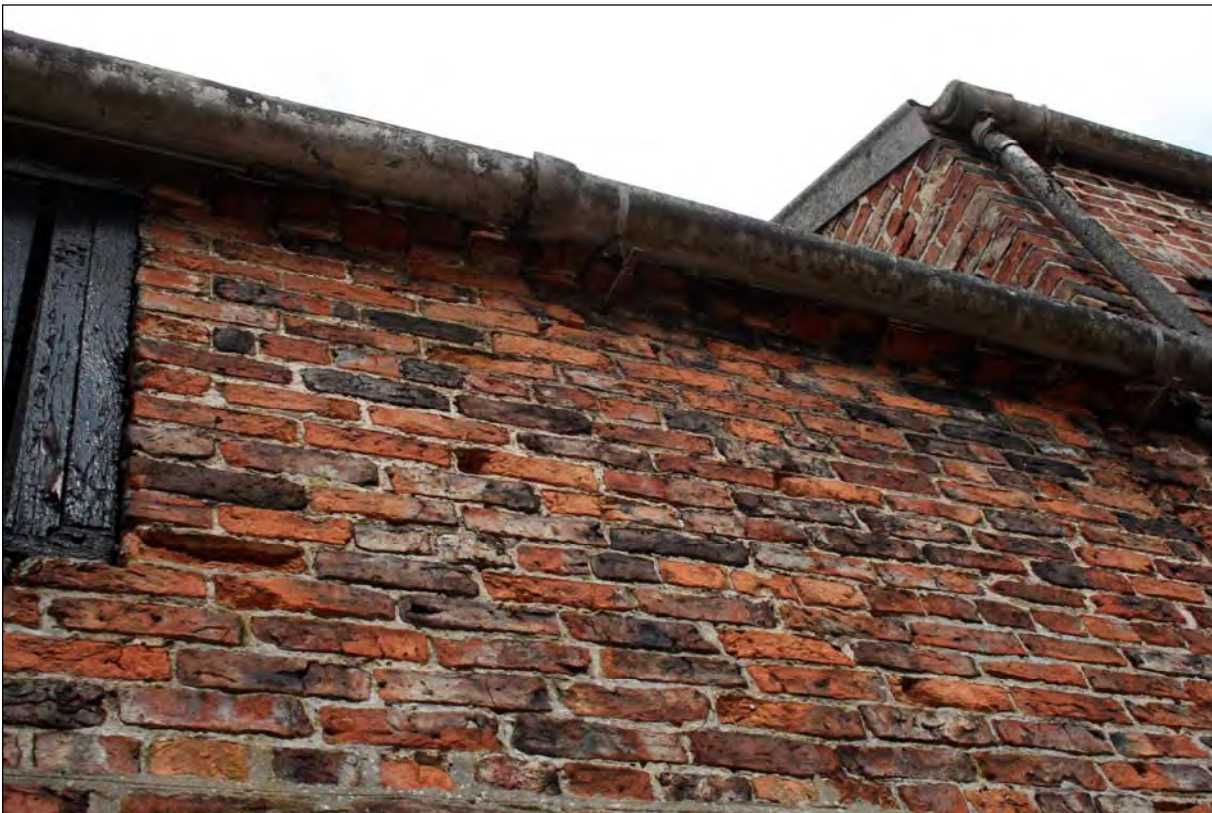
Plate 34. B3 and B4 exterior dentilated eave looking NE (image no. 371).

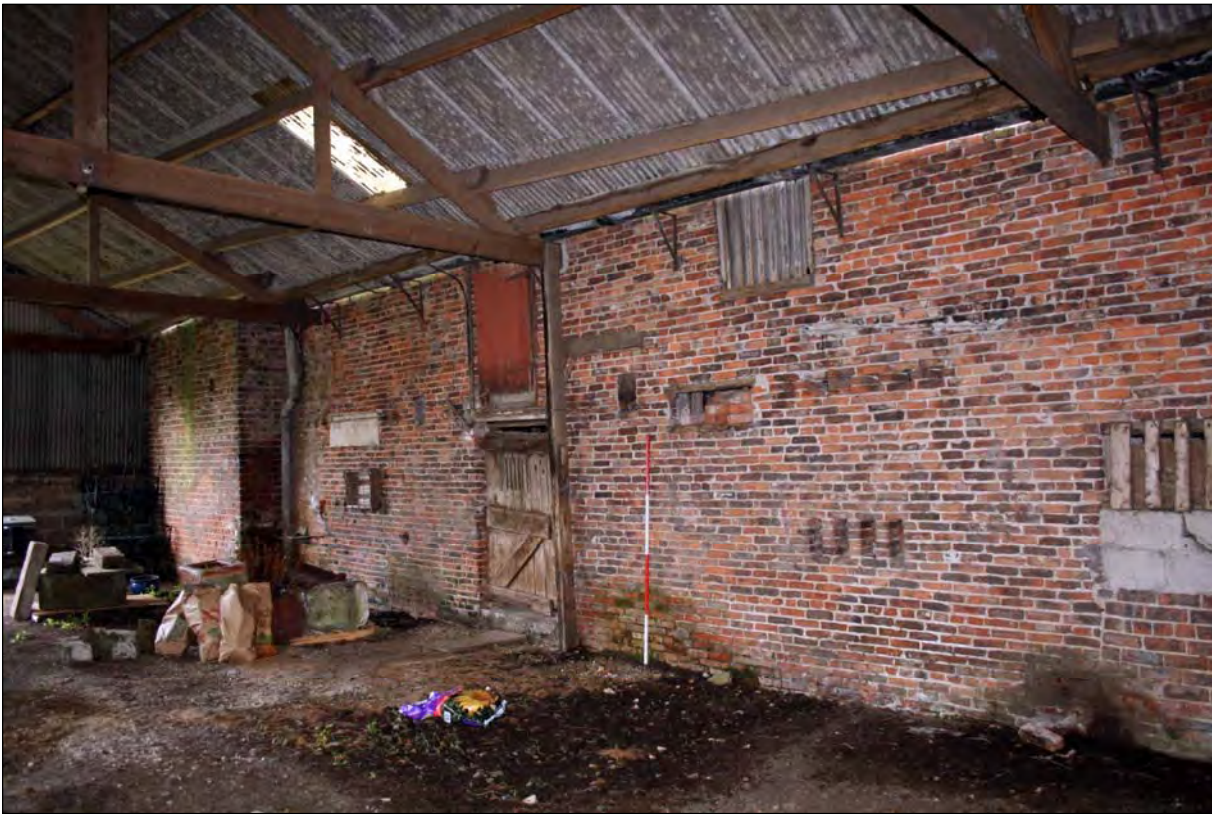
Plate 37. B3 and B4 exterior looking NE (image no. 332).

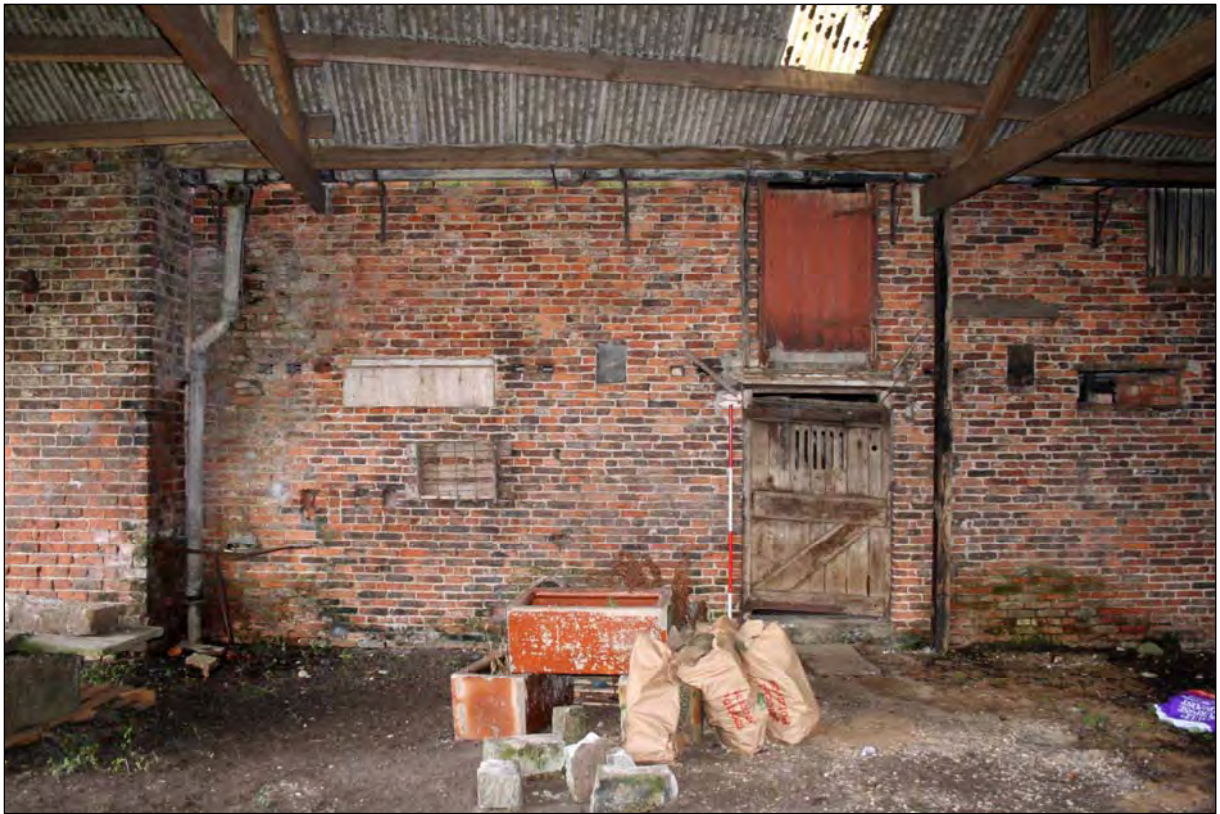
These stable block buildings appear to be of a contemporary build forming part of northeast to southwest range to the northwest of the cottage. The stables were constructed in red brick in English garden wall bond with dentilated brickwork eave with a pitched corrugated asbestos roof and guttering (Plates 33 and 34). At first floor level on the southeast elevation B3 had a doorway and a window opening. B4 first floor level had a small loft door and a bricked up window opening. At ground floor level B3 had two stable doorway openings with brick lintels and a double doorway opening with a wooden lintel. Located between the two single doorway openings was the shadow of and brickwork remains of stepping that would have led to the first floor door (Plate 35). B4 at ground level had a single doorway opening and was constructed against by B2. The northwest elevation B3 had a doorway and a window opening with a stone sill (Plates 37, 38 and 39). B4 at first floor level had no openings. At ground floor level B3 had doorway opening and ventilation holes. B4 had a blocked doorway opening (Plate 39). Adjacent building B1 was constructed up against the northeast elevation.

Plate 39. B3 and B4 exterior NE looking southeast (image no. 337).

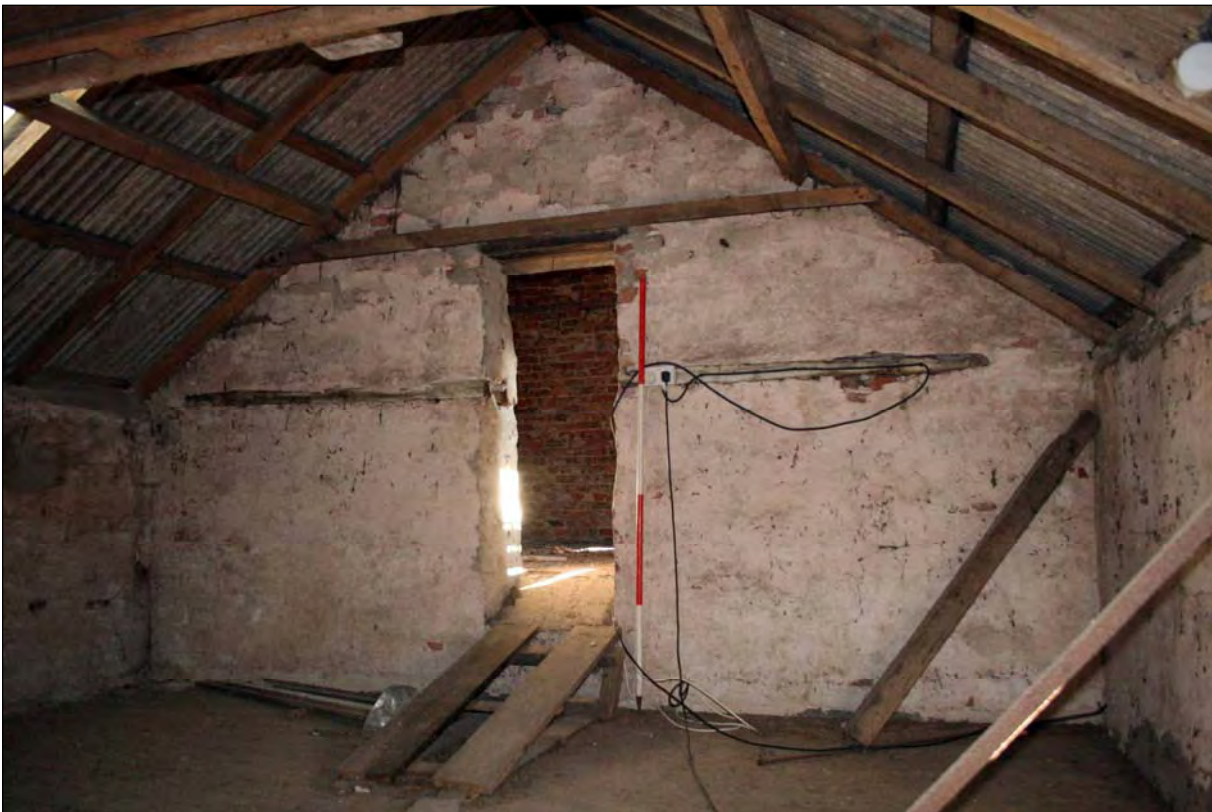
Plate 42. B3 interior first floor looking SW (image no. 044).

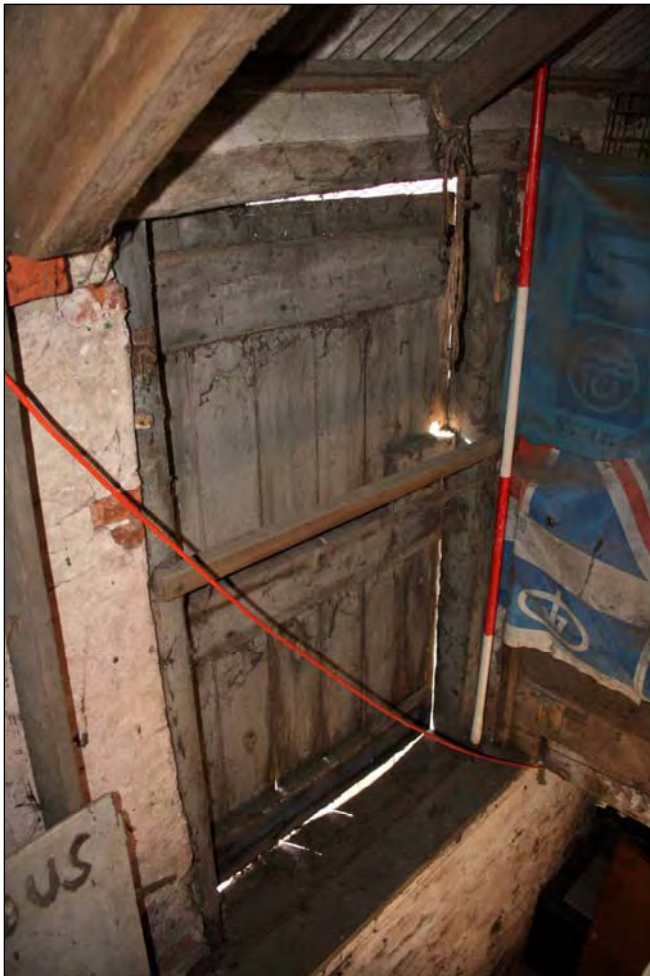
Plate 43. B3 interior first floor loft door looking south (image no. 080).

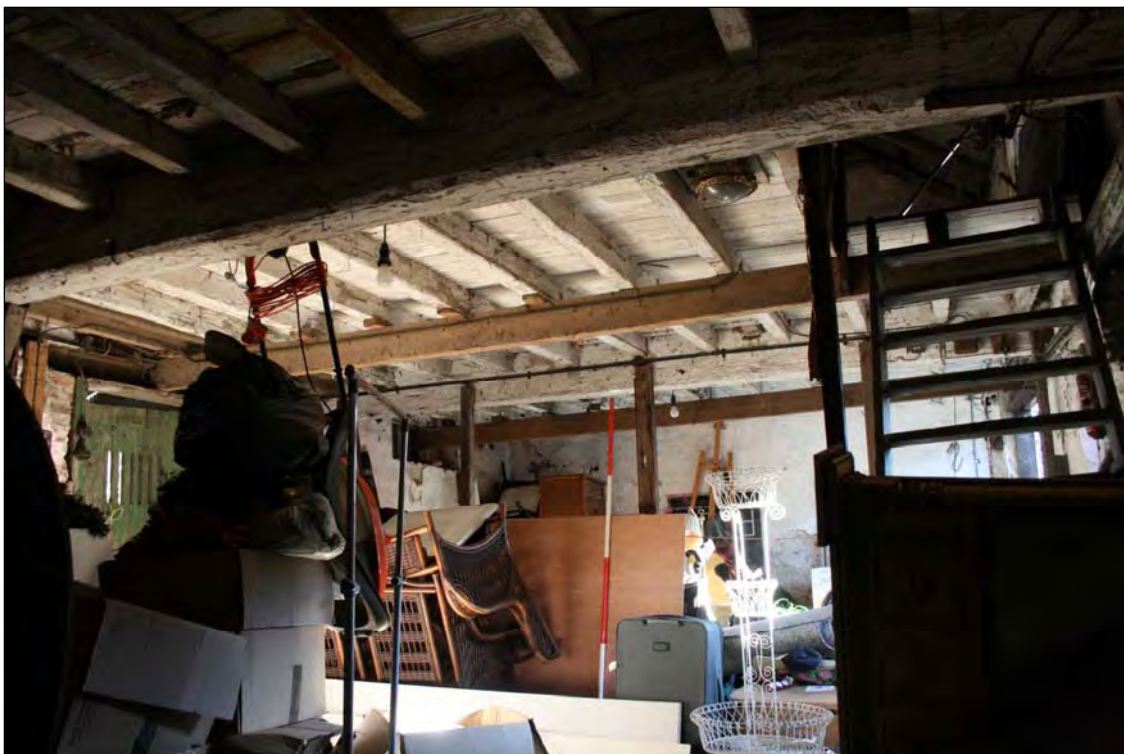
Plate 44. B3 interior ground floor looking north (image no. 081).

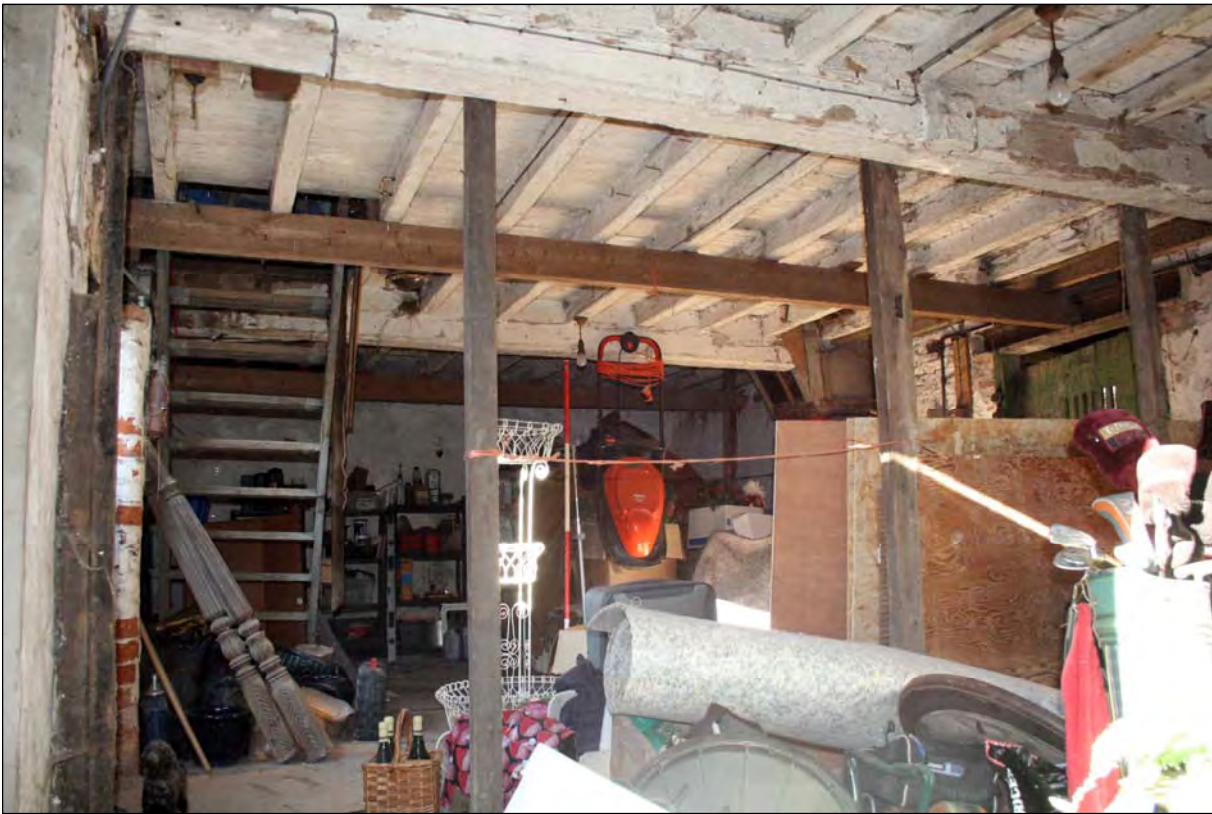
Plate 45. B3 interior ground floor looking SW (image no. 091).

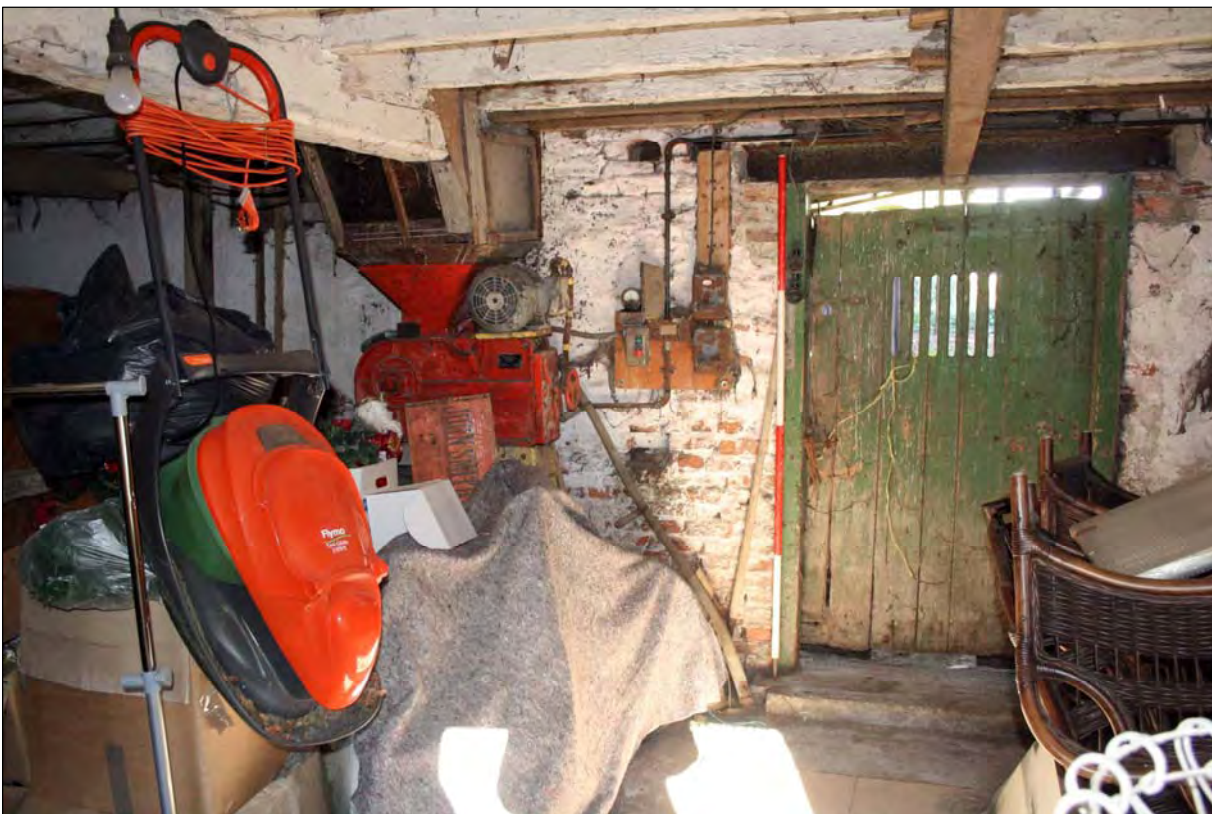
Plate 46. B3 interior ground floor thresher machine left of door looking west (image no. 104).

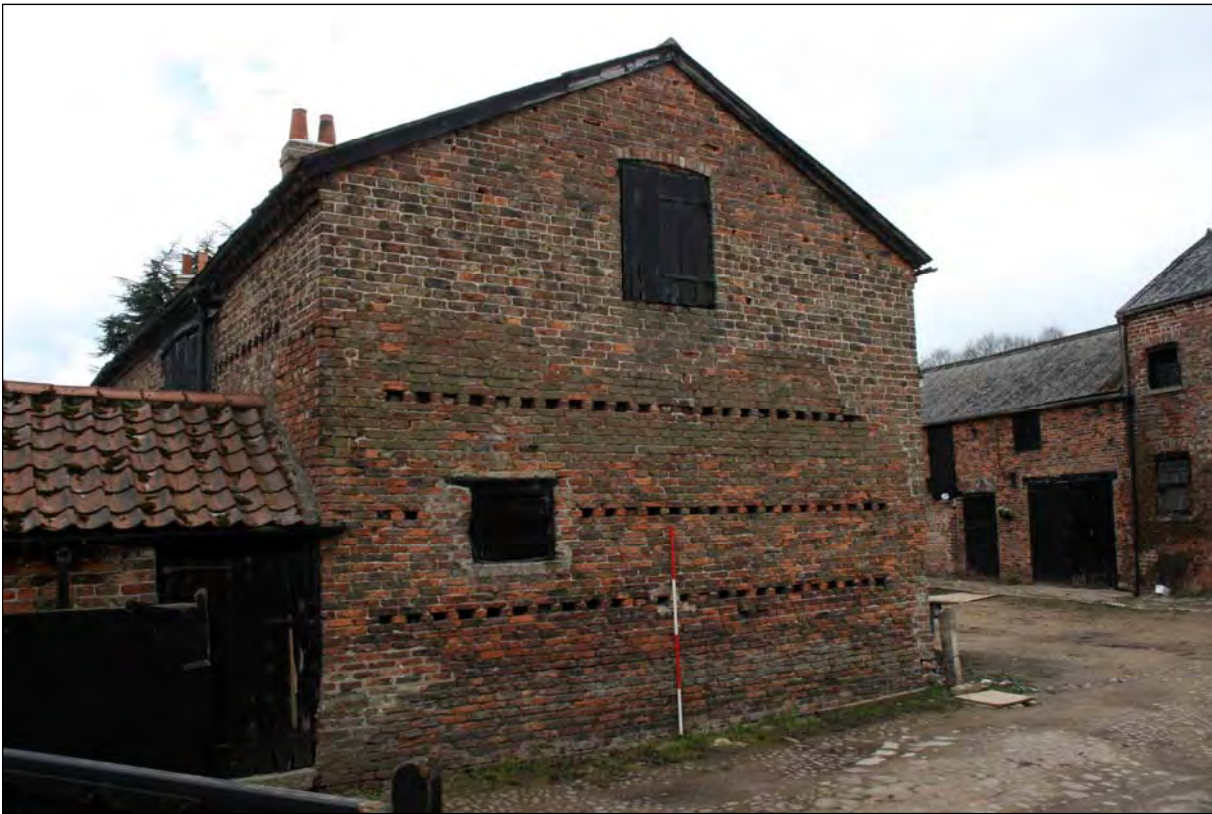
Plate 53. B5 exterior looking west (image no. 426).

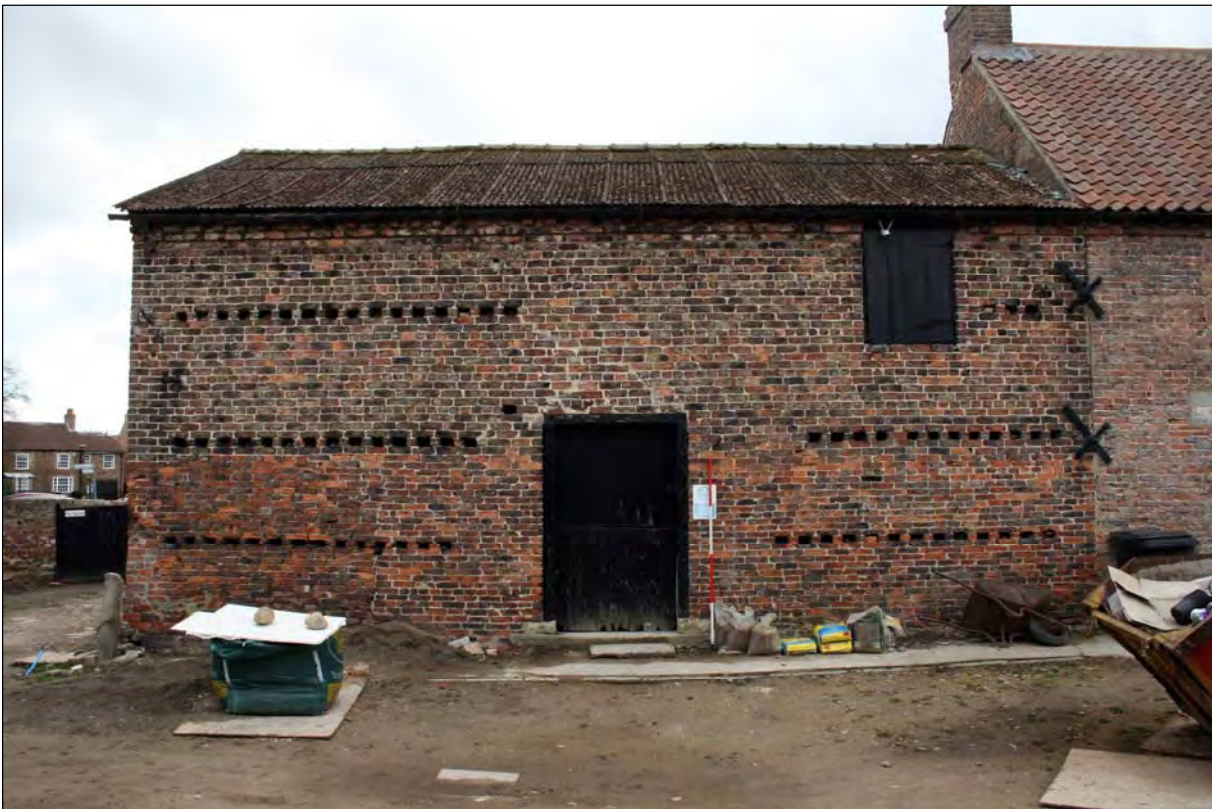
Plate 54. B5 exterior looking southeast (image no. 410).

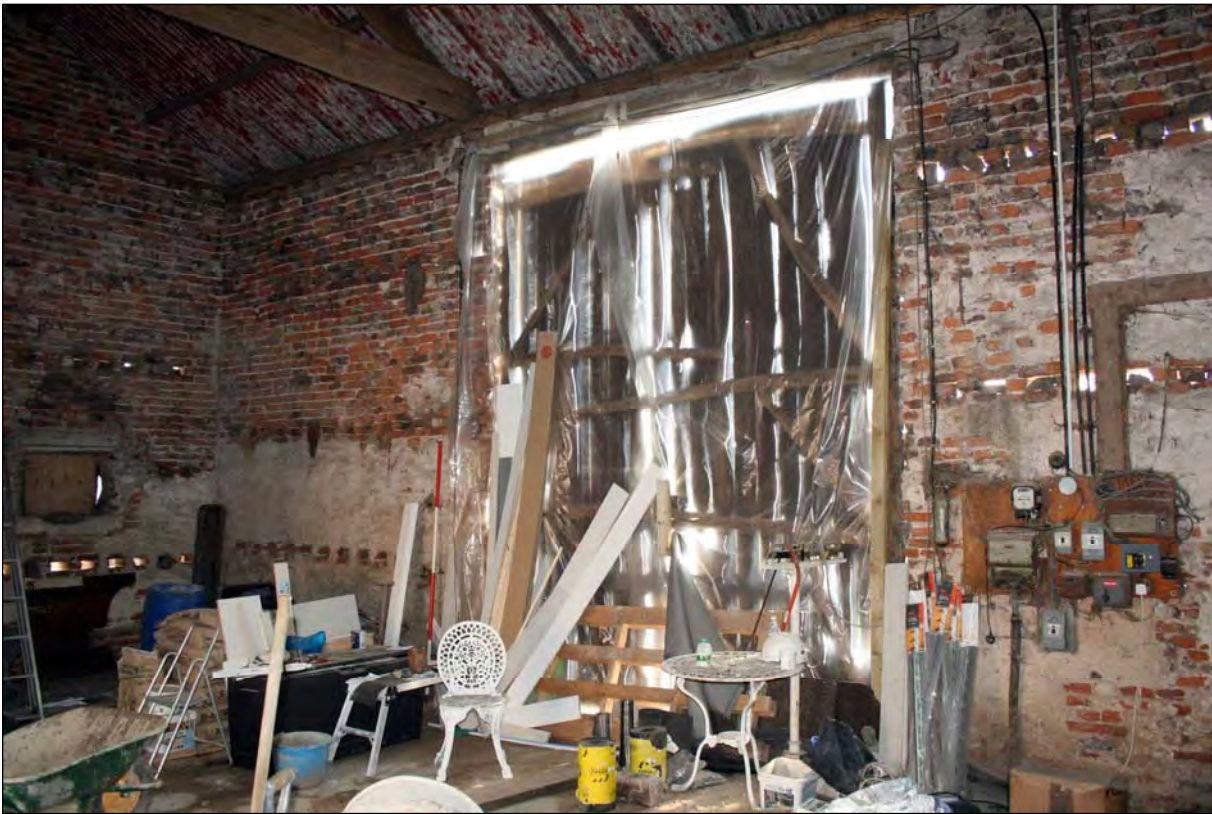
Plate 57. B5 interior looking east (image no. 296).
