St Chad's Church, Montford, Shropshire:
Repairs to Churchyard Wall

Archaeological Monitoring

SLR Ref : 406.04217.00001

November 2012

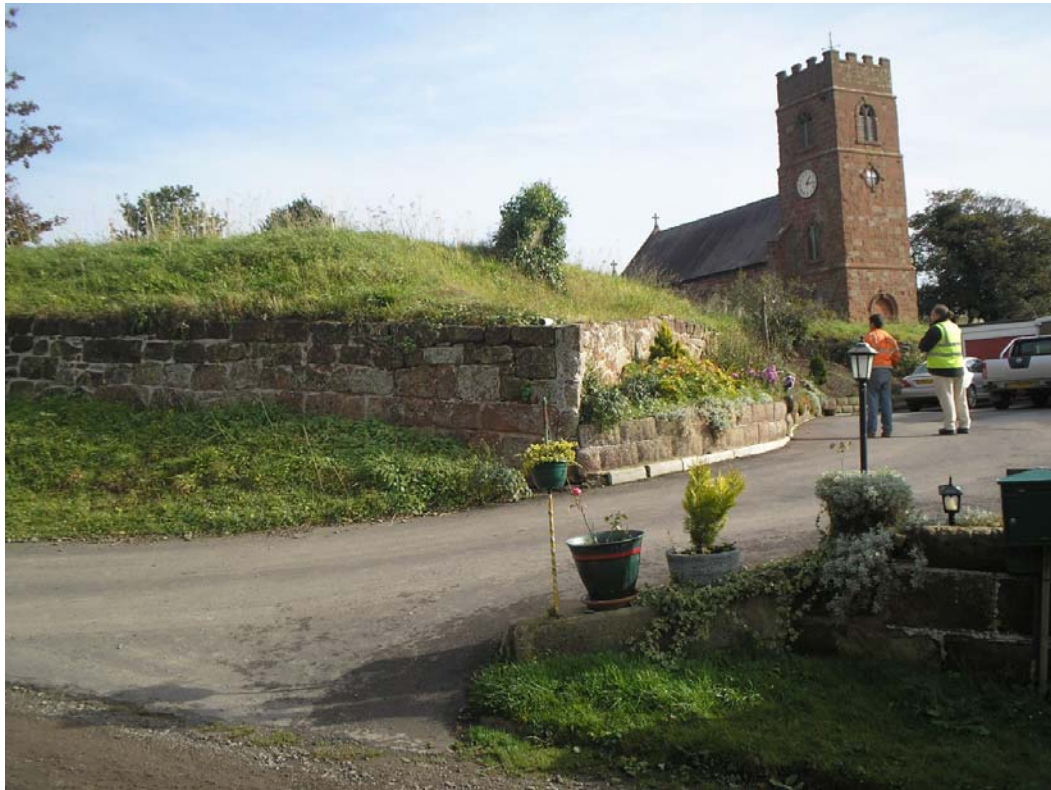
Figure 1 Location of churchyard wall repair in relation to St Chad's church

Repairs were undertaken to an eight metre length of the churchyard wall on the north-western side of the churchyard (Figures 1 and 2), which acts as the boundary between the churchyard and the driveway to a bungalow. The height of the churchyard deposits behind the wall had resulted in pressure against the wall in this location, destabilizing it so that it had bulged out and was likely to collapse in the near future. The design for the rebuilding of the wall and a specification for the engineering work is attached as Appendix A.

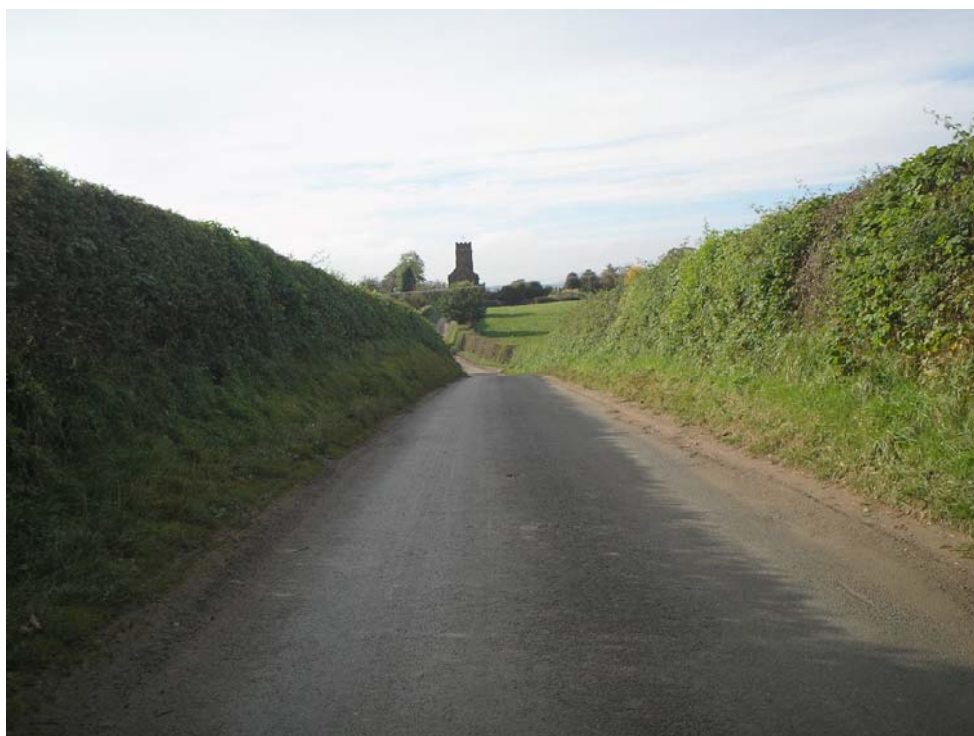
Figure 10 St Chad's from the east

The position of St Chad's shows that it had been carefully chosen to exploit a local high point, at the eastern end of a ridge which provided views overlooking the Severn floodplain to the south. The road from Shrewsbury approaches the church in a straight line from the east-north-east (the same alignment as the nave and chancel (Figure 10)), and on the first edition OS mapping (Figure 11) a footpath would appear to extend this route to the west from the Montford Farm. The current road loops around the churchyard which has several yew trees lining the northern boundary. The shape of the boundary wall suggests that originally a smaller enclosure might have surrounded the church, which was extended to the north-west at a later time. The repaired wall would have formed part of this extension. The juncture between the wall beside the road and the repaired section at the north-western corner of the churchyard, shows the repaired wall had been butted on to the road-side wall, rather than built as a single, interlocking structure.

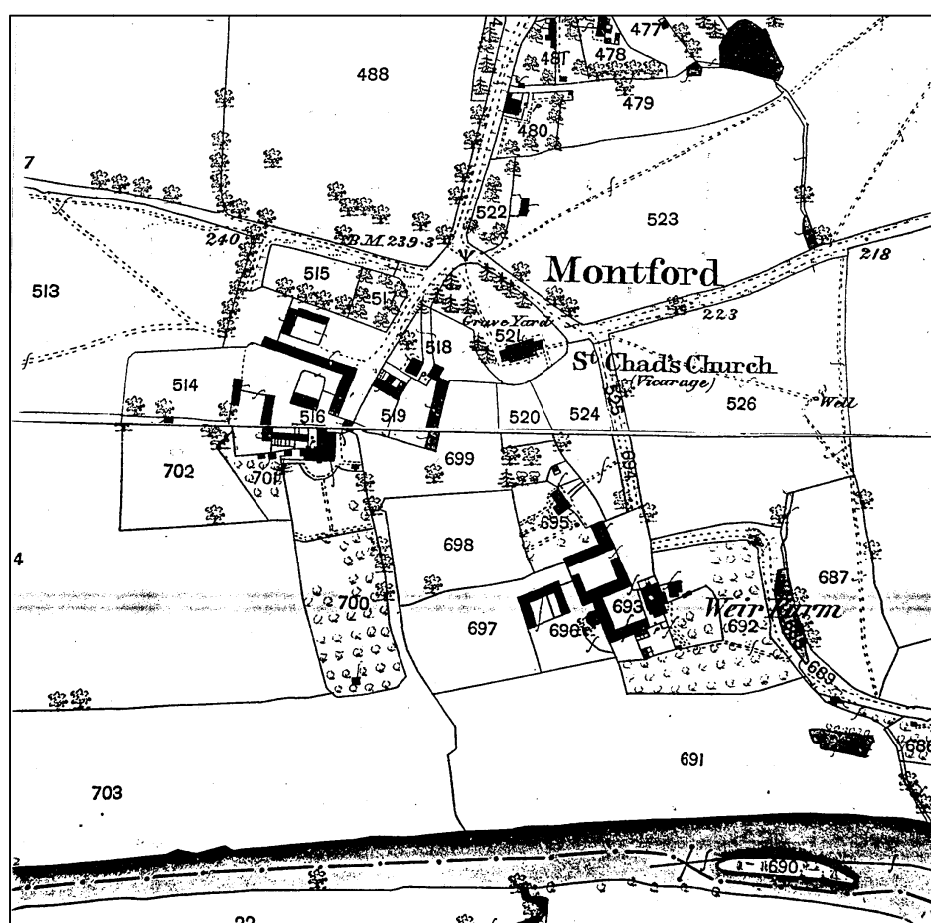
Figure 11 The 1882 1st edition OS map showing churchyard boundary

Note sub-rectangular enclosure around church, and extension of graveyard to north-west
