Land to the Rear of The Habit, 30 - 32 East Castle Street,
Bridgnorth

Heritage Statement:
survey of wall sections, analysis and historic mapping
along Castle Terrace and Bank Street

SLR Ref : 406-04694-00001

December 2013

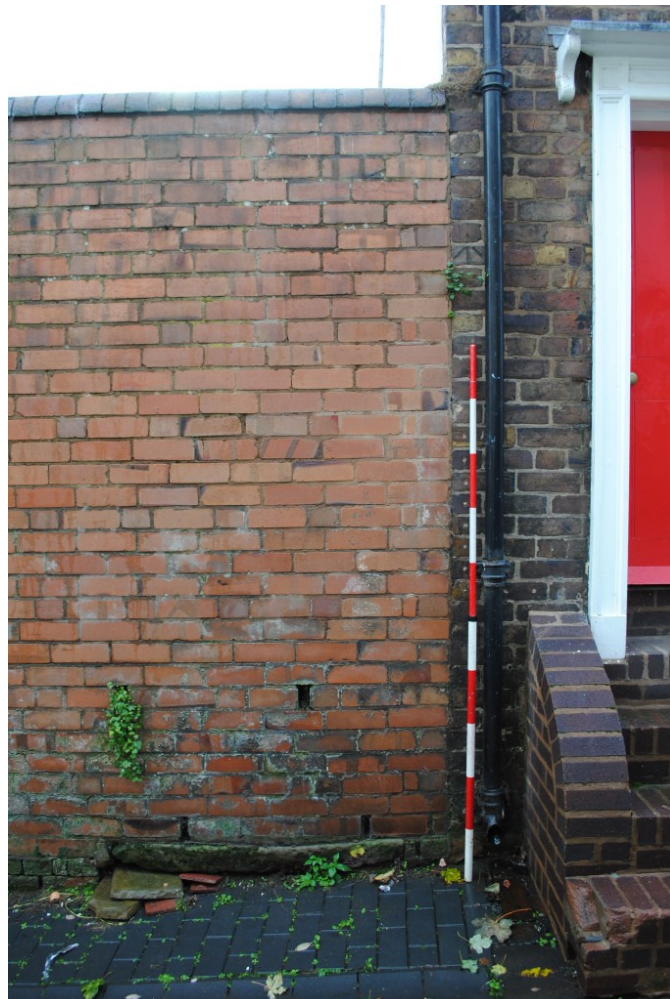
The wall section in Bank Street extends c. 12m in length and abuts the eastern elevation of No. 5 Bank Street. The earliest phase within this wall section (Phase 2) is identical to brickwork located on the Castle Terrace wall section (and is physically connected). The western section of the wall is constructed of a 20th century frogged rustic-type brick (Phase 11). This phase, the latest in the brick sequencing, probably represents a recent blocked-in entrance or a complete rebuild of this section of the wall. A clear vertical line exists between this wall section and the earlier wall phasing (Phases 2 and 7). The rustic brickwork sits on top of the earlier Phase 2 brick coursing. Along the entire Bank Street wall section, both the earlier and modern brickwork has been finished with mounded curvilinear brick capping, using conventional terracotta red brick sets and blue engineering brick (Phases 12 and 13).

Figure 2
The Bank Street wall section, looking south, and detail of western end with step (below)

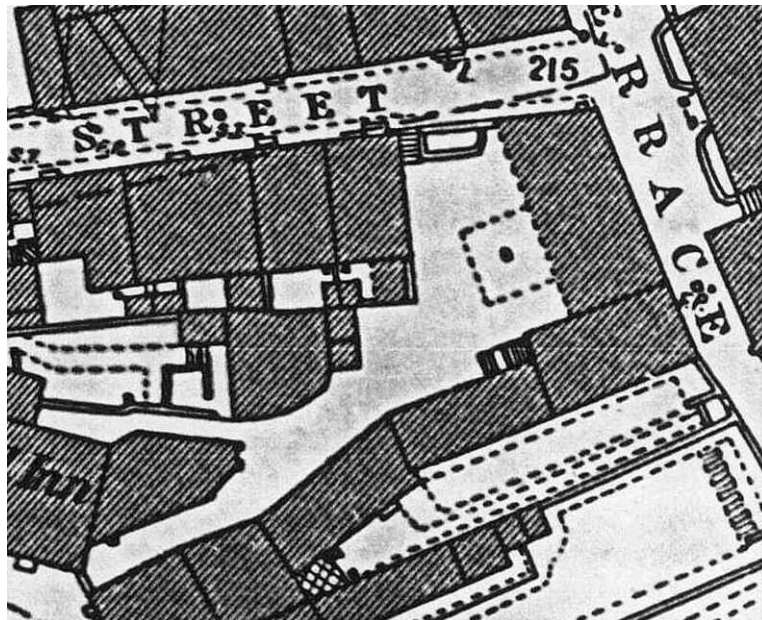
By the time of the publication of the Ordnance Survey map of 1884 (scale 1: 2500), the area behind both walls was probably developed as a terrace of three buildings, forming the eastern section of the enclosed Ball Inn courtyard (later to become the Ball Hotel – see Figure 6). Close scrutiny of the features shown adjacent to No. 5 Bank Street show a flight of steps (Figure 6a), which must have descended into Bank Street, as the ground level within the application site is c.2m above the street level. This demonstrates that an entranceway must have existed through the Bank Street wall in the late Victorian period, and the stone visible at the base of the modern brickwork (Figure 2) is in fact the bottom step of this stairway. Examination of the centre of the stone shows a depression, presumably caused by usage. There are six steps shown on the map, and if on average each was 0.4m, then the full depth of the stairwell would be 2.4m, which would accord well with the height above Bank Street of the existing ground surface within the application site.

Figure 6 1884 1st edition Ordnance Survey map

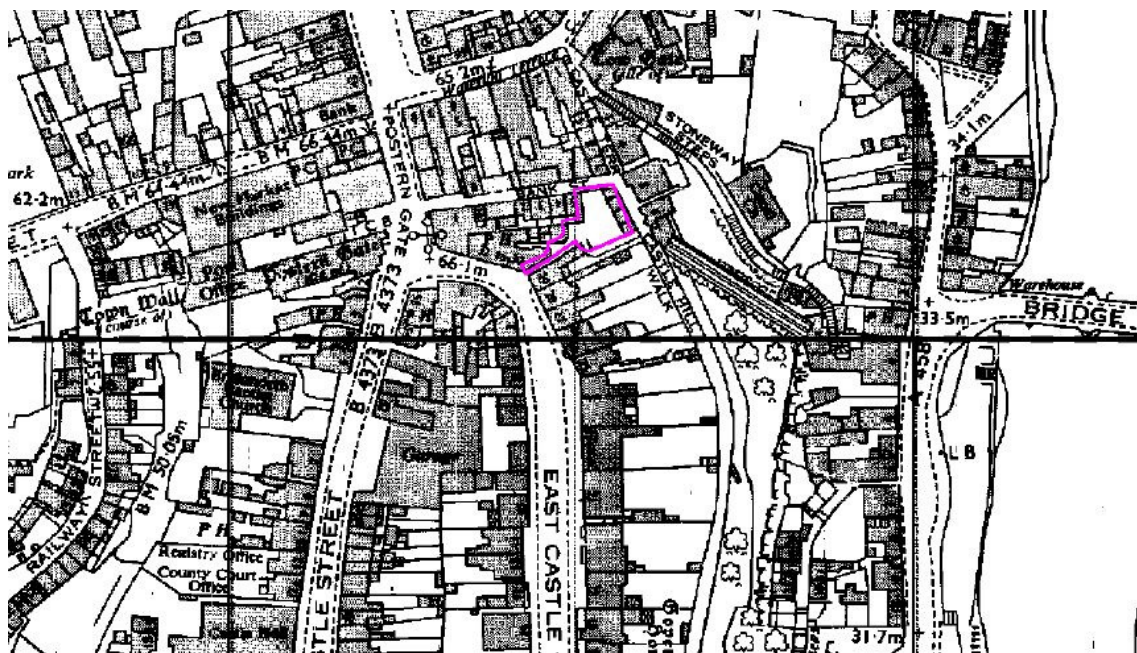
By the time the Ordnance Survey map of 1903 was published (scale 1:10560), three interconnected buildings are clearly delineated (Figure 7). The photograph dating to c. 1900 showing the upper winding house of the funicular railway also shows the Castle Terrace wall section, which at this time appears to have formed the eastern elevations and a gable end of three buildings; the two buildings to the north have their pitched roofs sloping towards Castle Terrace, whilst the southern building has the pitch perpendicular (Figure 4). The gable end of this building (fronting Castle Terrace) and neighbouring range appear to show window casements inserted into their upper sections (Figure 4). Based on height and individual character of each bay, this range was probably dwellings or workshops rather than stables.

Figure 7 1903 2nd edition Ordnance Survey map

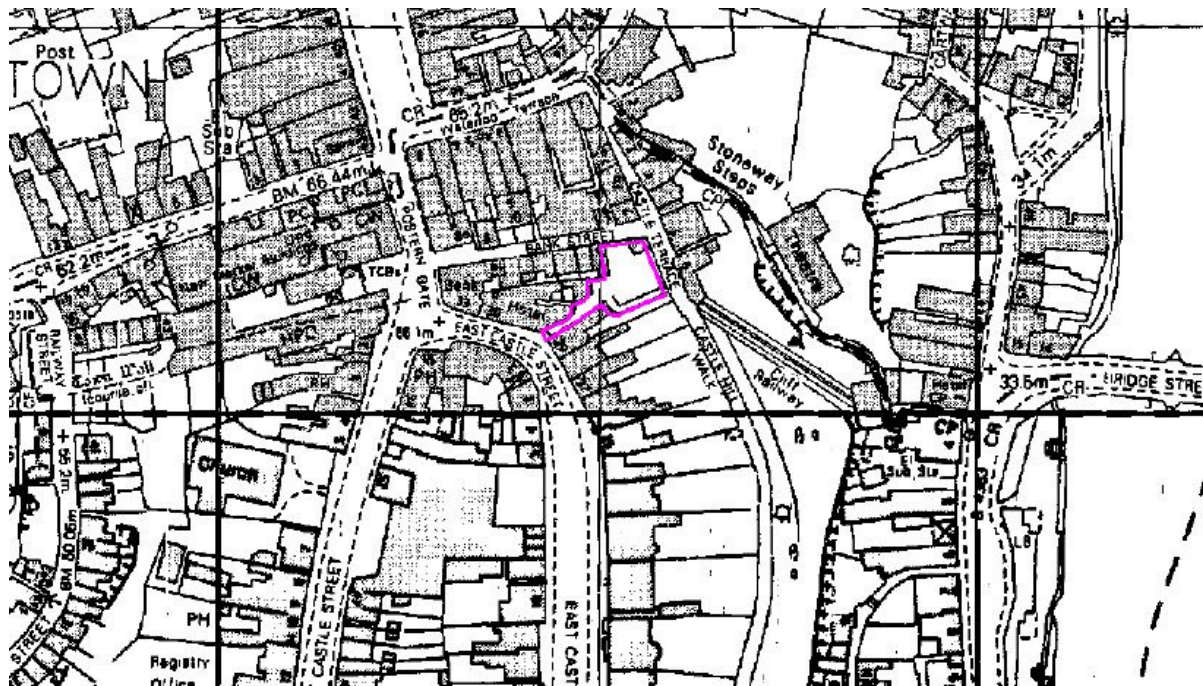
The Ordnance Survey map of 1926 shows that the building range has been demolished, thus opening the courtyard area further. The plot appears to have remained open until the early 1960s when a range of four individual cells, probably garages, are constructed along the Castle Terrace wall section (Figure 8). This innocuous development is also shown on Ordnance Survey maps between 1968 and 1978. However, three of the cells appear to have been demolished sometime around the publication of the 1991 Ordnance Survey map (scale 1:10,000). On this map the northern cell, connected to both wall sections, remains standing (Figure 9).⁶ The footprint of this cell may replicate the footprint of the medieval corner tower that was part of the castle curtain wall.

Figure 8 1967-78 OS map showing garages along east wall of application site
