ALL SAINTS' CHURCH, BASCHURCH, SHROPSHIRE

ARCHAEOLOGICAL WATCHING BRIEF REPORT

**On behalf of the Parochial Church Council of
All Saints' Church, Baschurch**

SLR Ref: 406.10768.00001
Version No:2
September 2020

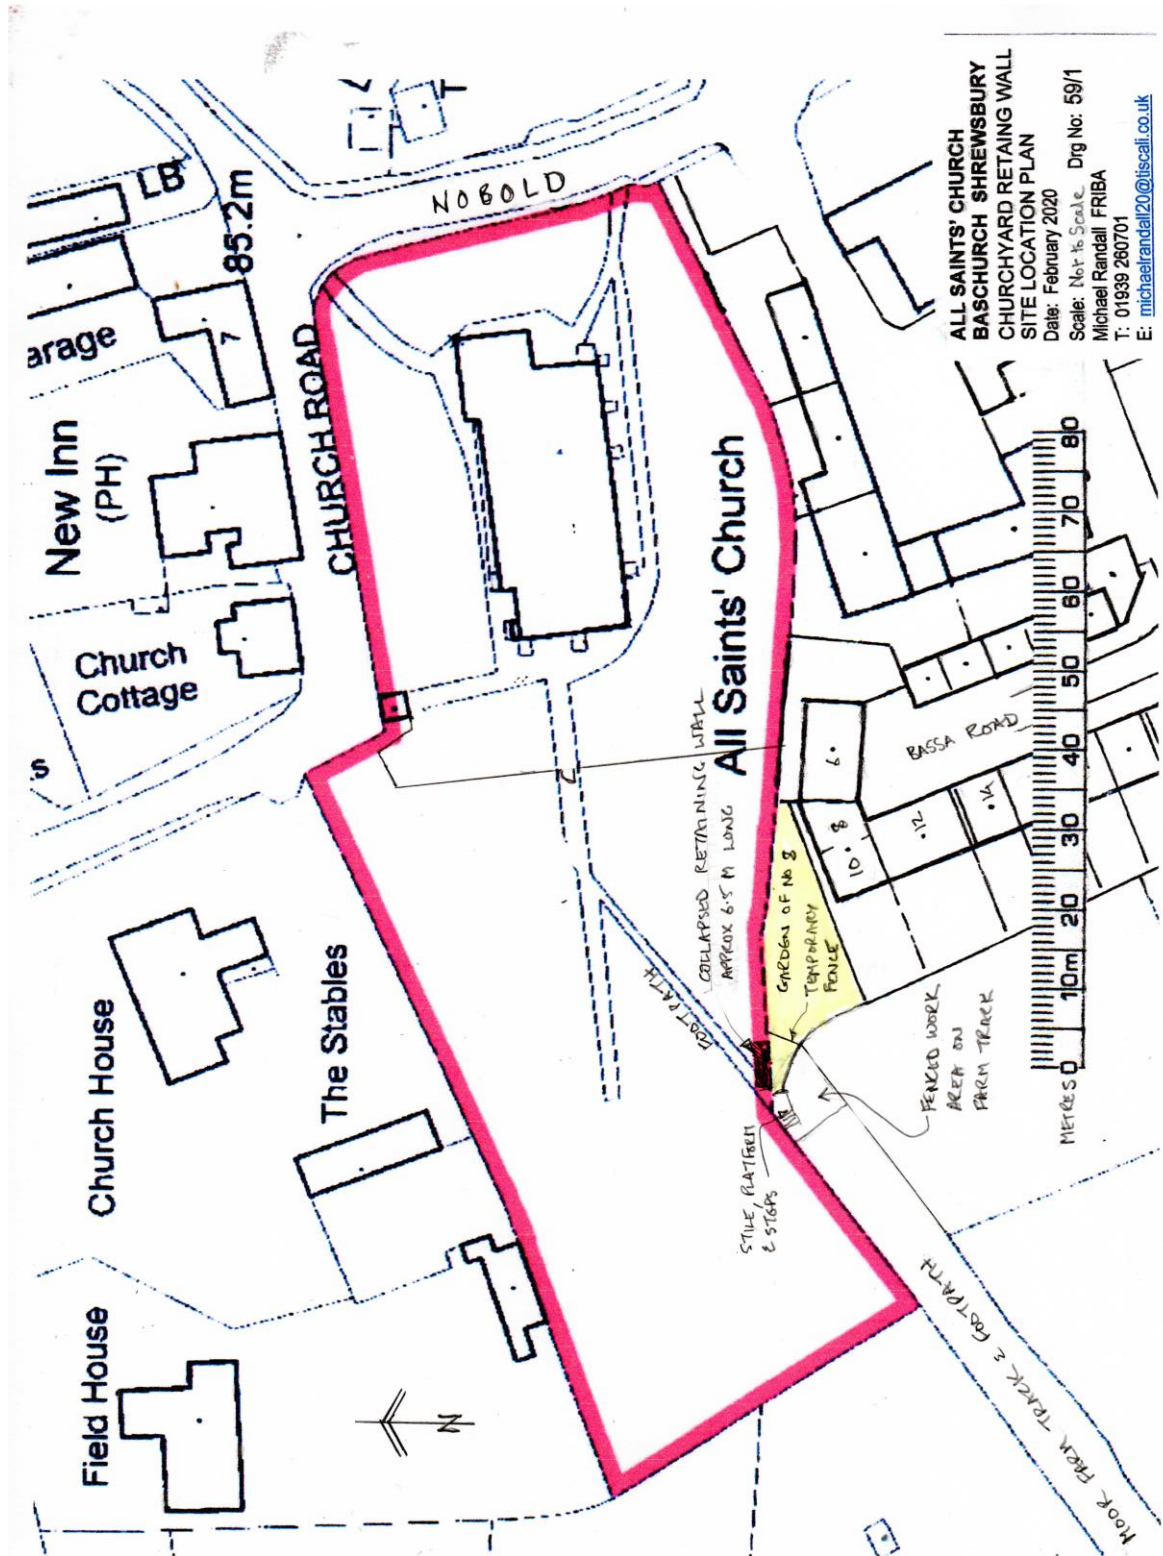
Figure 3
Detailed location of works

In March 2020 SLR was approached by Michael Randall, acting on behalf of the Parochial Church Council for All Saints Church, Baschurch, Shropshire, for assistance with the archaeological implications in relation to the repair of a graveyard retaining wall which collapsed into a neighbouring garden following storms earlier in the year. The site is centred at National Grid reference SJ 422 218 (Figures 1 and 2), and forms the southern boundary wall to the graveyard, which is a western extension to the churchyard surrounding the church. The graveyard is c.1.6m higher than the surrounding land (Figure 4), and the wall has collapsed into land that formerly formed part of the adjacent Moor Farm, recently converted into residential units as part of a development called Bassa Road.

51: REMOVE collapsed stone and other materials from the garden. Take care to avoid disturbance to the retained earth. If necessary, provide temporary shoring. At each end of the collapse check adjacent stones remaining in the wall and remove any that are loose or where the mortar is not sound.

52: EXCAVATION AND CONCRETE FOUNDATION Remove stones within the lower level of the wall down to bare earth, but do not excavate back into the churchyard. If necessary, provide shoring to retain the churchyard earth.
