SHERIFF HUTTON CASTLE,  
SHERIFF HUTTON, NORTH YORKSHIRE

ARCHAEOLOGICAL AND ARCHITECTURAL SURVEY  
OF THE NORTH-EAST TOWER

Report no: 2002/158.R01  
Version: Final  
Date: April 2008  
Author: Shaun Richardson & Ed Dennison

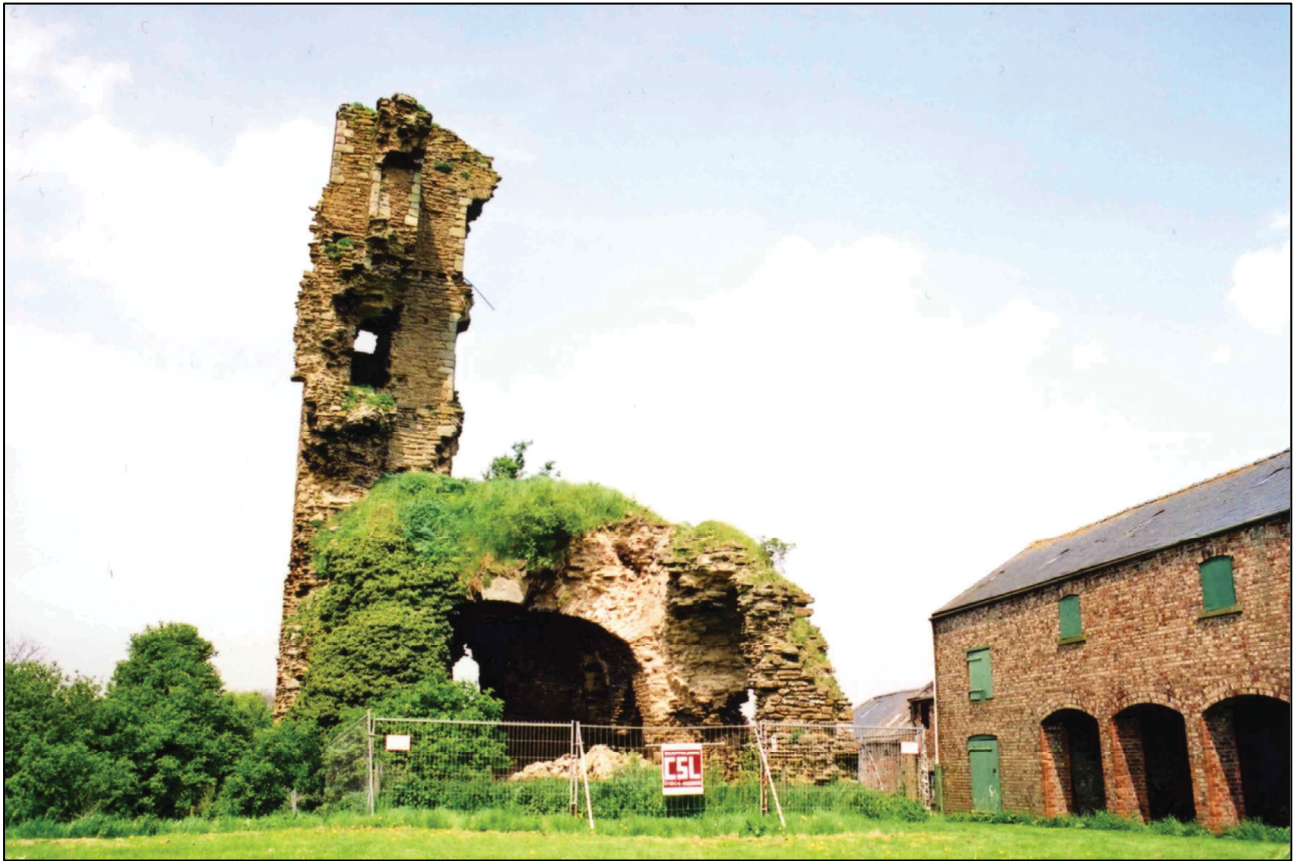
Plate 3: North-east tower, looking N, prior to repair and consolidation (September 2001).

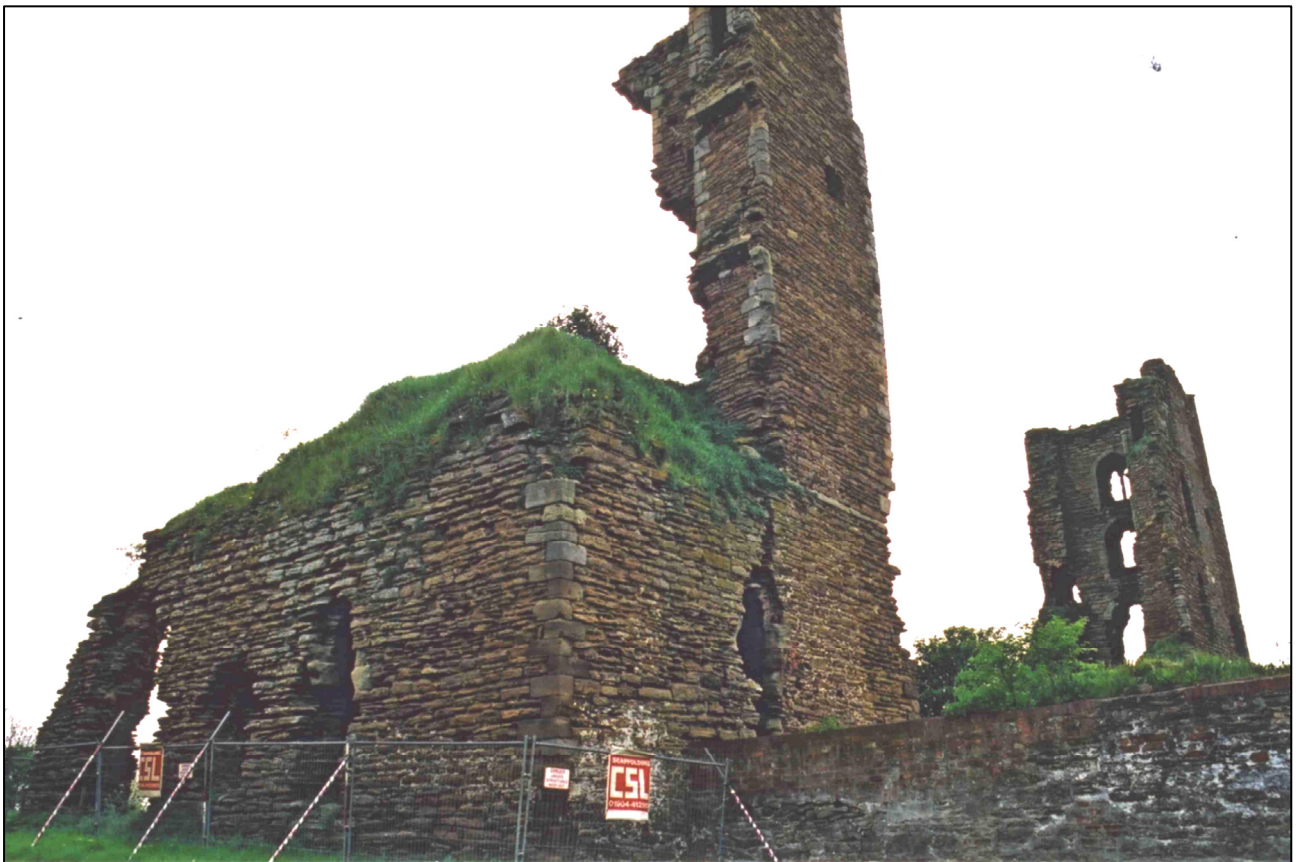
Plate 4: North-east tower, looking SW, prior to repair and consolidation (September 2001).

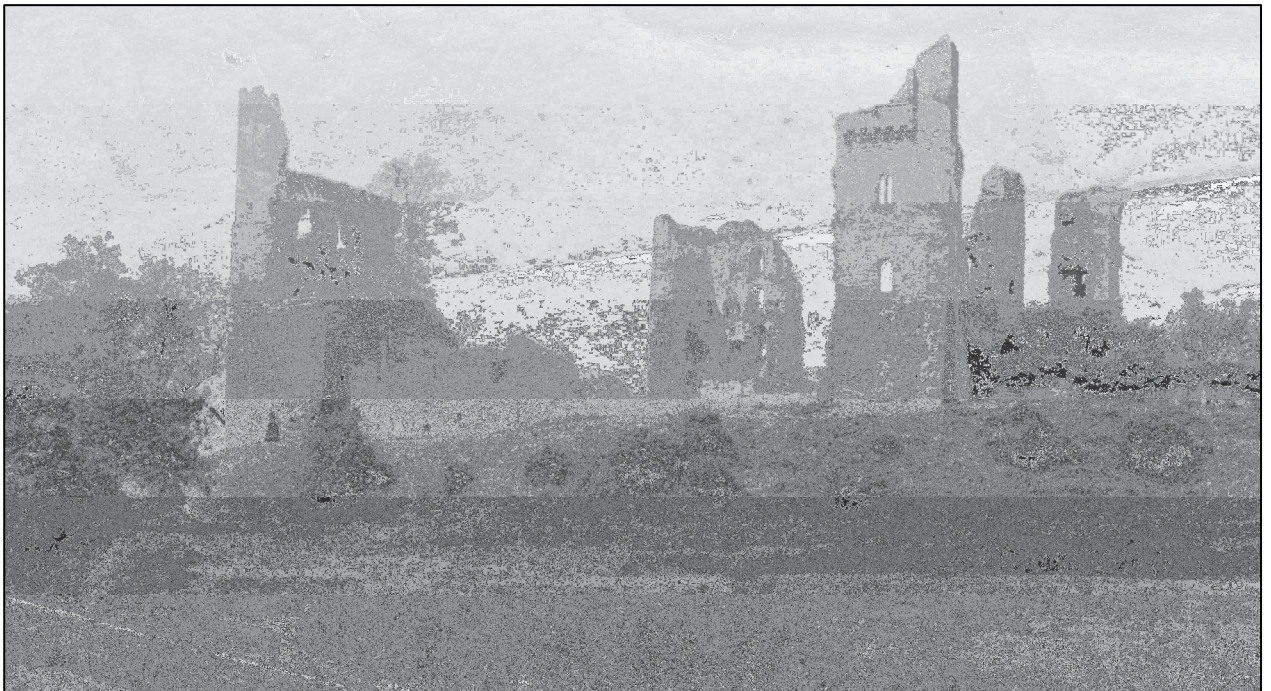
Plate 12: Photograph taken between 1875 and 1887, showing collapse of the NE tower (Tony Wright collection) (NE tower on extreme right).

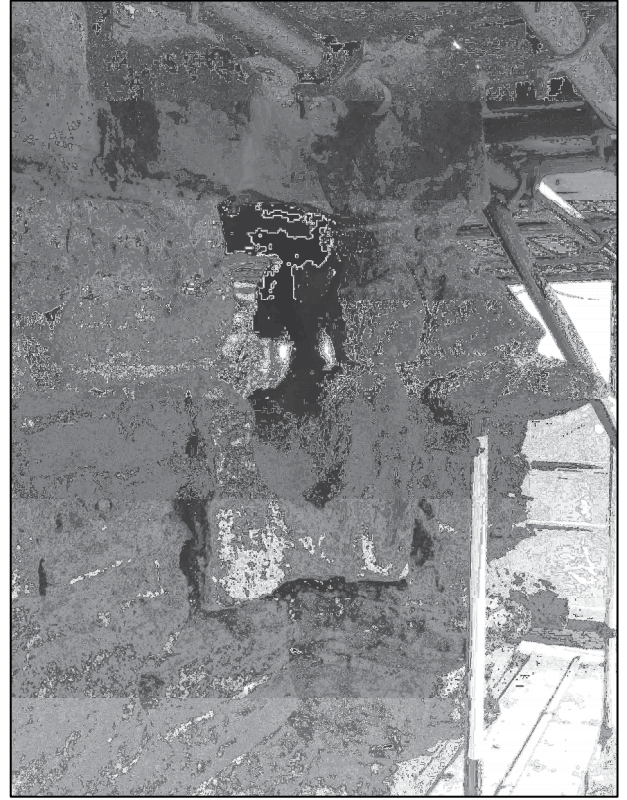
Plate 22: Second floor spout, west external elevation, prior to consolidation.

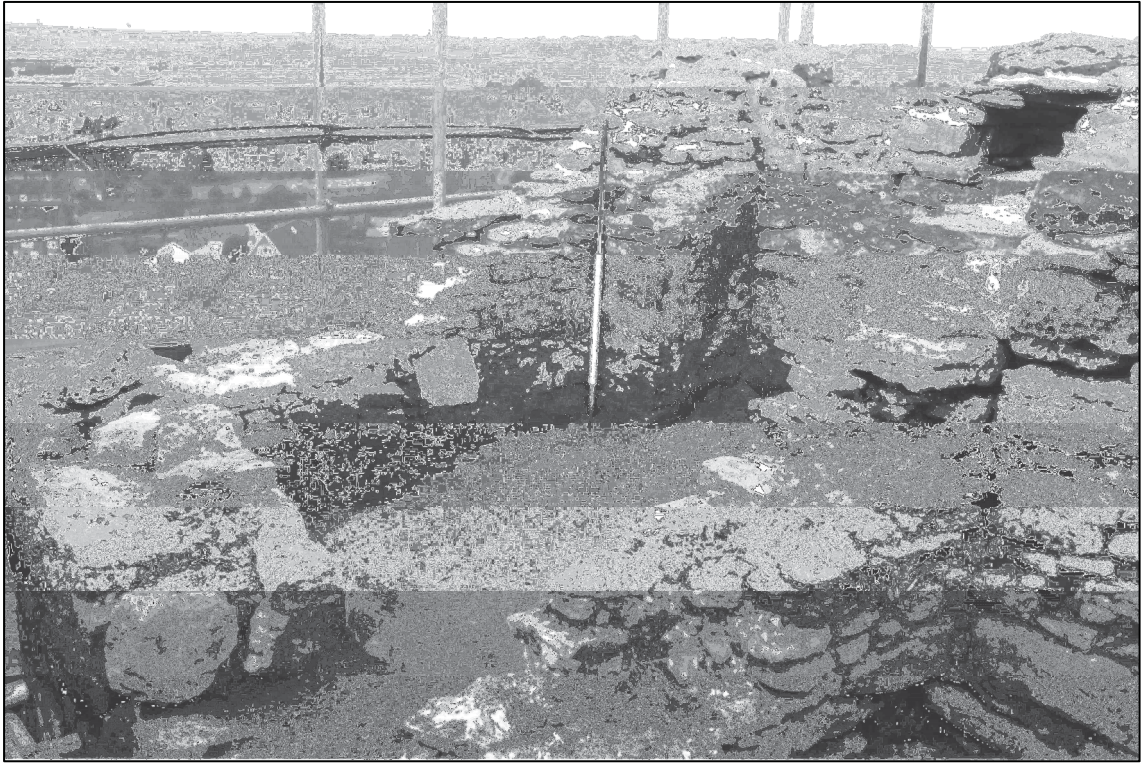
- 7.16 The uppermost surviving level of the north-east tower was represented by a small room, perhaps taking the form of a small corner turret (see plate 25). The room had a sink and spout (perhaps a urinal) in the north wall, and a fireplace (FP2/2) in the west wall, although there was little evidence that this had been used. The room was accessed by a doorway (D2/4) in the south wall, which presumably lead from a wall walk on the west side of the tower. There is no surviving evidence as to how this wall walk was accessed, but the newel stair discussed above in the south-east corner of the tower may have risen to this level; a newel staircase at Harewood Castle in West Yorkshire does just this, rising the full height of a tower to a wall walk (Richardson & Dennison, *in prep.*), and a similar arrangement is shown in reconstruction drawings of Middleham Castle during the late 15th century (Weaver 1998, 15). There is fragmentary evidence for a flight of stone steps rising over the room, perhaps to a corner platform positioned above. This is exactly the arrangement shown at Bolton Castle by Hislop in an isometric reconstruction (Hislop 2007, figure B17), while the external string courses and vertical "ribs" at this level also bear a strong similarity to those seen at Bolton.

Plate 25: Room at uppermost level, showing fireplace (FP2/2), after excavation and prior to consolidation, looking NW.

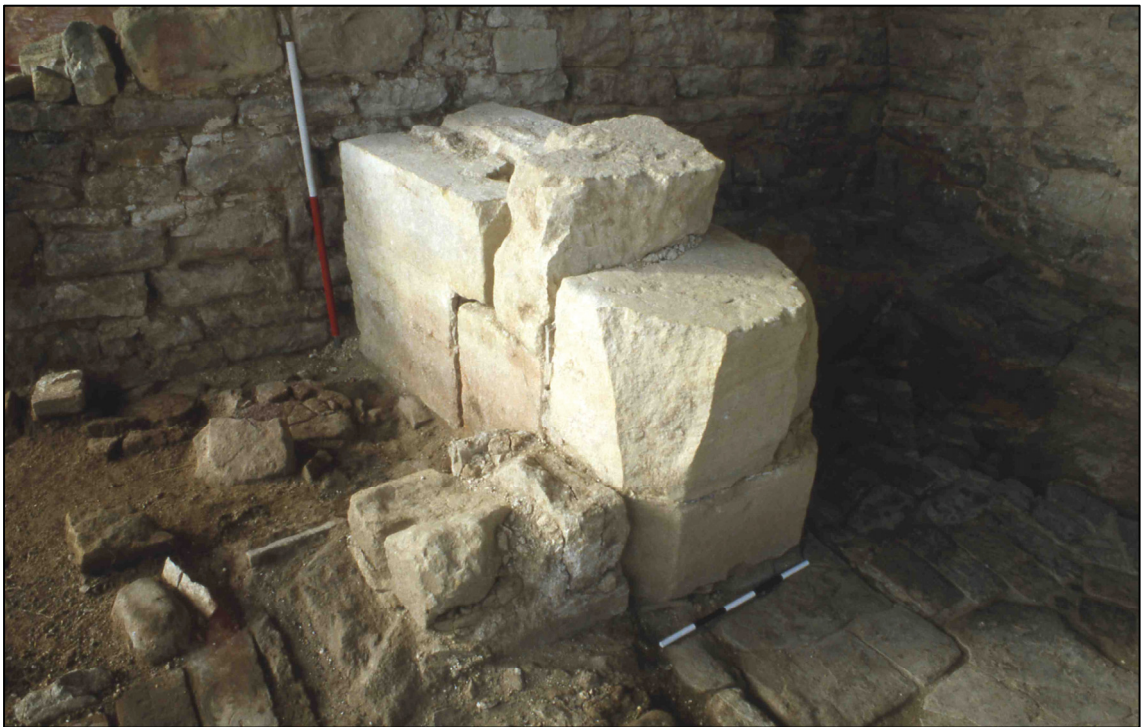
- 7.12 It seems likely that the ashlar wall (005) was a later addition to the room, and a great deal of trouble was taken with its appearance and the quality and type of the stone from which it was built (see plate 33). Although it has been suggested that it formed the remnants of a diaphragm arch (FAS 2003, 52), this is unconvincing for a number of reasons. Firstly, a diaphragm arch of stone on the first floor would be a massive structure, and no evidence was found for the collapse of such a structure. One might also at least expect the opposite side to survive, at least to some extent, and, although there was a block of stone (023) in this location (see figure 16), it was not convincing as being part of the same structure. Arguably any support produced by a diaphragm arch would have been more economically and less intrusively achieved by the use of timber. The quality of the stonework in the wall is also too high, and the surviving chamfering, together with the evidence for a small opening in the wall, suggest it is more likely to have been an internal partition of some kind.

Plate 33: Excavation Area D - detail of ashlar wall (context 005), showing burning on south side.

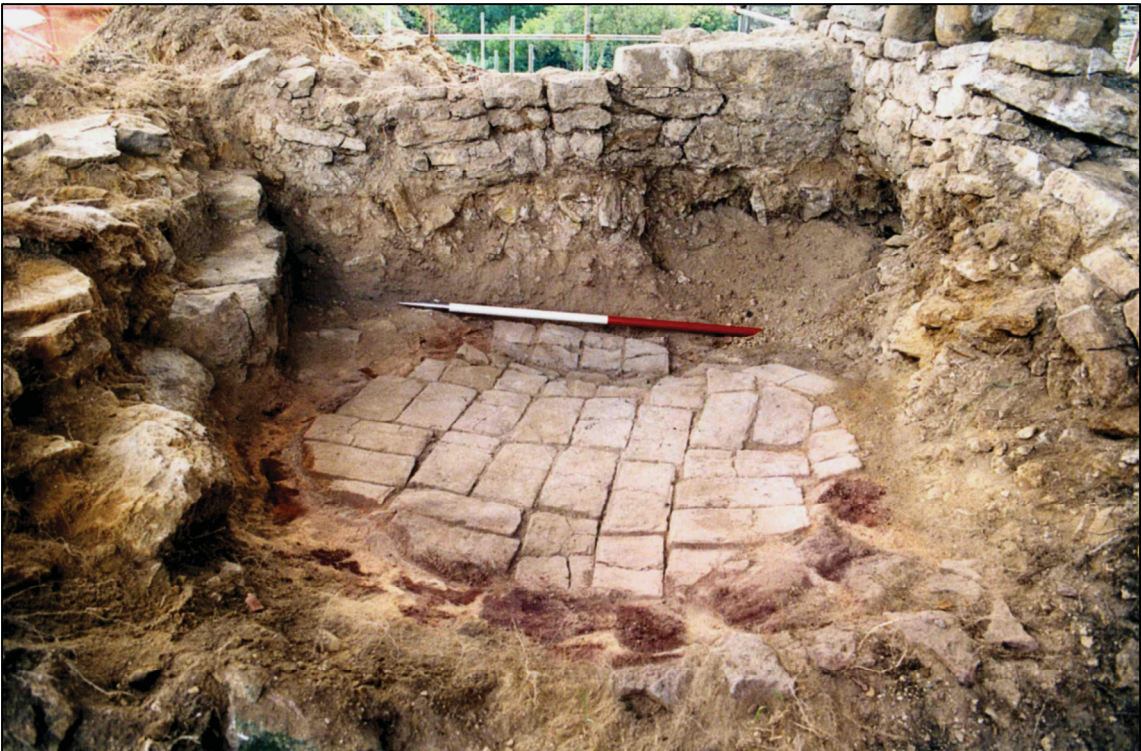
- 7.13 The other features arranged around the edge of the floor surfaces are easier to interpret. The awkward juxtaposition of the north window (W2/4) and the small circular oven (025) (see plate 35) to its east suggests that the oven is a later insertion, although this is not certain, and a fairly major effort would have been needed to cut the accompanying flue into the existing wall. It is assumed that the oven had a small beehive dome over it, and it may have functioned as a small bread oven, as seen in the kitchens of, for example, Skipton or Harewood castles. The presence of a bread oven in one corner of the room is in contrast to the apparent high status suggested by the ashlar partition wall (005), the rib above the window arch, and the possible projecting hood to the fireplace in the east wall, again suggesting it is a later insertion. The chamber was almost certainly once served by a garderobe, although the exact position of this is now lost; it may have been in the south-east corner over the one on the ground floor (see figure 5). There was no obvious access between the chamber and the north range, although there may once have been a connection to other rooms at this level in the east range.

Plate 35: Excavation Area D - brick oven base (context 025), looking S.
